UNDERWATER FACILITIES
INSPECTIONS
&
ASSESSMENTS

U. S. NAVAL STATION
GUANTANAMO BAY, CUBA

AUGUST 1980

PERFORMED BY:
UNDERWATER CONSTRUCTION TEAM ONE

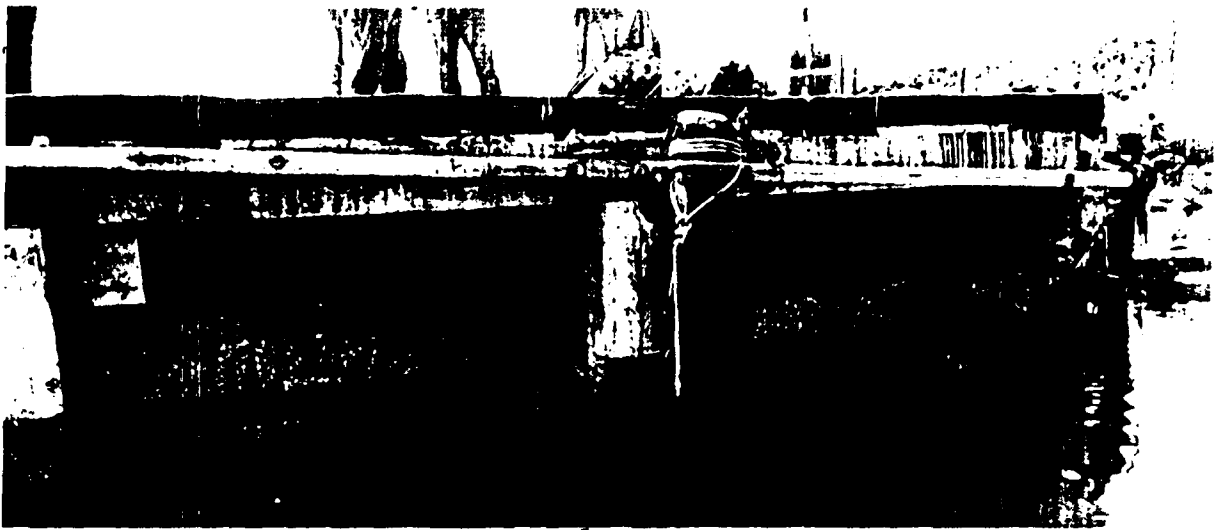
FIGURE 1

EXPOSED REINFORCING BAR OF PILE CAPS AND DECK BEAMS, PIER D

- o Repairs to the deteriorated concrete be initiated, as soon as possible.

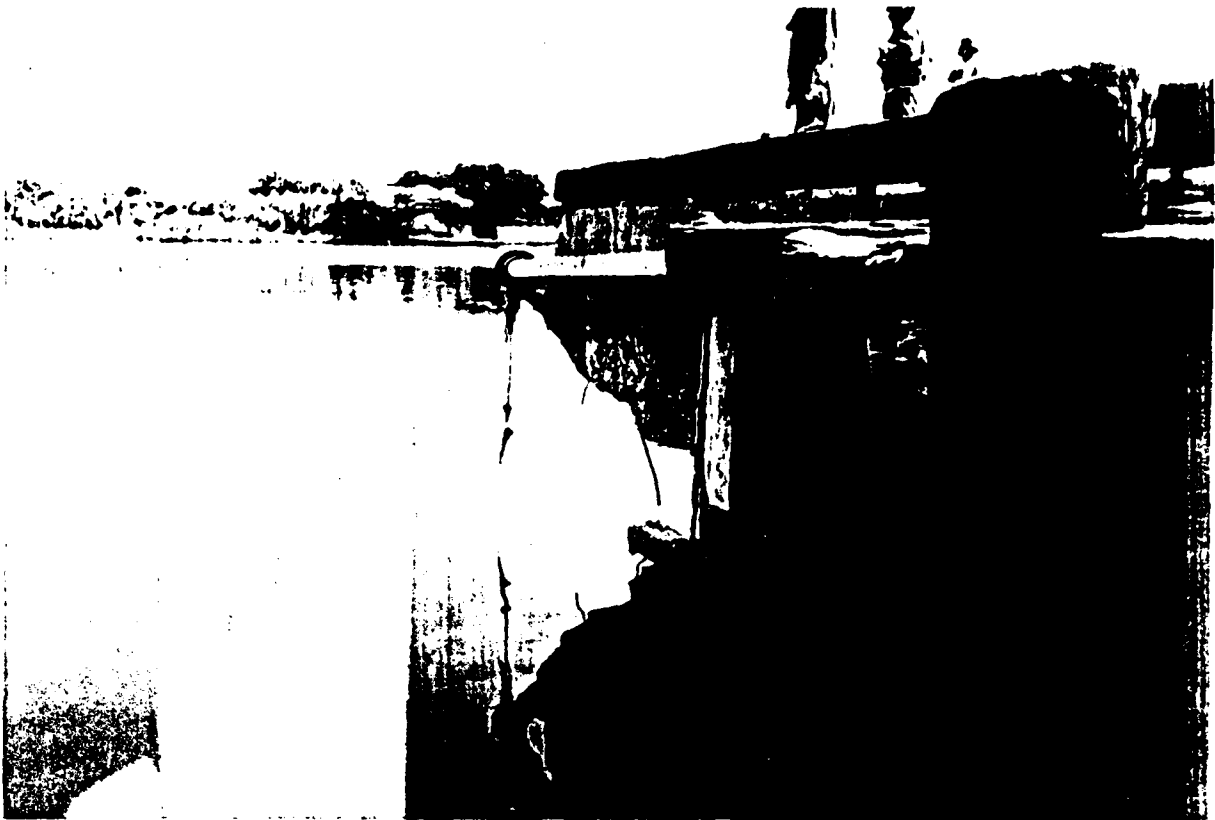
FIGURE 20

DESTROYED FENDER SYSTEM; PIER D

- o The present system of floating wood camels be removed from contact with the pier and that a camel system be designed and installed in a manner that is not detrimental to the structure.
- o The fender system be repaired and maintained to prevent destruction of the pier support system.
- o The pile tops be treated and capped to prevent fungus rot.
- o Dolphin piles be removed or repaired and protected to prevent degradation by limnoria attack.
- o Deck hardware be protected by isolation or protective coatings applied to prevent accelerated degradation by concrete. Deck hardware degrades because it is anodic to the passivated steel within the adjacent concrete.

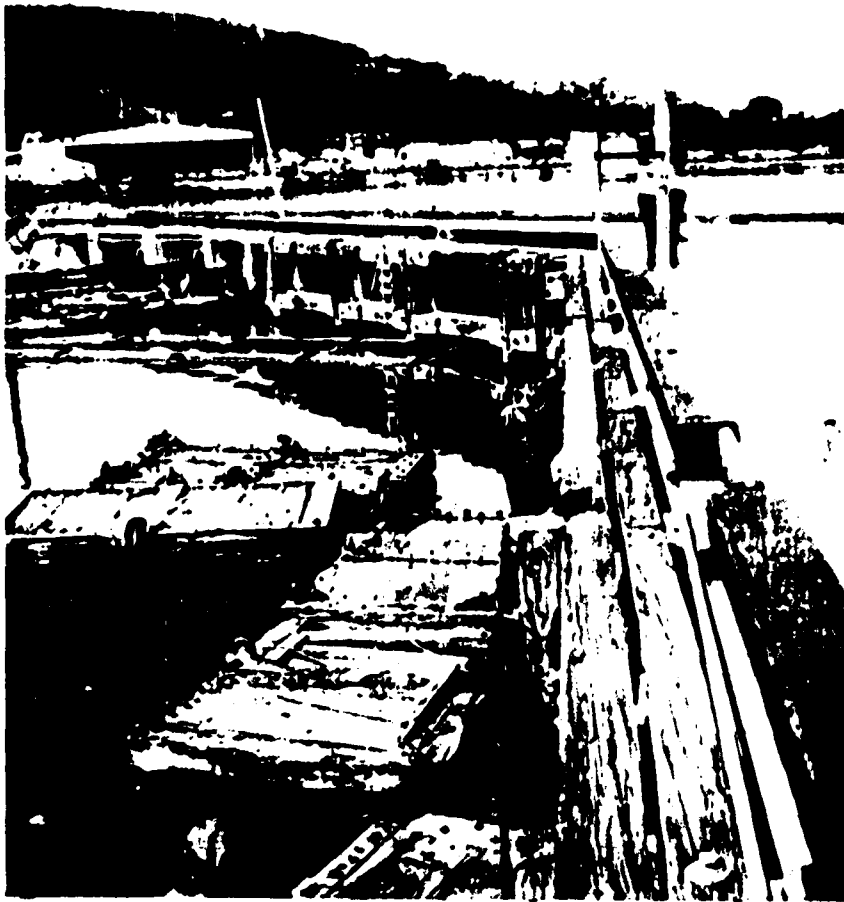
FIGURE 22

DESTRUCTIVE CAMEL SYSTEM; PIER D

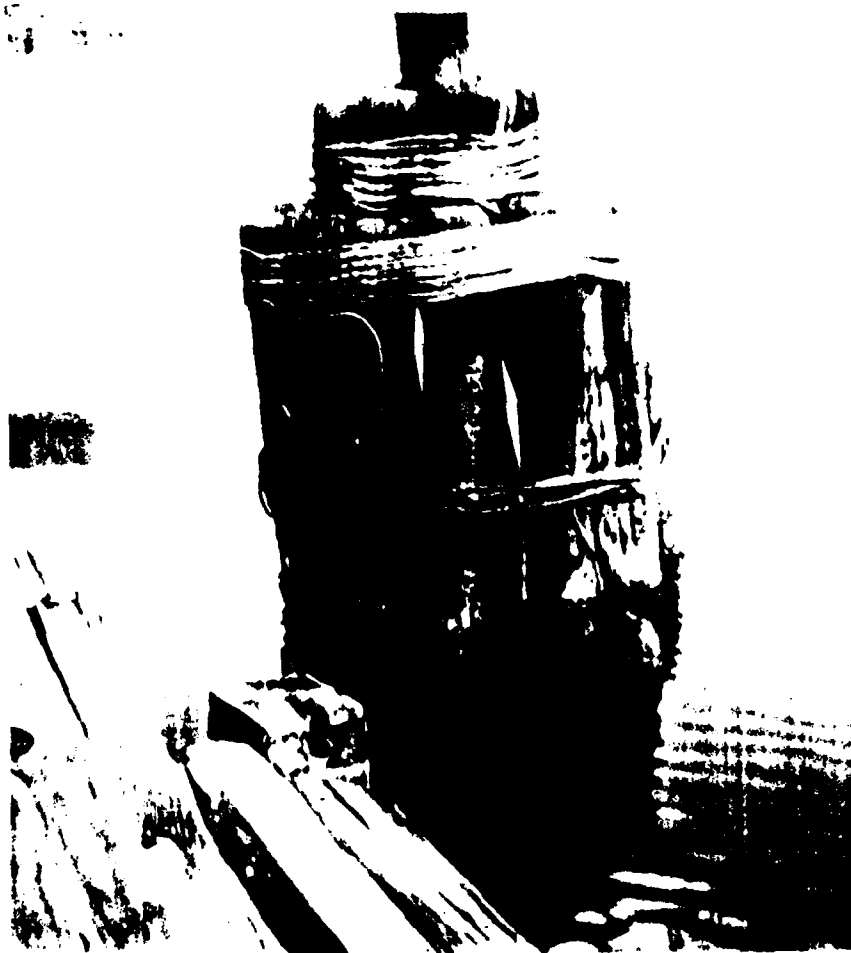
FIGURE 24

LIMNORIA ATTACK AND FUNGUS ROT OF
DOLPHIN PILES; PIER D

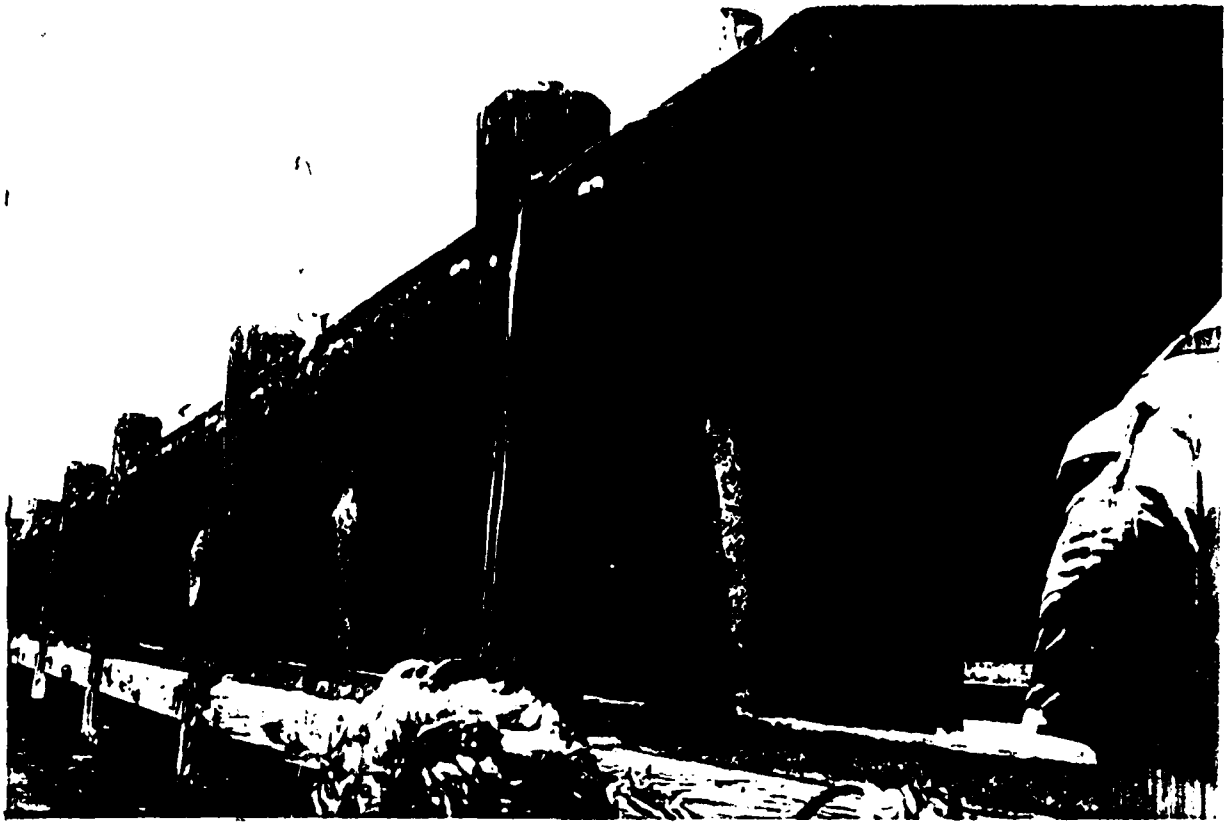
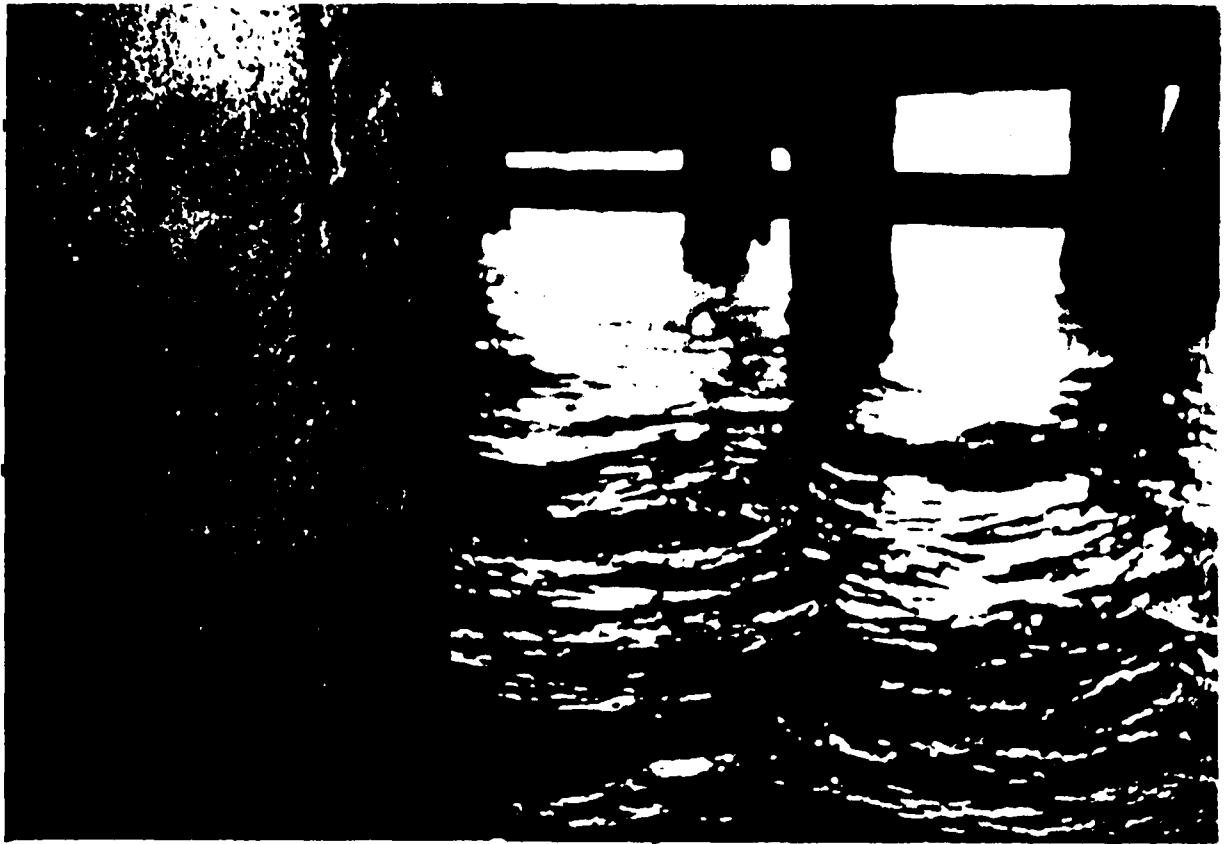
FIGURE 39

SPALLING CONCRETE COVER OF FENDER PILES; PIER C

- o The sheet piling be repaired to prevent further soil subsidence.
- o Repairs of spalling concrete, cracked girder, and areas of *bleeding* concrete be repaired to halt further deterioration of the structure.
