**FLEET MOORING  
UNDERWATER INSPECTION REPORT  
LA MADDALENA, ITALY**

FPO 1-81 (24)  
DECEMBER 81

OCEAN ENGINEERING  
AND CONSTRUCTION PROJECT OFFICE  
CHESAPEAKE DIVISION  
NAVAL FACILITIES ENGINEERING COMMAND  
WASHINGTON, DC 20374

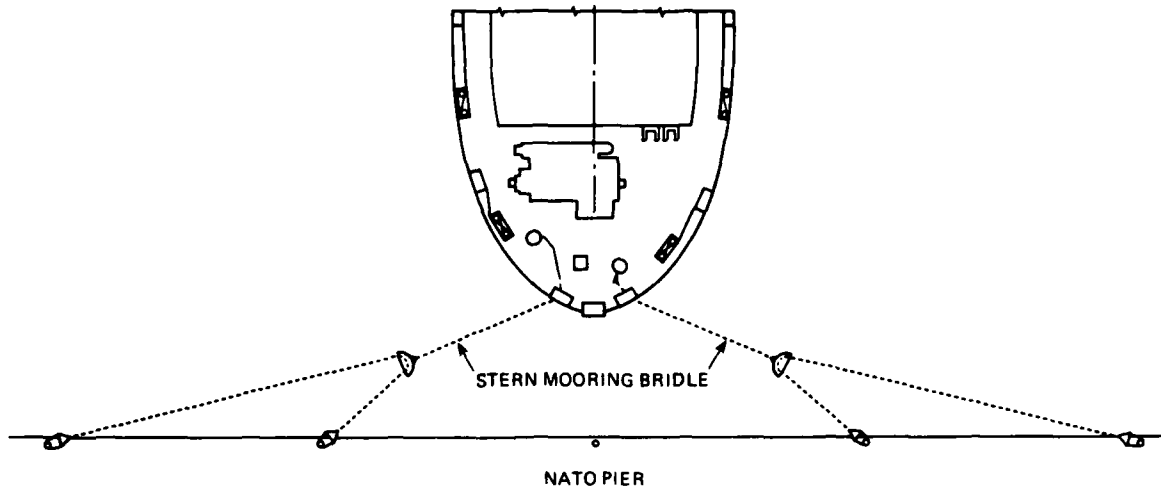
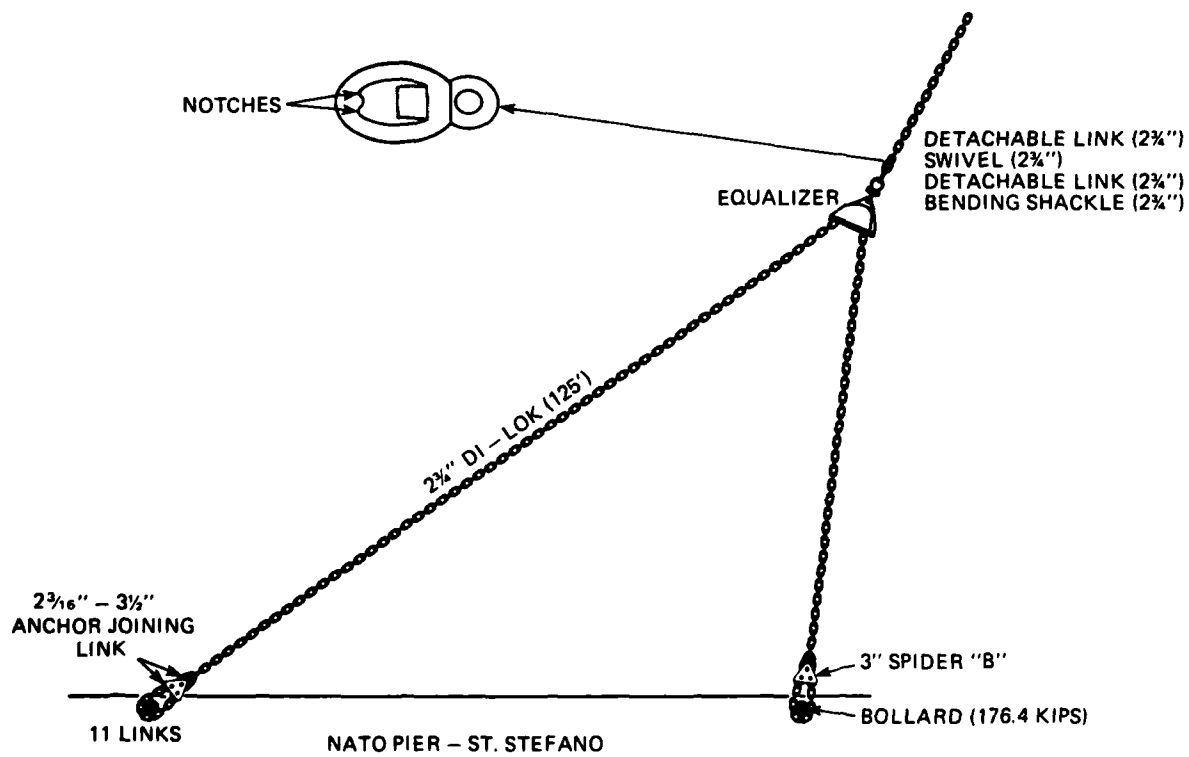
Figure A-1-1. La Maddalena Mooring, Stern Legs

1.2 Findings. All of the chain was coal tar epoxy or black paint coated and, with all of the sample wire diameter measurements taken showing greater than 90 percent of the original size, it appeared to be in good condition. Those links of chain which passed through the starboard equalizer had lost about 50% of their coating due to rubbing, and some light rust had formed. The equalizers were also coated, but about 30% of their surface areas had some light rust. The swivel above the equalizer, in each of the mooring bridles, contained a notch on each side of the lower wire, as shown in Figure A-1-2. These notches, however, did not appear to be caused by wear, and the swivels may have been cast this way during fabrication.

1.3 Conclusions/Recommendations. When the submarine Tender departs the mooring, the stern leg assemblies are presently dropped into the water and left hanging from the bollards. Thus, the majority of these assemblies are underwater about 20 percent of the time. It is recommended that a portable crane be utilized to lift the leg assemblies to the pier for storage when the ship deploys.

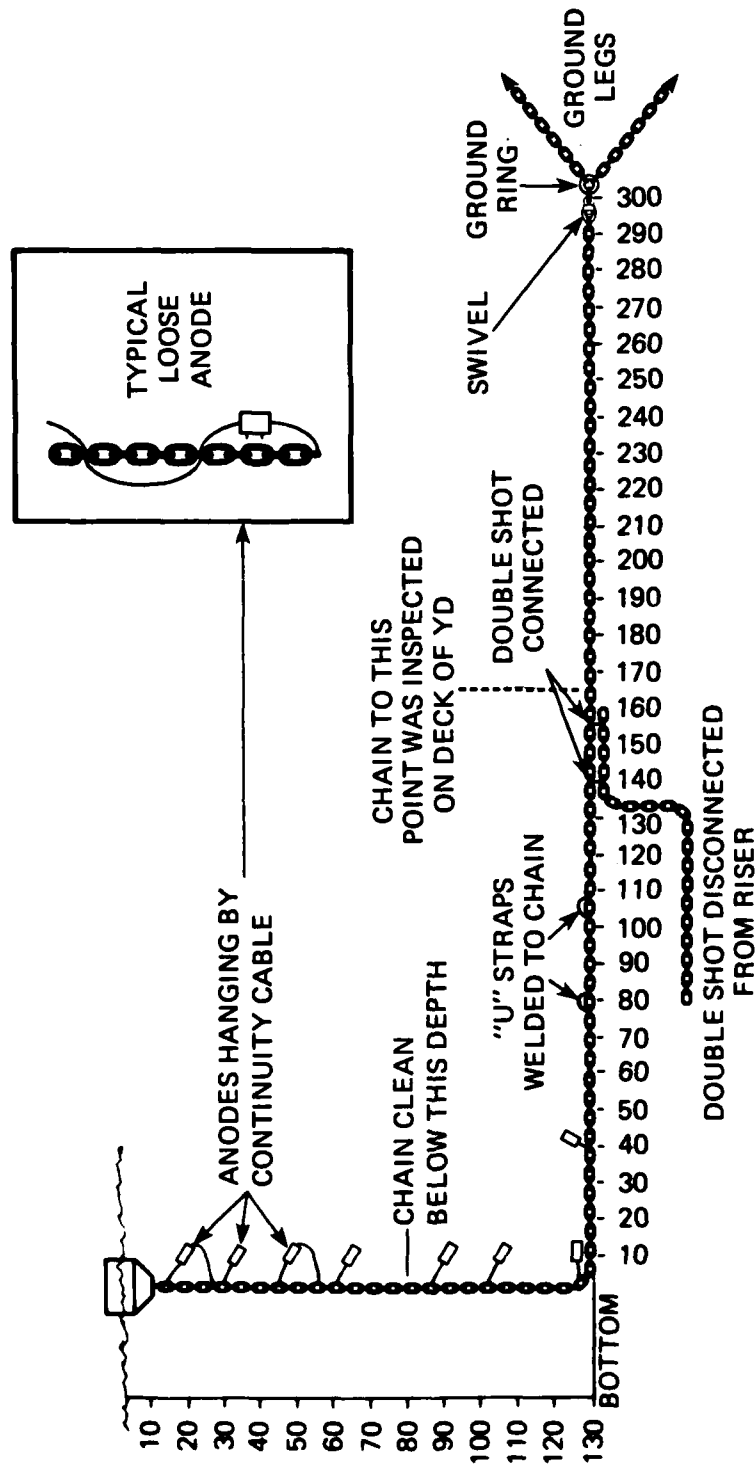
Figure A-11-1. North Bow Mooring Schematic After Removal of Twenty Links  
(Not to Scale)

- NOTES:
- 1 79 LINKS PER SHOT - 1.1 FT PER LINK
  - 2 UPPER SHOT HAS 23.1' REMAINING PLUS WHAT IS IN HAWSE PIPE

1.4 Conclusions and Recommendations. In general, this mooring appears to be in satisfactory condition. However, the cathodic protection system and double shot sinker are in need of repair, and the internal condition of those links to which anode studs were welded is questionable. It is recommended that the design of this mooring be reviewed in order to develop improved cathodic protection and sinker systems. Based on the results of the design review, the mooring should be overhauled and necessary design changes incorporated. In addition, the installed Di-Lok chain should be replaced with stud link chain, and the buoy's hawse pipe should be fitted with a rubbing casting, or preferably, replaced with a tension bar type buoy.

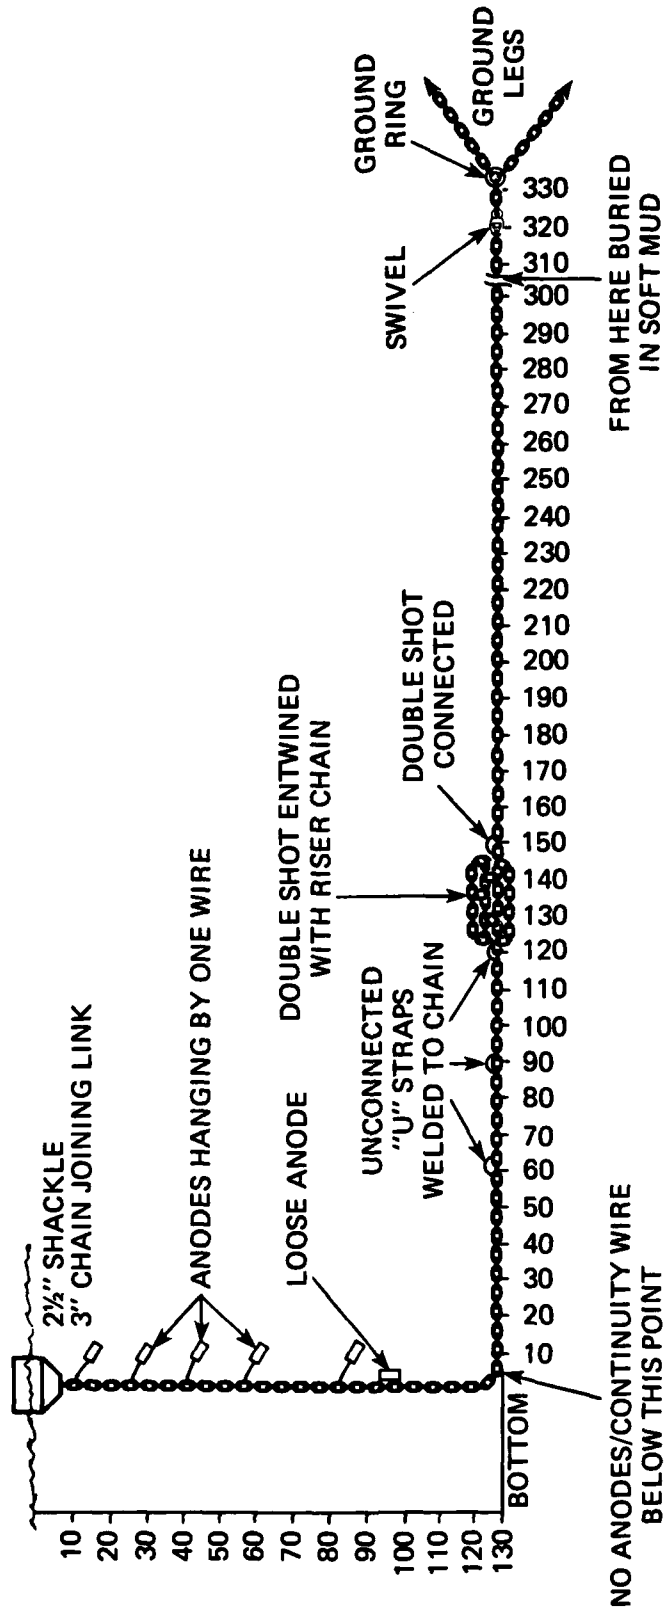
Figure A-111-1. South Bow Mooring Sketch, After Removal of Twenty Links  
(Not to Scale)

1.3.2 Chain Assembly. The riser chain and visible portions of the ground legs showed little signs of wear or corrosion, and all sample-link wire diameters were well within tolerance. However, compared to the rest of the chain assembly, the 2-1/2" shackle connecting the riser to the buoy was undersized and could possibly fail under peak loads.

1.4 Conclusions and Recommendations. The southern bow mooring is considered to be in satisfactory condition for fleet usage, but the temporary buoy should be replaced with a permanent fleet mooring buoy. In addition, the apparently undersized and unnecessary 2-1/2" shackle, which connected the riser chain to the buoy via a 3" detachable link, should be removed.

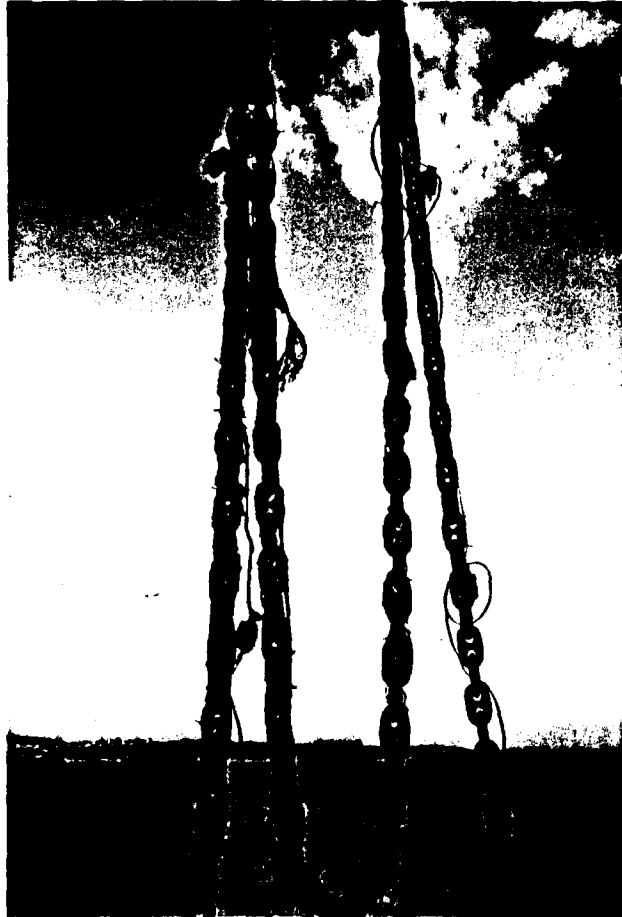
1.3.4 Cathodic Protection System. This system was in poor condition. Most anode mounting brackets had broken loose from the chain links, and many anodes were dangling from the riser chain by the wire rope continuity cable. In general, contact between the continuity cable and the chain was poor, and the continuity cable was broken in numerous places along the length of the riser chain.

Figure C-2. Northern mooring riser chain being lifted at two points by the YD's crane. Note disconnected anodes and loose wire rope continuity cable.

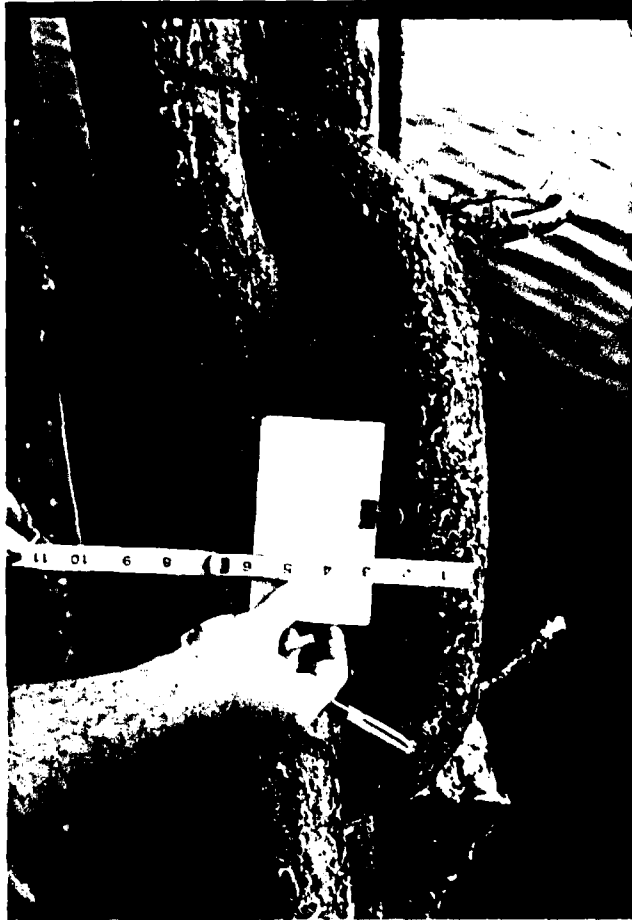
1.3.4 Cathodic Protection System. The cathodic protection system was unsatisfactory and in need of repair. Most anodes were either missing or loose, and below 130' from the buoy, there was no evidence that anodes or wire rope continuity cable were ever installed.

Figure C-4. Southern mooring link #92. Note anode attachment brackets welded to the link and anode hanging by the continuity cable.
