UNDERWATER FACILITIES INSPECTIONS & ASSESSMENTS

U.S. NAVAL STATION
KEY WEST, FLORIDA

FPO 1-80(9)

SEPTEMBER 1980

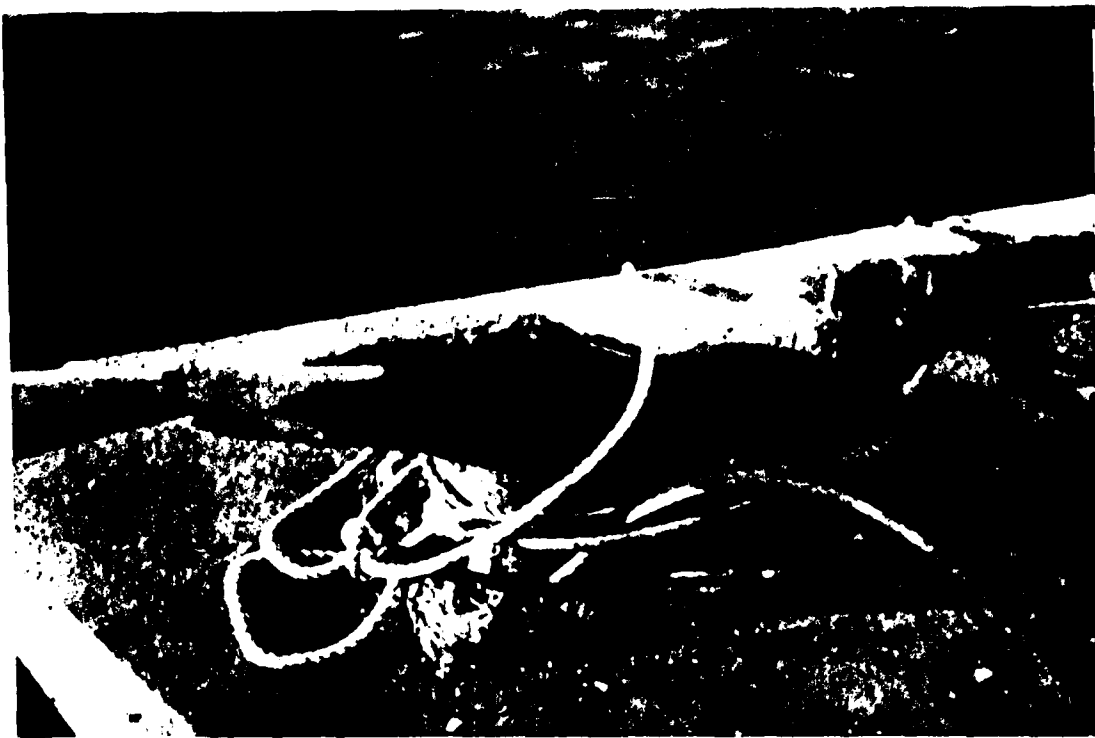
FIGURE 13

The topside walk-around inspection revealed that most cleats and bollards on the pier were very heavily pitted by corrosion and all should be replaced if the pier is to be utilized for mooring naval vessels (Figure 13). The fender system is mostly missing or disintegrated and where it still exists it is totally ineffective. The concrete curbing, Figure 14, is cracked and spalled in many locations; although this does not pose any structural problem it should be repaired for cosmetic effect. The utility tunnel access covers are rusted or missing in many locations. Shrimp boat crews have been using the utility tunnels for trash dumping and thorough cleaning-out is needed before they can again serve their basic intended purpose.

TYPICAL BADLY CORRODED CLEAT ON PIER D-3

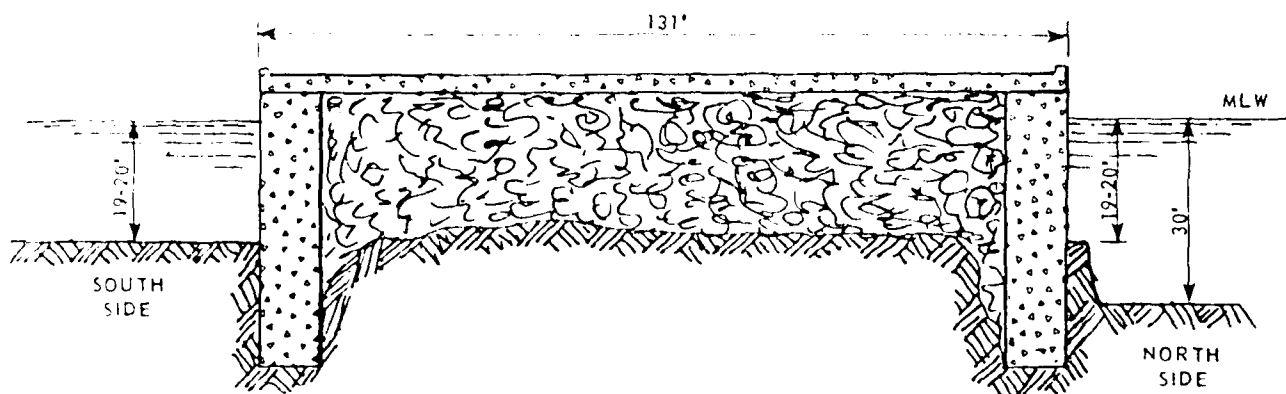
FIGURE 29

During some previous dredge operation the dredge apparently worked very close to the concrete wall of Pier D-1; the wall is undercut in a few places. The undercutting is minor, however, and there appears to be no major damage to the pier. A typical dredging profile along the length of Pier D-1 is shown in Figure 29.

CROSS SECTION OF PIER D-1 SHOWING DEPTHS
