NAVAL AIR STATION SIGONELLA (AUGUSTA BAY) FLEET MOORING UNDERWATER INSPECTION REPORT

NOVEMBER 1983

OCEAN ENGINEERING
AND CONSTRUCTION PROJECT OFFICE
CHESAPEAKE DIVISION
NAVAL FACILITIES ENGINEERING COMMAND
WASHINGTON, D.C. 20374

FPO-1-83 (45)

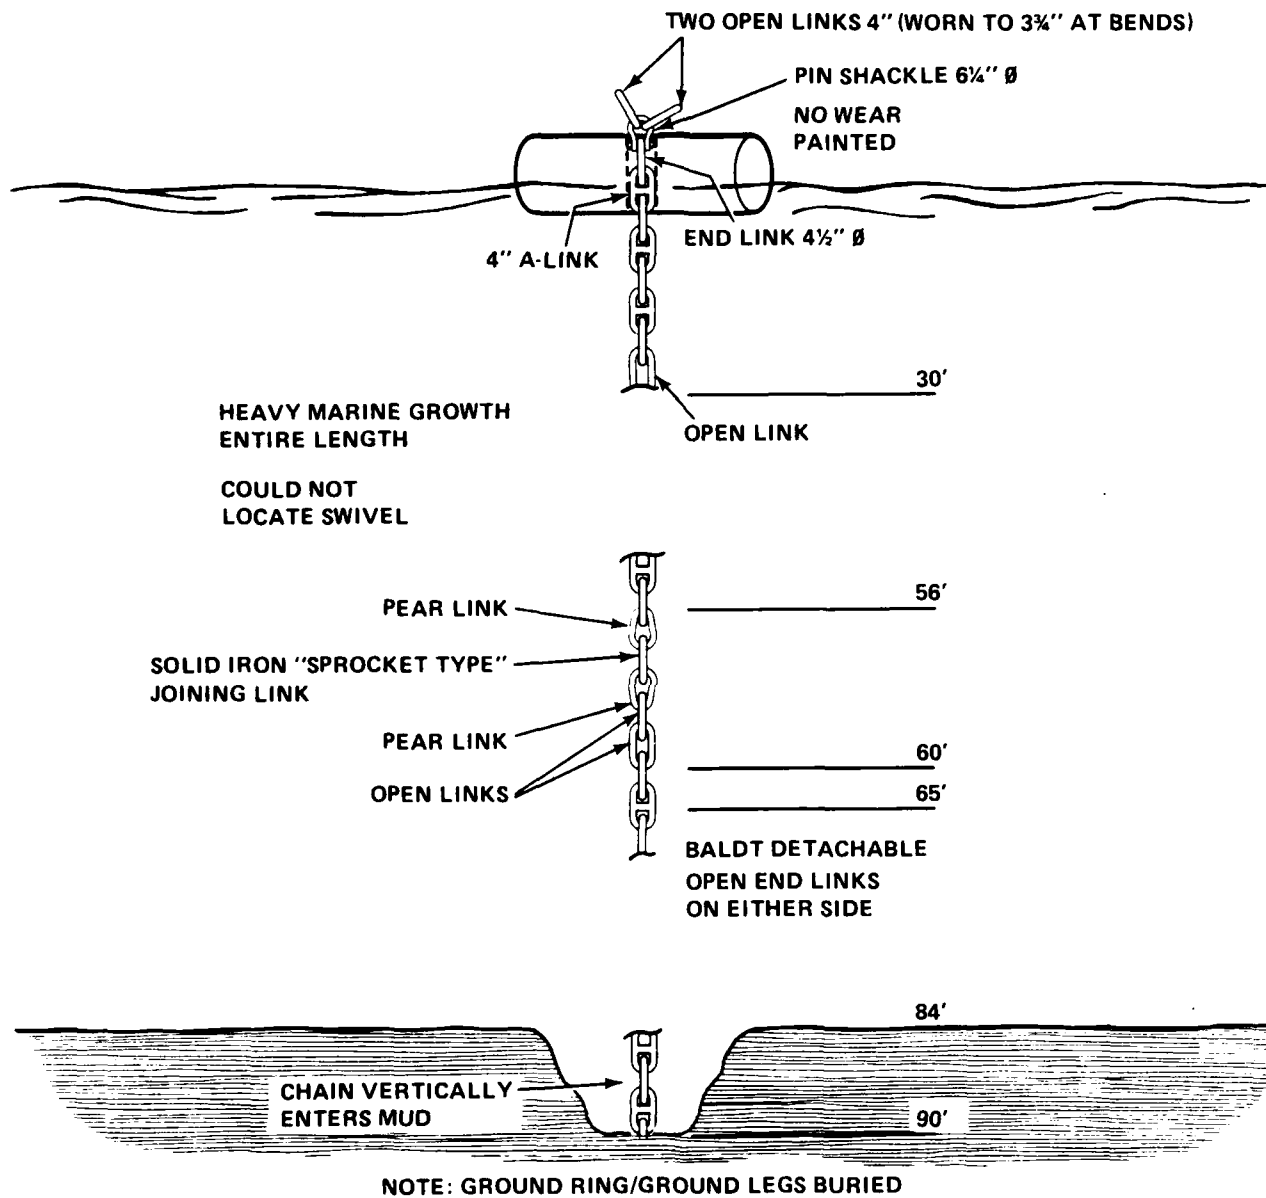
FIGURE 4. MOORING A-3 AS-BUILT CONFIGURATION

This is a 7-foot diameter, 13-foot long cylindrical-type buoy with a hawsepipe. The buoy is painted and shows no sign of damage. The top jewelry is painted and shows no evidence of usage. The fenders are in good condition.

The riser is heavily encrusted with marine growth. Several areas were cleaned and double link measurements taken. The riser consists of various sizes of chain and accessories all of which were larger than the 3 1/2 inches required for a class CC mooring. Sizes ranged from 3 5/8 inches to 4 1/8 inches and all measurements were greater than 90 percent of the links' original wire diameter. The riser swivel was not located but could be hidden beneath the heavy mussel growth. The riser drops vertically into the bottom.

On the basis of the good condition of the buoy and riser chain, this mooring is considered to be in satisfactory condition for continued use as a CC class mooring.
