**UNDERWATER FACILITIES  
INSPECTIONS  
AND  
ASSESSMENTS  
AT  
NAVAL SHIPYARD  
CHARLESTON, SC**

**FPO-1-81 (8)**

**MAY 1981**

**CHILDS ENGINEERING CORPORATION  
MEDFIELD, MASSACHUSETTS 02052**

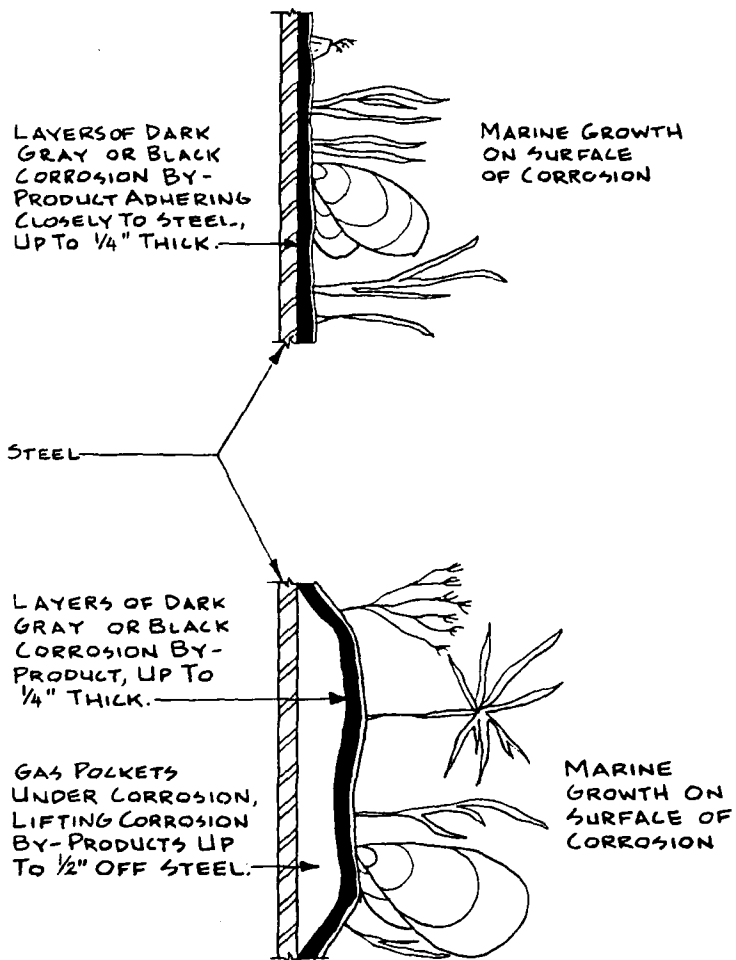
On the steel piles, deposits of black corrosion by-product with gas pockets trapped beneath were common. This corrosion buildup was not heavy, usually less than 1/4". An example of this type of corrosion is illustrated in Figure 5.

GRAPHIC SCALE	Childs Engineering Corporation Box 333 Boston, MA	CHESAPEAKE DIVISION NAVAL FACILITIES ENGINEERING COMMAND WASHINGTON, D.C.	
N/A		NAVAL SHIPYARD CHARLESTON, SC <b>TYPICAL CORROSION BUILDUP</b>	FIG. NO. <b>5</b>
