**UNDERWATER FACILITIES
INSPECTIONS
AND
ASSESSMENTS
AT**

**NAVAL STATION
MAYPORT, FLA.**

JULY 1980

**CHILDS ENGINEERING CORPORATION
MEDFIELD, MASSACHUSETTS 02052**

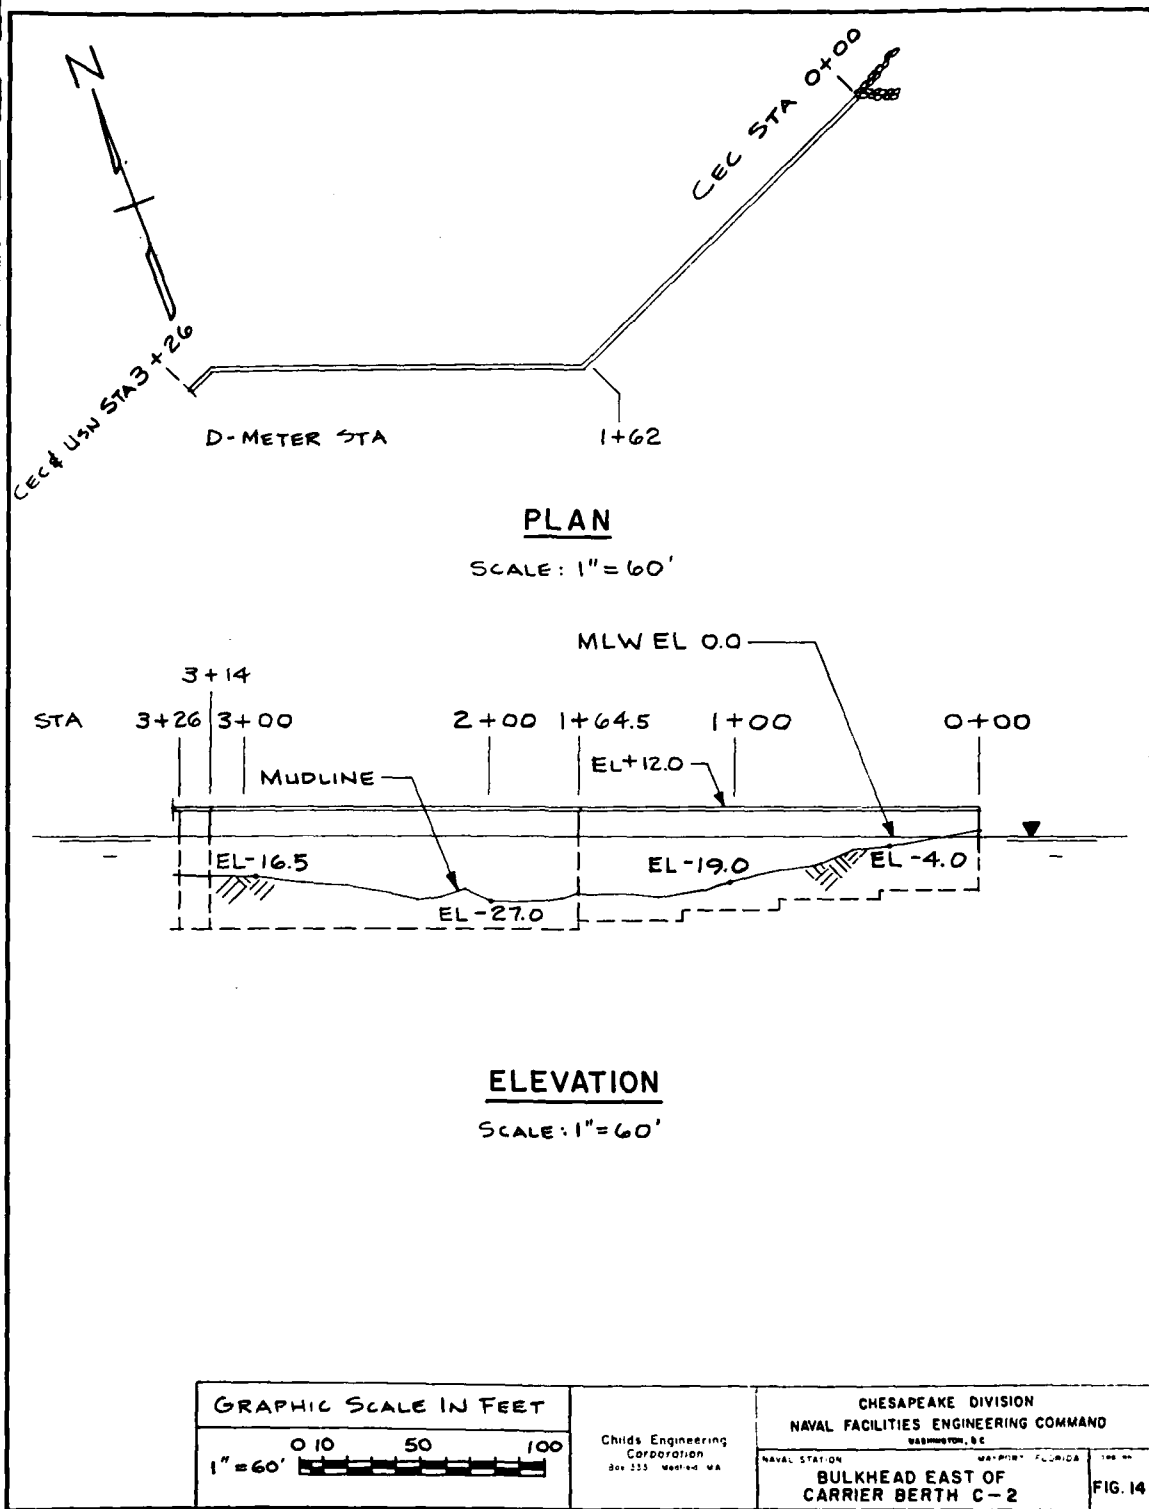
- 1) At CEC Sta. 2+07, the web of this pile is distorted (bulged out) from the mudline up 12';
- 2) At CEC Sta. 1+64, a hole, 8" wide x 4' high (top el. -5.0') was found in the web;
- 3) At CEC Sta. 1+62, a rip was observed at the web/flange intersection in the first Z section sheet pile just east of the corner pile (see Photo #9). It originated at el. -5.0' and continued to mudline (21' long). A maximum displacement of 64" was measured at the mudline. The side east of the rip was displaced outward with respect to the side west of the rip. Mounding of the sandy granular fill extended 10' away from the wall before the bottom became silty.
