**UNDERWATER FACILITIES
INSPECTIONS
AND
ASSESSMENTS
AT

U.S. NAVAL STATION

ROOSEVELT ROADS, P.R.**

FEBRUARY 1982

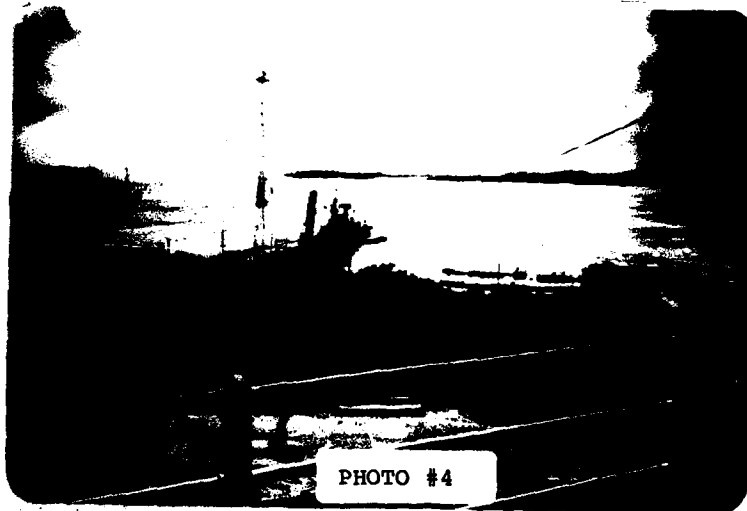
PHOTO #4: View of Supply Pier (267)
from the Naval Station

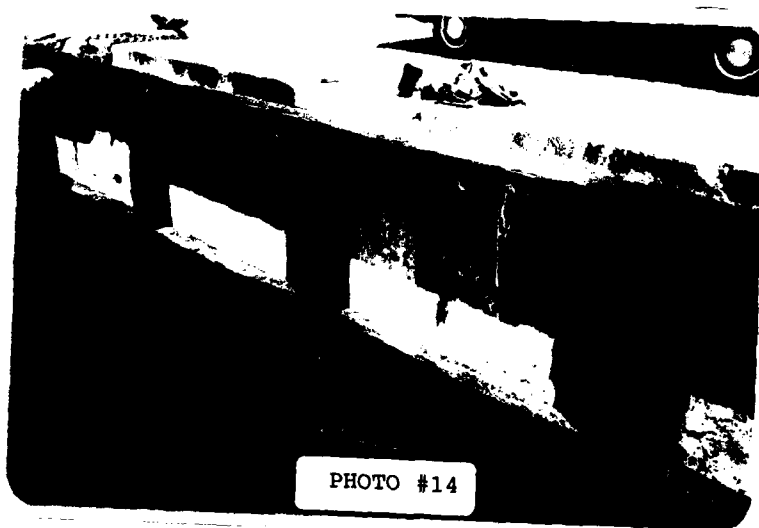
PHOTO #14: View of Concrete Encasement
and Fender System in Section A
of the Berthing Wharf (890),
Showing Typical Conditions

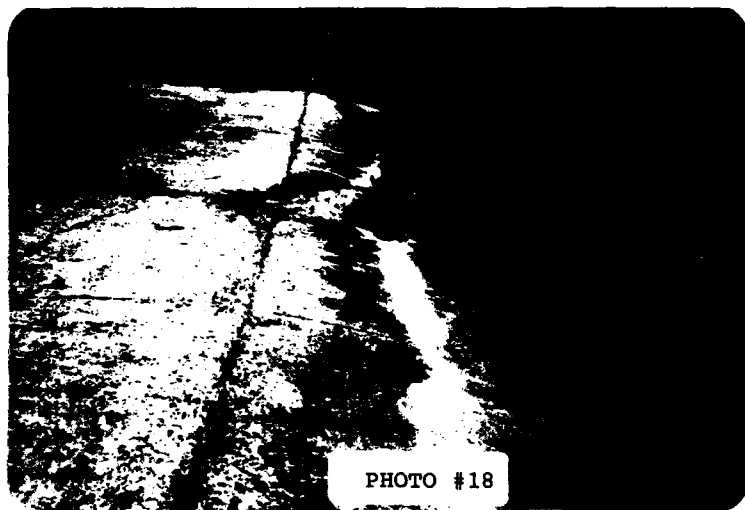
PHOTO #18: Spalled and Broken Area of
Concrete Slab in Center of
LST Ramp (843)

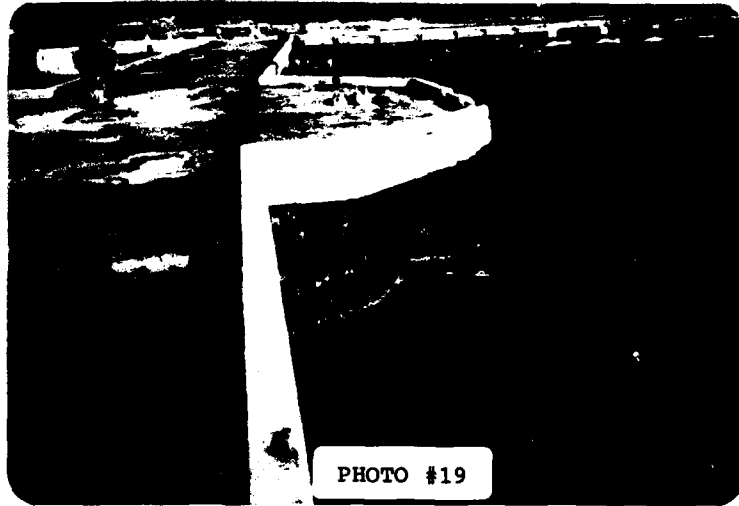
PHOTO #19: View of Deck and Cylinder B1,
Looking Inshore Along Northeast
Edge of the Approach Pier (273).
Note Corrosion of Steel Sheet
Piling in Splash Zone (Typical
Condition)

The concrete and steel piles supporting the Approach Pier are in fair shape and have sufficient capacity to support the applied loads. Although severe deterioration is evident in the tidal zone and splash zone on the steel sheet pile cylinders, the steel below the mean low water area is in fair condition. The cylinders are therefore not in excessively deteriorated condition from a structural standpoint. However, if the severely corroded areas around mean low water and in the splash zone are not repaired, fill material would be lost through holes formed in the sheet piling. This condition could eventually result in distortion and failure of the upper section of the cylinders.

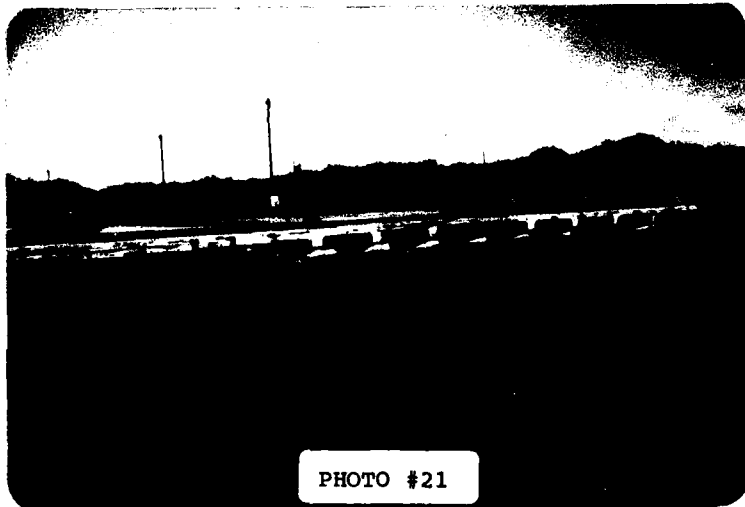
PHOTO #21

PHOTO #21: View of Face of North Quaywall
of Small Craft Berth (844).
