# UNDERWATER FACILITIES INSPECTIONS & ASSESSMENTS

NORFOLK NAVAL SHIPYARD  
PORTSMOUTH, VIRGINIA

FPO-1-81(19) AUGUST 1981

OCEAN ENGINEERING AND CONSTRUCTION PROJECT OFFICE  
CHESAPEAKE DIVISION  
NAVAL FACILITIES ENGINEERING COMMAND  
WASHINGTON, D.C. 20374

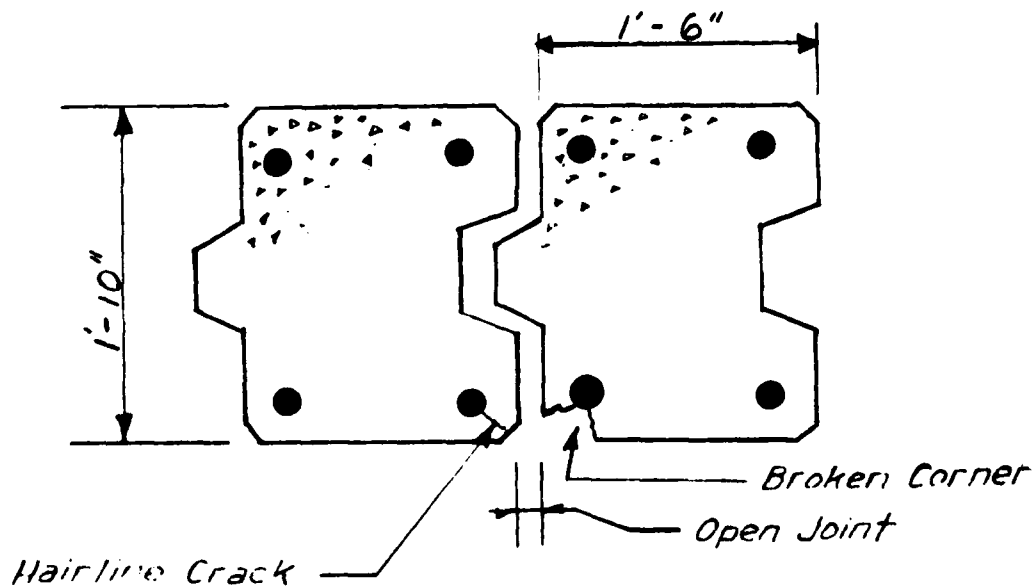
**FIGURE 10 CONCRETE SHEET PILE DETERIORATION**

The condition of the precast concrete sheet piling at each pier is similar in nature, although the degree of distress varies. Generally, the pile faces are full and solid, and the piles are properly aligned. There are many areas, however, where the edges of the piles are cracked or broken and the joint at the interlocking is not tight. Figure 10 below and Photographs 13 through 20 on Pages 27 through 30 show typical conditions.
