**NAVAL WEAPONS
STATION
CHARLESTON
FLEET MOORINGS
UNDERWATER
INSPECTION
REPORT**

AUGUST 1983

OCEAN ENGINEERING
AND CONSTRUCTION PROJECT OFFICE
CHESAPEAKE DIVISION
NAVAL FACILITIES ENGINEERING COMMAND
WASHINGTON, D.C. 20374

FPO-1-83 (17)

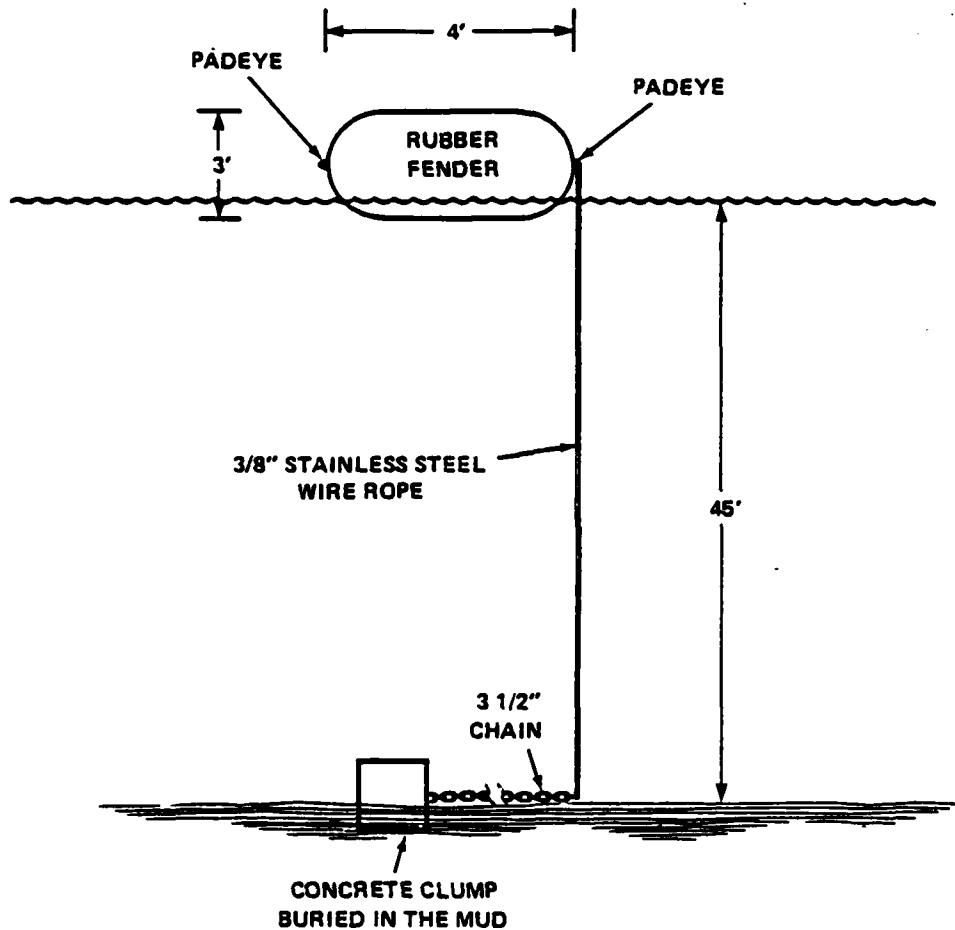
Currently, large rubber fenders (normally used for protection of yard craft) are being used in place of buoys. The buoys are located about halfway between each stakepile and the Tender (see Figures 1 and 2), and are used as navigation aids during Tender mooring operations. Each marker buoy is attached by 3/8-inch steel wire rope to a short length of 3 1/2-inch chain which is embedded in a concrete clump (see Figure A-1). Note: The marker buoys (including riser and anchor) are used only as navigation aids and do not serve as in-line mooring components.

Figure A-1. Mediterranean Mooring Bow Leg Marker Buoy

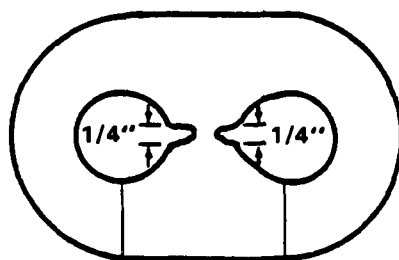
LEG K

- Ground leg K has a badly worn or damaged detachable link at the 45-foot depth.
- The anchor joining link at the inboard end of leg J is missing the lead plug which secures the pin in place.

Ground Leg K. This leg is 2 3/4-inch cast chain which drops vertically into the bottom. Detachable links were found at 20- and 45-foot depths. The detachable link at the 45-foot depth is damaged and should be replaced. There appears to be a deep 1/4-inch-wide cut into each side of the stud of this link (see Figure A-3). Double link measurements near the mudline were between 80 and 90 percent. The chain is heavily rusted and no evidence of pitting was noted. The leg has no catenary.

Figure A-3. Deep Cuts on Either Side of Detachable Link Stud

- The damaged detachable link in ground leg K should be replaced.
- A lead plug should be inserted in the anchor joining link at the inboard end of leg J.

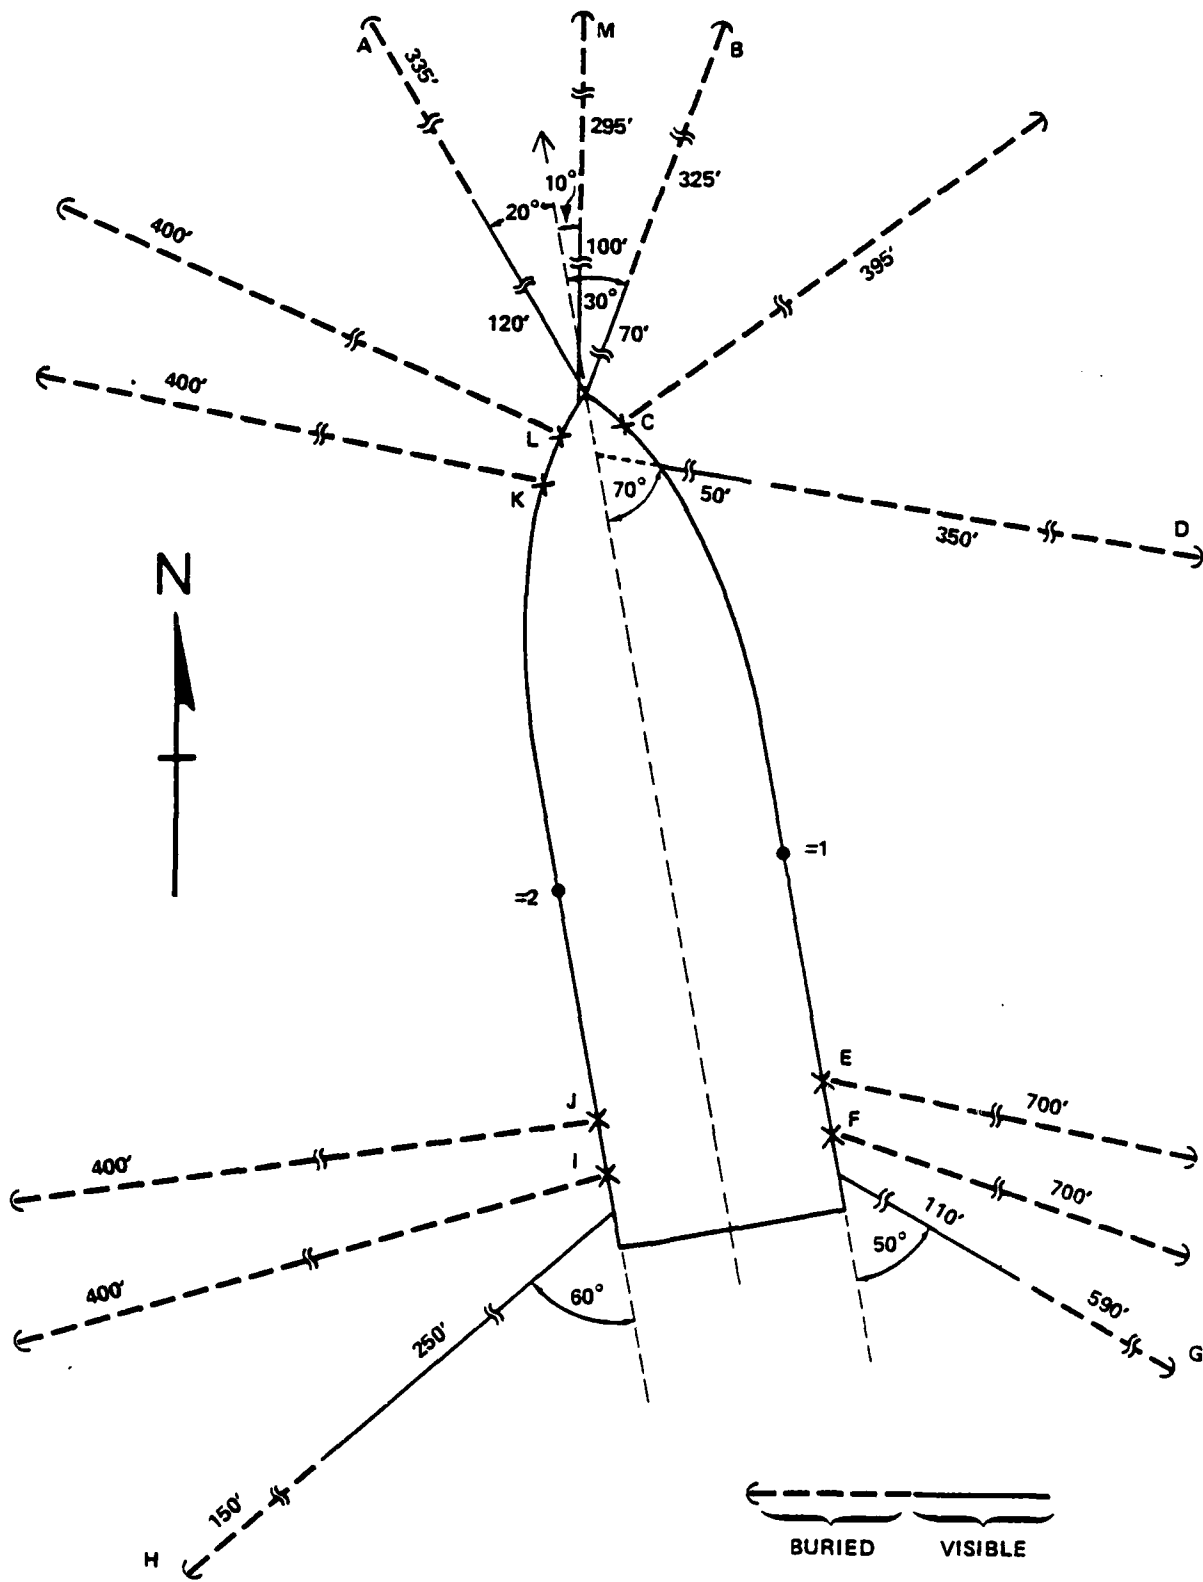
Figure A-4. ARDM Leg Positions

Except for some heavy pitting and rusting, the chain appears to be in fair to good condition. However, only six legs are under tension. The remaining seven are slack and drop vertically into the bottom. Figure A-4 shows which legs are under tension, while Table A-1 provides a summation of the condition of the ARDM-2 ground legs.

The ARDM-2, USS ALAMAGORDO, has an impressed current system consisting of port and starboard direct current power supplies. The starboard power supply puts out more amperage than the port side. This could be the reason for heavy localized corrosion of the starboard leg chains. However, because the condition of the chain in each leg was not recorded when the chain was installed, it is impossible to draw any firm conclusions regarding the possible corrosive effects of the imbalanced power supplies. Numbers 1 and 2 in Figure A-4, show the positions of the starboard and port impressed current power supplies.

- The drydock should be realigned to the desired magnetic heading and each of the ground legs should be reinstalled so that all are under tension and sharing the mooring loads.
- The impressed current system should be inspected, repaired, and calibrated as required to ensure that the potentials being provided are within design limits.
- The damaged detachable link in leg K should be replaced.
- The lead plug should be replaced in the anchor joining link which connects leg J to the drydock.
