UNDERWATER FACILITIES
INSPECTION AND ASSESSMENT

DEPERMING FACILITY
U.S. NAVAL STATION
NORFOLK, VIRGINIA

FPO-1-81-(16)

July 1981

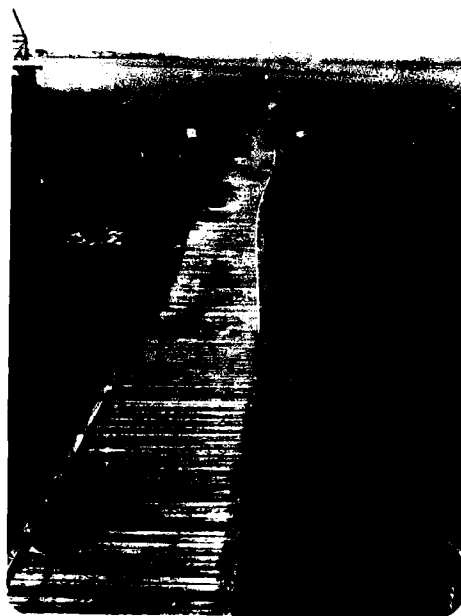
PHOTOGRAPH 2

Pier C. Note deperming berth for submarines and small craft in berth to right and larger berth left. Also note impact deflections of Pier C.

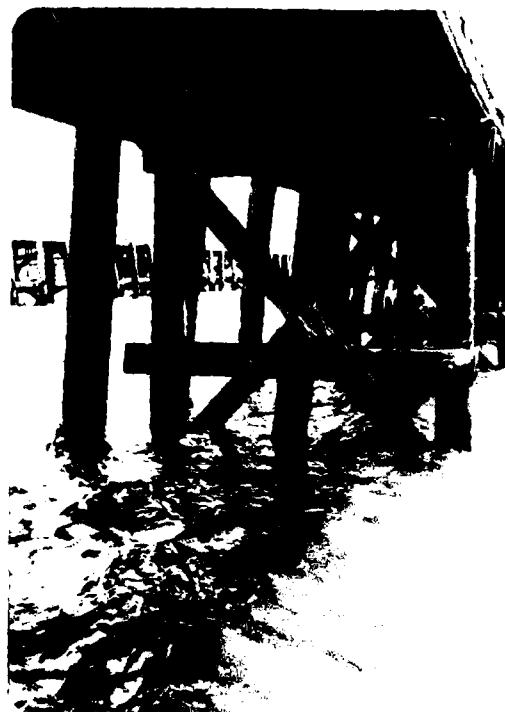
PHOTOGRAPH 4

Pier C - Bent 19. Typical pier
construction, showing untreated
deck assembly and treated bolted
pile caps and timber bracing.
Also note several open boltholes
in center pile.

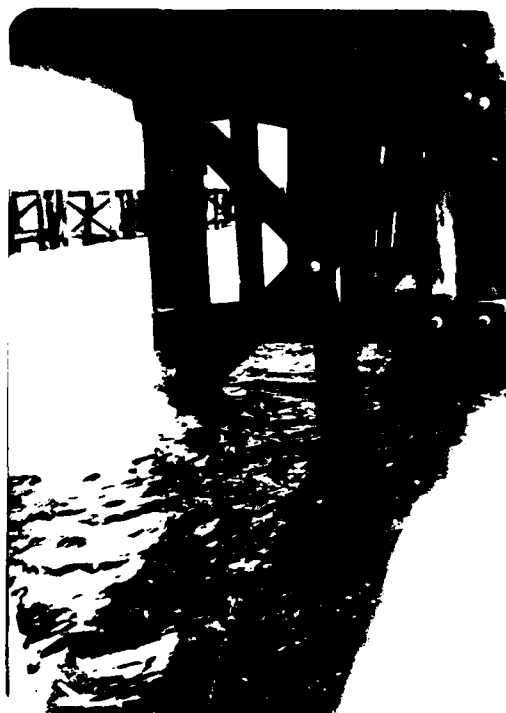
PHOTOGRAPH 5

Pier C - Bent 9. Refurbished bent showing one additional pile at right side of structure. Note good condition of brace timbers.

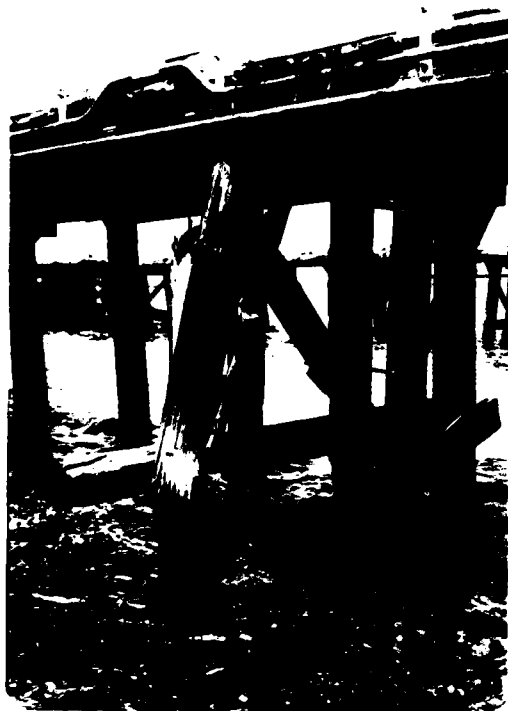
PHOTOGRAPH 10

Pier C - Bent 17. Note pile in foreground. The pile caps and braces have been smashed by impact.

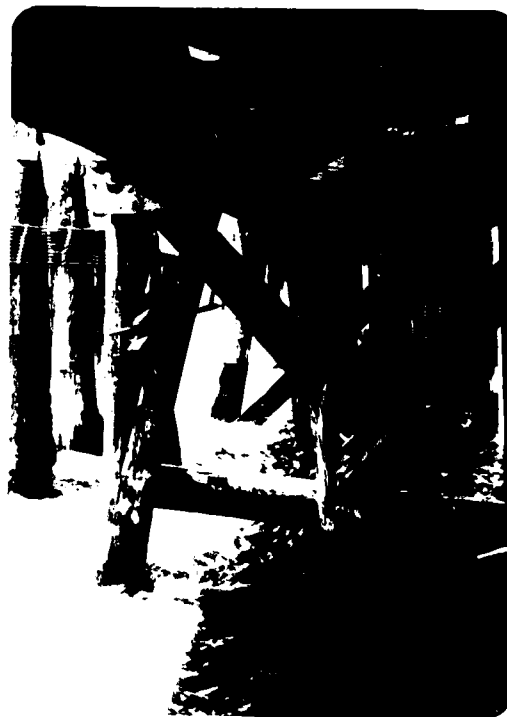
PHOTOGRAPH 11

Pier C - Bent 17. Pile 1 on left has been smashed, pile 2 has broken at elevation of walers. Note several boltholes in pile 2 and also in pile 1 of bent 16 in background.
