# SAN NICOLAS ISLAND BARGE LANDING SITE SURVEY

FPO-1-79(3)  
NOVEMBER 1978

OCEAN ENGINEERING AND CONSTRUCTION PROJECT OFFICE  
CHESAPEAKE DIVISION  
NAVAL FACILITIES ENGINEERING COMMAND  
WASHINGTON, D.C. 20374

Subj: San Nicolas Island Survey

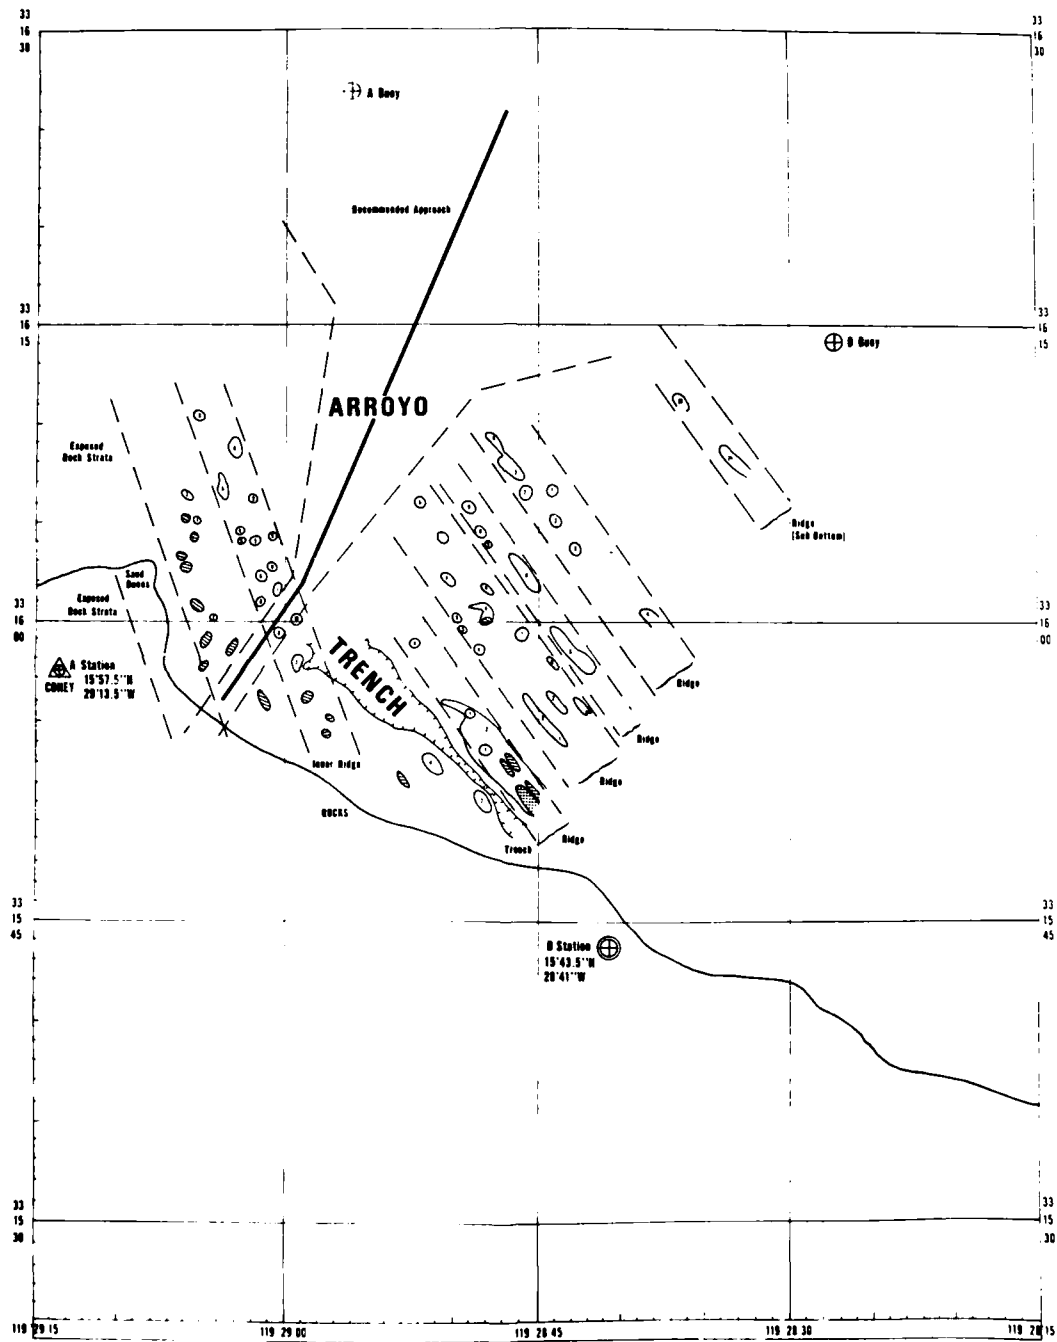
Figure 4. Rocky Feature Locations, With Minimum Depths

On the basis of this survey data, it is recommended that the range markers used in the approach of the YFU to the beach be replaced by a new set of markers, perhaps four, to establish a line close to the center of the submerged arroyo as shown in Figure 4. This alignment, with its dog leg offset, offers a safer distance for the YFU from the submerged obstructions.

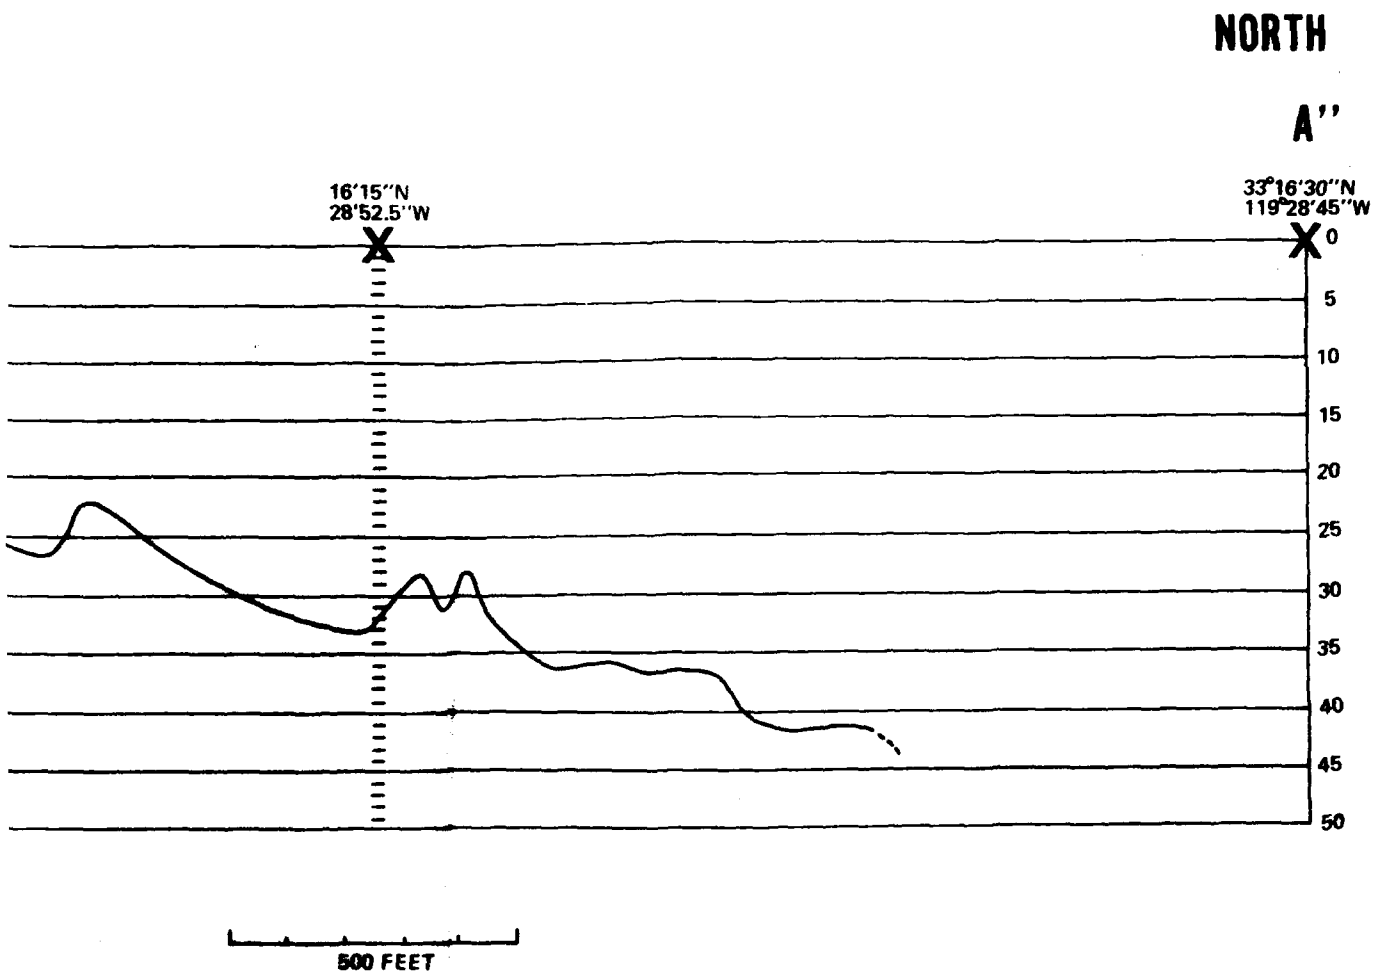
Figure 14. Bottom Profile, A - A'  
(Center of Channel)

The most important profile, A - A' - A'', shown in Figure 14, is that taken down the center of the recommended approach channel. This is not a straight line profile. It has a change of direction about 800 feet from shore. The recommended channel follows this same offset in direction in order to avoid submerged obstacles. The profile shows the channel to be clear of submerged obstacles which might interfere with a YFU hull having a loaded draft of 7 feet. Overlaying the fold-out depth contour chart and the A - A' - A'' profile permits observation of the available channel width clear of obstruction. Near shore, the channel is only 200 feet wide. At a distance of 400 feet from shore, the channel widens becoming a useable 400 foot width at 500 feet from shore. At 1000 feet from shore, the channel width is also 1000 feet. Beyond 1500 feet from shore, no obstructions reach high enough into the water column to restrict the YFU operations.

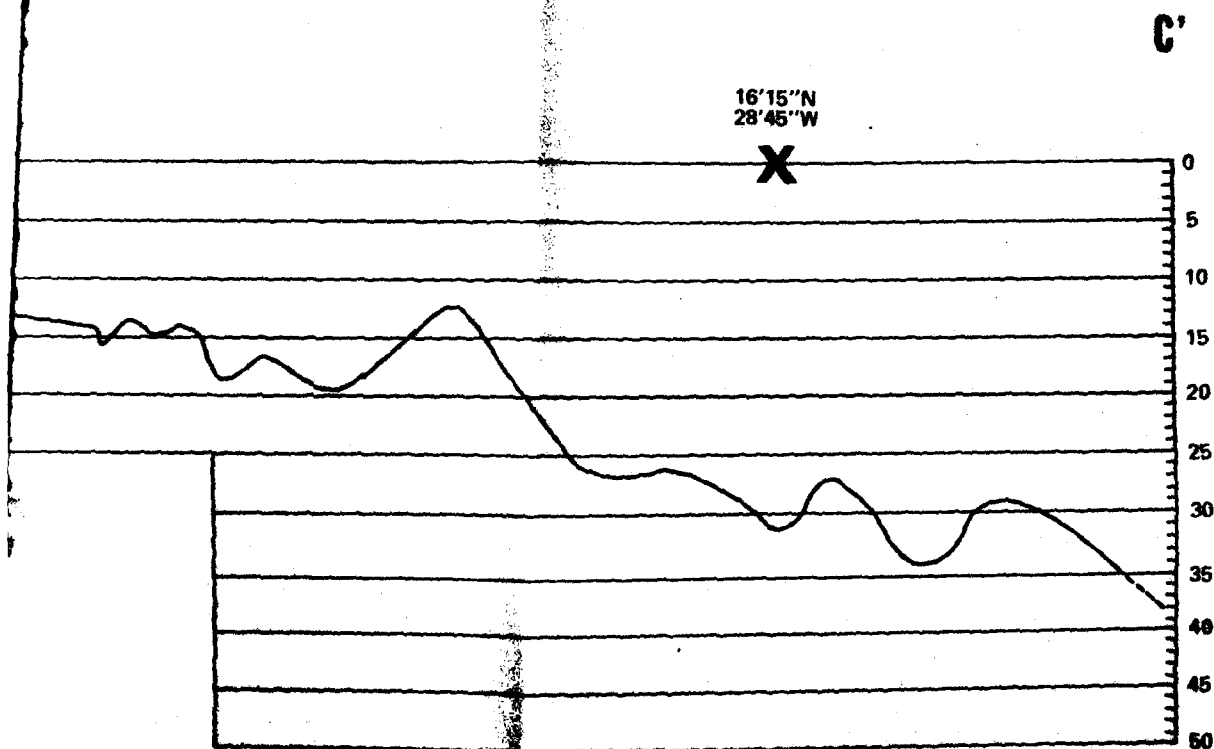
Figure 17. Bottom Profile, C - C'

The profile (Figure 17) transects the ridges in the eastern sector of the survey area, along a line closer to the recommended channel. With the exception of the one near shore prominence, which limits the width of the channel near shore, the profile indicates that the bottom is relatively clear of obstruction. This profile crosses the deeper portions of the ridges of Position 4 and Position 5, which have minimum depths less than 6 feet at MLLW. Hence the profile indication is that one can expect sufficient water depth for the YFU on the side towards the channel but should be suspect on the other side (towards profile B - B').

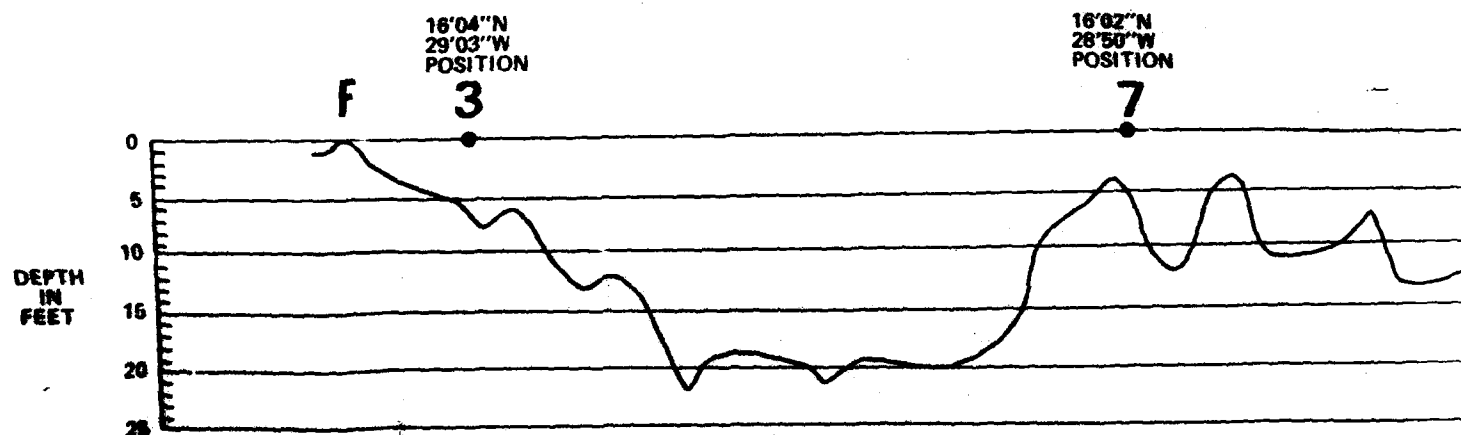
The obstructions identified by the divers in Positions 3 and 7 lie on opposite sides of the recommended channel. A profile of the bottom through these obstructions is shown in Figure 20, line F - F'. This profile is almost perpendicular to the channel axis about 900 feet from shore and indicates a channel width of 800 feet.
