UNDERWATER FACILITIES INSPECTIONS AND ASSESSMENTS AT  
NAVAL STATION NORFOLK (U) STOCK (ARTHUR U) AND  
ASSOCIATES INC DEERFIELD BEACH FL SEP 81

# UNDERWATER FACILITIES INSPECTIONS & ASSESSMENTS

NAVAL STATION

NORFOLK, VA.

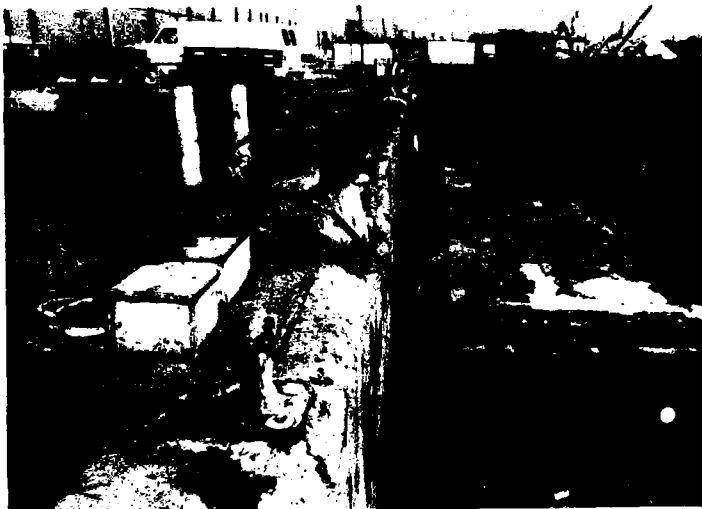
Photo No. 18

Bulkhead CEP-111 - Photo shows section of bulkhead with damage to cap in foreground (Station 2+50).

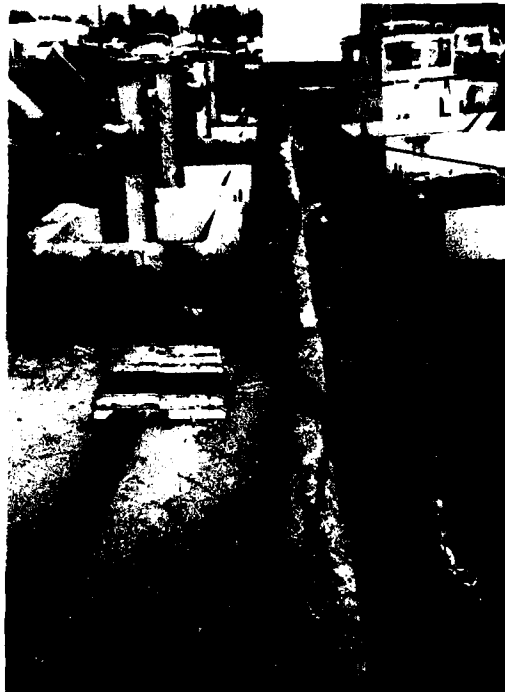
Photo No. 21  
Eastern end of Bulkhead CEP-111.
