UNDERWATER FACILITIES INSPECTIONS & ASSESSMENTS

PIER J/K
NORTH ISLAND
NAVAL AIR STATION
SAN DIEGO, CALIF.

FPO-1-81-[21]

AUGUST 1981

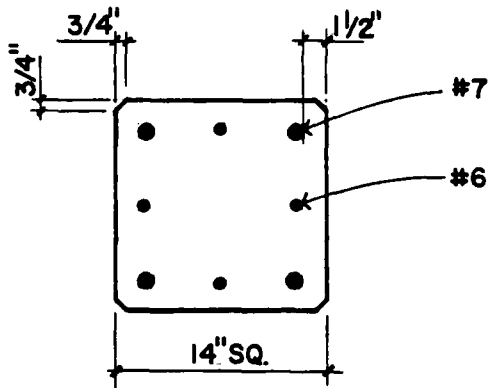
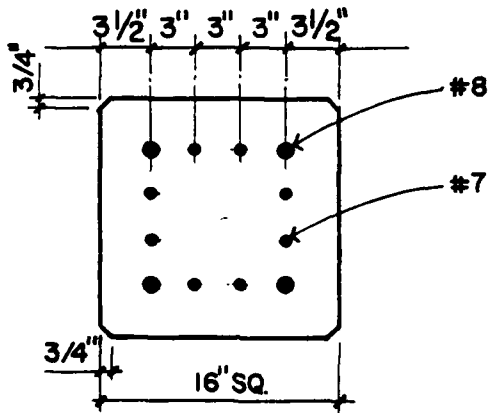
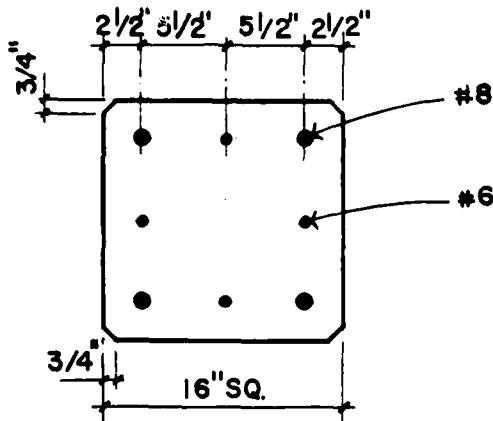
FIG. 5

1. Clear cover for the principal reinforcement equal to 1-1/2 inches. This is small for a salt water pile by present standards (DM 25.6⁽¹⁵⁾ requires 3 inches), but could have been satisfactory for that day. The lesser cover disfavors the steel which rusts in the presence of too little cover, but favors the design of a buckling member because the Moment of Inertia (I) and the Radius of Gyration (r) of the transformed area are increased.
2. The effective diameter is equal to 11 inches. This is the clear distance inside the cover, and conforms to the total net area criteria of the time.⁽¹⁰⁾
