NEW RIVER DAM FOUNDATION REPORT GILA RIVER BASIN:
PHOENIX ARIZONA AND VICINITY (INCLUDING NEW RIVER) (U)
ARMY ENGINEER DISTRICT LOS ANGELES CA OCT 85

New River Dam Foundation Report

**NEW RIVER DAM
FOUNDATION REPORT**

**U.S. ARMY CORPS OF ENGINEERS
LOS ANGELES DISTRICT
OCTOBER 1985**

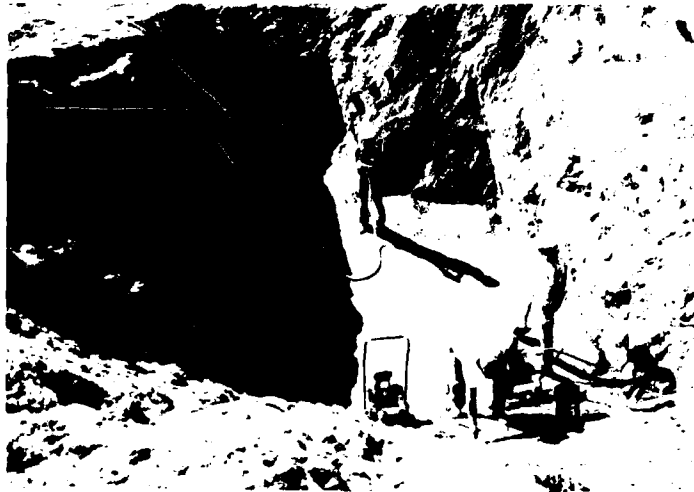
Photo 26. Backfilling foundation depression upstream of dam centerline between stations 14+85 and 15+25. 7 February 1984

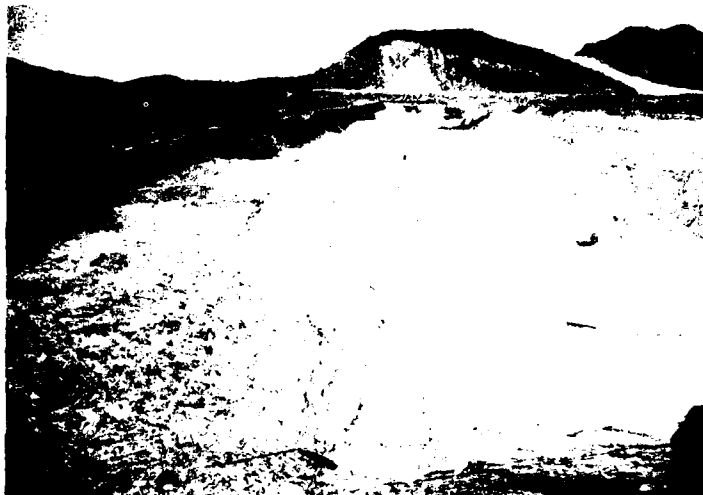
Photo 29. Looking west at core trench excavation from top of slope at station 16+40. Note major shear zone near upstream edge of excavation at right and smaller individual shears which criss-cross remainder of foundation surface. Contact between granite and diorite (in foreground) near center of photo. 29 March 1984

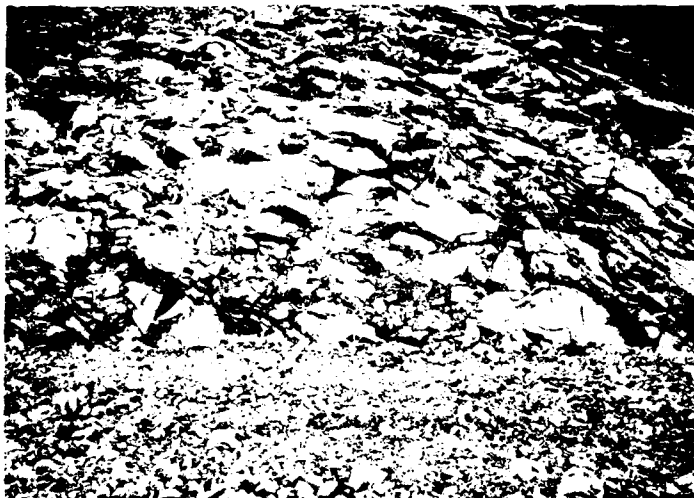
Photo 33. View of right abutment prior to start of Stage III construction. Note highly fractured, blocky nature of andesite rock mass and well-defined layering which dips obliquely upstream (toward lower right of photo).
26 September 1984

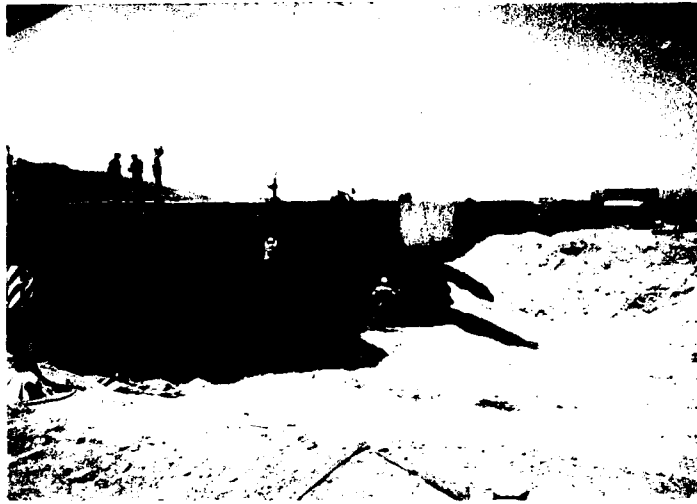
Photo 90. Outline of concrete plug area on east side of outlet conduit. Note most of conduit projects above adjacent foundation surface due to greater depth of core trench excavation. 24 April 1984

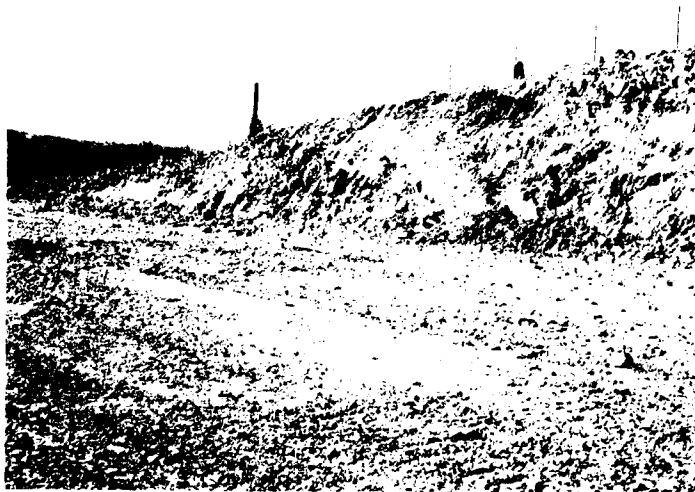
Photo 94. View of downstream north wall of completed spillway excavation showing layered volcanic sequence which dips 30° NE. Note massive flow breccia separating fractured andesite (on right) and tuff units. Alluvium exposed near edge of photo on left. 29 November 1984

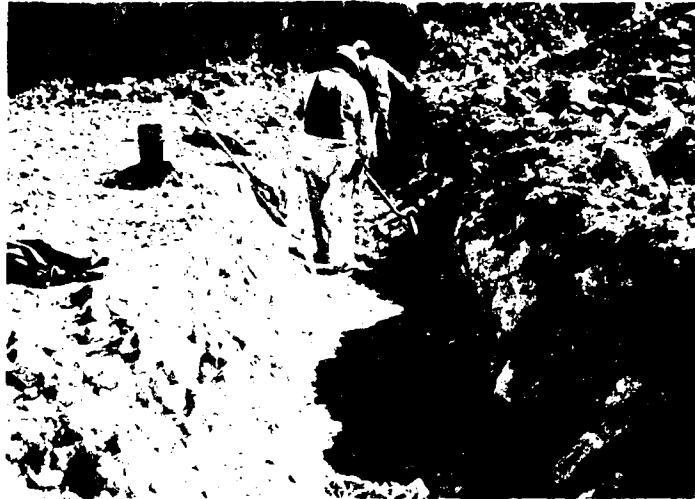
Photo 105. Laborers cleaning loose rock from invert section of spillway sill. Variable bedrock structure resulted in wider and slightly deeper excavation than originally designed. 29 November 1984

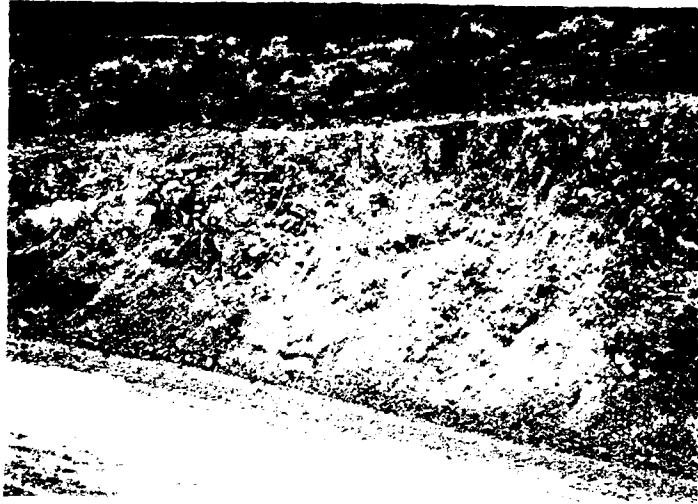
Photo 117. Slope failure in intensely fractured platy andesite, north wall of spillway excavation, vicinity station 14+00. 18 April 1985
