# PRESIDENTIAL COMMISSION

*on the Space Shuttle  
Challenger Accident*

*Report to the President*

June 6th, 1986  
Washington, D.C.

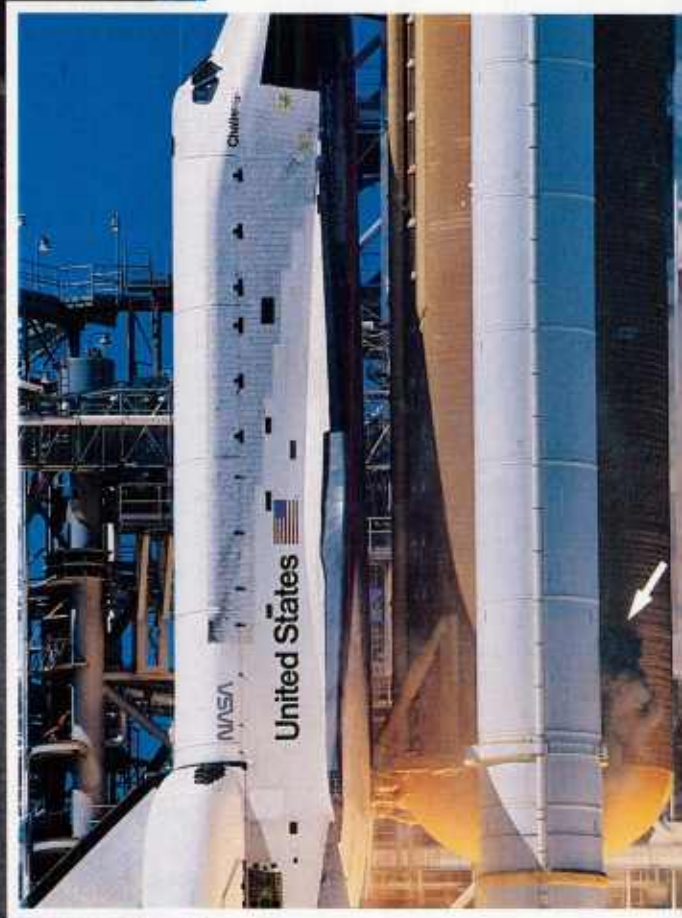
Immediately after solid rocket motor ignition, dark smoke (arrows) swirled out between the right hand booster and the External Tank. The smoke's origin, behavior and duration was approximated by visual analysis and computer enhancement of film from five camera locations. Consensus: smoke was first discernible at .678 seconds Mission Elapsed Time in the vicinity of the right booster's aft field joint.

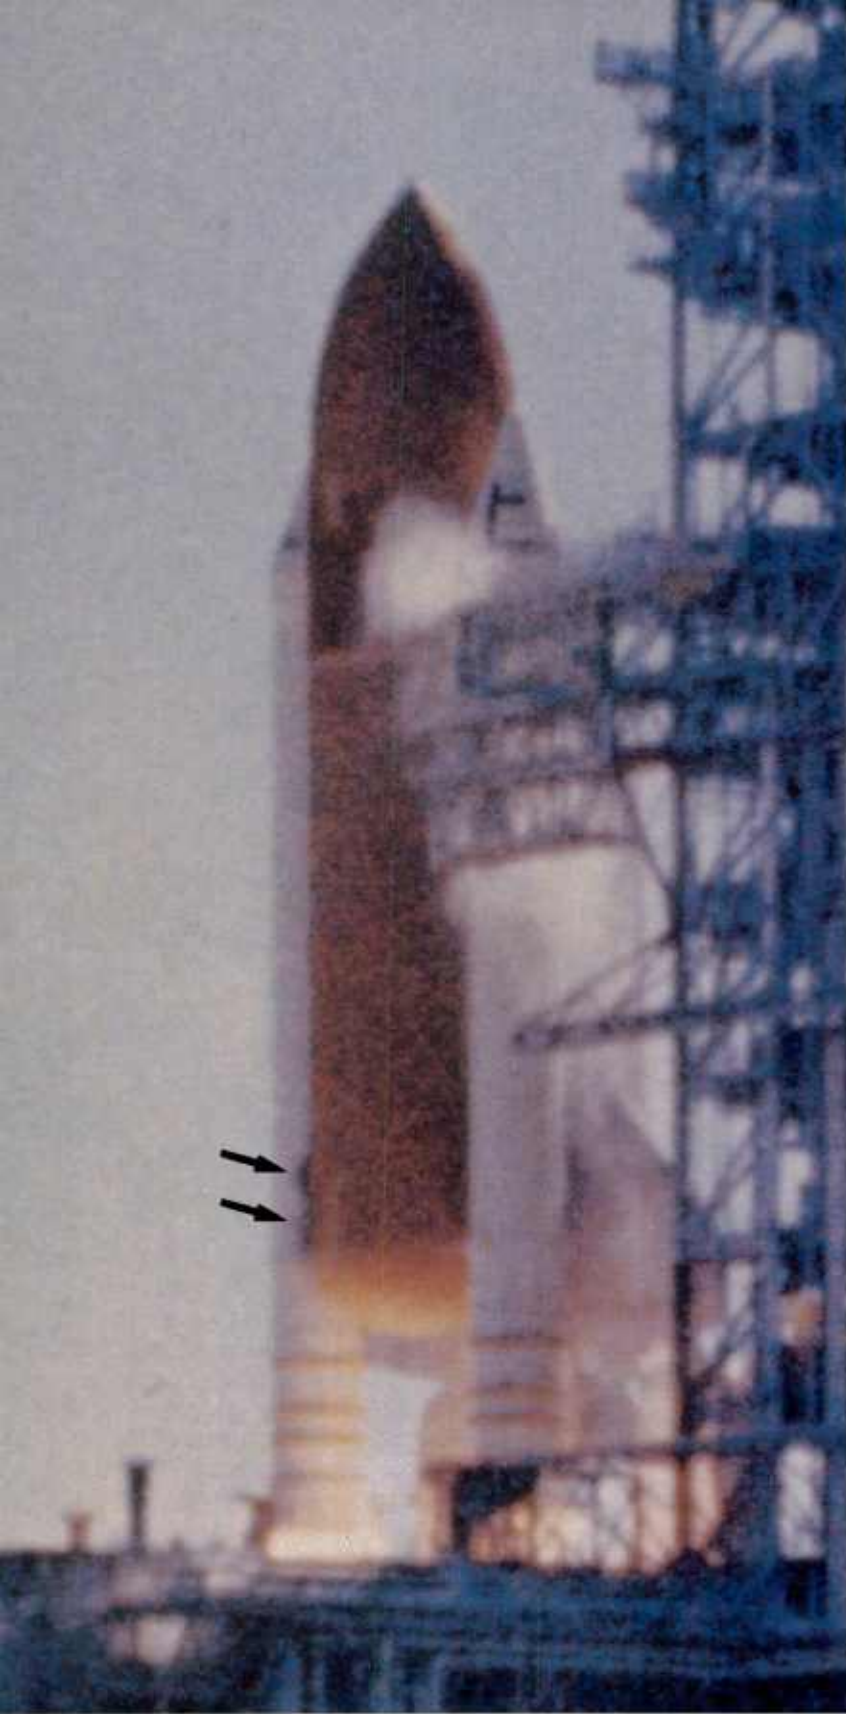
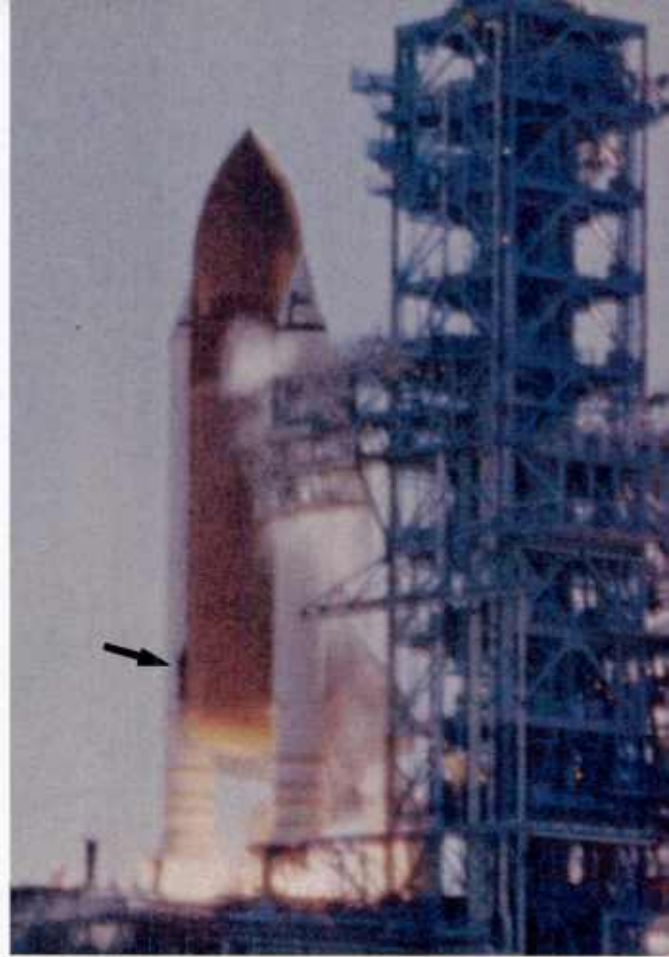
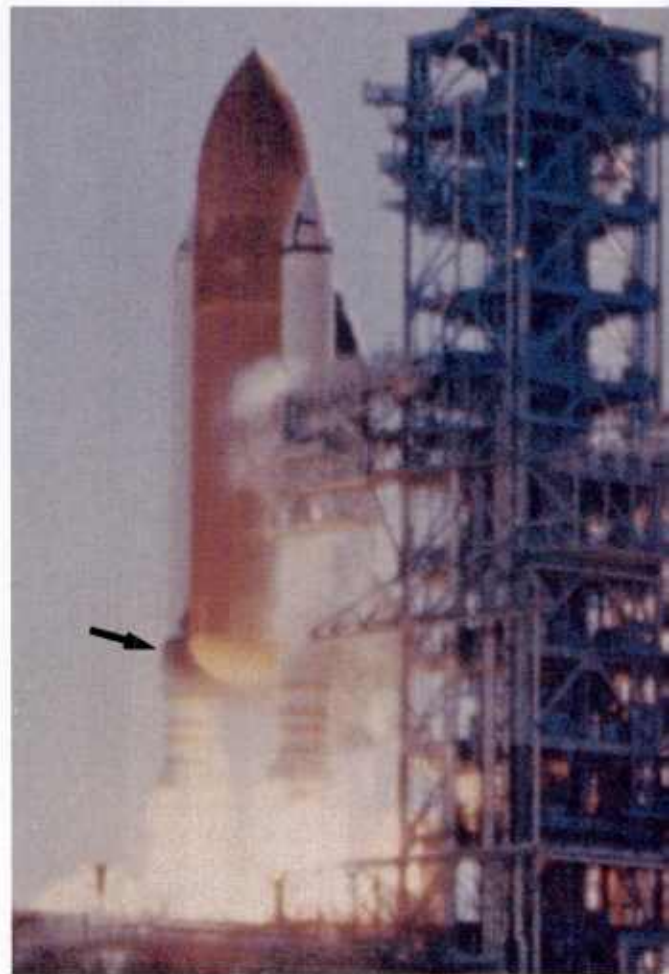
Multiple smoke puffs are visible in the photo above (arrows). They began at .836 seconds and continued through 2.500 seconds, occurring about 4 times a second. Upward motion of the vehicle caused the smoke to drift downward and blur into a single cloud. Smoke source is shown in the computer generated drawing (far right).

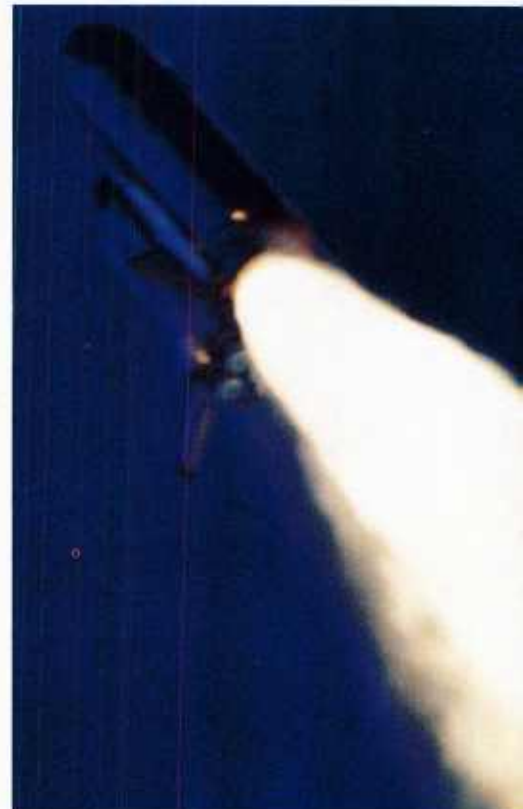
At 58.788 seconds, the first flicker of flame appeared. Barely visible above, it grew into a large plume and began to impinge on the External Tank at about 60 seconds. Flame is pinpointed in the computer drawing between the right booster and the tank, as in the case of earlier smoke puffs. At far right (arrow), vapor is seen escaping from the apparently breached External Tank.

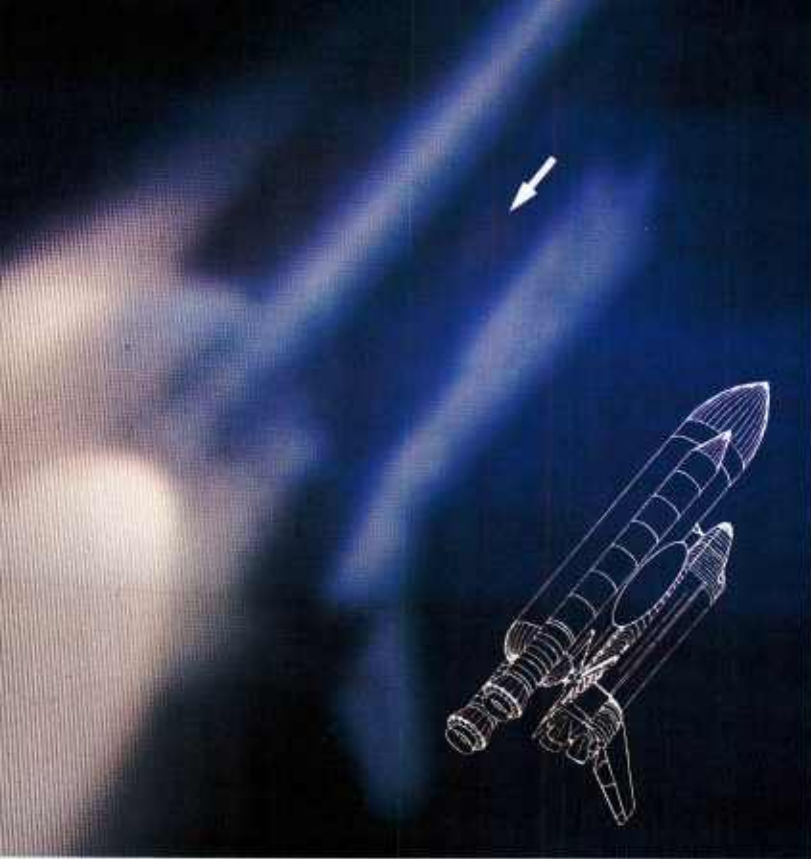
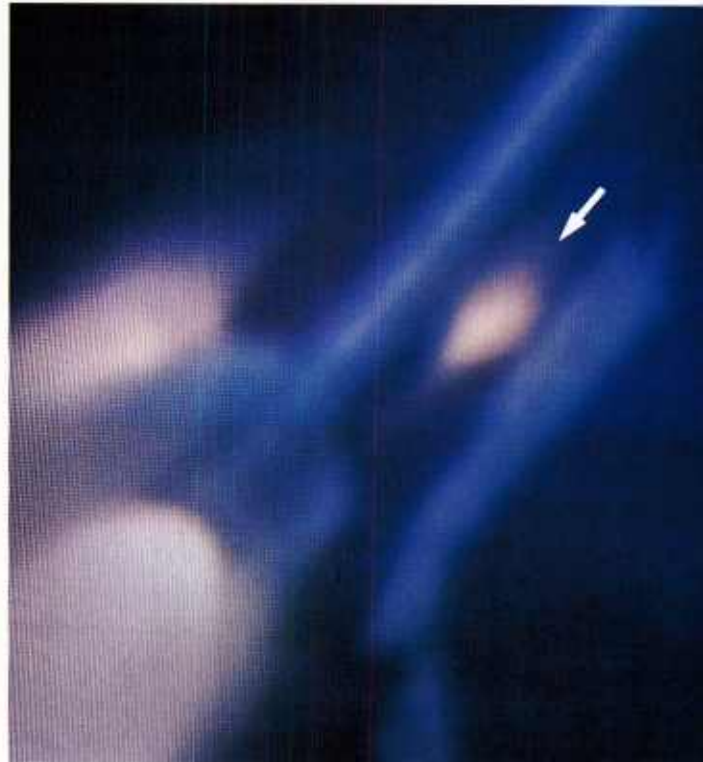
Camera views indicate the beginning of rupture of the liquid hydrogen and liquid oxygen tanks within the External Tank. A small flash (arrows above) intensified rapidly, then diminished. A second flash,

attributed to rupture of the liquid oxygen tank, occurred above the booster/tank forward attachment (below left) and grew in milliseconds to the maximum size indicated in the computer drawing.

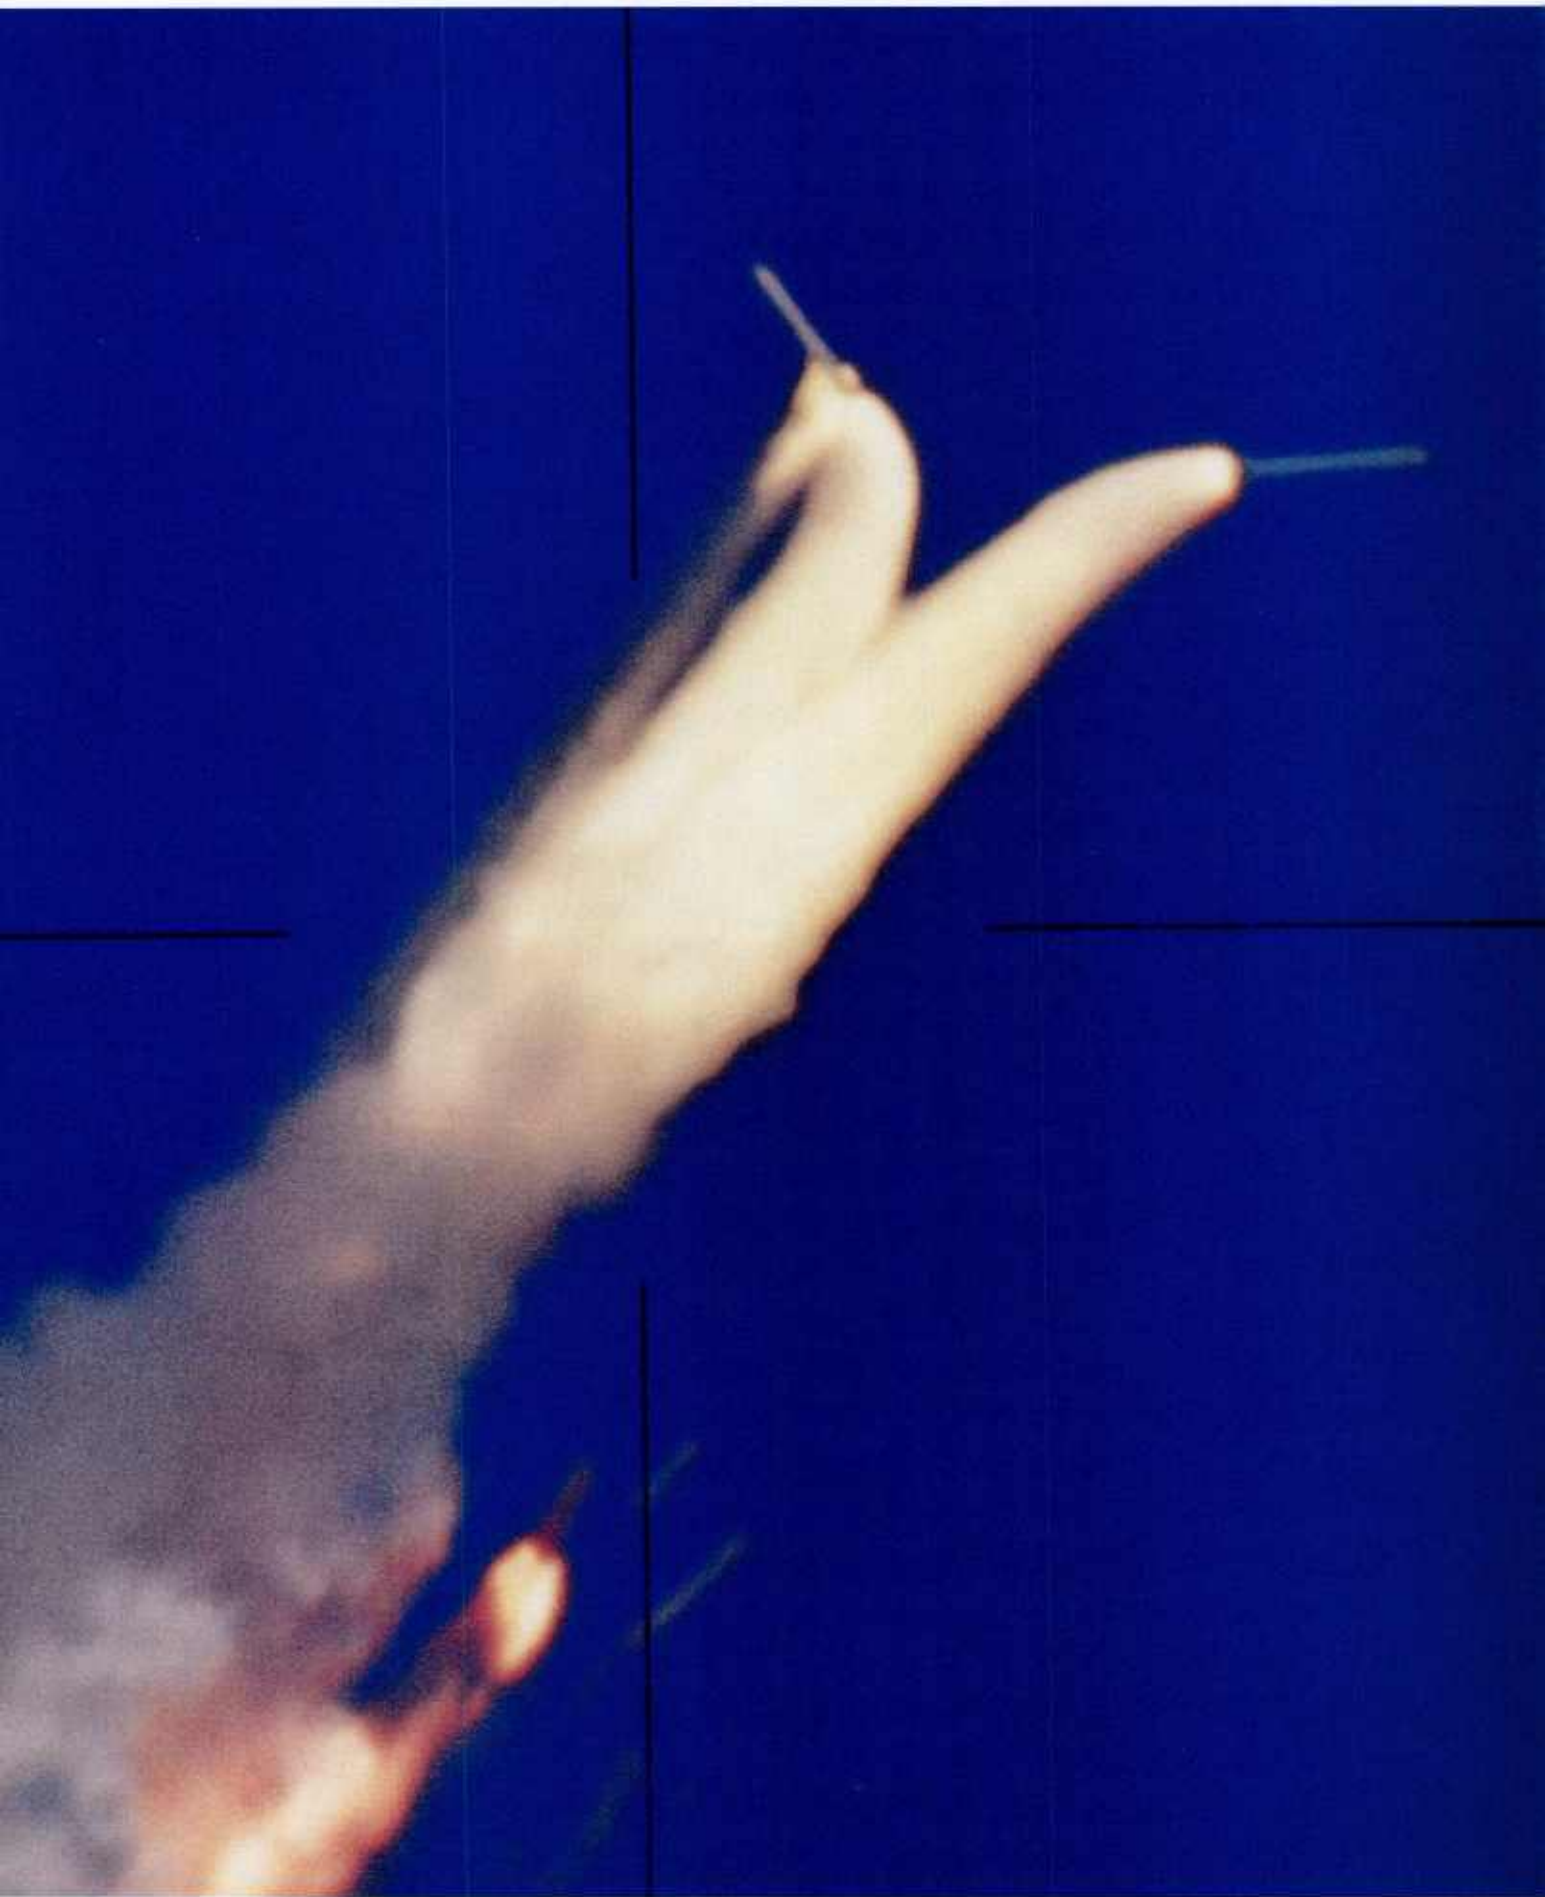
Structural breakup of the vehicle began at approximately 73 seconds. Fire spread very rapidly. Above, a bright flash (arrow) is evident near the nose of the Orbiter, suggesting spillage and ignition of the spacecraft's reaction control system propellants. At left, the two Solid Rocket Boosters thrust away from the fire, crisscrossing to form a "V." The right booster—identifiable by its failure plume—now to the left of its counterpart. At right, the boosters diverge farther; the External Tank wreckage is obscured by smoke and vapor. The Orbiter engines still firing, is visible at bottom center.

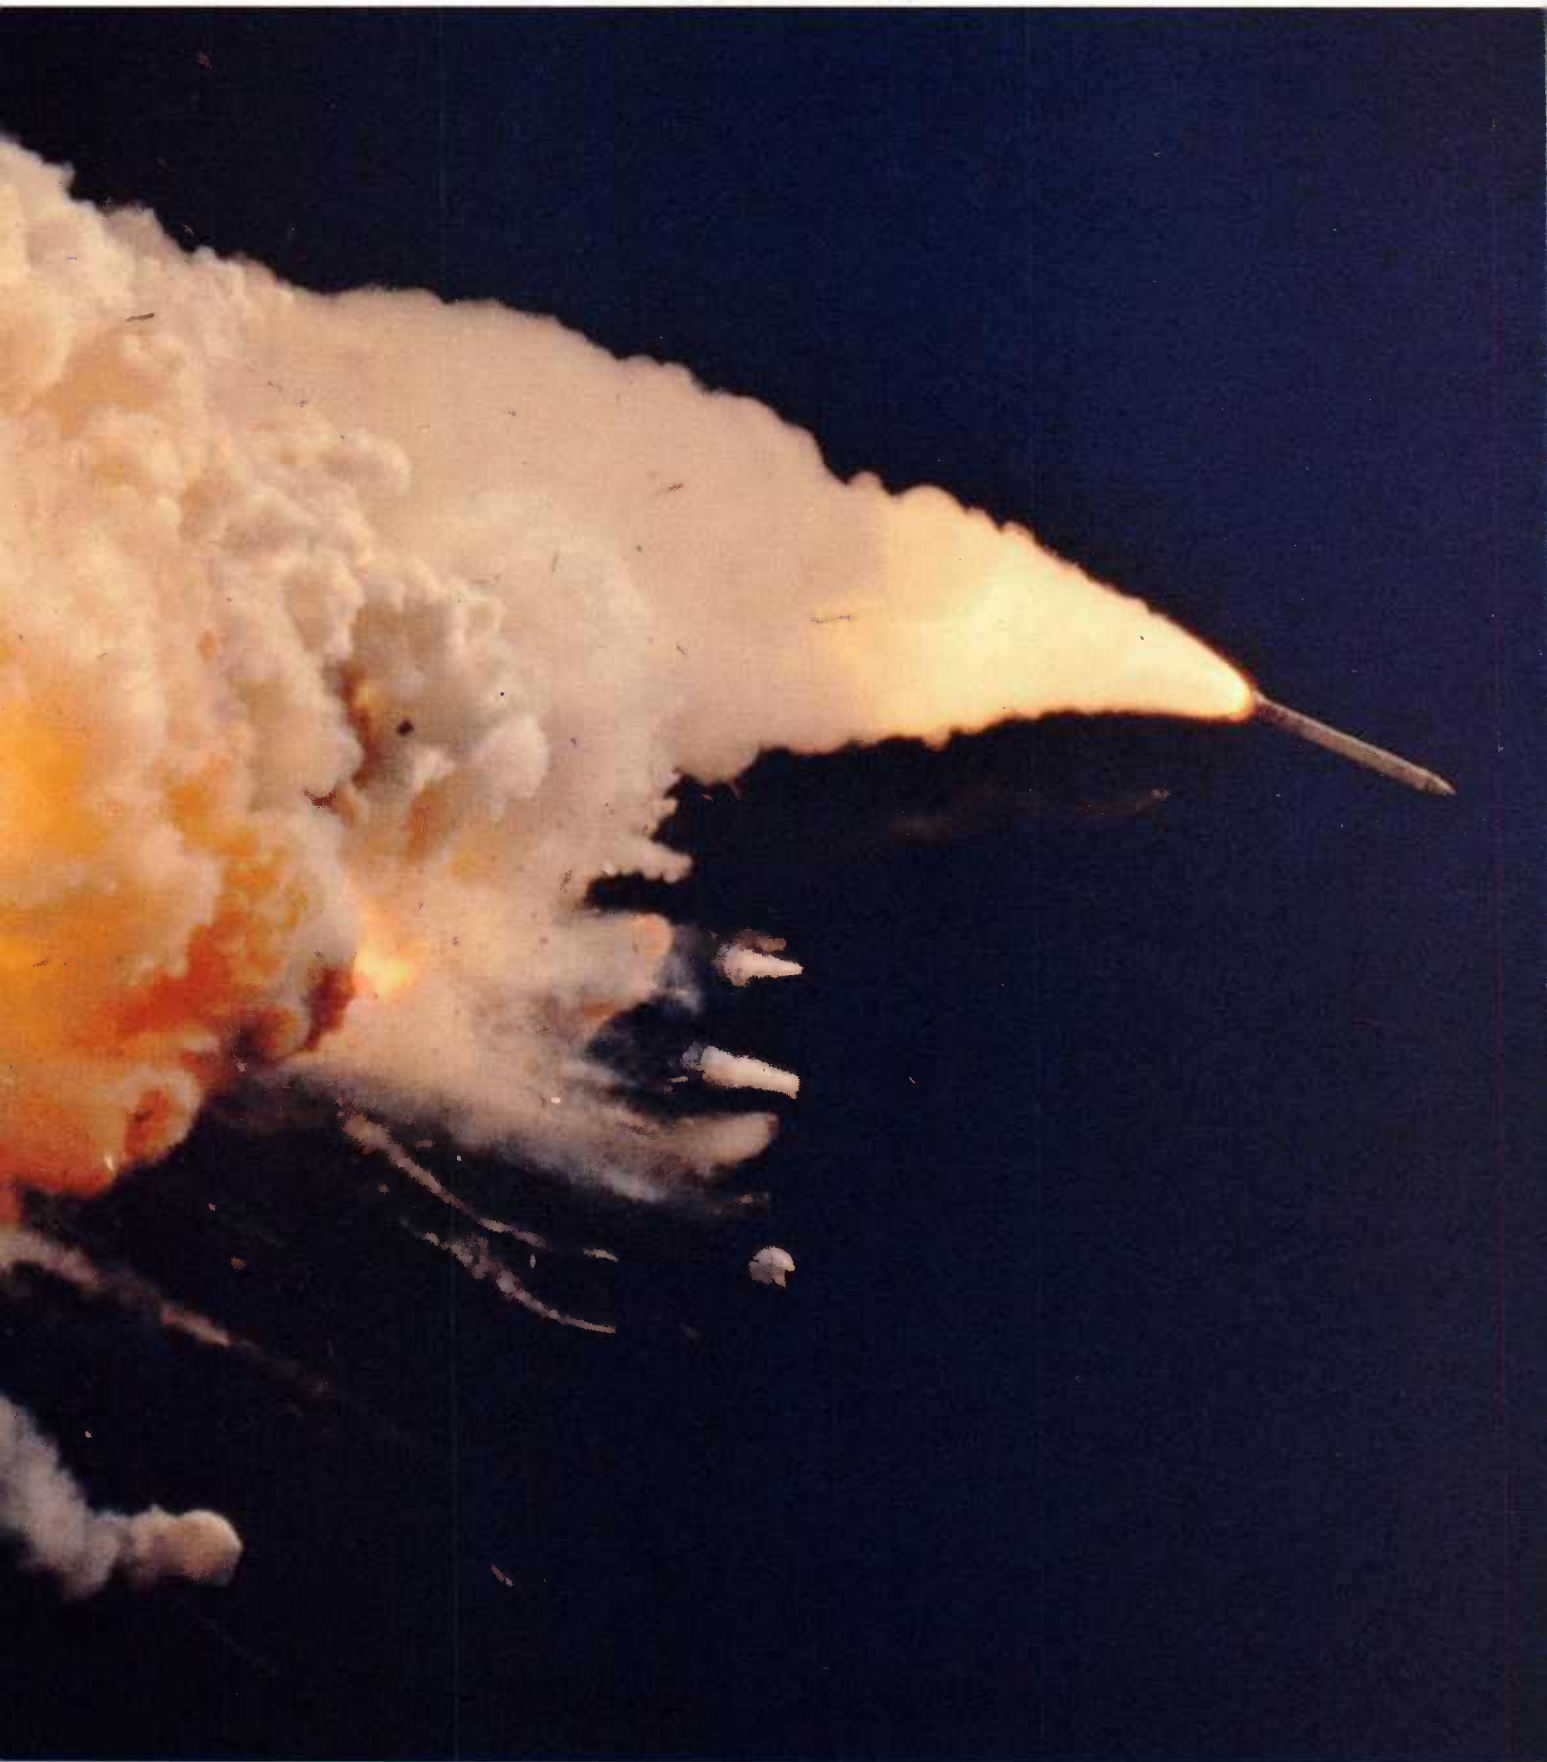
At about 76 seconds, unidentifiable fragments of the Shuttle vehicle can be seen tumbling against a background of fire, smoke and vaporized propellants from the External Tank (left). In the photo at right, the left booster (far right)

soars away, still thrusting. The reddish-brown cloud envelops the disintegrating Orbiter. The color is characteristic of the nitrogen tetroxide oxidizer in the Orbiter Reaction Control System propellant.

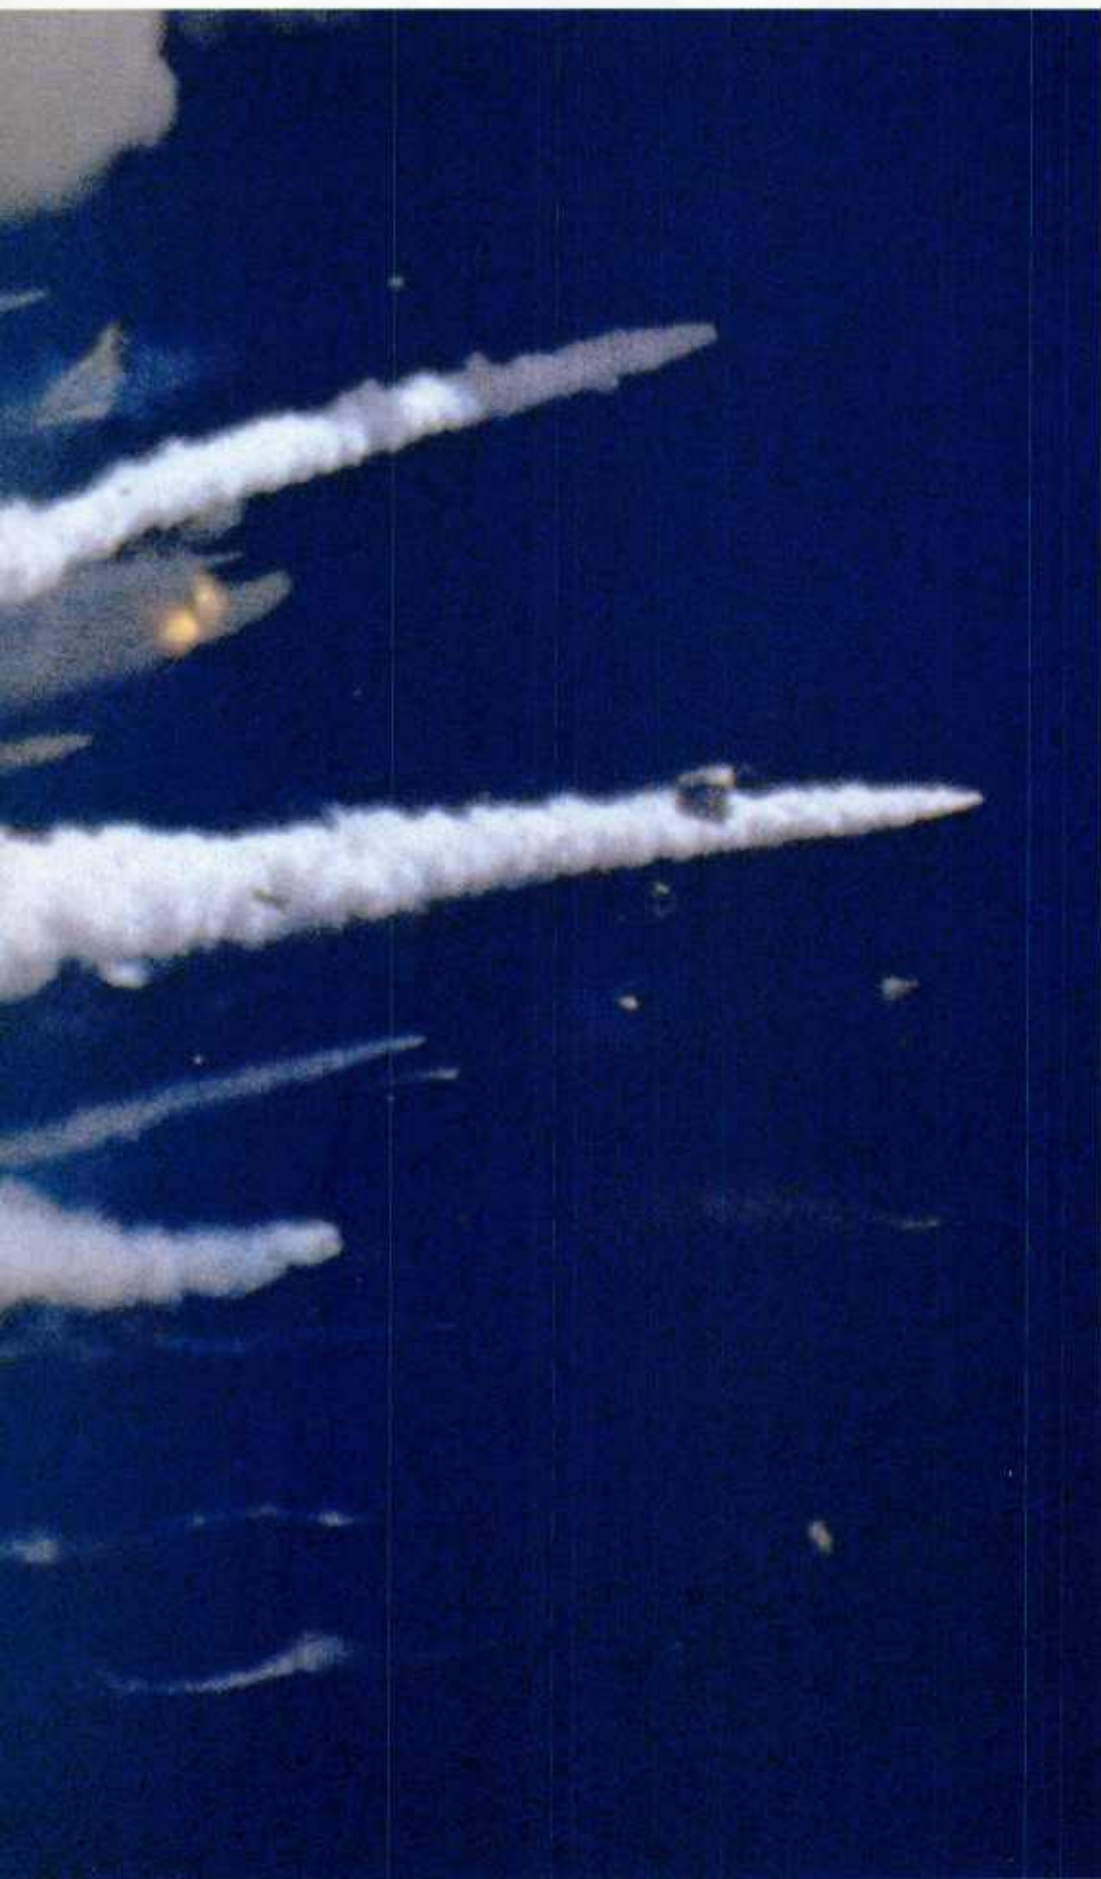
Hurling out of the fireball at 78 seconds (left) are the Orbiter's left wing (top arrow), the main engines (center arrow) and the forward fuselage (bottom arrow). In the photo below, it plunges Earthward, trailed by smoking fragments of Challenger.

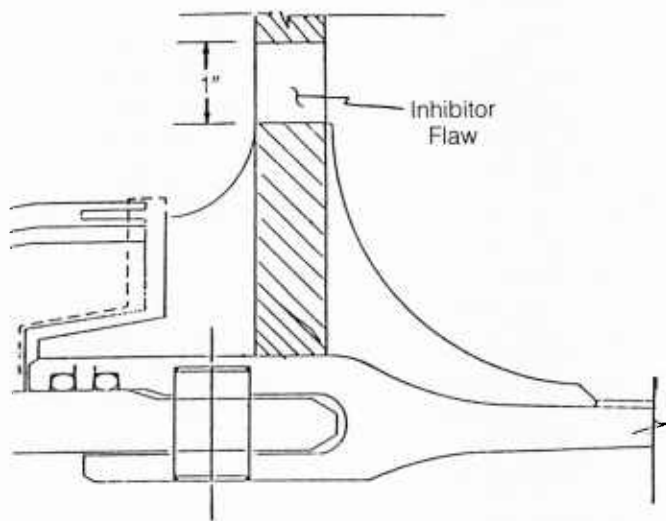
Figure 12  
Sketch shows location of assumed inhibitor flaw used in eliminating such a problem as a possible cause.

Evaluation of potential insulation or inhibitor (see Figure 12) flaws against the three criteria above resulted in elimination of all candidates except a defect in the forward-facing inhibitor. This potential failure mode was evaluated by assuming a 1-inch-diameter hole in the inhibitor. Analysis indicated that the change in motor internal pressure resulting from this failure would probably not be detected. However, an erosion rate substantially higher than the observed values would be required to burn through the membrane by 58 seconds. In addition, the assumed flaw is unlikely since the inhibitor is constructed by vulcanizing eight individual plies of the material. Subsequent damage of the magnitude required is improbable and would be easily detected.

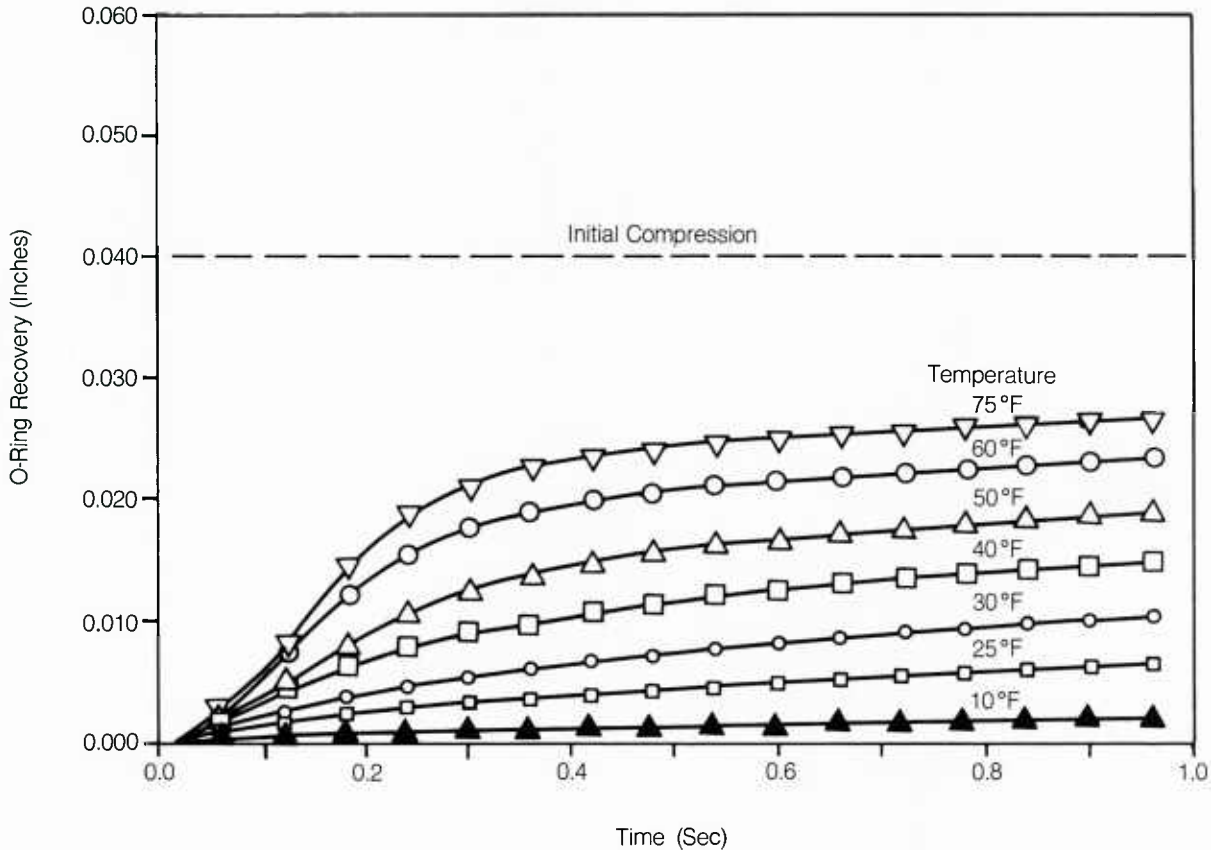
Figure 23  
Graph plots O-ring shape recovery in inches against time in seconds for a variety of temperatures.

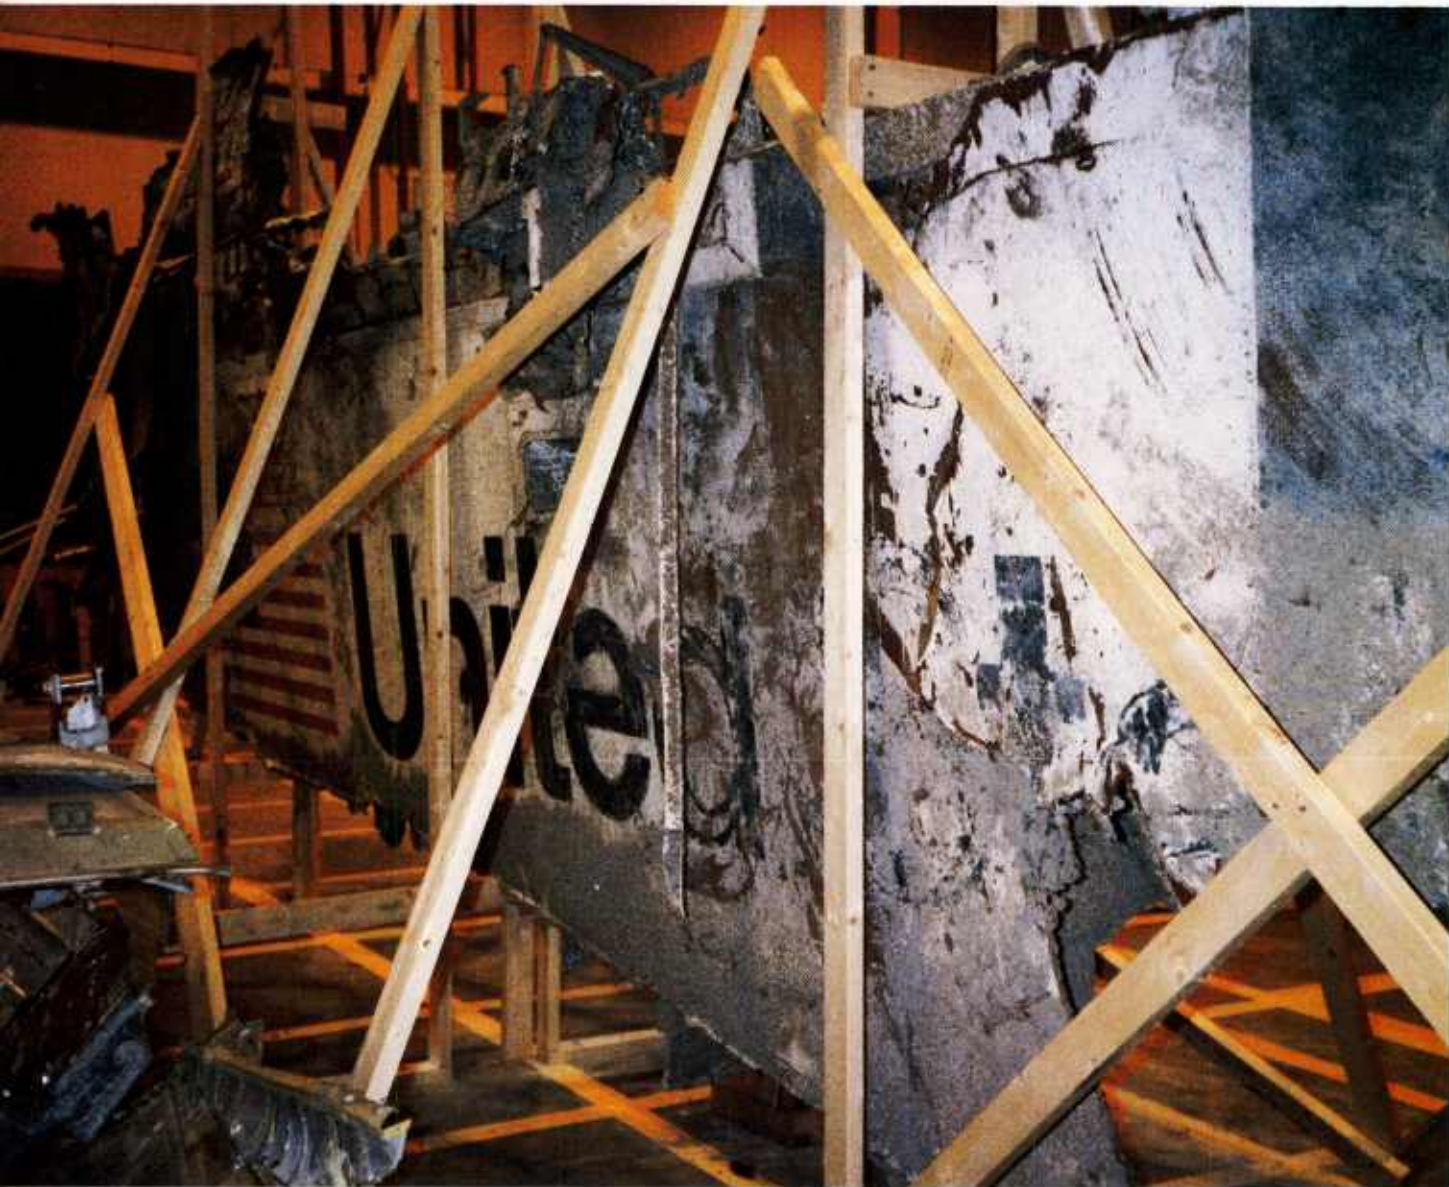
**A** The upper photos show, from left to right, the left side of the Orbiter (unburned), the right lower and upper rudder speed brake (both burn damaged) and left upper speed brake (unburned), confirmation that the fire was on the

right side of the Shuttle stack. The lower photos show the range safety destruct charges in the External Tank. These charges were exonerated when they were recovered intact and undetonated.

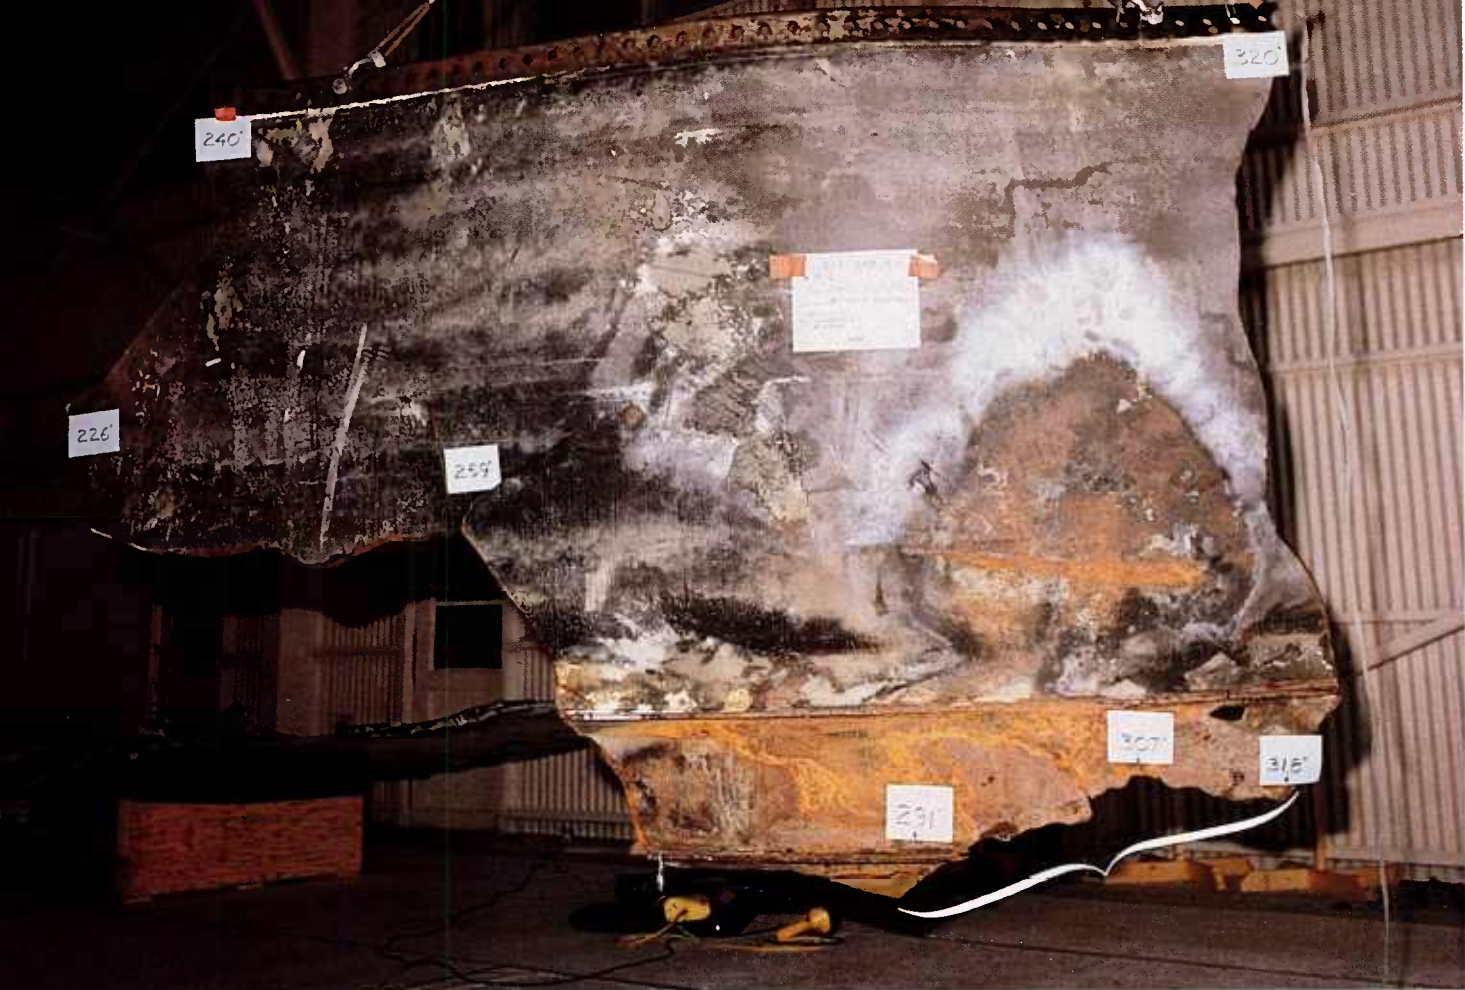
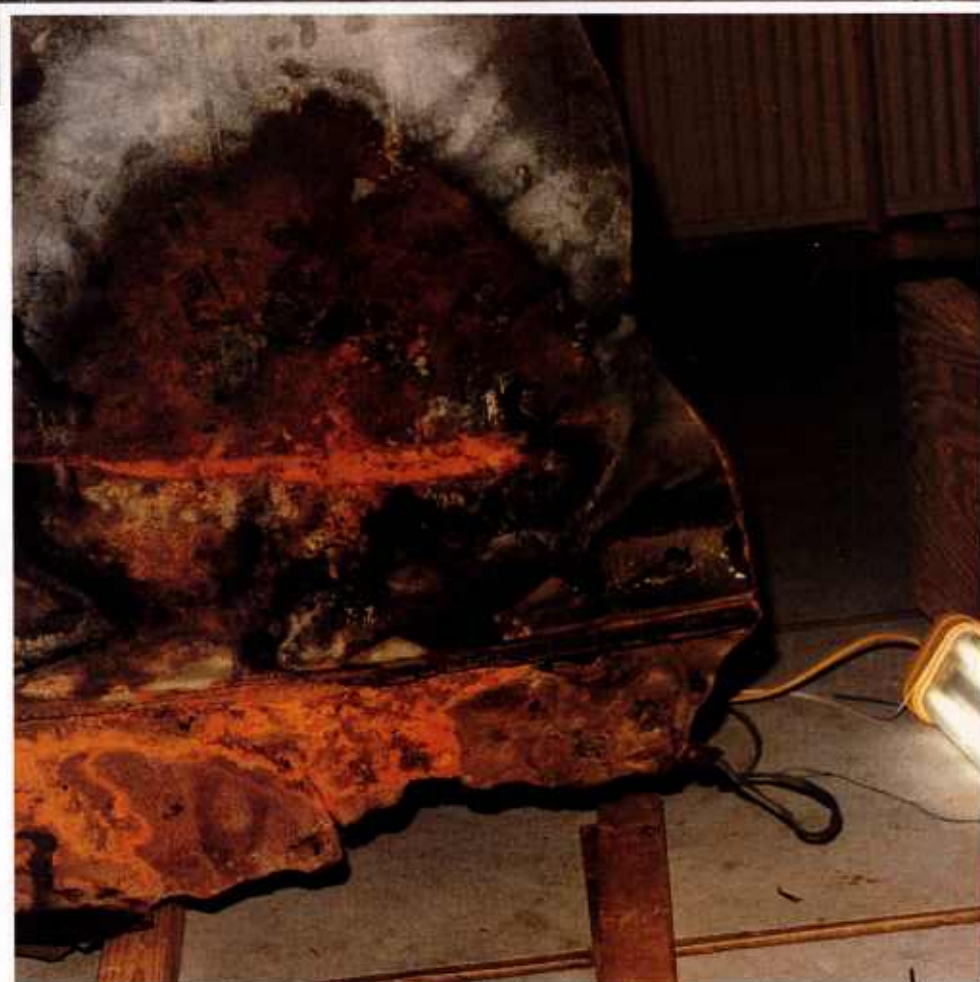
L  
 Examined at Kennedy Space Center after their recovery from the ocean, these fragments show the extent of burn through the right hand booster's aft field joint. On the left page are sections of the aft center motor segment above the joint. On the right page are sections (inverted) of the aft motor segment showing burn-hole below the joint (bracket). Except for the interior views on lower left, the camera is viewing the parts from outside the casing.

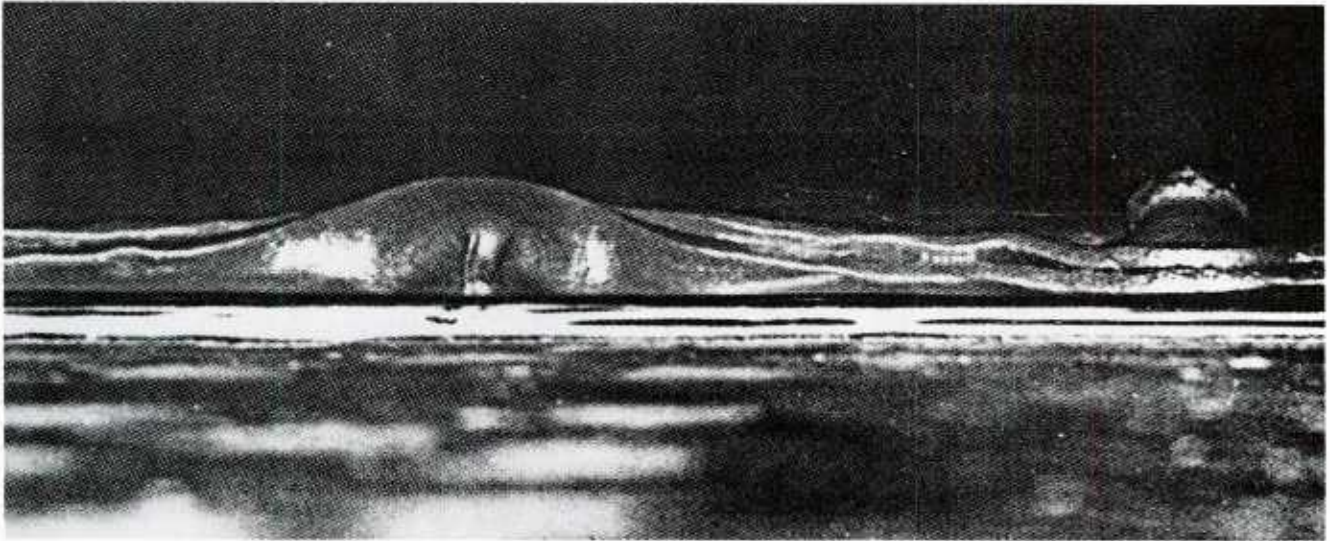
Pressure tests at 200 pounds per square inch of the Solid Rocket Booster joints produced bubbles in putty used to line the joints.
