MISCELLANEOUS PAPER SL-86-7

# FACILITIES TECHNOLOGY APPLICATION TESTS; CONCRETE REPAIR

Tony B. Husbands

April 1986

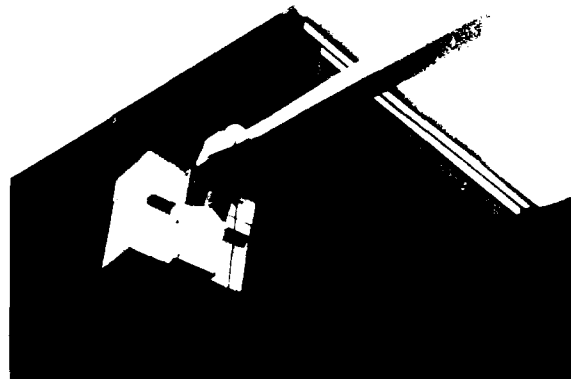
on the balconies and columns had previously been repaired by in-house personnel using a cementitious repair material, and a large number of these repairs had started to fail due to loss of bond and cracking. Spalling of the concrete columns is shown in Figure 4.

**Figure 4. Spalling of concrete columns, Fort Bragg**

49. All vertical spalls on the columns were repaired with an LMM. The spalled areas were prepared using the same method described in paragraphs 46 and 47. It was less difficult to remove the concrete around the reinforcing steel, and the reinforcing steel was completely exposed for most vertical spall repairs. A few of the columns had been repaired using a fast-setting cementitious patching material. Some of these repairs had started to fail because of excessive cracking and loss of bond. Four of these areas were repaired by removing the previous repair material and repairing again using the LMC. Preparation of these areas and the finished repairs are shown in Figures 16 and 17, respectively. Some of the vertical repairs were exposed to direct

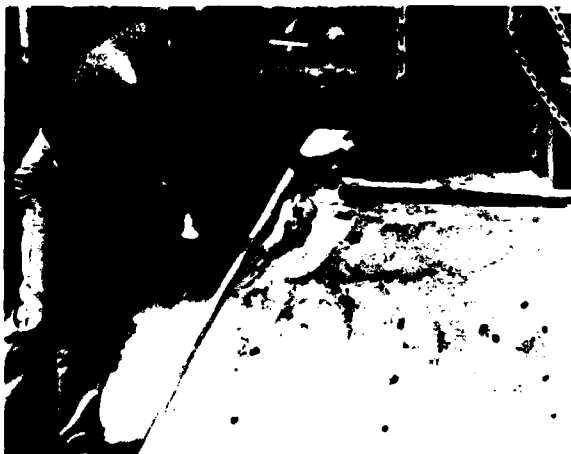
**Figure 11. Repair of spalls on concrete footings with latex-modified mortar**

42. All entry ports were removed the following day after the epoxy-resin injection had been completed. The holes left after removal of the entry ports were filled with the LMM. This material was recommended by WES over an epoxy-resin mortar proposed by the contractor because it would be less expensive and compatible with the coating to be used. All footings were sounded to determine if any delaminations were evident after injection and if unsound concrete was present. Six areas in three of the footings were found to be unsound, and these areas were removed with an air hammer and repaired with the LMM (Figure 11). The footings were then cleaned

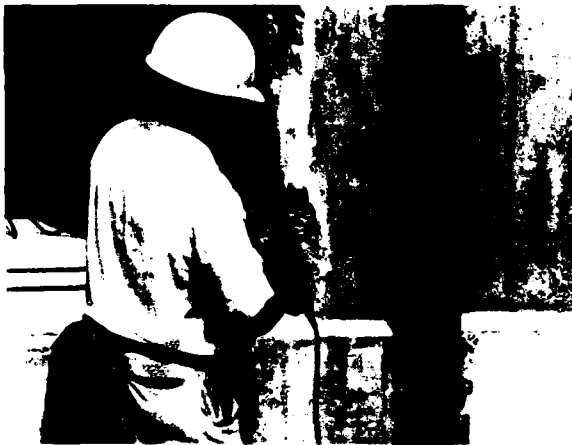
**Figure 16. Preparation for vertical spall repair on columns**

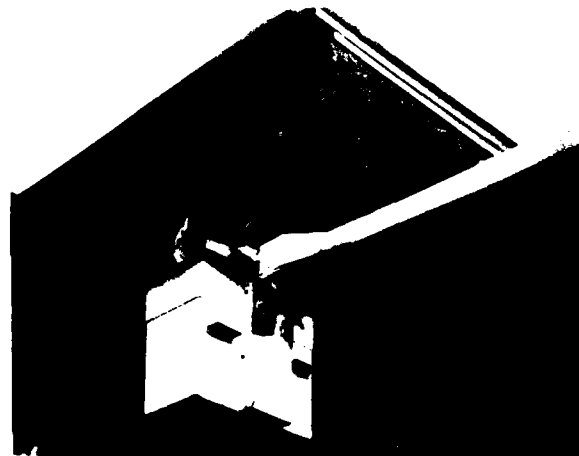
**Figure 18. Removal of unsound concrete for column repairs**

sunlight and wind. A few of these were protected by covering the freshly placed material with a damp cloth to protect the material from the heat and wind which could cause shrinkage cracking. Most of the repairs were not protected and the heat did not appear to cause any cracking. The largest spalled area repaired was located on a column near the top of the building. A lift was used to raise personnel performing the repairs to the desired heights. The repair materials were prepared on the ground and transferred to the lift bucket by means of a rope and pulley. Removal of the unsound concrete and the finished repairs are shown in Figures 18 and 19, respectively.

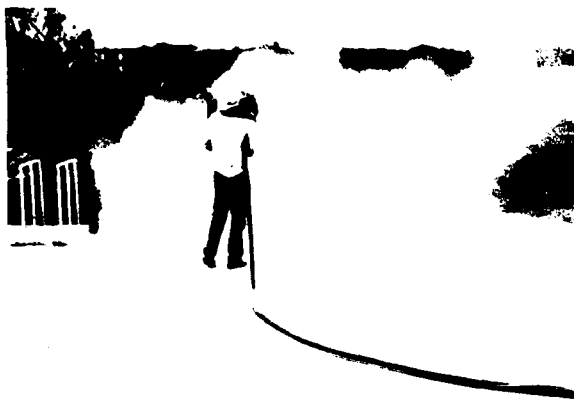
**Figure 21. Cleaning of roof surface by sandblasting, Fort Ord**

dirt, previous coatings, and the epoxy resin used to seal the cracks. Cleaning was accomplished by sandblasting. The subcontractor in charge of the cleaning operation used a large rotary sandblaster which obtains a constant air pressure of up to 1,800 psi. An air pressure of 1,000 psi was used for the sandblasting of the roof decks. All excess fines left by the sandblasting were removed using a mechanical sweeper. The remaining fines were blown off using compressed air. The preparation of the roof deck before repairs is shown in Figures 20 and 21.

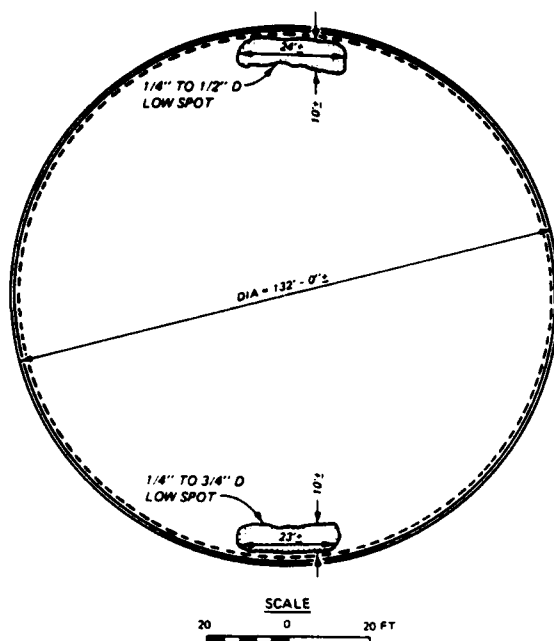
**Figure 30. Low areas on reservoir D**

61. The roof deck of the reservoir D water storage tank was coated with two slurry coats of polyester-resin mortar. The roof deck of this tank was cleaned and repaired using the same procedure that was used for the sand trap water storage tank. Two low areas (Figure 30) were brought to grade using the polyester-resin concrete before the polyester-resin mortar coatings were applied.

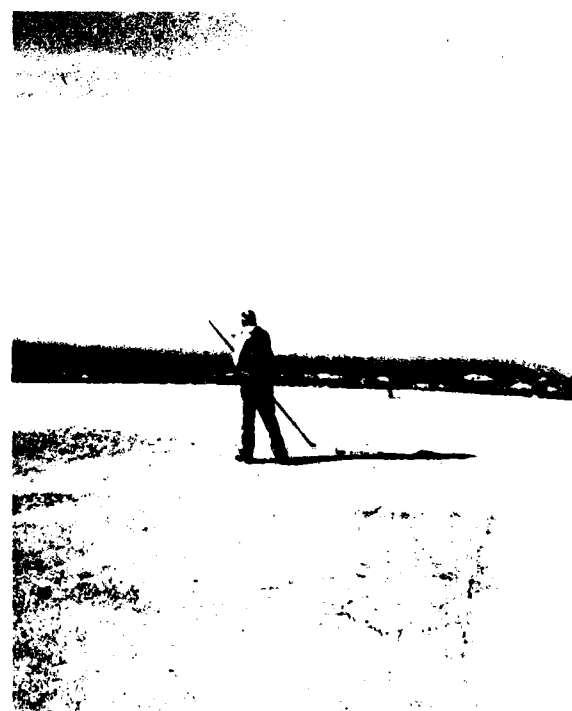
**Figure 32. Finishing of slurry coat, reservoir D**

until it was no longer tacky. The polyester-resin mortar was spread over the primed surface using squeegees followed by finishing with a magnesium float. The mortar coating was allowed to cure overnight and a second application of the coating was applied.
