MISCELLANEOUS PAPER HL-86-6

ST. STEPHEN POWERHOUSE TAILRACE VELOCITY MEASUREMENT

Final Report

Prepared for US Army Engineer District, Charleston
Charleston, South Carolina 29402-0919

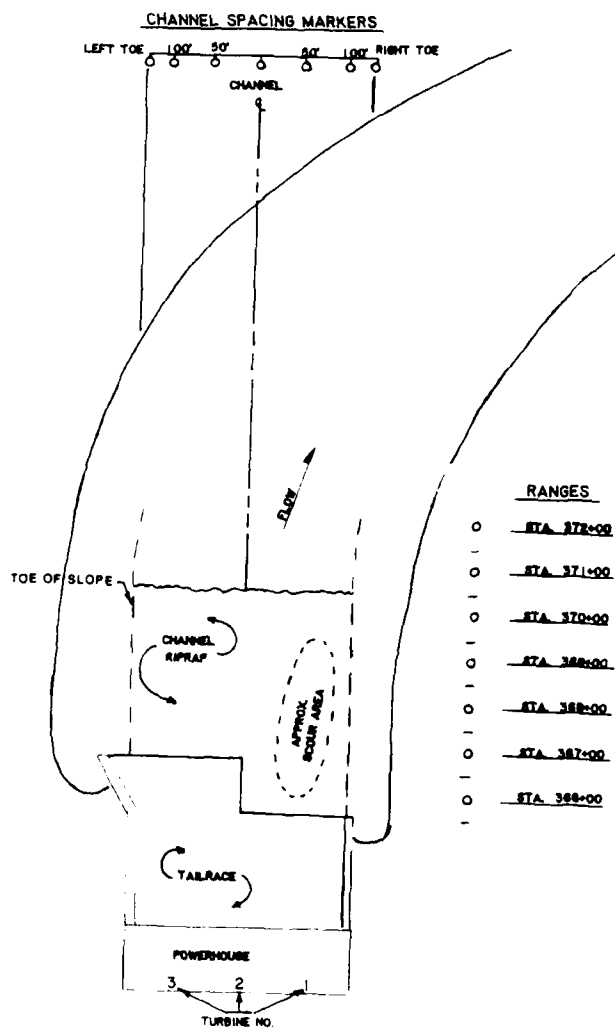
Figure 1. Range and channel spacing markers

2. The construction of the powerhouse started in the spring of 1983, and the first commercial operation began in March 1985. After only 5 days of operation, it was discovered that a large scour hole had developed in the tailrace channel (Figure 1). The major scour area was located on the right side (looking downstream) of the tailrace channel from the channel center line up to and including the existing toe and slope of the right bank. The length of the scour area extended from the edge of the concrete apron to a point 300 ft downstream. The scour depth was found to have reached a maximum of 21 ft below the original channel bottom elevation.

repairs to the tailrace channel included excavating all the remaining bottom material above el -4.75 ft* from the edge of the concrete apron to sta 368+50, then removing all material above el -2.25 ft from sta 368+50 to sta 370+00 and using this material as fill for the scour area. Next a nonwoven filter fabric material, overlain with 9 in. of sand, and three sizes of riprap stone were placed, the largest of which was placed nearer the apron. The stone sizes used in the channel decreased with distance downstream of the powerhouse. In the areas where erosion extended into the existing side slope, additional layers of stone were added to increase the protection of the toe and slope. The following tabulations describe the extent and composition of the tailrace protection provided and the gradation of the various riprap and bedding stone used (see Figure 1 for location of station numbers):

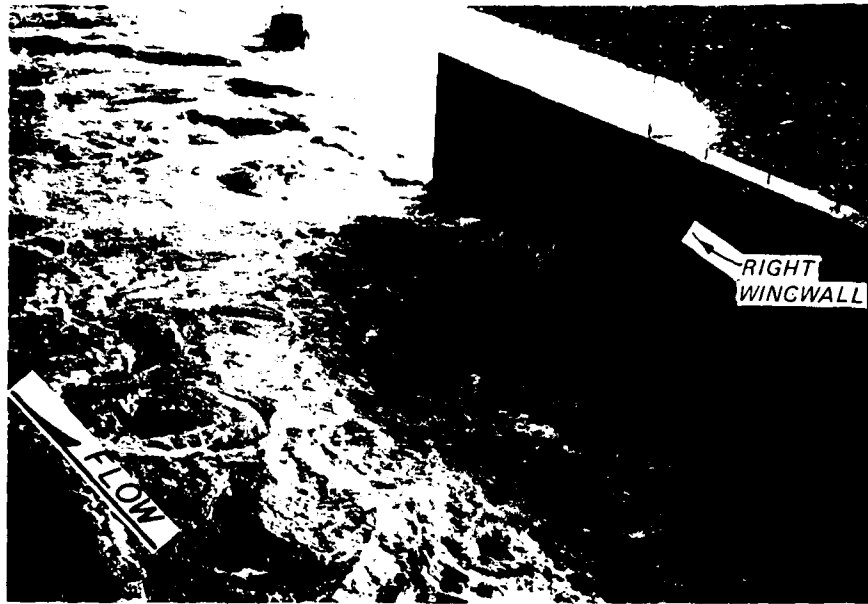
Figure 4. Flow turbulence in the area of the right wing wall

11. A few spot velocity measurements were attempted at a location immediately downstream of the right wing wall. Due to extreme turbulence, standing waves, and critical surface currents in this area, as shown in Figure 4, and difficulty in maintaining boat position, these efforts were discontinued after a few attempts. Therefore, the spot velocity information obtained in this area during the test period should be interpreted for determination of trends and not considered as absolute values. Velocity readings taken at all other locations are considered to be accurate to within ± 0.2 fps.
