NATIONAL DAM SAFETY PROGRAM INSPECTION REPORT SOUTH  
BRANCH ROOT RIVER LAN. (U) CORPS OF ENGINEERS ST PAUL  
MN ST PAUL DISTRICT JUL 78

NATIONAL DAM SAFETY PROGRAM  
INSPECTION REPORT

July 1978

INSPECTION REPORT  
NATIONAL DAM SAFETY PROGRAM  
LANESBORO DAM, INVENTORY NO. 517  
SOUTH BRANCH ROOT RIVER, MINNESOTA

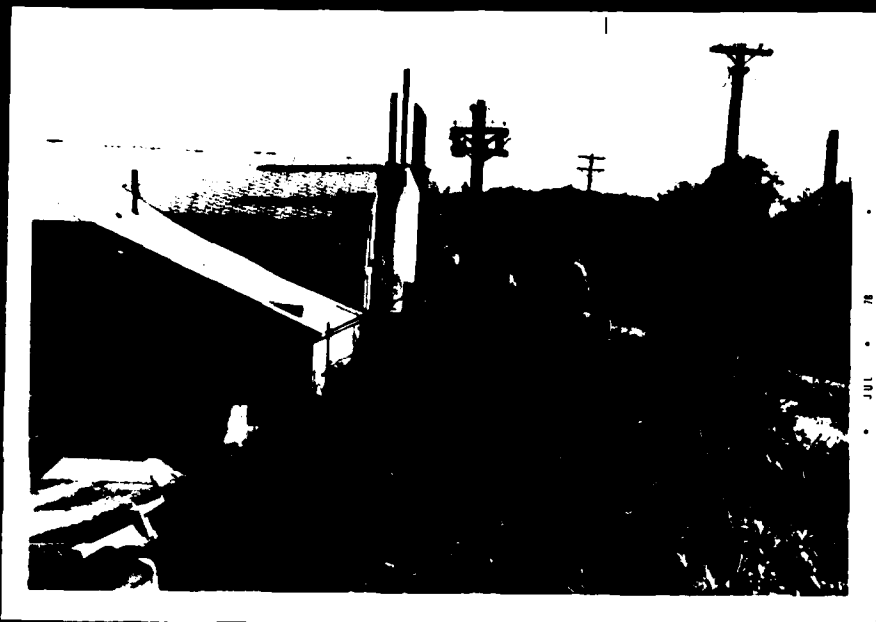
7. Powerhouse - Picture taken 30 May 1978. Photograph taken from end of canal looking upstream. Note: 1) powerhouse of immediate left; 2) boiler room immediately behind powerhouse; 3) old railroad grade serving as top of embankment; 4) powerhouse inlet to right of embankment; 5) one of two possible old turbine shafts in foreground left of wall.

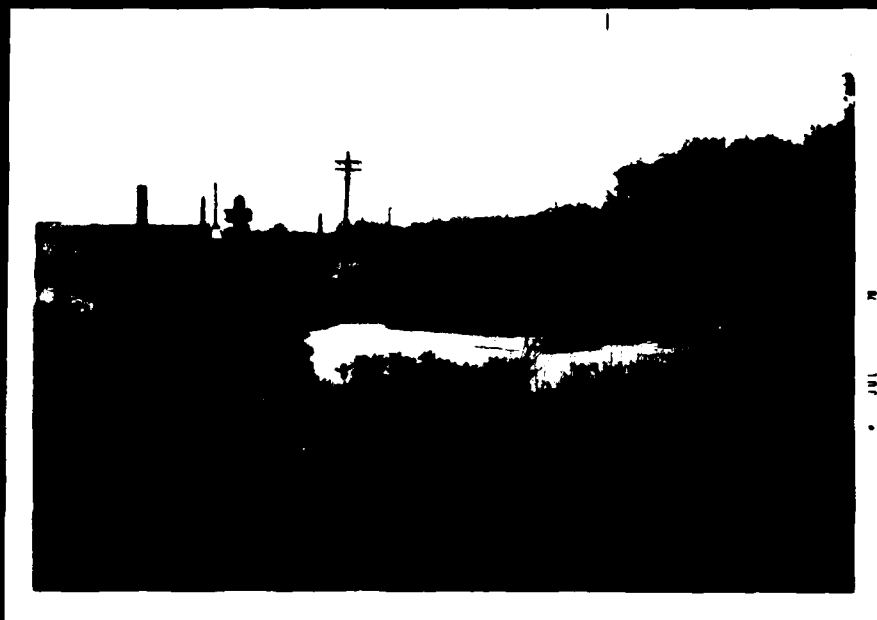
8. Canal - Picture taken 17 May 1978. Photograph taken from railroad grade downstream of canal looking upstream. Note: 1) abandoned intake structure in line with possible old turbine shaft; 2) powerhouse in background with inoperable gate structure; 3) canal embankment separating race from mill pond (right side of picture).
