TECHNICAL REPORT M-86/17
September 1986
Underground Distribution Systems

Corrosion of Aluminum Jackets on Aboveground Heat Distribution Systems

by
Kirk E. Cooper
Ellen G. Segan

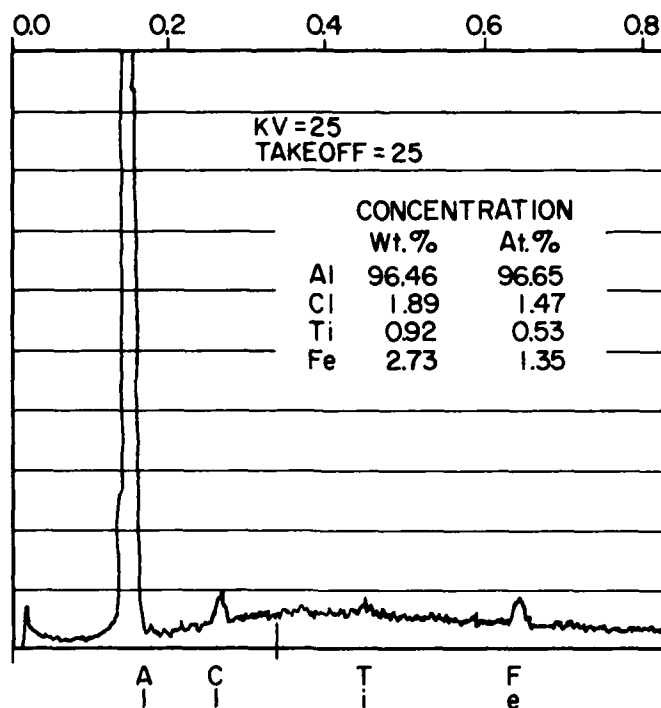
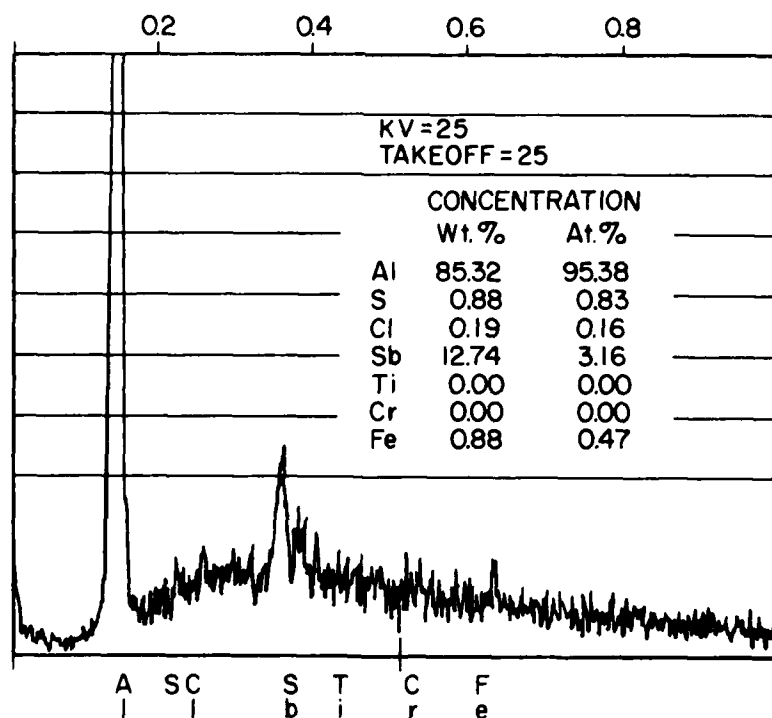
Figure 11. EDAX spot spectra. a: EDAX spot spectrum (1000 X) on the white deposit shown in Figure 10a. Elemental concentrations are shown in the inset. b: Spectrum (1000 X) on corrosion product around the pit shown in Figure 10b. The peak marked as antimony may be calcium.

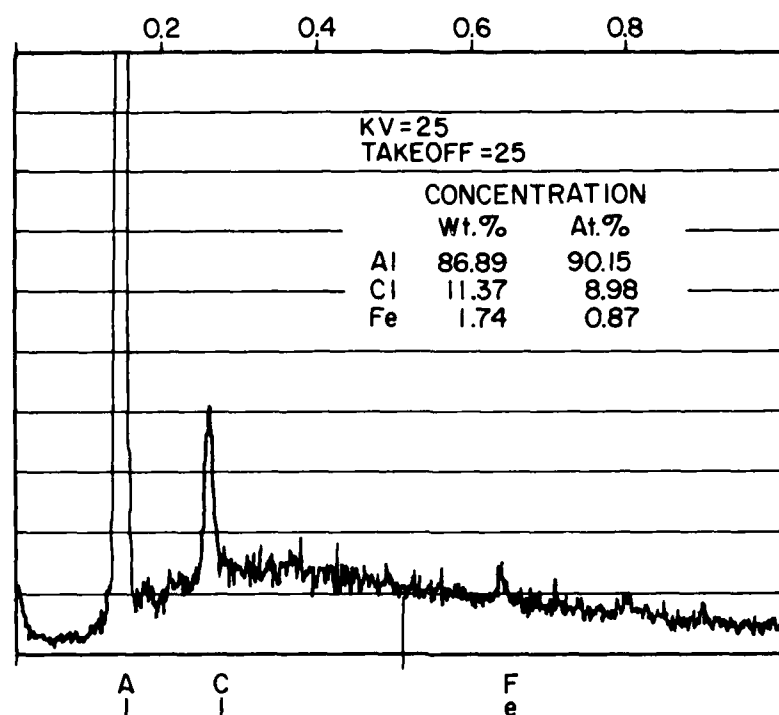
Figure 12. High chlorine concentration in a section of corroded jacket. (Spectrum taken at 50 X).

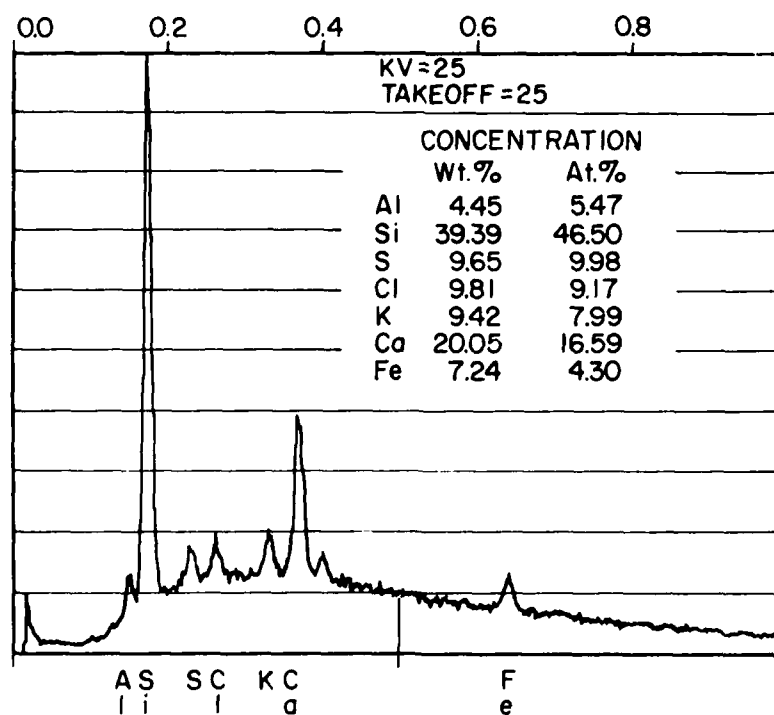
Figure 13. Spectrum (50 X) from a metallic-looking deposit on the paper side of corroded aluminum jacket. Note the high chlorine concentration.

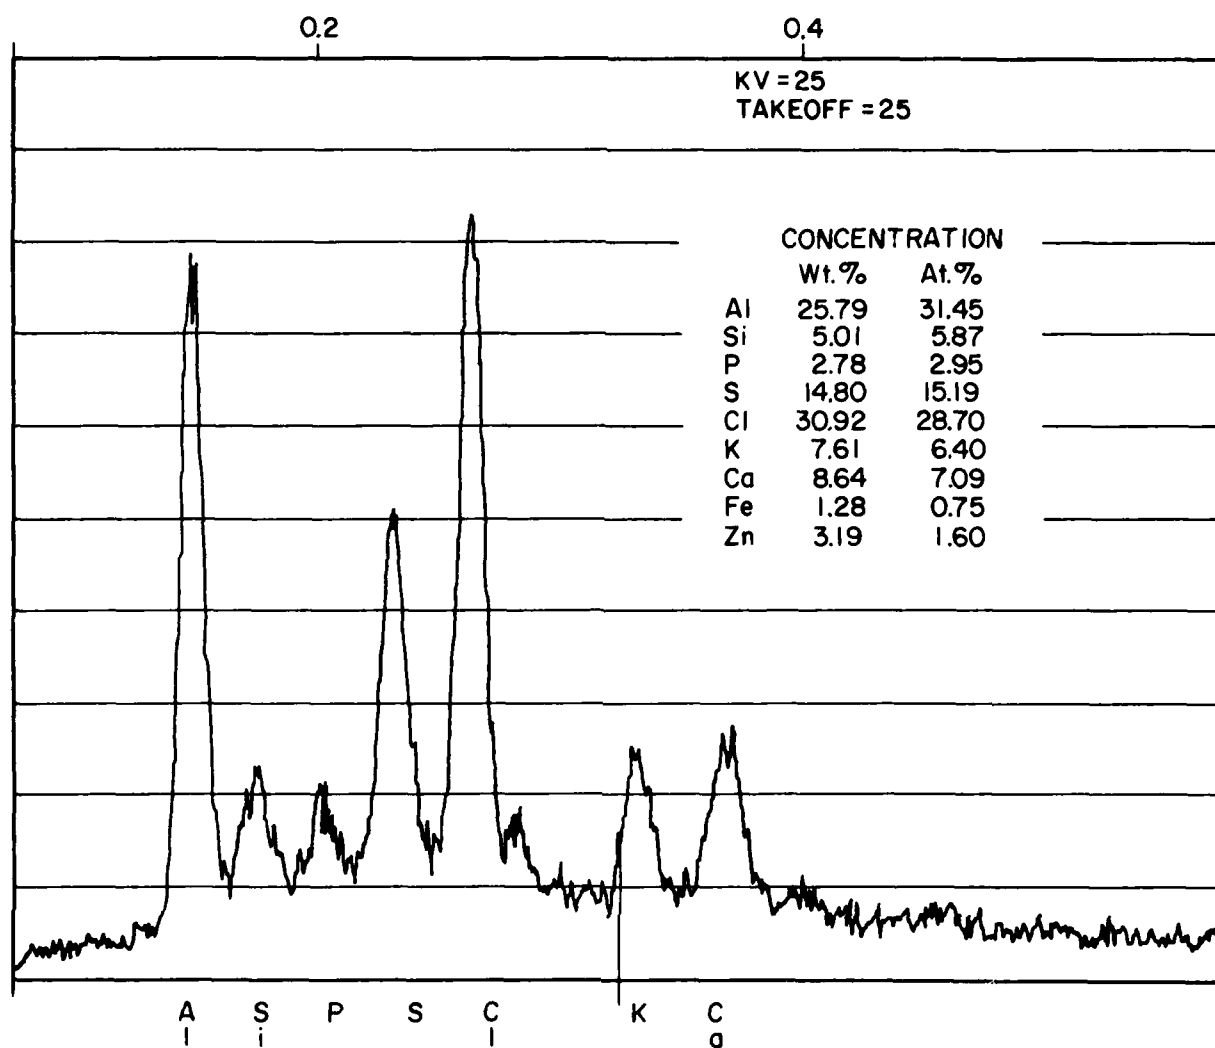
Figure 14. EDAX spectrum of white corrosion product present on vapor barrier.

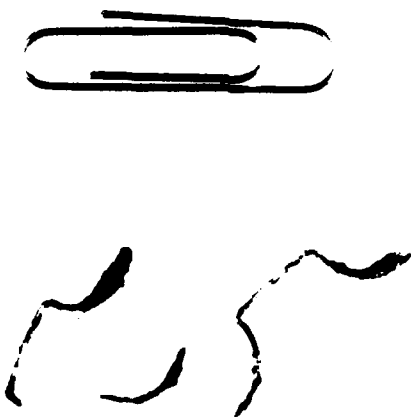
Staples used on vapor barriers were rusted, indicating that carbon steel was used instead of the required stainless steel. Iron cations from these staples could deposit on the aluminum jacket interior, thus enhancing corrosion at these sites.

Figure 15. Staples taken from used vapor barrier (1.4 X). The presence of rust indicates that carbon steel staples were probably used. (Paper clip used to indicate size of staples.)

Monel, stainless steel, and carbon steel staples have been used or are recommended for fastening joints in vapor barriers. However, serious corrosion problems may arise if these are coupled galvanically with aluminum. There are potential differences of 1 V or more between aluminum and 304 stainless steel or Monel in an NaCl solution of pH = 10. Therefore, it is recommended that the guidance require aluminum staples. An alternative should be to require a self-sealing lap, which avoids the use of staples; this is already available on some products.
