TECHNICAL REPORT REMR-CO-1

**STABILITY OF RUBBLE-MOUND
BREAKWATER AND JETTY TOES;
SURVEY OF FIELD EXPERIENCE**

Dennis G. Markle

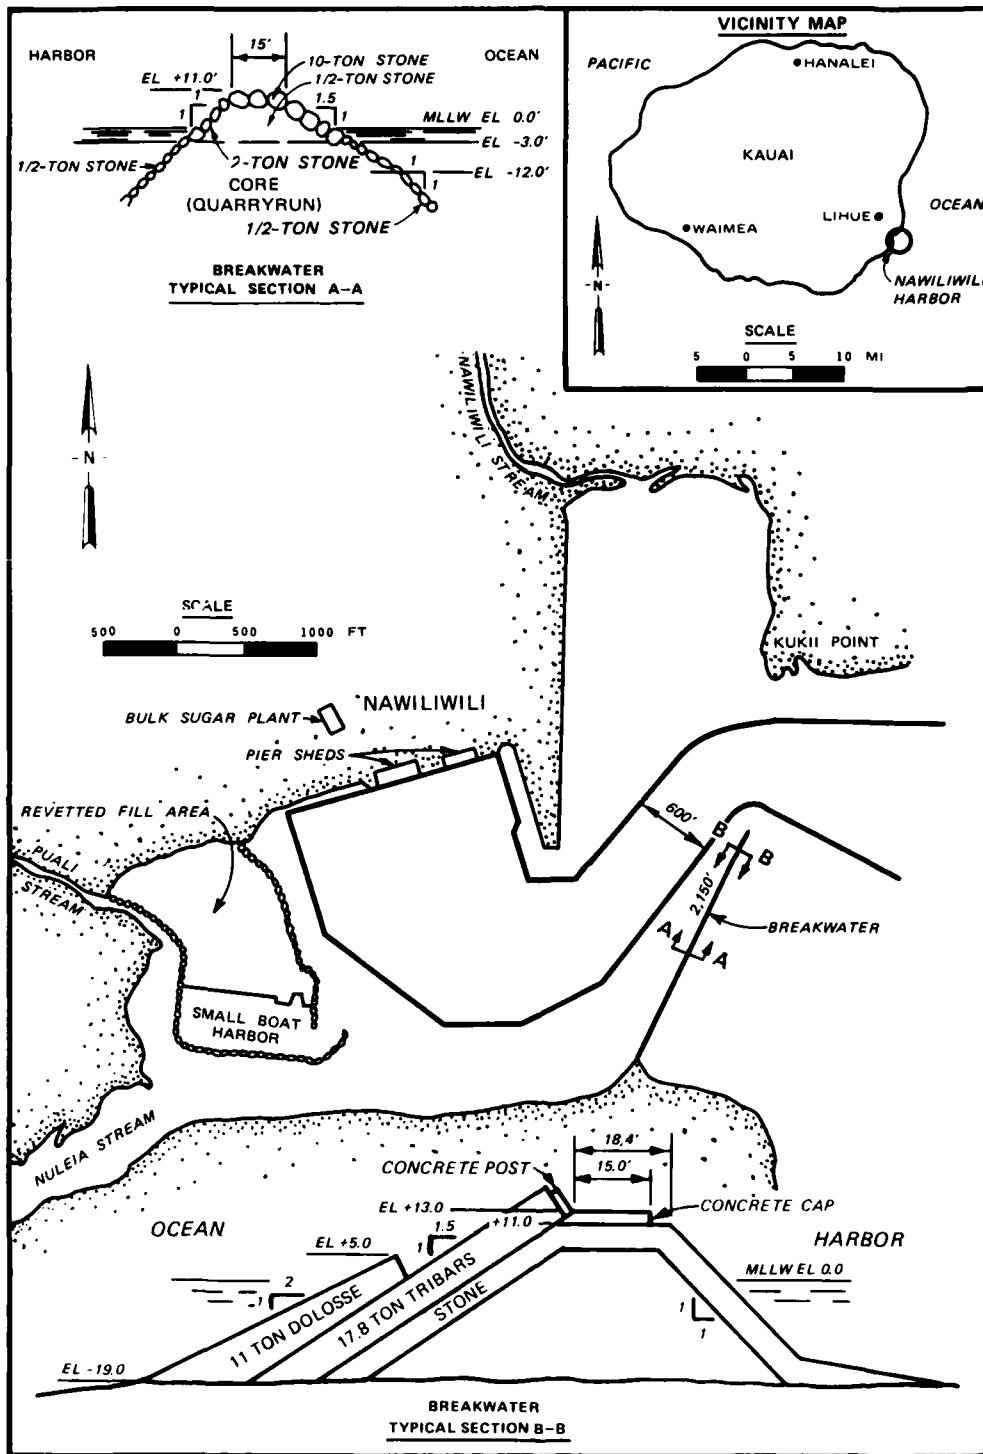
Figure 1. Nawiliwili Harbor Breakwater, Kauai, Hawaii

10. The Honolulu District of POD has three breakwaters which have problems and/or design questions that are related to toe stability. Two of the structures, Nawiliwili and Hilo, had a related problem. The head and adjacent 500 ft* of breakwater trunk at Nawiliwili Harbor, Kauai, Hawaii (Figure 1), were rehabilitated in 1959 using 17.8-ton tribars. Model

tests*, conducted at WES in 1958, revealed that two layers of randomly placed tribars on the head and one layer of uniformly placed tribars on the trunk were the best methods of rehabilitating the storm damaged structure. A survey in 1975 revealed extensive tribar breakage, and later it was found that the toe buttressing stone recommended for placement at the toe of the one layer of uniformly placed tribars had not been incorporated into the construction specifications. It was surmised that in the absence of these buttressing stones the tribar toe slid on the hard bottom which resulted in an en masse slippage and breakage of several tribars. This area was rehabilitated with two layers of randomly placed 11-ton dolosse on slope and through the use of special placement of the toe dolosse. This latter work was also model-tested at WES.**

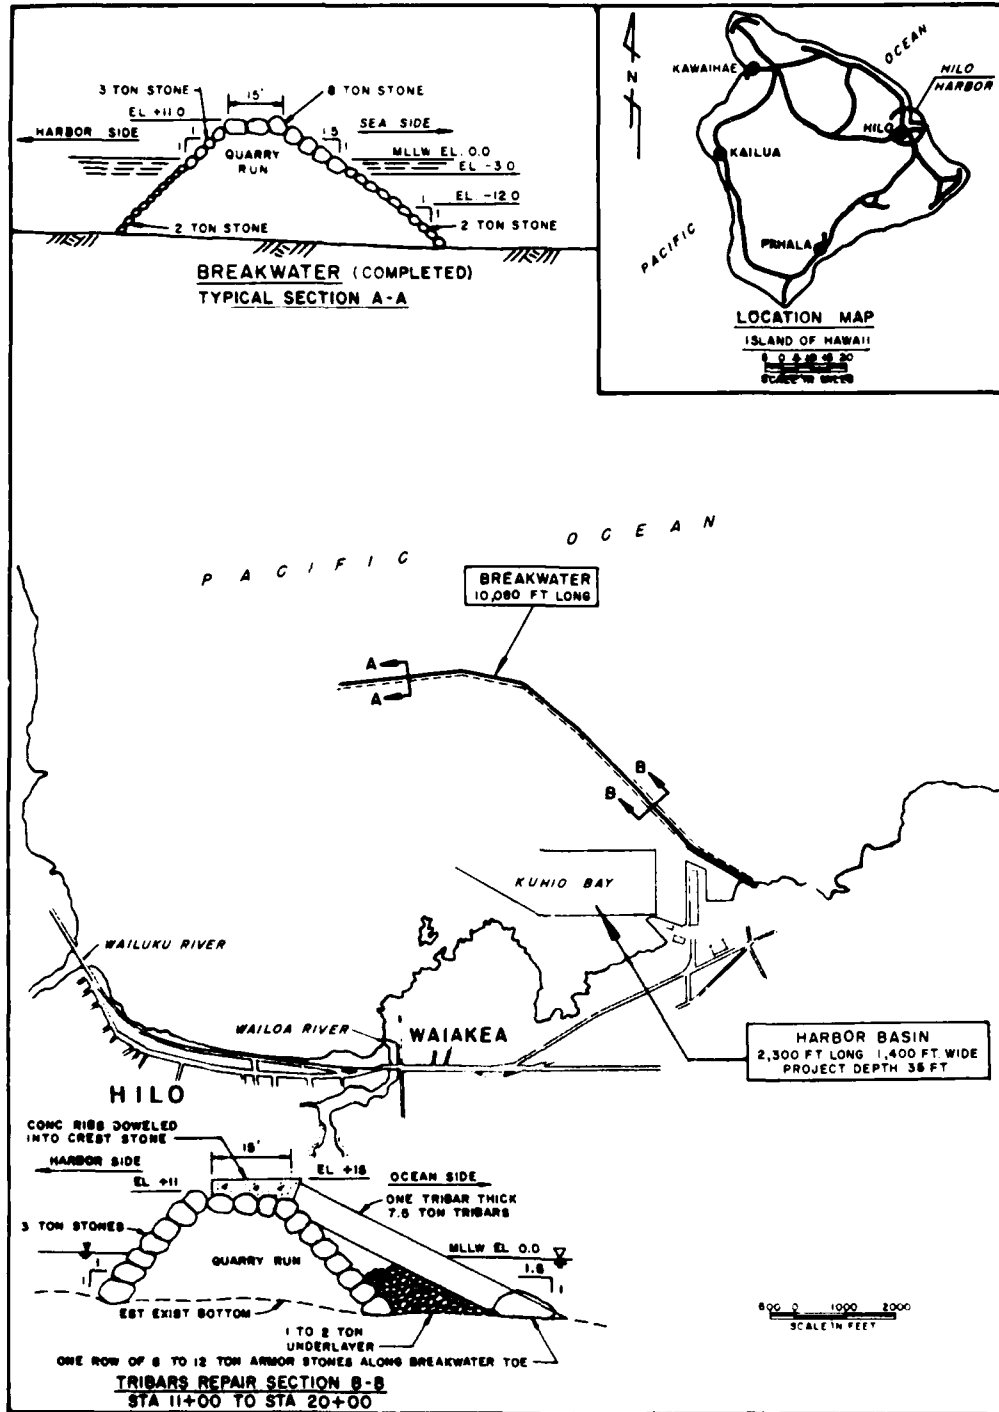
Figure 2. Hilo Harbor Breakwater, Hawaii, Hawaii

11. A repair similar in design to that used on Nawiliwili in 1959 was completed on the Hilo Harbor Breakwater, Hawaii, Hawaii (Figure 2), in 1981. One layer of uniformly placed 7.5-ton tribars was placed on the sea-side slope of the breakwater between sta 11+00 and sta 20+00. Based on knowledge gained through the failure of the Nawiliwili tribar section, a row of 8- to 12-ton buttressing stone was incorporated into the toe repair. No design guidance is presently available to aid in sizing the buttressing stone for an incident wave environment, and no model tests were conducted. For this reason, close monitoring of the repair work should be carried out after storm events. Thus, POD and the Corps as a whole will gain from prototype experience which can be used to complement the data acquired during the experimental model tests on toe buttressing stone design proposed to be carried out under this work unit.

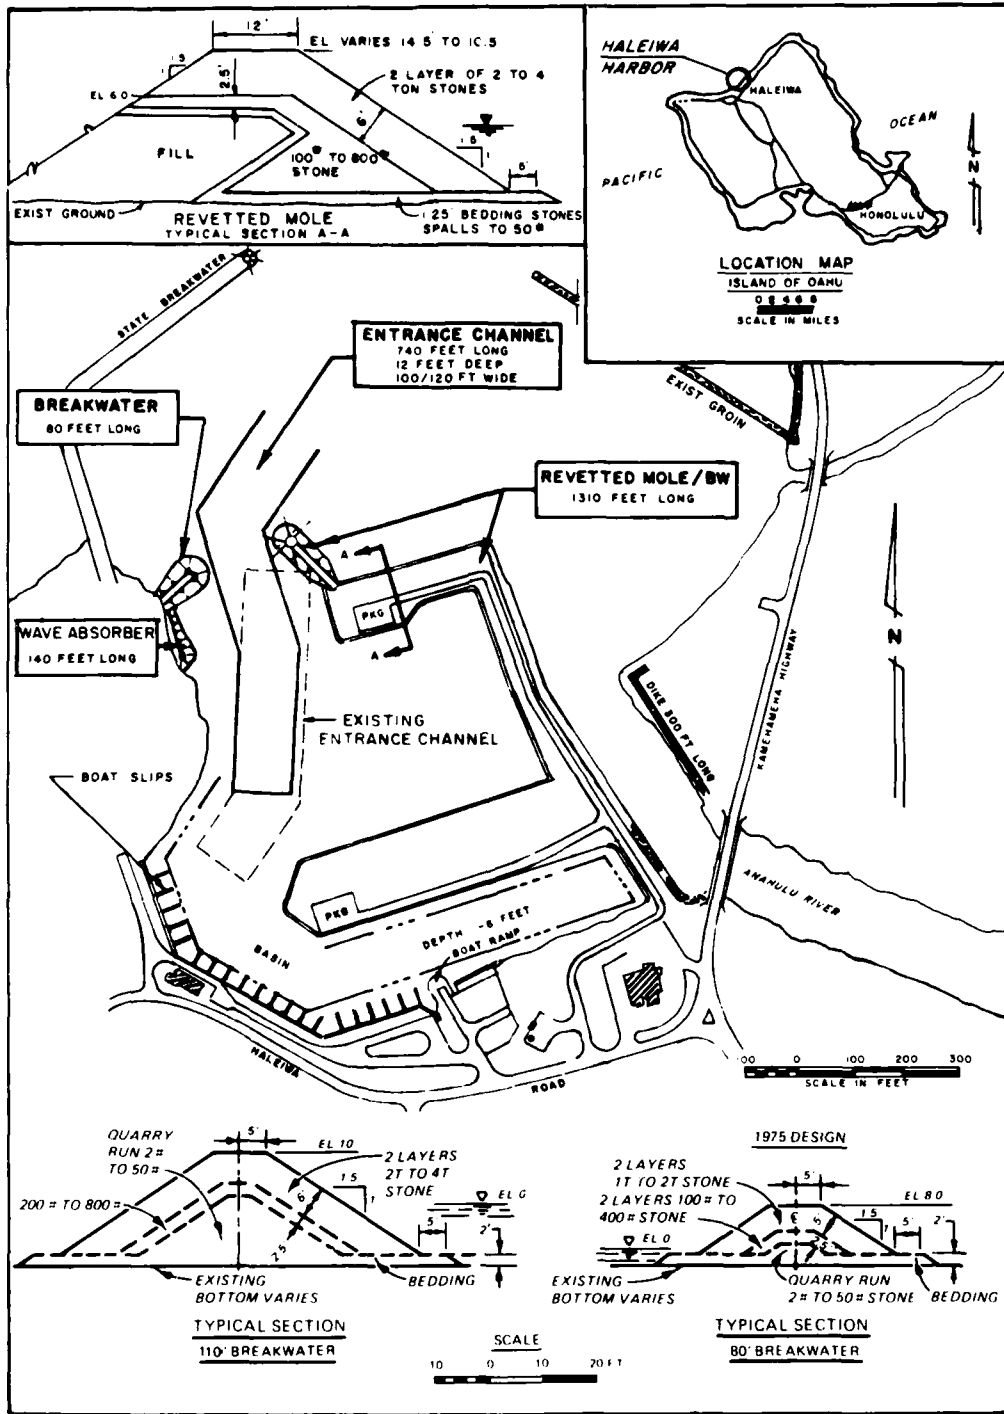
Figure 3. Haleiwa Harbor Breakwaters, Oahu, Hawaii

12. Haleiwa Harbor, located on the north side of the Island of Oahu, Hawaii (Figure 3), was modified in 1975 by the addition of a revetted mole and two stub breakwaters. Subsequent to this time, repairs were required on the 80-ft breakwater due to a slippage failure of the primary armor stone. Close inspection of the structure revealed that the bedding and berm had been

omitted from the construction. Localized scour had undermined the armor stone toe and resulted in the slippage failure. The structure was repaired by excavating around the perimeter of the structure down to firm bottom and overlaying the structure head with an additional layer of 1- to 2- ton armor stone which extended down to the toe. This repair was feasible due to the shallow depth of the sand in the area of the west breakwater. No stability problems have been observed since the repair was completed.

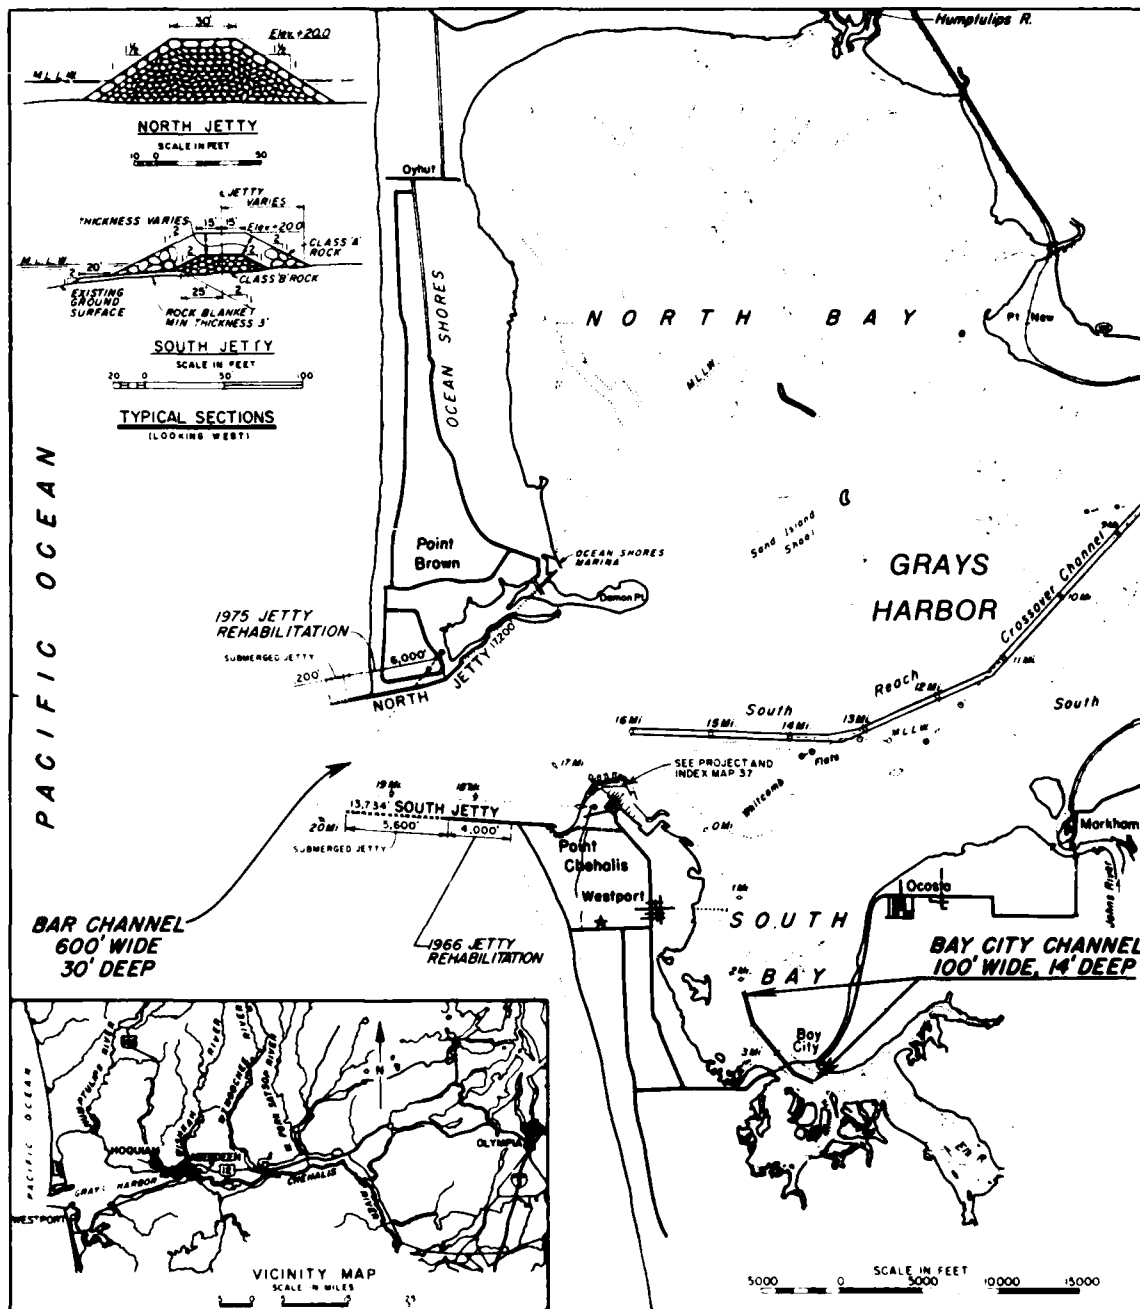
Figure 4. Grays Harbor Jetties, Washington

13. The south jetty at the entrance to Grays Harbor, Washington (Figure 4), has sustained severe scour on the channel side toe. The outer 5,600 ft of the jetty are presently below mean lower low water (mllw). It is not known if the toe scour is the cause, or a portion of the cause, of the present deteriorated condition of the jetty. Presently, no repair work is planned for the Grays Harbor Jetties.

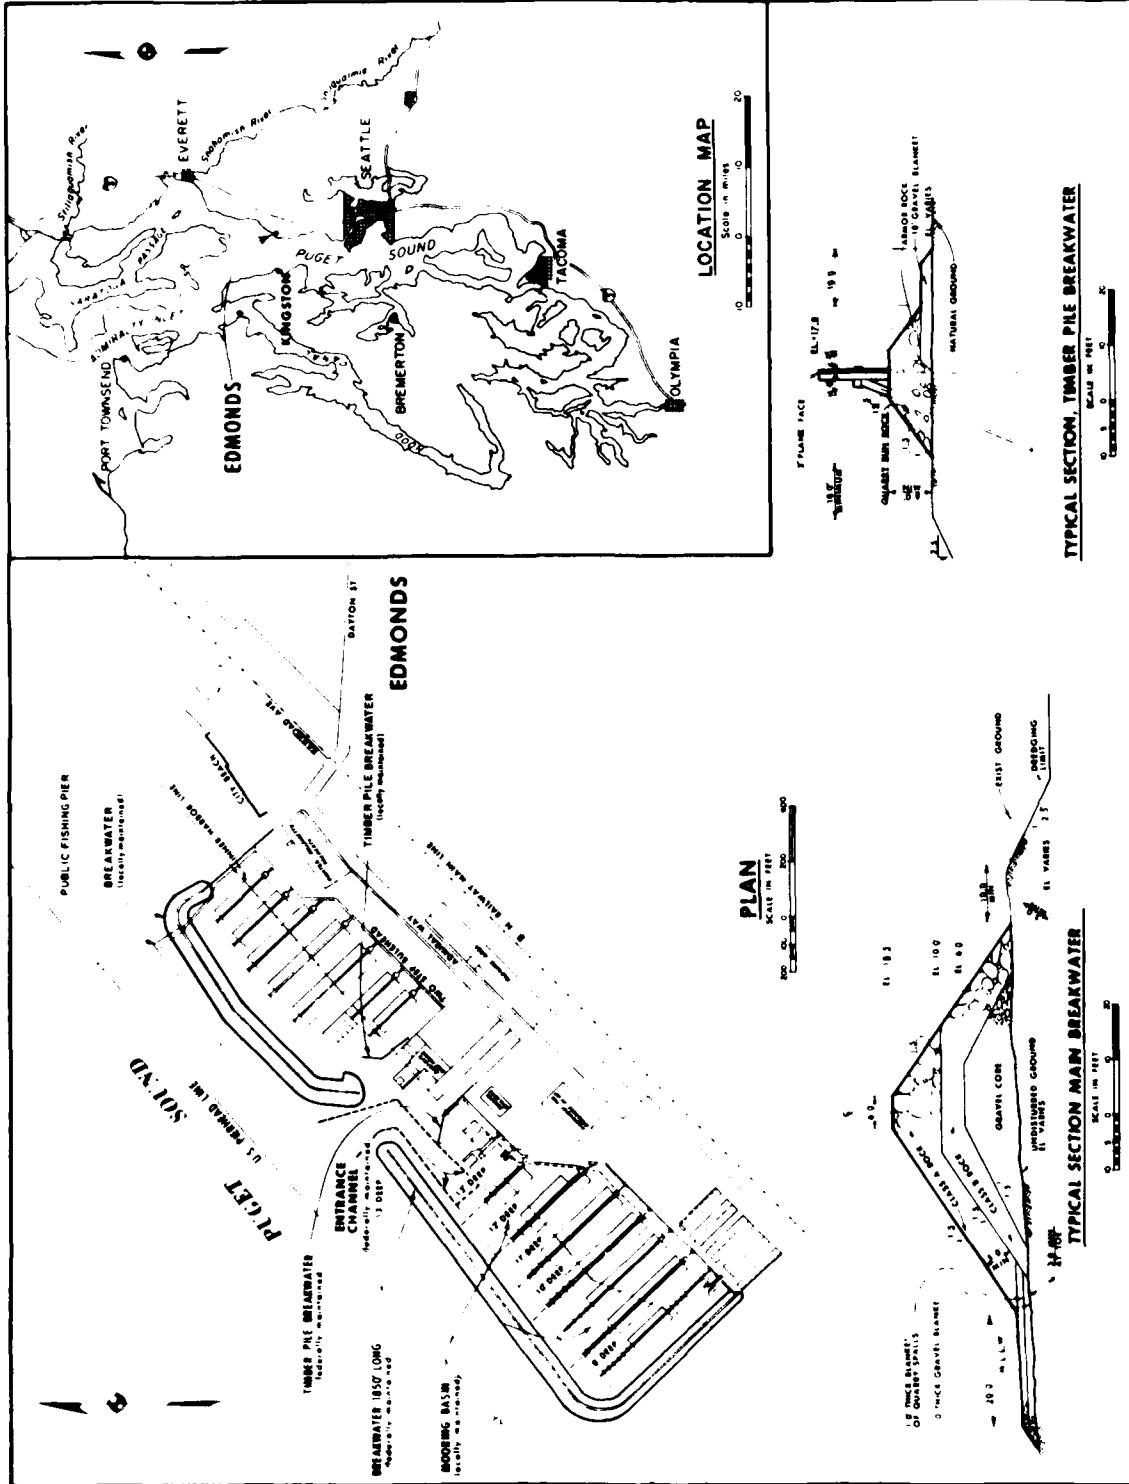
Figure 5. Edmonds Harbor Breakwaters, Washington

14. As of August 1985 plans were being developed for the repair of the rubble-mound breakwaters at Edmonds Harbor, Washington (Figure 5). It is not definitely known that toe stability was a cause of some of the existing damage, but it is thought to be a probable cause. The bottom drops off on a 1V:2H slope to a deep depth just out from the toe of the breakwaters. There is some thought that this deep water adjacent to the structure, which allows large amounts of wave energy to reach the structure, could be initiating toe stability problems. No firm decisions had been made on the repair design when this report was being prepared.

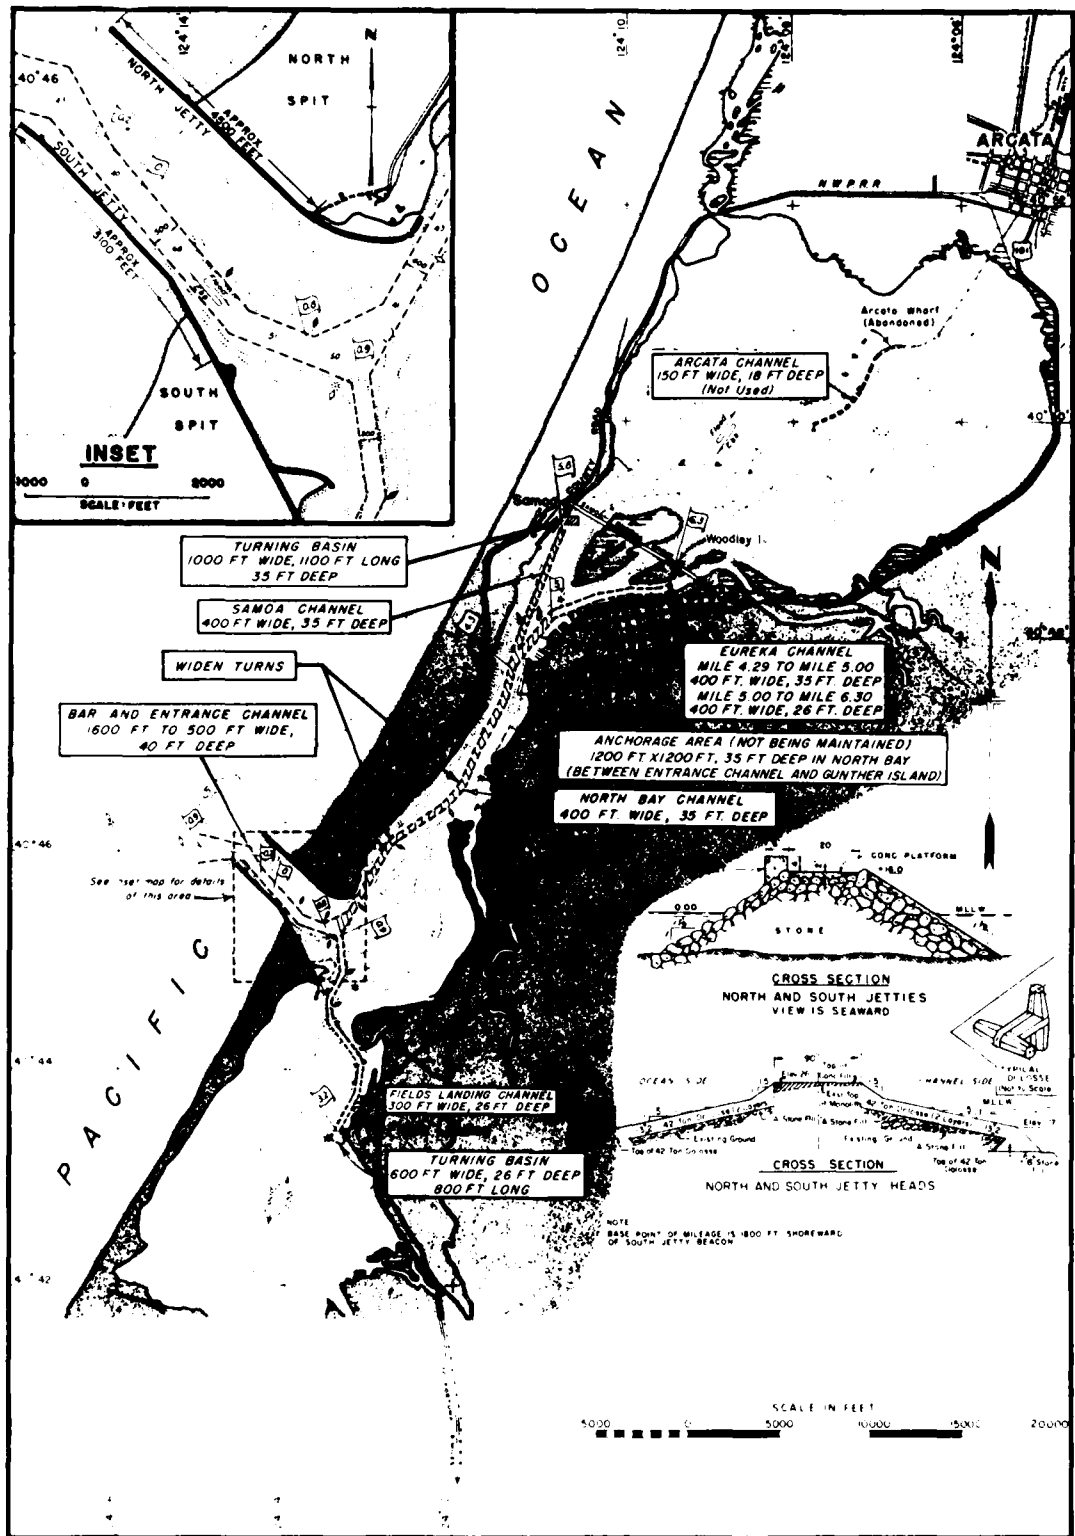
Figure 15. Humboldt Bay Jetties, California

16. The San Francisco District sited the jetties at Humboldt Bay (Figure 15) as being the only area showing obvious toe stability problems. The channel side of the north jetty and exposed side of the south jetty have shown obvious signs of scour and undermining which resulted in instability and slippage of the dolos toe. Condition surveys of the area have revealed the depths of the scour holes appear to have a seasonal fluctuation. An armor stone berm, extending from 70 to 100 ft out from the existing dolos toes, was included in the jetty repair work conducted in 1985. The multilayered berm consists of a 3- to 6-ton primary armor stone overlying two graded filter layers (Figures 16 and 17).

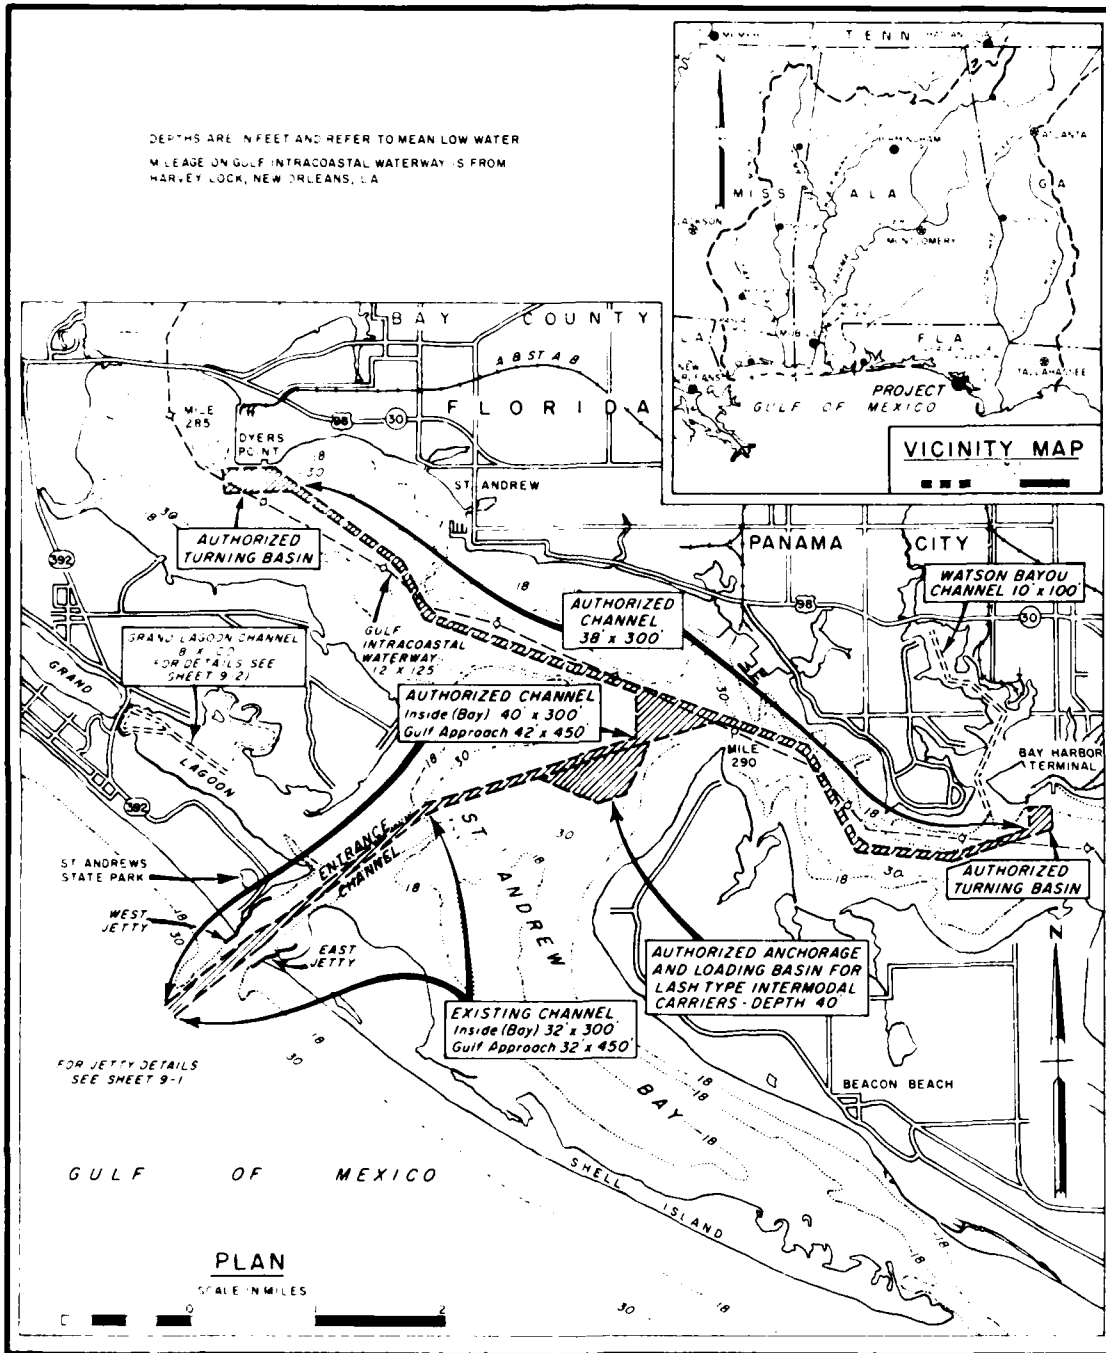
Figure 21. Panama City Harbor Jetties, Florida

20. During the period 1937 to 1938 attempts were made to alleviate toe scour problems on the Panama City Harbor Jetties (Figures 21 and 22) by encasing the jetties with asphaltic concrete. Asphaltic concrete mats (2 in. thick) were anchored on the channel side of the jetties and extended over the jetties to a point 24 ft seaward of the existing jetty toe. A hot asphaltic concrete was poured over the matting in an effort to bond the mats together

as well as stabilize them to the existing armor stone structure. This design proved to be unsuccessful. Scour initiated at the toes of the mats and, as the mats subsided into the scour holes, they pulled the mats and armor stone off the upper slope which resulted in general deterioration of the jetties. Subsequent repairs were carried out by placing a toe berm of 100- to 200-lb stone and, where needed, overlaying the old structure with additional armor stone.

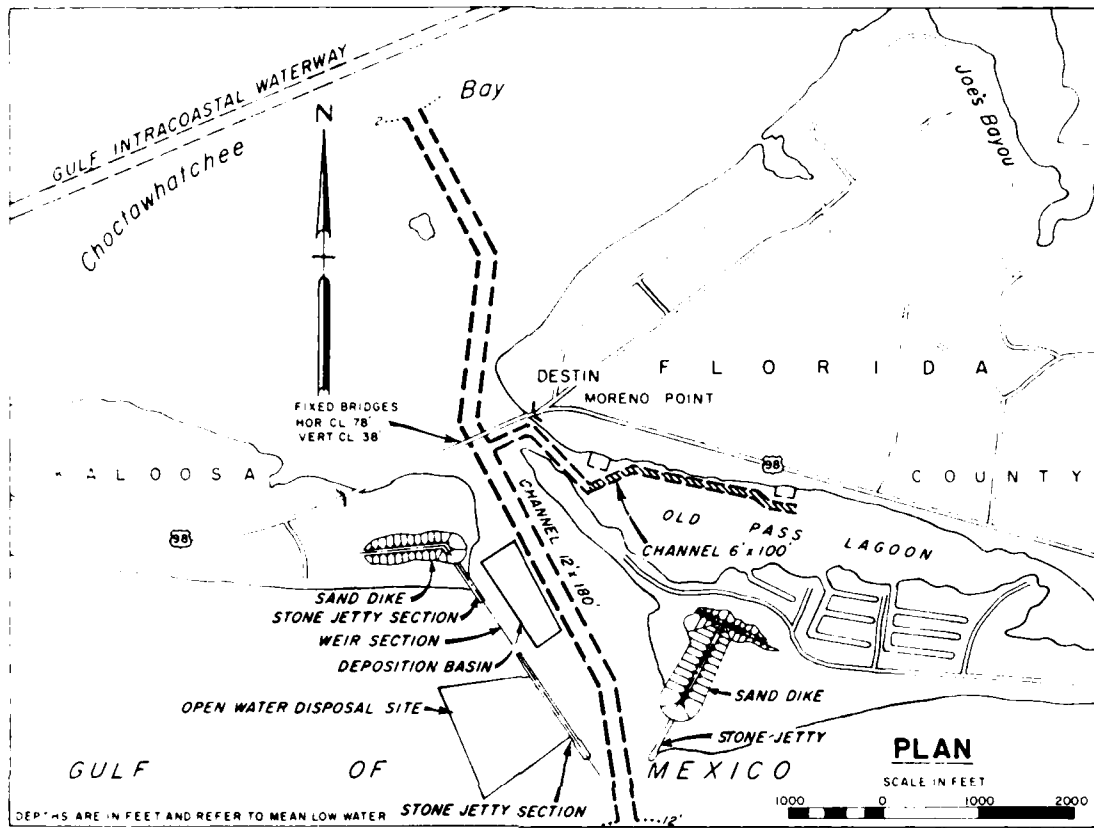
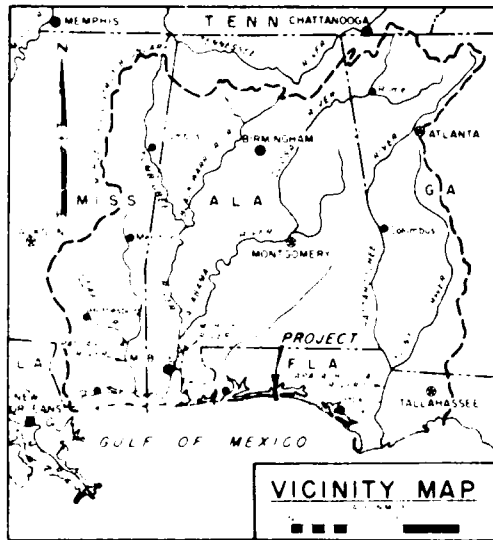
Figure 23. East Pass Channel Jetties, Florida

21. Toe scour also has been noted as a problem with the jetties at East Pass Channel and St. George Island, Florida, and Perdido Pass Channel, Alabama (Figures 23-25, respectively). Scour on the channel side of the east jetty at East Pass is so severe that it is thought that portions of the jetty may slide into the channel at any time. In the past, this type of slippage failure has caused severe damage to the west jetty at Panama City.

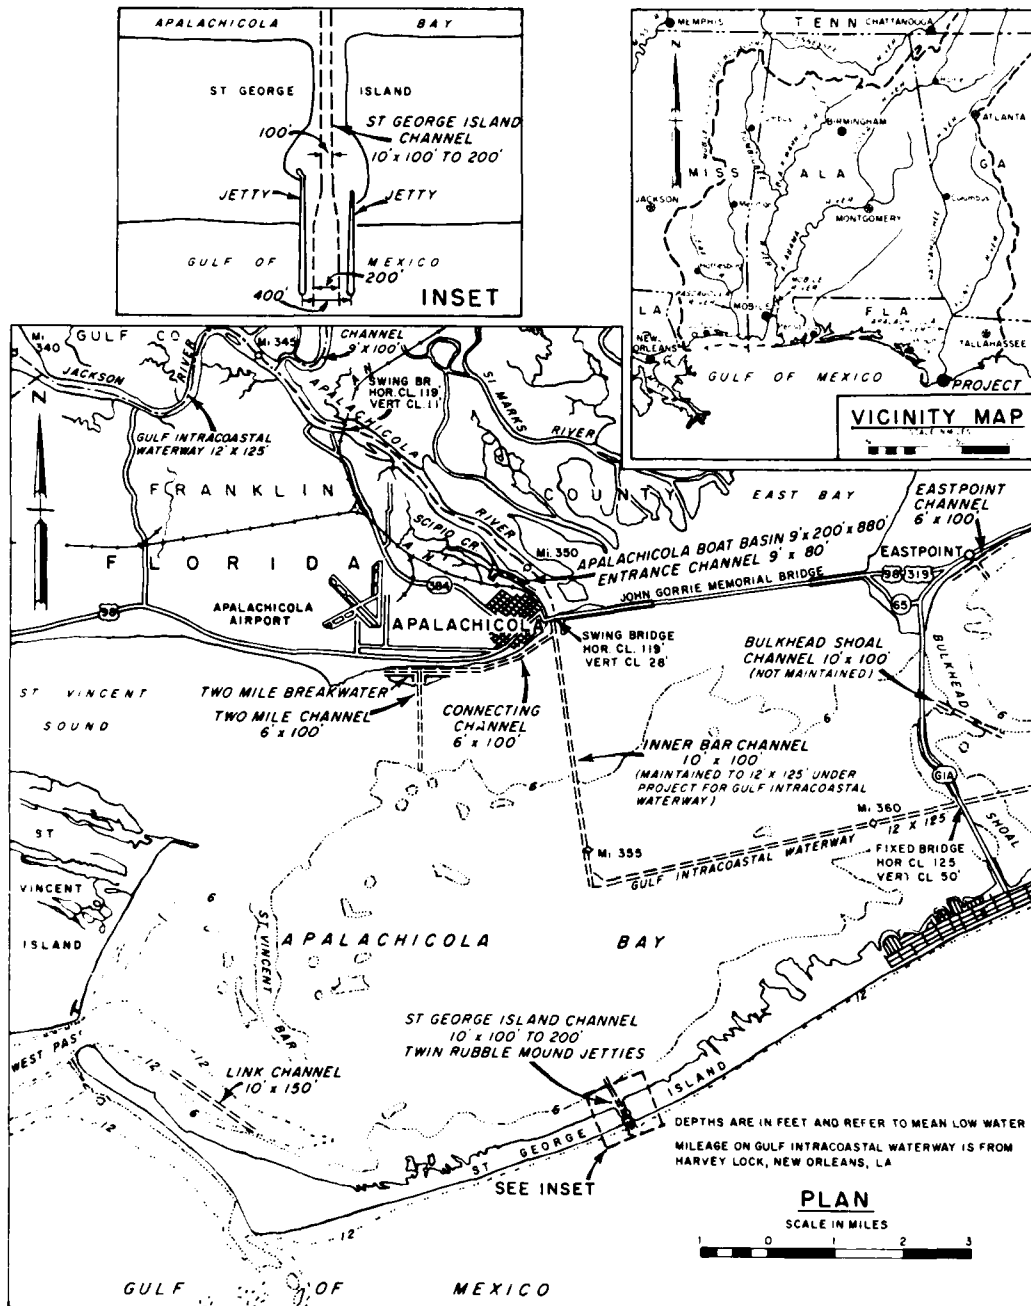
Figure 24. St. George Island Jetties, Florida

22. Jetties at St. George Island have suffered cover stone loss resulting from the undermining action of toe scour. The west jetty at Perdido Pass presently has significant amounts of toe scour on the channel side, and Hurricane Frederick produced significant amounts of toe scour on the east jetty. The overall condition of the Perdido Pass jetties was said to be good; therefore, it is assumed that the toe scour has not caused any obvious damage above the waterline.

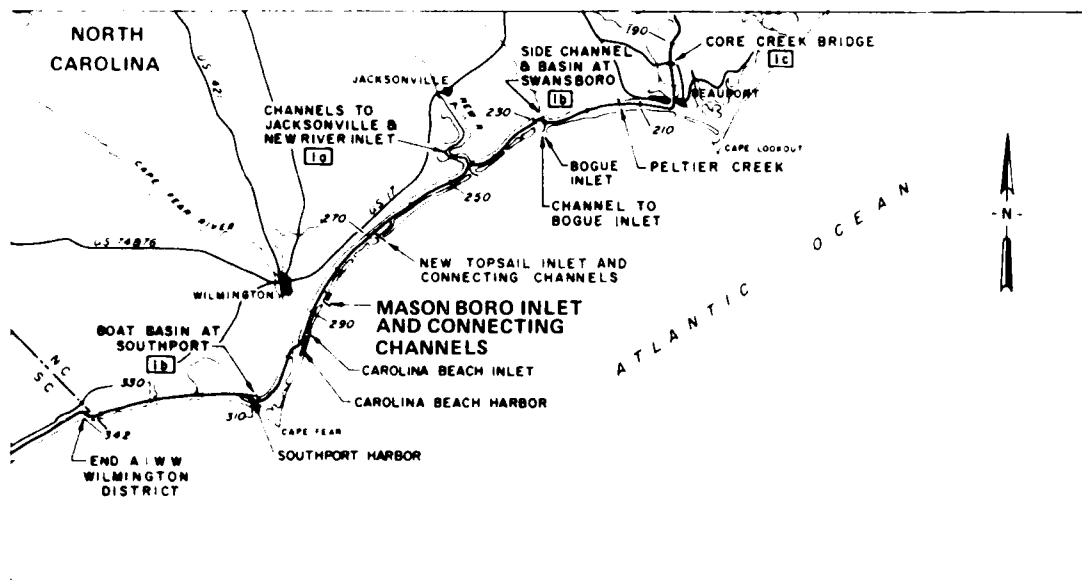
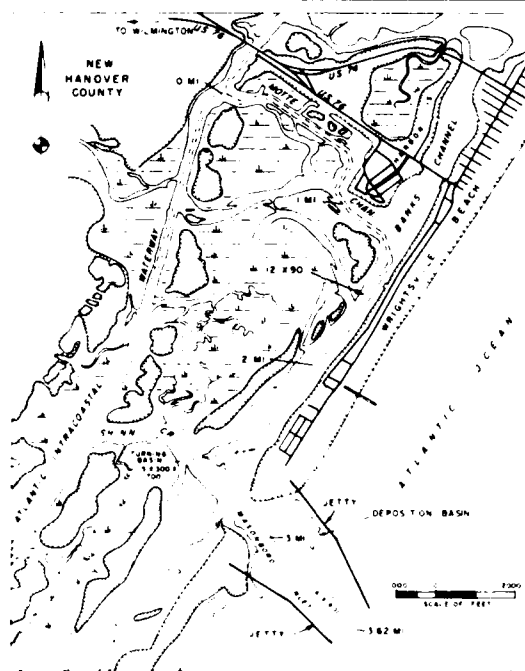
Figure 26. Masonboro Inlet Jetties, North Carolina

23. The 3,650-ft-long rubble-mound north jetty located at Masonboro Inlet, North Carolina (Figure 26), was constructed between August 1965 and June 1966. The north jetty required extensive repair on the channel-side toe of the outer rubble-mound structure in 1969 and to the channel-side toe of the inner weir section in 1973. This was prior to construction of the south jetty (14- to 22-ton armor stone) in 1980. It was thought that ebb and flood flows had caused the channel to move adjacent to the north jetty, creating the scour problem. In both repairs, a 2- to 3-layer protection of bedding material and riprap (25 to 2,000 lb) was used. This toe protection butted against the existing armor stone toe or sheet-pile weir. The berm width varied from 30 to 50 ft. It is thought that this work had limited success because the jetty has not totally deteriorated, but it is presently in need of repair work in several areas. Presently it is unknown whether the deteriorated appearance of the north jetty results from a toe scour problem or from the possibility

that the original 7- to 12-ton armor stone may have been an inadequate design for the incident wave environment.

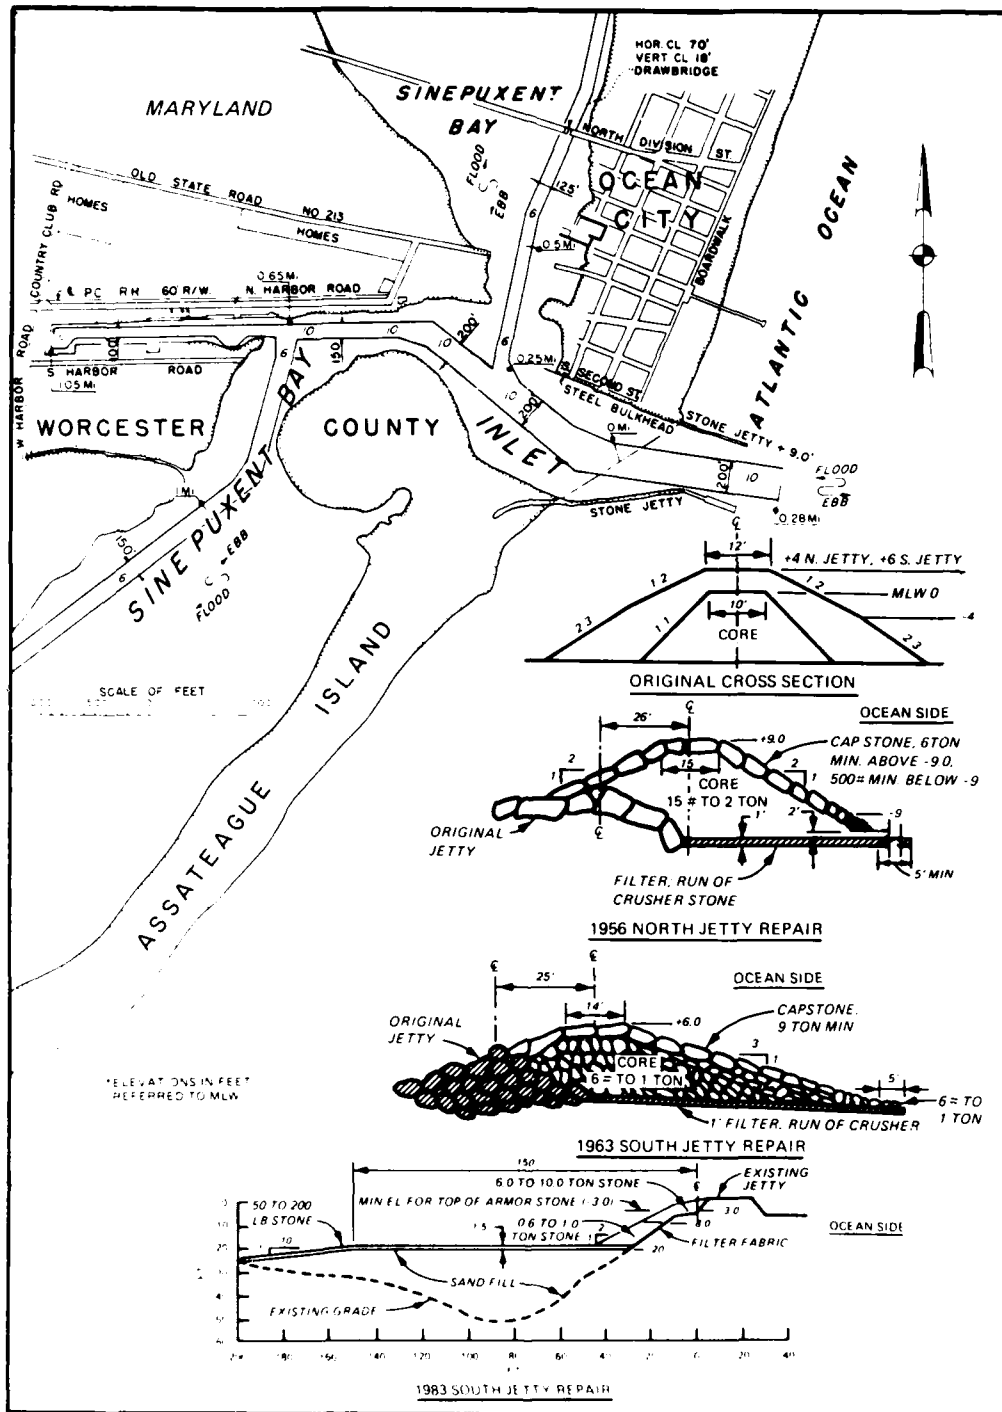
Figure 27. Ocean City Inlet Jetties, Maryland

24. The south jetty at Ocean City Inlet, Maryland (Figure 27), is the only structure within the Baltimore District that was reported as having significant toe stability problems. The original north and south jetties, both rubble mound, were constructed in 1934 and 1935, respectively. The crown elevation on the shoreward end of the north jetty had to be increased in 1937 to stop flow of sand into the inlet. The landward end of the south jetty required extensions in 1956 and 1963 to repair flanking caused by erosion. The south jetty has suffered major deterioration along its outer leg caused by ebb flow induced scour and undermining of the structure's inlet side toe. During major repair of the south jetty in 1963, the center line of the structure's repair section was offset outward from the inlet (Figure 27). This was done to alleviate the need to fill the massive scour hole that existed where the inlet side of the structure was originally constructed. The ocean side of the existing structure that remained was used as a base against which the inlet side toe of the jetty repair section was positioned. By 1982, the 1963 repair section of the south jetty was once again very deteriorated. Like the original, this damage was only on the converging portion of the jetty and was caused by ebb flow induced undermining of the structure's inlet side. In order to prevent failure of the outer end of the south jetty, which would lead to severe inlet shoaling, the scour hole adjacent to the structure was filled with dredge material and capped with stone. The lower portion of the inlet side of the jetty was overlaid with an intermediate stone size, and the remainder of the inlet side slope was covered with primary armor stone. This work was completed during 1983 to 1984, and a typical repair cross section is shown in Figure 27. The majority of the south jetty's original repair section still shows considerable deterioration and is highly overtopped. It is unknown how well the scour protection is performing. It appears that scour on the north side of the inlet has slowed down, and the north jetty is in good condition; however, the overall scour in the throat of the inlet shows no signs of stabilizing.

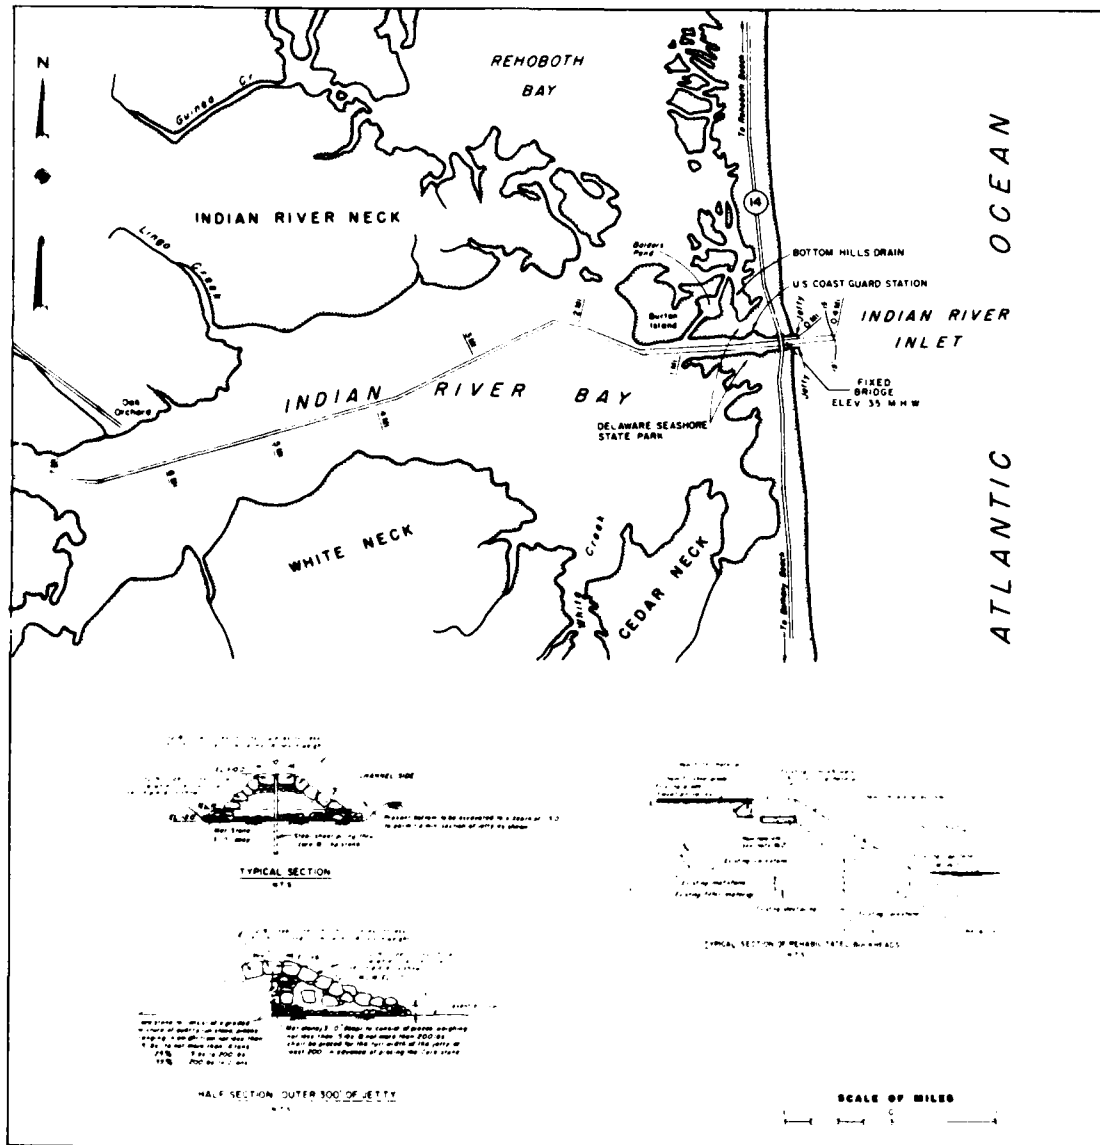
Figure 29. Indian River Inlet Jetties, Delaware

27. The rubble-mound and sheet-pile composite jetties at Indian River Inlet, Delaware, were completed in 1939 (Figure 29). The jetties required storm damage repairs in 1956 and 1957. At that time, the north jetty was extended inshore a distance of 320 ft. At present both jetties are 1,566 ft long. Both jetty heads have deteriorated significantly from a combination of toe scour, armor stone slippage and displacement, and overall subsidence. Because of the success of the Manasquan River Jetty repairs, dolosse are being considered for inclusion in the repair and rehabilitation designs for the structure slopes. No details on the proposed toe repair design are available.

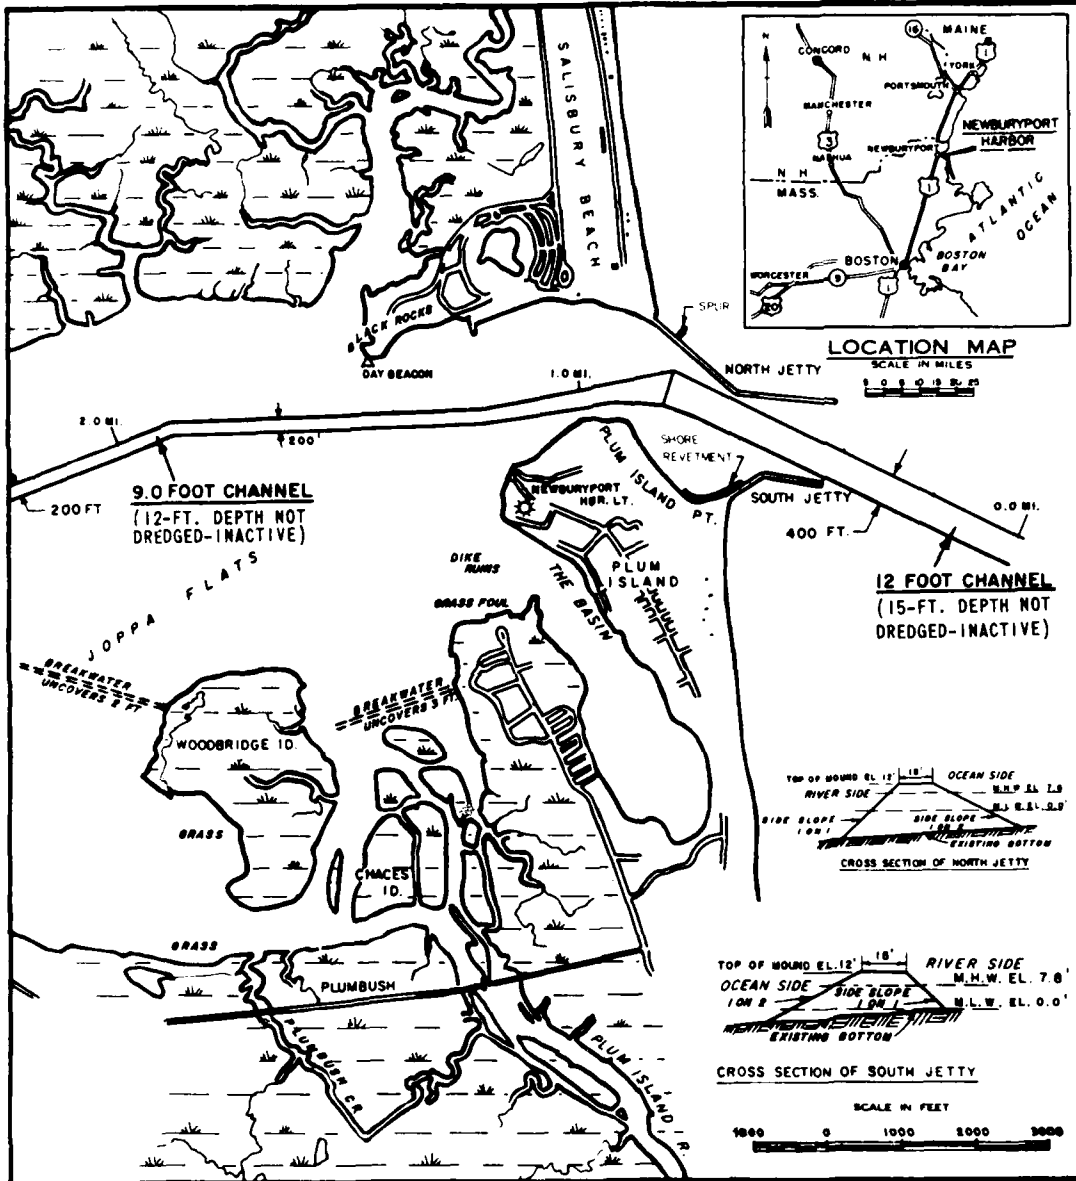
Figure 31. Newburyport Harbor Jetties, Massachusetts

28. Based on review of historical repair data, it appears that three project sites within the New England Division that contain rubble-mound jetty structures have exhibited stability problems which could be related to instability of the structure toes. Both jetties at the mouth of the Kennebunk River, Maine (Figure 30), have a history of extension and repair. The latest jetty rehabilitation work was completed in 1982. Recent inspections show that both jetty heads are damaged and that 250 ft of the channel side of the east jetty have been undermined. The most recent inspection reports (1973-74), indicate that the north and south jetties at Newburyport Harbor, Massachusetts

(Figure 31), which have an extensive repair and rehabilitation history, are showing considerable damage. This damage appears to result primarily from subsidence. Damage on four areas on the channel side of the south jetty most likely result from undermining of the rubble toe. The jetties at Hampton Harbor, New Hampshire (Figure 32), were originally constructed by the State and were turned over to the Corps in 1964. During 1965 to 1966, considerable work was done on both jetties. Since that time the south jetty has remained in good condition, while the north jetty has required continuous maintenance. Most of the repair and rehabilitation work has been needed on the seaward portions of the north jetty. The last rebuilding of the north jetty was completed in 1980, and it is thought that part of this recurring damage can be attributed to scour and undermining of the jetty toe.
