STAGE I AND II PLATFORM STRENGTH EVALUATION OFFSHORE  
PANAMA CITY FLORIDA (U) BARNETT AND CASBARIAN INC  
METAIRIE LA FEB 81 CHES/NAUFAC-FPO-8331A

FPO 8331A

Feb. 81

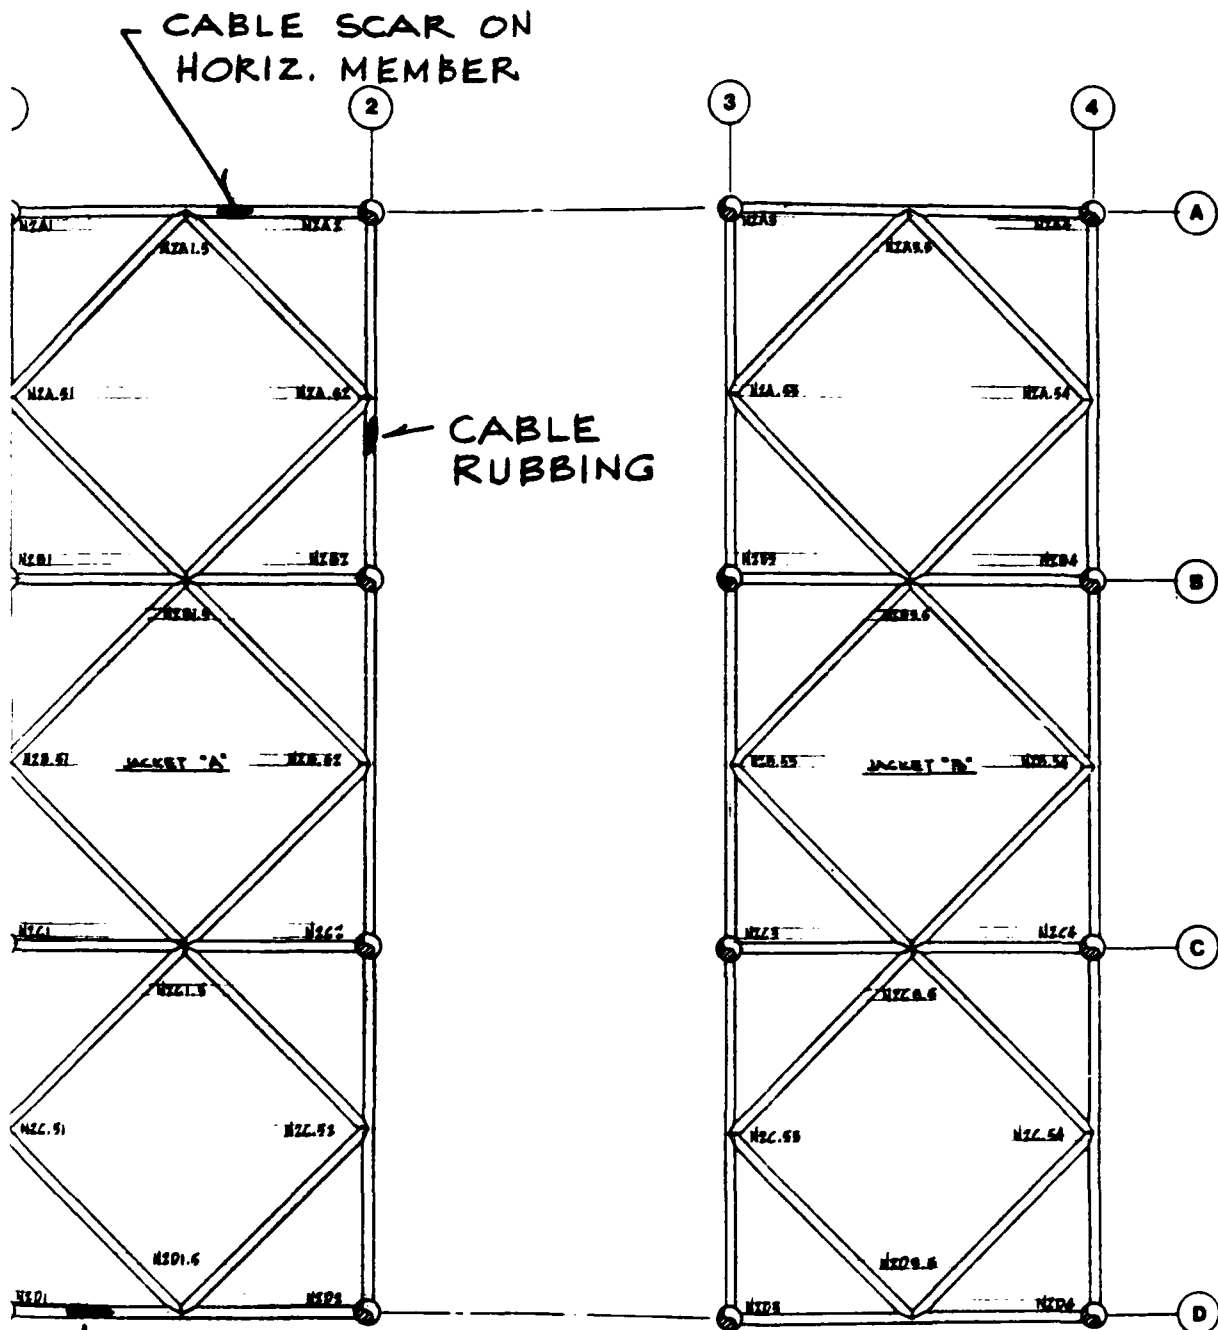
PIPE FLATTENED  
 1/2" TO 2" DEEP LEVEL "2"  
 2' LONG.
