TECHNICAL REPORT GL-86-17

TECHNICAL EVALUATION REPORTS OF AIRFIELD DAMAGE REPAIR SOLUTION

October 1986

Final Report

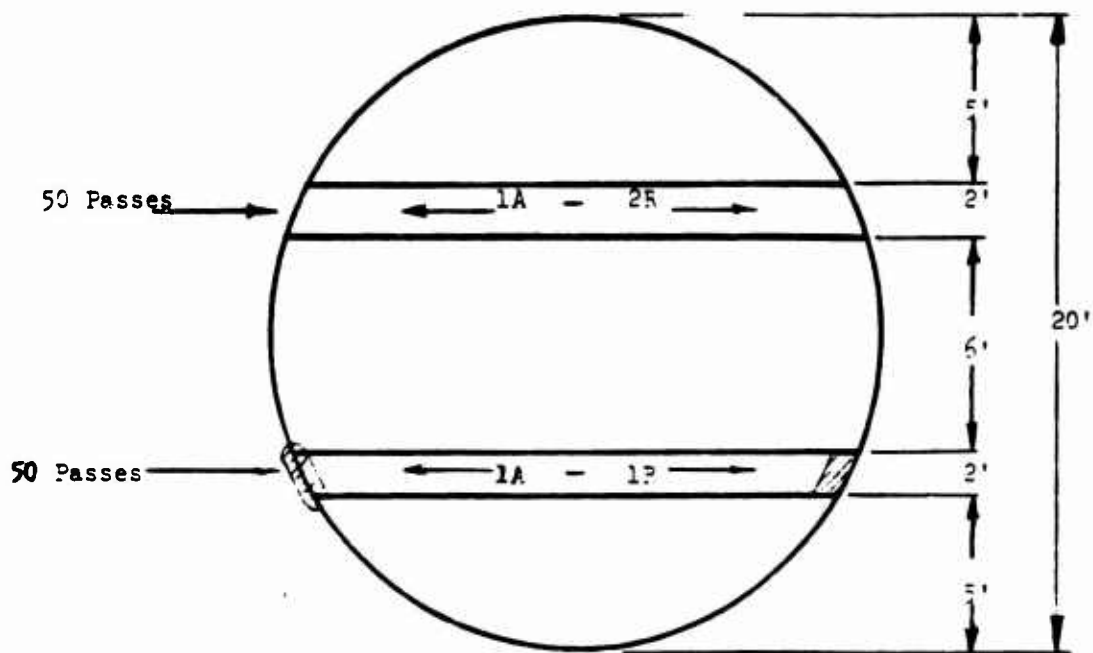
Figure A1. Top view of crater after test

Test strip 1A-1R (Figures A1 and A3) completed 50 passes. A depression formed at each end of the test strip where the new cap met the existing surface. The concrete became a soupy mixture and had little aggregate within it. The depression stopped where aggregate was located. Along the path of the test vehicle's tire, a slurr of about 1/8-3/16 in. depth formed. This slurr was caused by frost action over the night, therefore curing did not take place. A high moisture content was found in the top 3/16-in. layer. No deflections or cracks were observed. Figure A2 shows the actual construction of the crater.

Test strip 1A-2R (Figures A1 and A4) completed 50 passes. Along the path of the test vehicle's tire, a slurr of about 1/8 in. deep formed. This slurr was caused by the frost action over the night and curing did not occur. The top 1/8 in. also had a high water content when the concrete was floated. No deflections or cracks were observed.

a. During very cold or very hot conditions, proper curing methods need to be added to the TEO (Appendix B). The use of a plastic film (10 mil polyethylene) or straw would have produced better curing results.

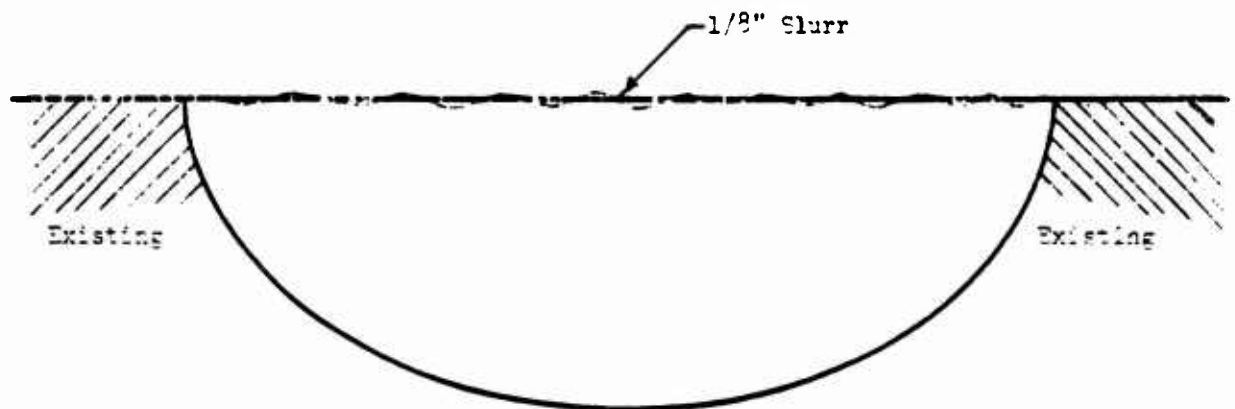
Figure A4. Side view of test strip 1A-2R

e. Analysis: If the crater was given more time to cure during hours of freezing temperature, the depressions would not have occurred. This is also true for the slurr caused by the friction between the crater surface and test vehicle's tire.

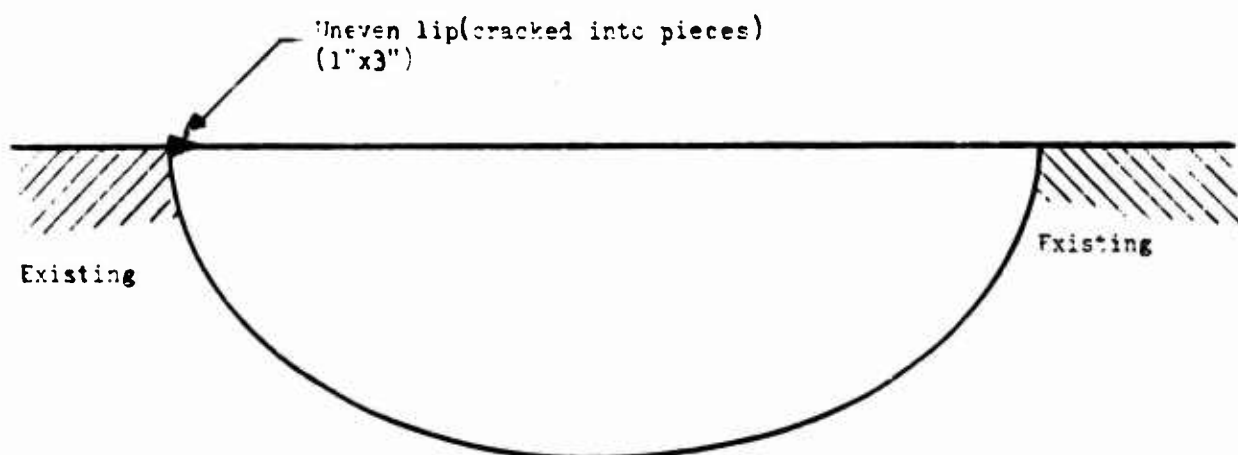
Figure A8. Side view of test strip, 1B-2R

Test strip 1B-2R (Figures A5 and A8) completed 50 passes. No deflections or cracks were observed. The strip showed no signs of being affected by the frost. At one edge where the strip meets the existing pavement, there was an uneven lip. Under the weight of the test vehicle, this lip collapsed.

e. Analysis: The concrete cap had no deficiencies except for that of the lip. The moisture content of the debris and aggregate was 18% which caused the poor compaction effort. The subgrade did not affect the results of the test. The crater had 26 in. of standing water prior to the repair. Large aggregate (75-125 mm) was found to be very useful in achieving a 68% CE 55 whereas the compaction would have been very low using water saturated debris only. Vehicles would have been entrapped if nothing was used.

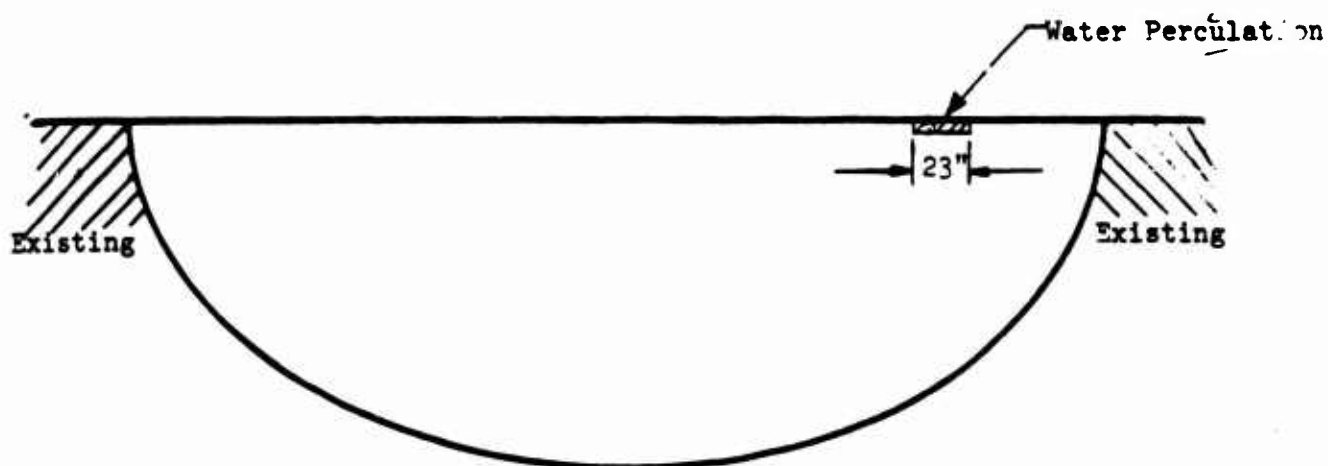
Figure A3. Side view of test strip 1A-1H

Test Strip 1A-1H (Figures A1 and A3) completed 50 passes. After these passes, water percolated up through the concrete in one area on the strip 23 in. long. No deflection or cracking was observed on the strip. Figure A2 shows actual construction of crater after test.

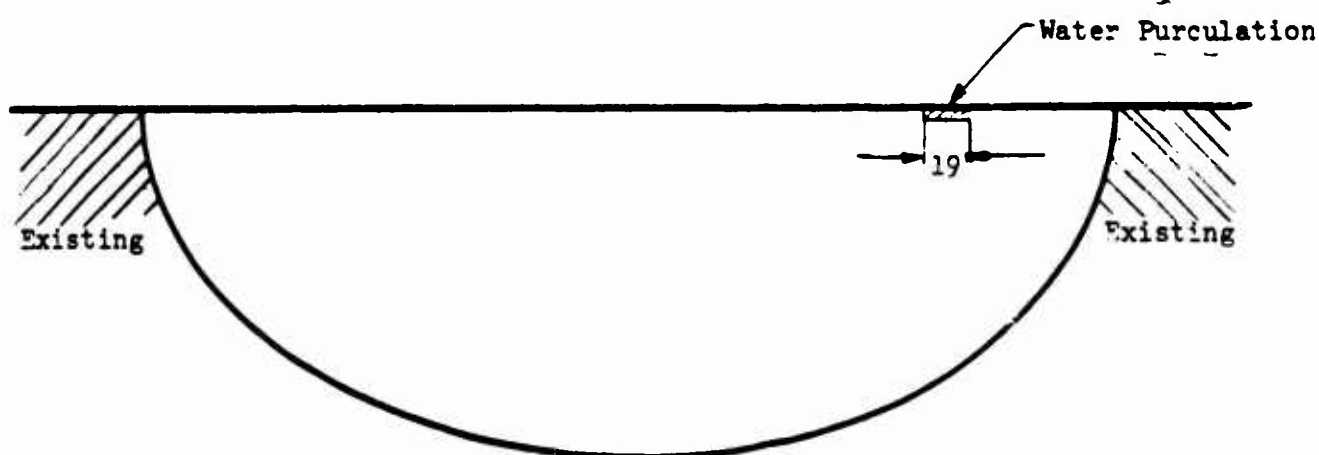
Figure A4. Side view of test strip 1A-2H

Test Strip 1A-2H (Figures A1 and A4) completed 50 passes. After three passes, water percolated up through the concrete in one area on the strip 19 in. long. No deflections or cracking was observed on the strip. Figure A5 shows the top view of the crater after test.

Analysis: If the crater was given more time to cure during hours of above-freezing temperatures, the concrete would have set up and no percolation would have occurred. The frost action slowed the curing process. The concrete in these areas must have had a higher moisture content than the other concrete, for percolation only occurred in one section of the cap (Photo A5).

a. During very cold weather conditions, appropriate curing methods need to be added to the TEO (Appendix C). The use of a plastic film (10 mil polyethelene) or straw would have produced better curing results.

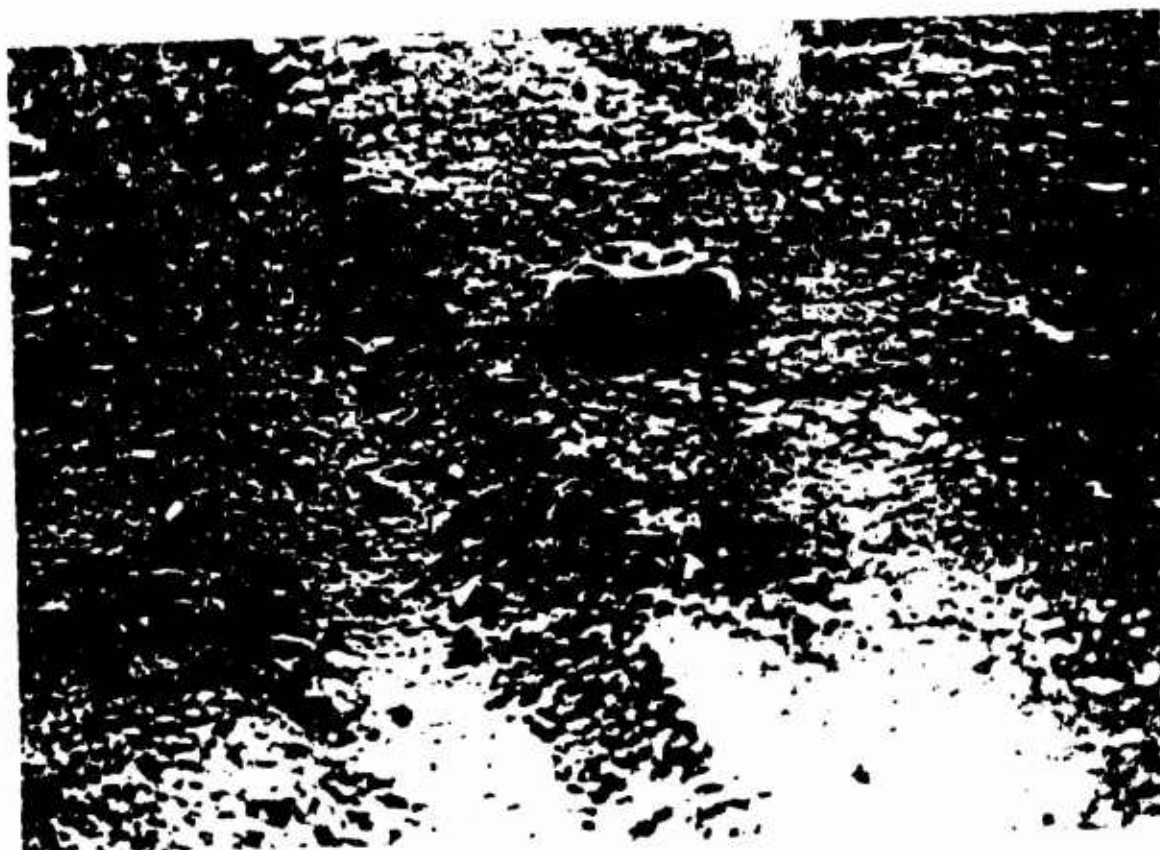
Photo A4. Rutting
