Research Report 1434

**Human Factors Assessment:  
Light Armored Vehicle,  
Maintenance/Recovery Vehicle (LAVM/RV)**

**December 1986**

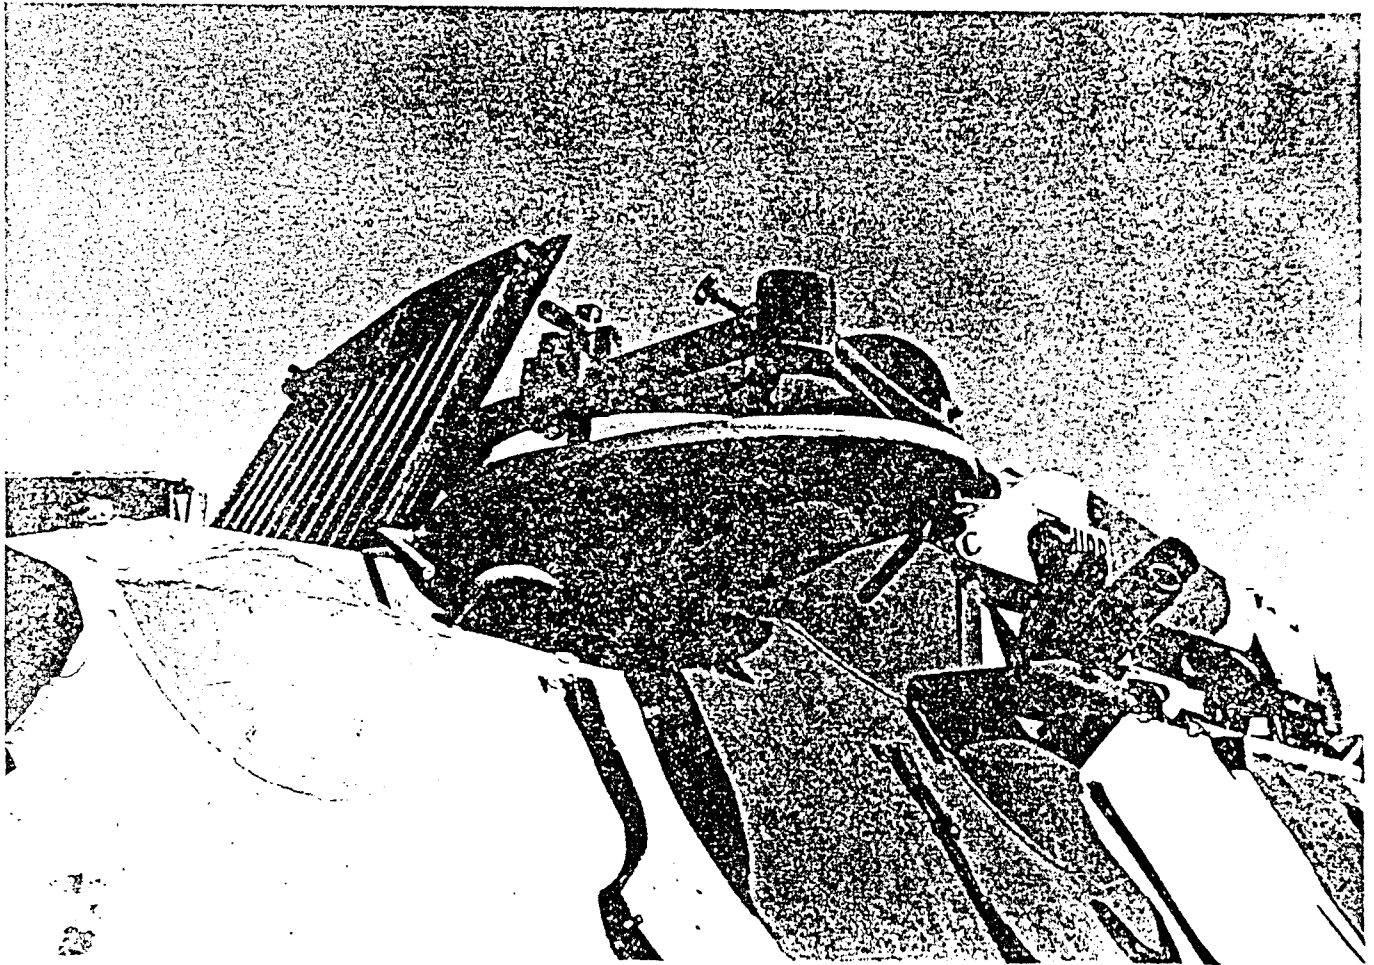
Figure 5. The M60 gun mount (above the open hatch) blocks the opening or closing of the driver's hatch.

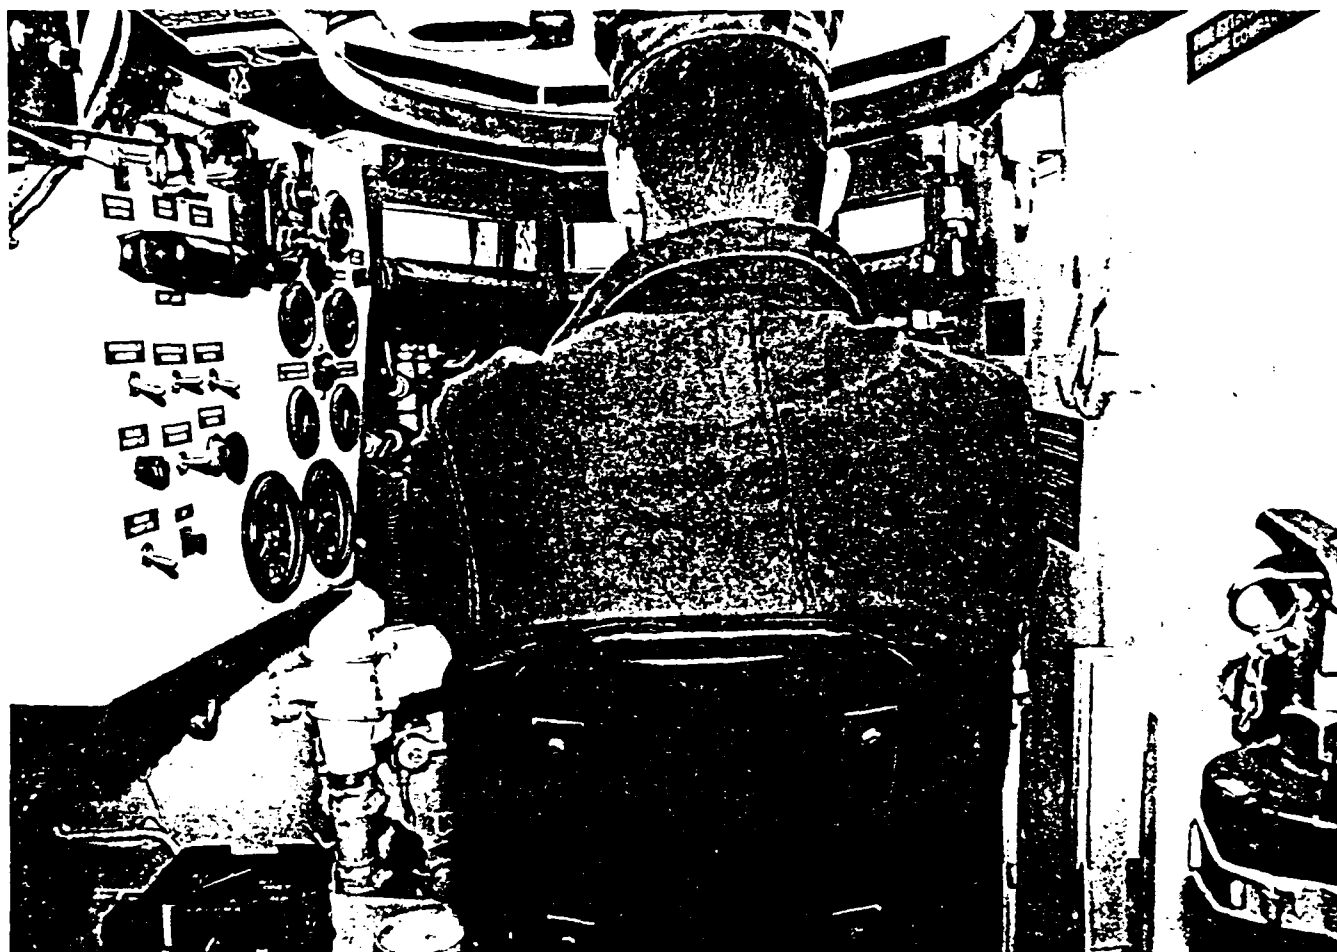
Figure 9. The gauge display panel (left) is difficult for the driver to see.

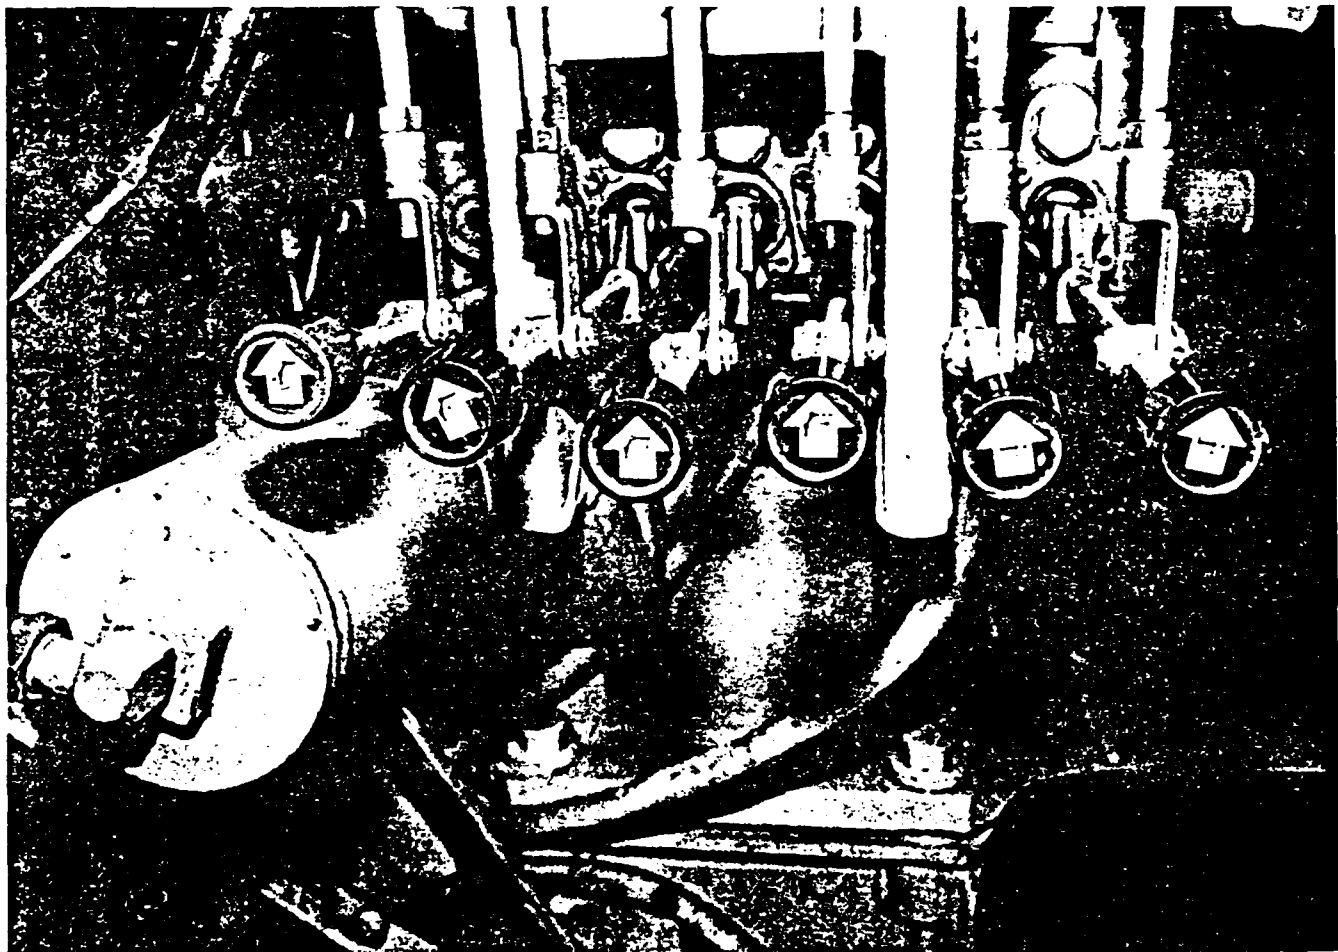
1. The operator cannot view the crane responses to the control lever movements. The operator can see very little crane movement through the periscopes. Moreover, the operator's head height when handling the control levers is approximately 20 in (51 cm) below the open hatch level. Finally, the control levers are 119 in (302 cm) from the rear doors, making it impossible to view the crane's movement.
2. The control symbols are too small to be easily viewed. The symbols within the larger arrows are less than one-quarter inch in height. The symbols cannot be seen in low light or blue light conditions.

Figure 10. The on-board crane control lever symbols are difficult to view.

3. Control lever activation directions are the opposite of the machine response directions. Activating the inner and outer arm levers by moving them up causes the inner and outer crane arms to move down (the control levers are the second and third levers from the left in Figure 10).
4. The control knobs become unscrewed and often symbols point in incorrect directions.

Human factors deficiencies such as those listed above are likely to increase task completion time, errors, and may result in equipment damage or injury. All crane control levers should move in the same general direction as the crane functions they control. Design changes might include reversing (if possible) the position of the input and output hydraulic lines on the manifold for the inner and outer arm levers. Place larger control symbols directly in line with the control levers on the valve manifold housing (not shown in Figure 10). It may also be possible to turn the valve manifold over, appropriately switching the input/output lines, so that the control levers are closer to the commander's hatch and can be activated in the appropriate directions. This would also place the control symbols closer to the overhead light.

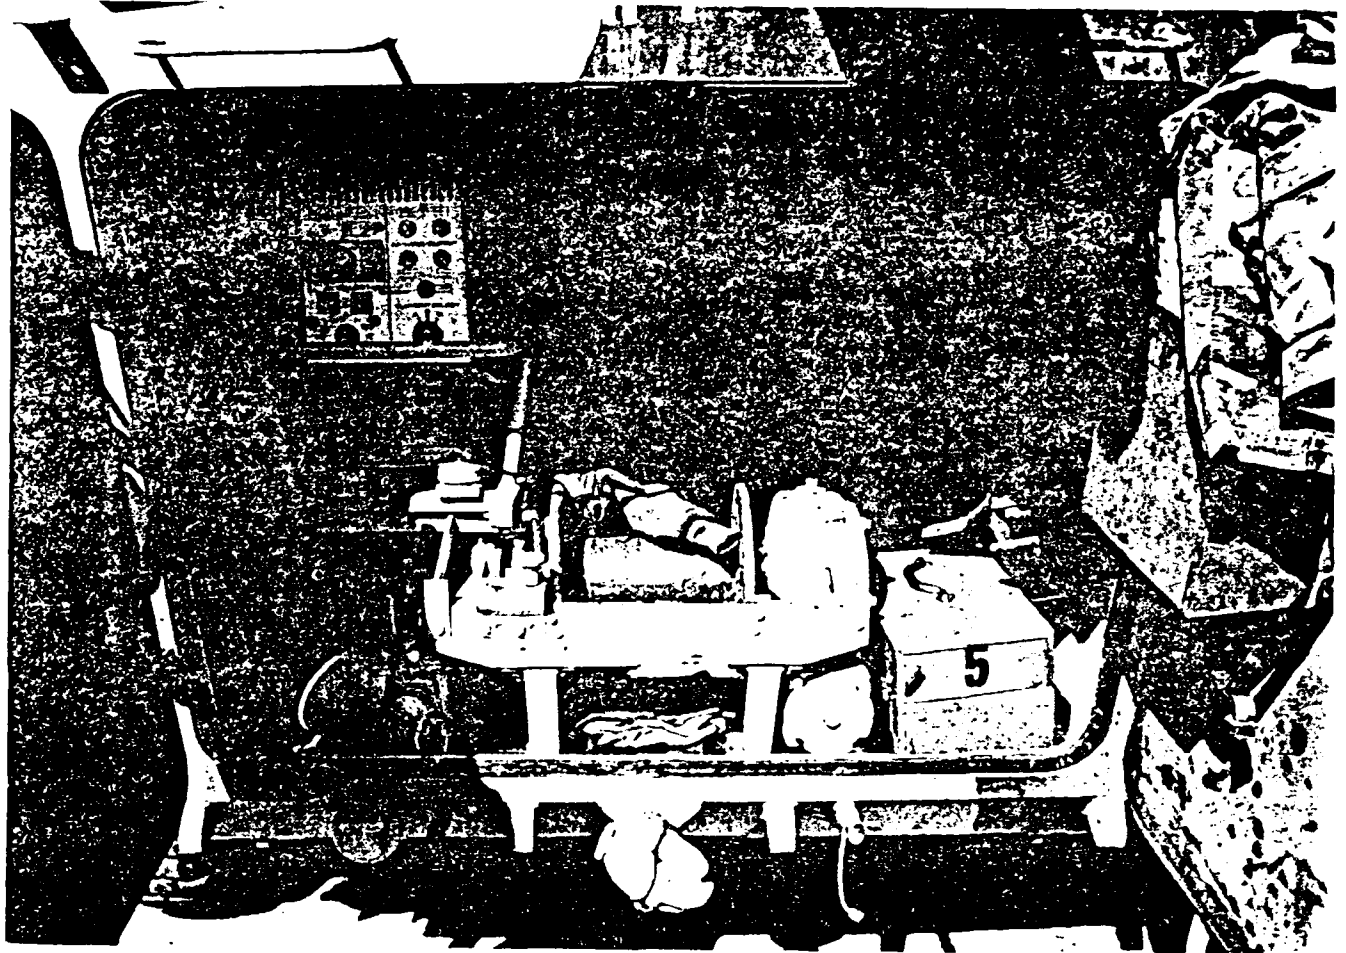
Figure 12. This is the way equipment is stored.

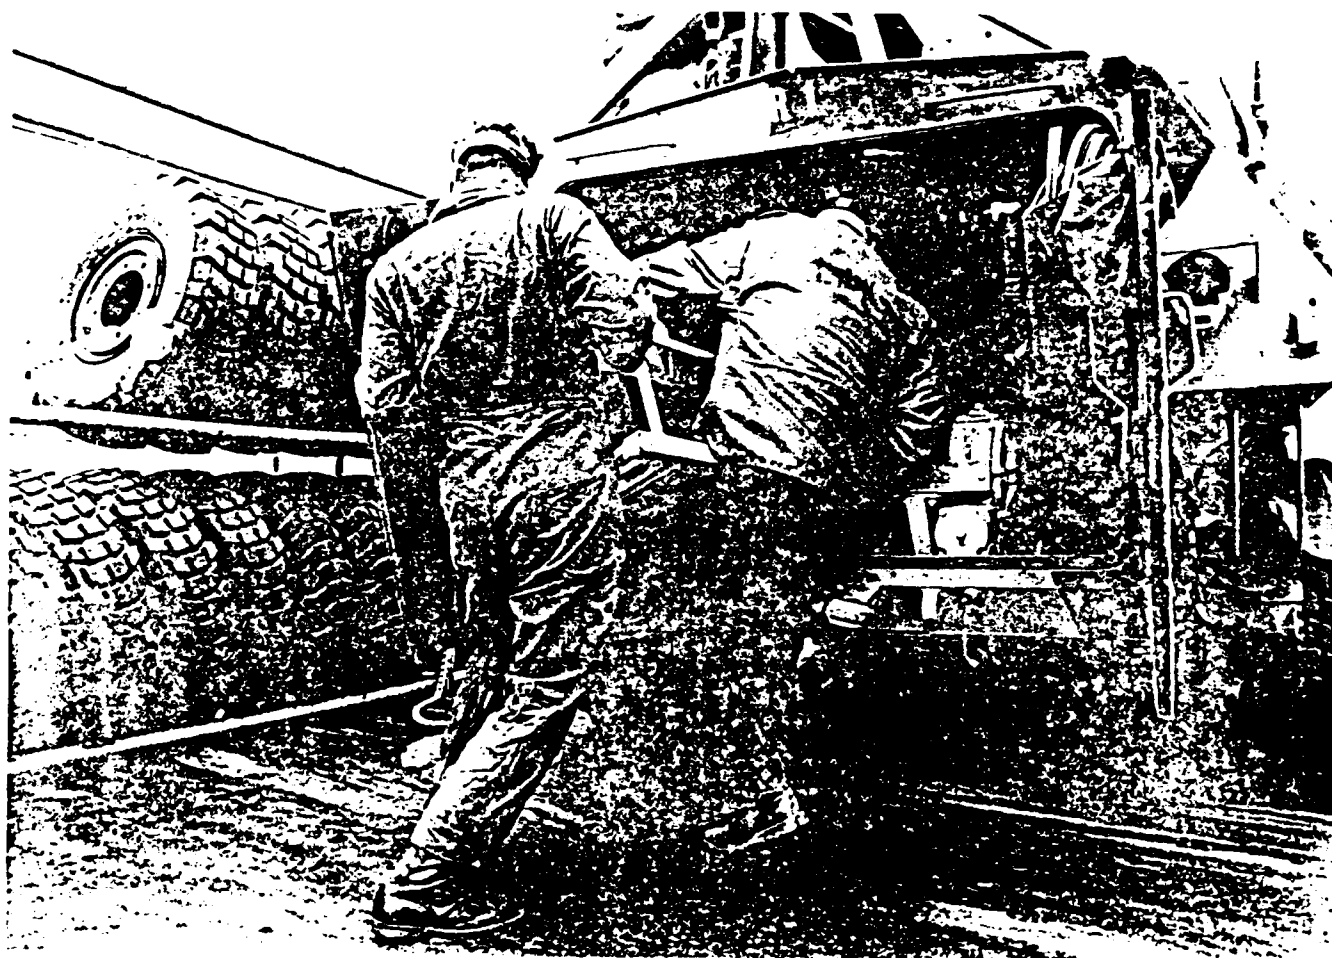
1. Injury to the crew,
2. Equipment damage to the APU or storage rack,
3. Abandonment of the APU during an emergency.

Figure 14. Crew members loading the APU onto its storage rack.

Design changes might include repositioning the APU to allow more of the crew to participate in lifting the device. However, even if all five crew members lift the APU, the lifted weight per person is 75 lb (34 kg) and violates the MIL standard. A better solution might be to add a sliding carriage rack to the APU storage rack that slides out and locks in place beyond the rear door opening. It would then be possible to load the

APU onto the carriage rack using the crane and some type of attachment device. Should this solution be implemented, the APU attachment device should be permanently attached to the APU to avoid its loss.

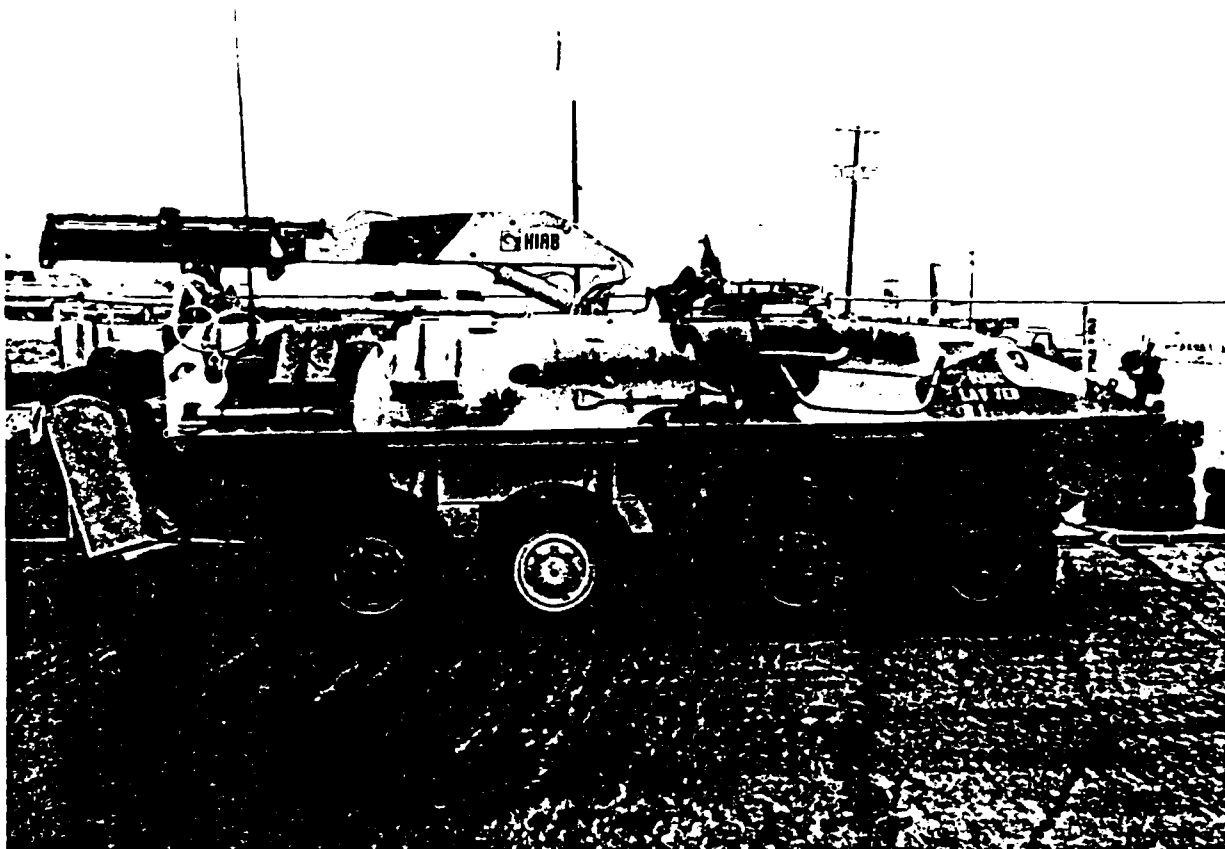
Figure 15. Lighter equipment is stored on the side of the vehicle while heavier equipment is stored on the upper deck.

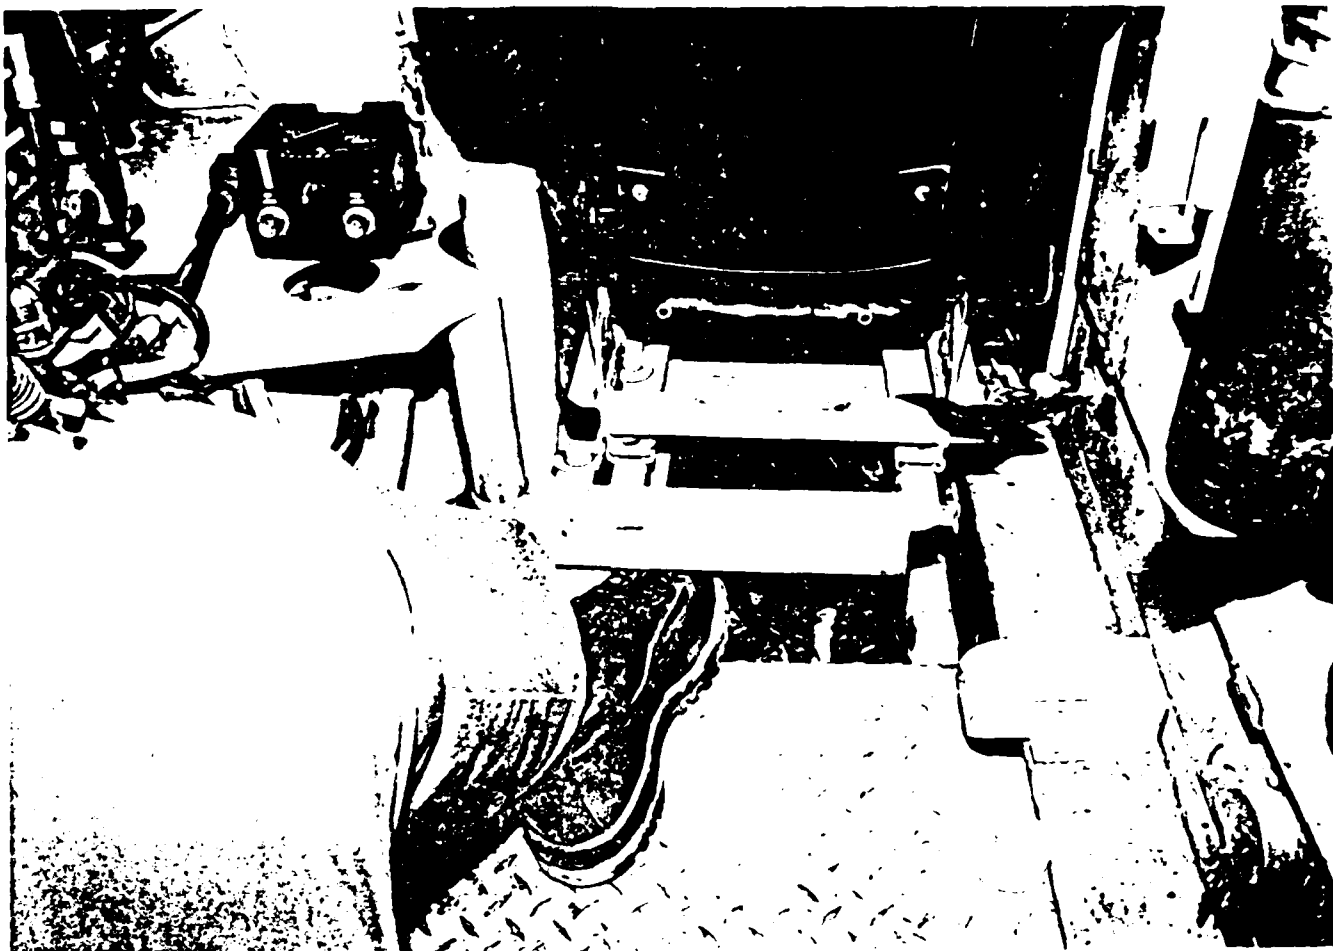
**Driver's seat.** The two vehicle commanders reported that their feet could be injured beneath the driver's seat. Figure 17 shows the hazard for the commander as the driver's seat descends. The seat is driven hydraulically and descends rapidly with a force coinciding to the driver's body weight. The greatest potential for injury occurs when the crew must button up rapidly. The driver must lower his seat entirely in order to close his hatch. The commander may remain standing in a crouched position with his feet possibly in the hazardous area. The back of the driver's seat should be guarded to prevent the commander's foot from being positioned beneath the seat.

Figure 17. The driver's seat may descend on the commander's foot.
