AEFA PROJECT NO. 84-23

ARTIFICIAL AND NATURAL ICING TESTS OF AH-64 (PHASE II)

MARCH 1987

FINAL REPORT

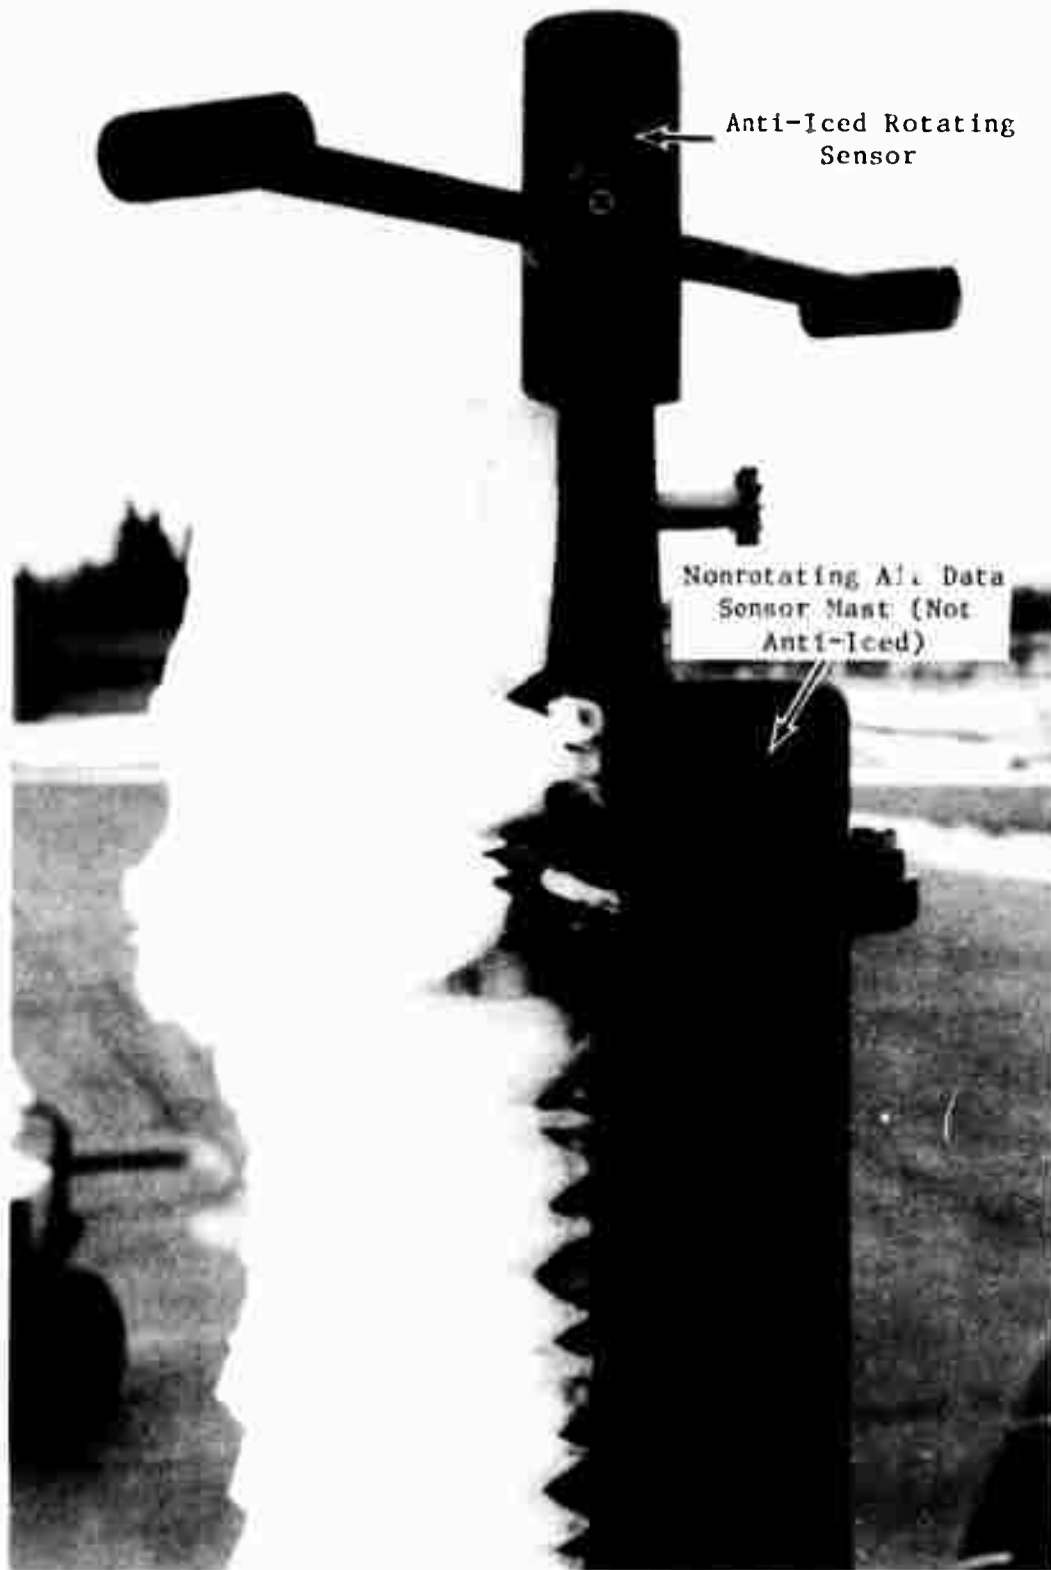
22. The Air Data Sensor (ADS) was located above the main rotor and attached to a stand pipe through the main rotor mast. The rotating hub and arms of the ADS were electrically heated. The same switch that activated pitot heat activated the ADS anti-ice system. Ice did not accrete on the heated portion of the ADS (photo 3). On one occasion after departing icing conditions, an ADS failure occurred probably due to a weak heater. The ADS was replaced and no further incidences occurred. The ADS anti-ice system is satisfactory.

Photo 3. AH-64A - Air Data Sensor

Conditions: Avg LWC = 0.43 gm/m^3
Avg OAT = -8.5°C
Time in Cloud = 83 minutes

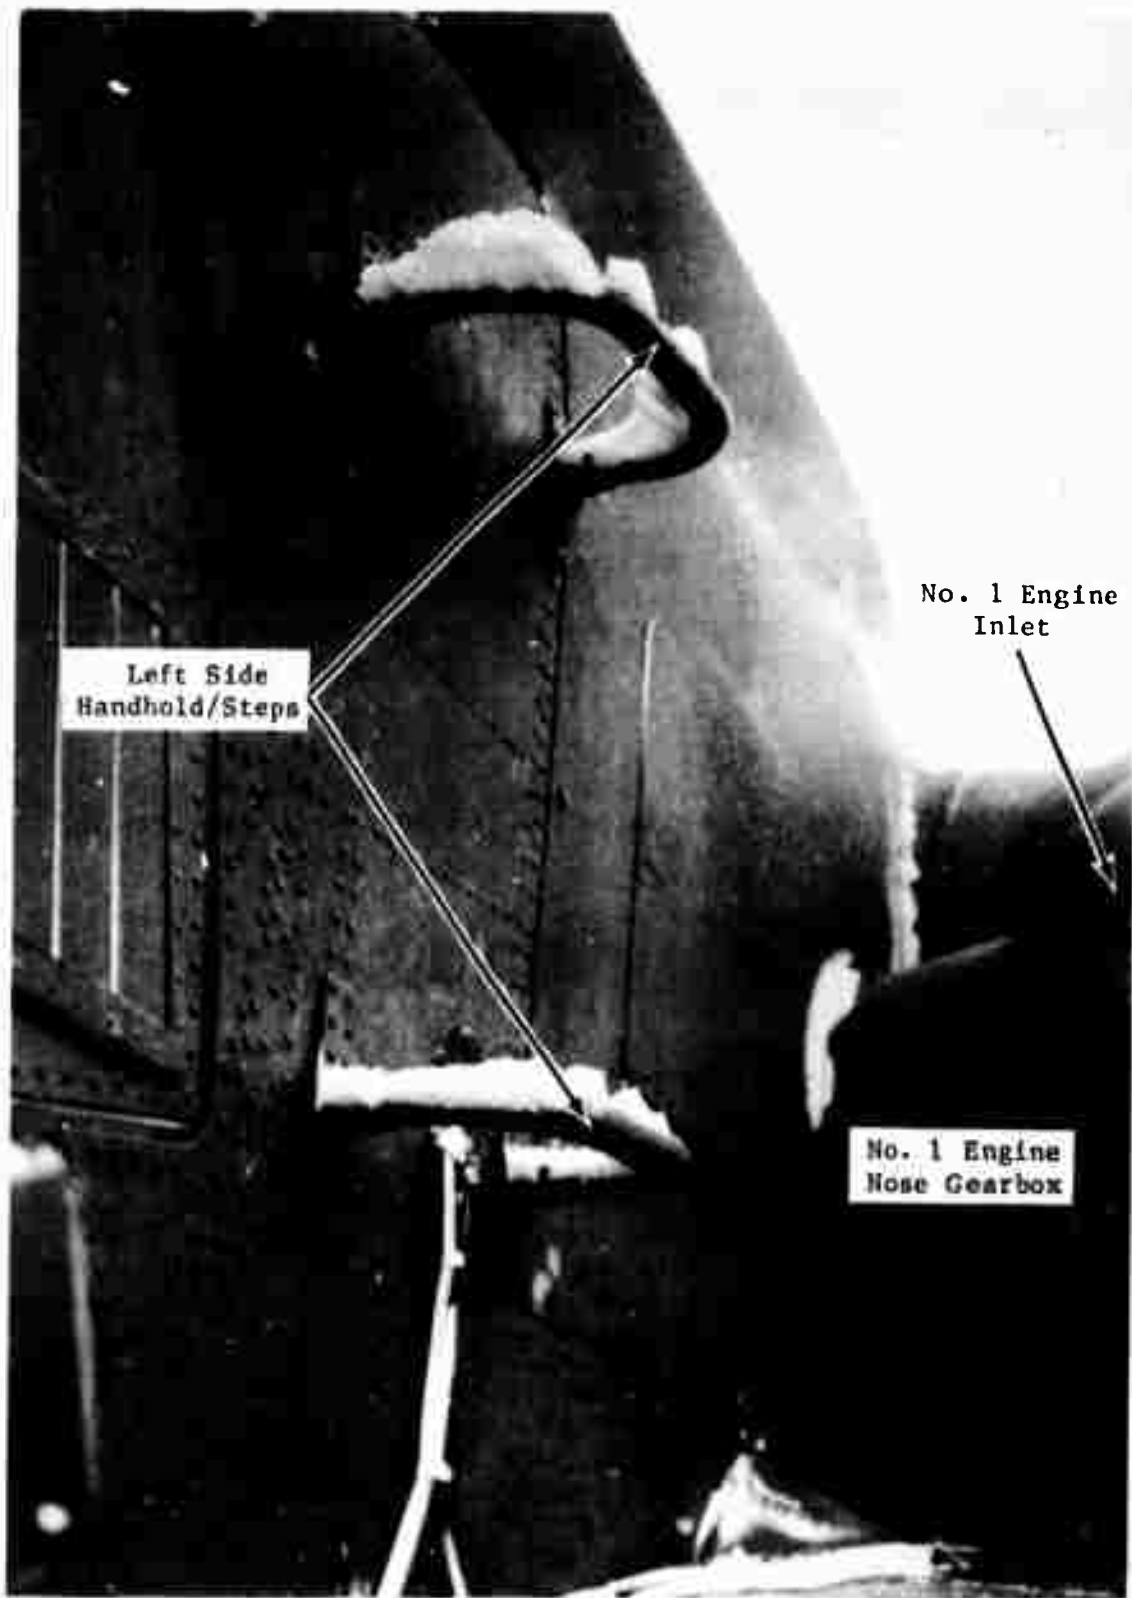
27. Typical fuselage ice accretions are shown in photo 4, enclosure 6 to appendix F. Large accumulations of ice were noted on the wing leading edges, nose, handholds/steps, landing gear, landing gear struts, and surface irregularities on the fuselage but created no operating difficulties. All windows, doors, and access panels remained functional after icing encounters. Ice accretion and shedding from the right and left side fuselage handholds/steps (photo 4) create the potential for engine FOD (see para 31) but no damage was specifically documented as being due to ice shed from these areas. Future aircraft designs should incorporate recessed handholds/steps to minimize ice accretion and FOD potential.

Photo 4. AH-64A - Left Side Fuselage

Conditions: Avg LWC = 0.28 gm/m^3

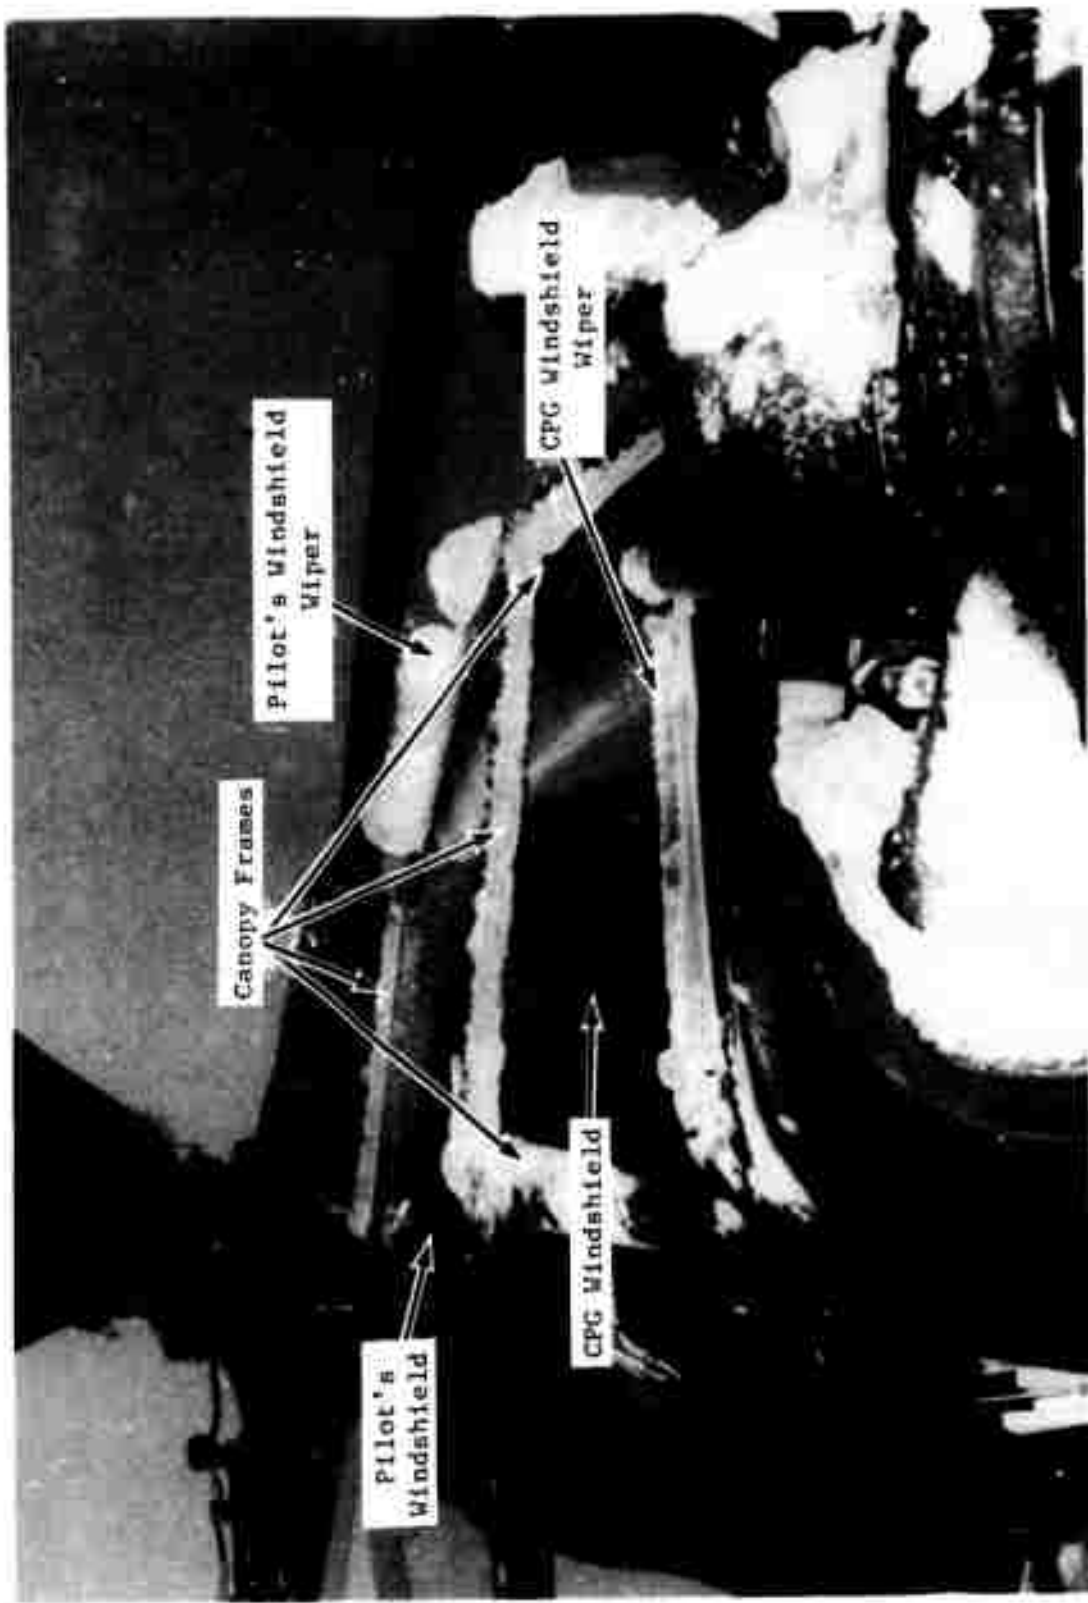
29. The framework supporting the essentially flat plate canopy was not anti-iced. The forward canopy frames accreted large quantities of ice (photo 5) which could break away during flight and damage aircraft components or result in engine ice ingestion. No damage was specifically documented as being due to ice shed from the canopy frames. Future aircraft designs should incorporate canopy frames which minimize ice accretions.

30. Large ice formations on both the pilot's and CPG windshield wipers (photo 5) could break away resulting in aircraft damage or engine ice ingestion. No damage was specifically documented due to ice shed from the wipers. The wipers were deliberately not activated in flight to prevent any damage. Future aircraft designs should incorporate windshield wipers which minimize ice accretions.

Photo 5. Canopy Frames and Windshield Wipers

Conditions: Avg LWC = 0.48 gm/m³
Avg OAT = -9.0°C

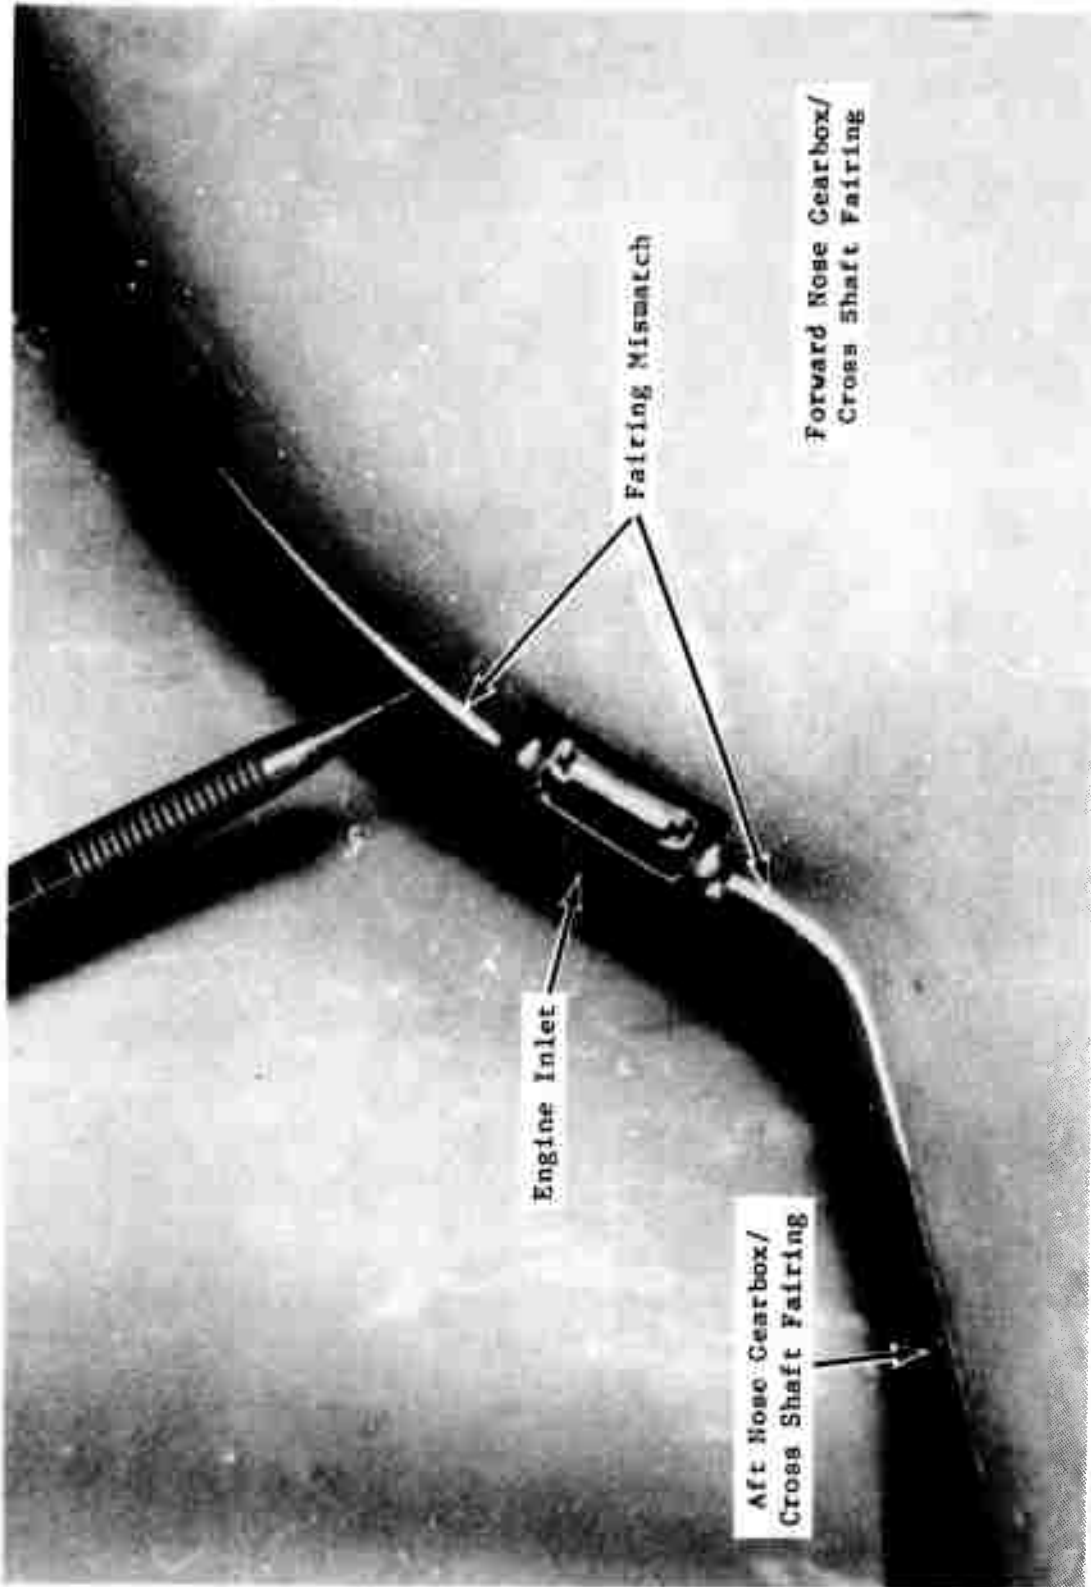
32. Ice accretion on the mismatch at the joint between the fore and aft nose gearbox/cross shaft fairings was previously documented during artificial icing tests (photo 6, enclosure 6 of appendix F). Ice accreted in this area is immediately in front of the engine inlet and presents a high probability of damage to the engine. No permanent modification to correct this problem has yet been implemented and the mismatch has been observed on most production aircraft. The fairing edges were smoothed during this test to eliminate the mismatch and prevent engine FOD. An example of the mismatch present with the most recent fairing configuration is shown in photo 6. The high potential for engine FOD due to shed ice from the mismatch at the joint between the fore and aft nose gearbox/cross shaft fairing is a deficiency.

Photo 6. No. 1 Engine Inlet

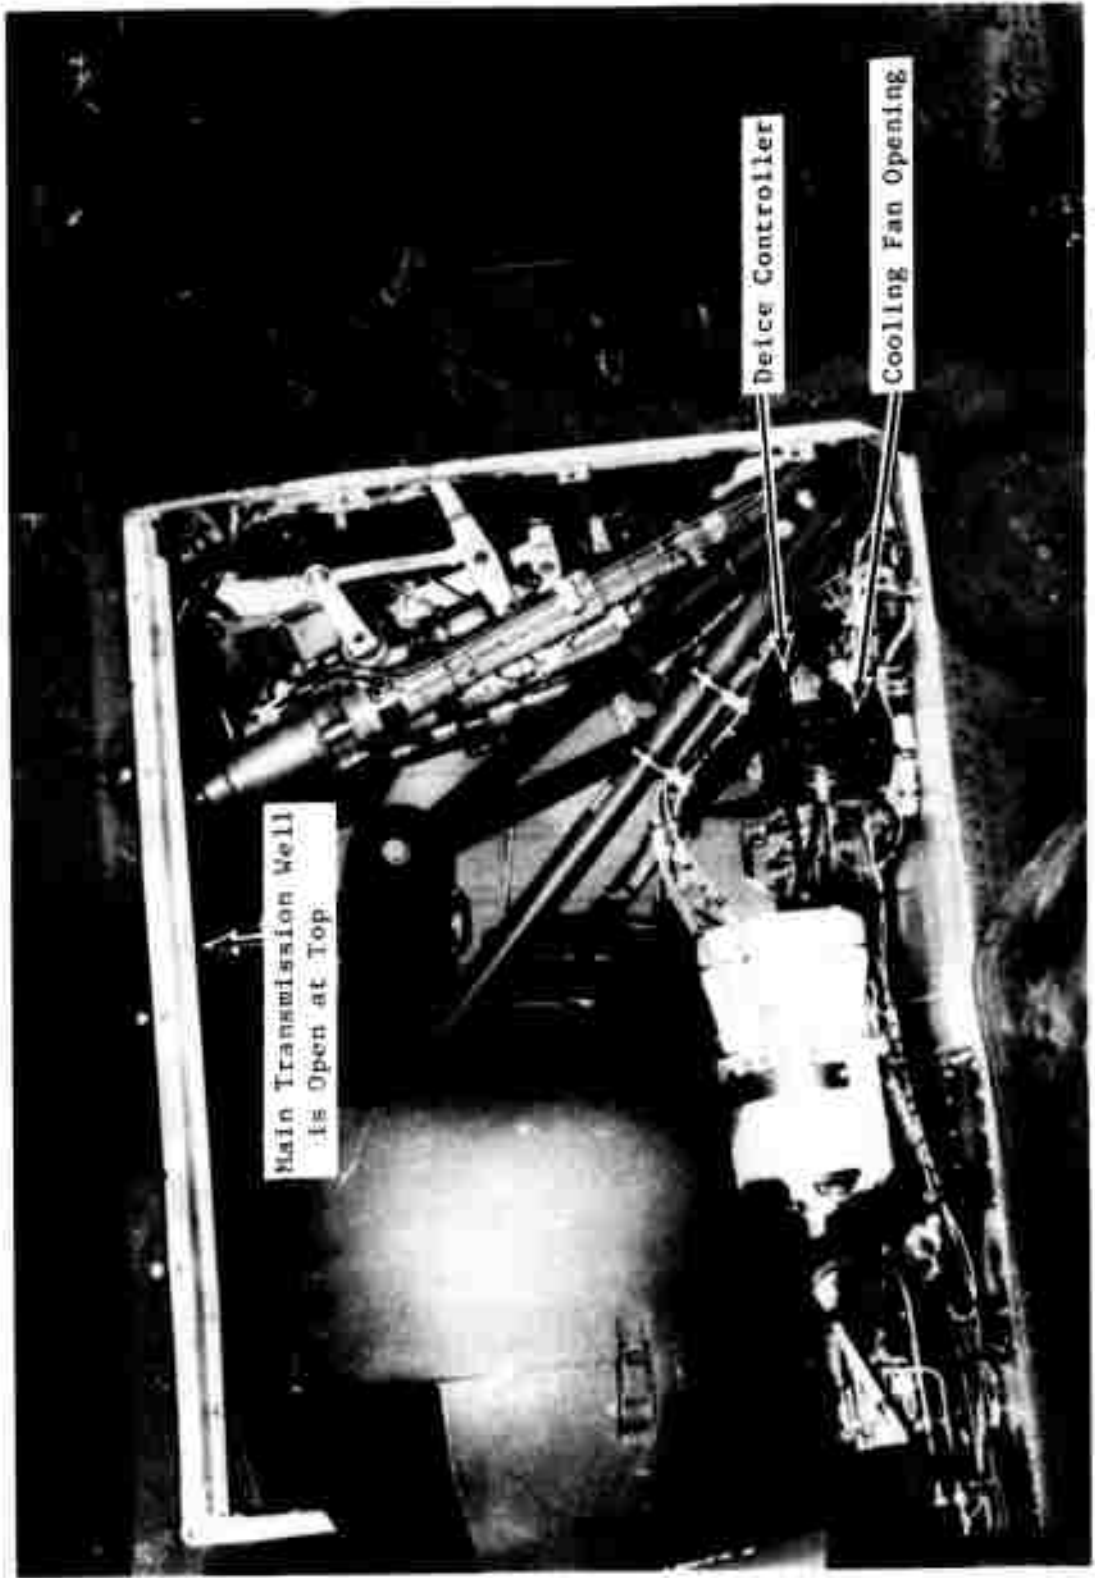
48. The main and tail rotor deice controller is mounted on the forward transmission deck (photo 10). Cooling vents and a fan

Photo 10. Fuselage Right Side - Main Transmission Access Panel Removed

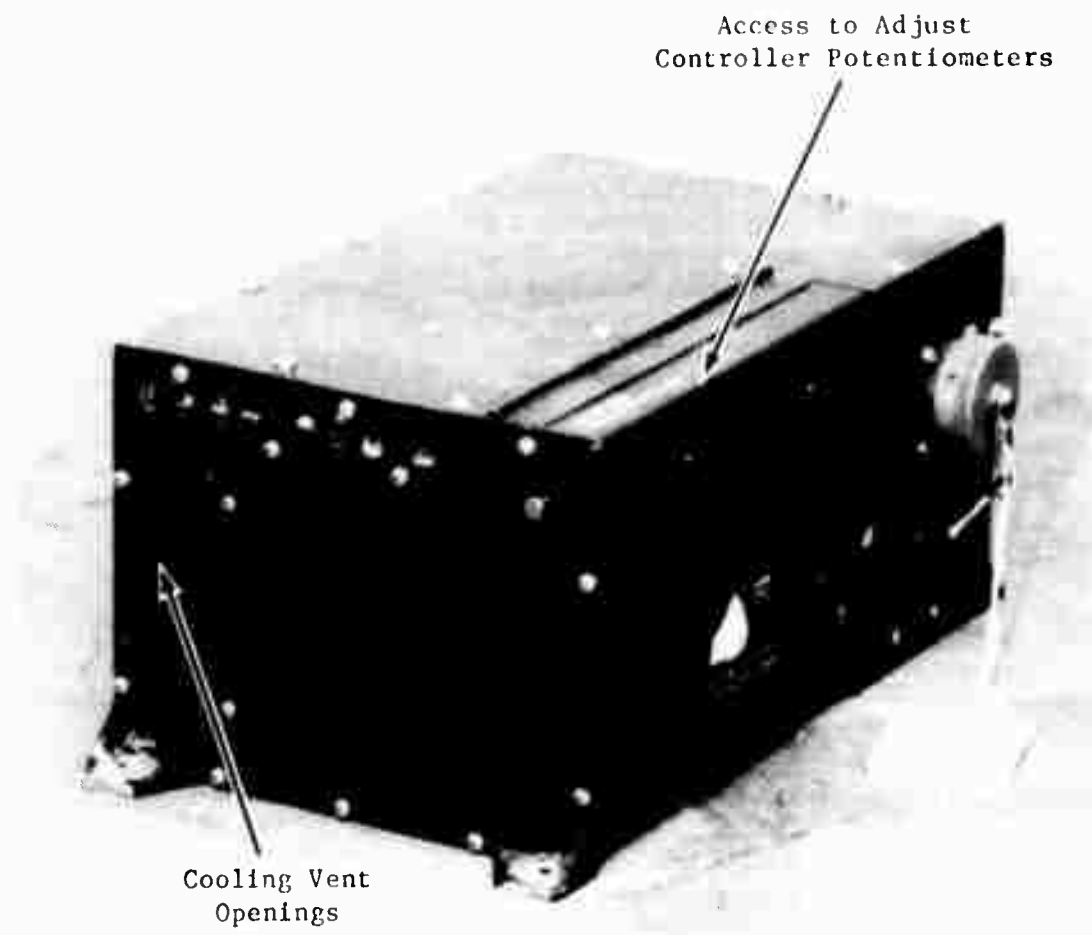
inlet at the ends of the controller case (photo 11) allow oil, hydraulic fluid, and water to penetrate the unit. Following a flight in natural icing, the deice controller was removed from the aircraft and water was discovered inside the unit. The potential for failure of the deice controller caused by penetration of oil and water into the unit is a shortcoming.

Photo 11. AH-64A Deice Controller

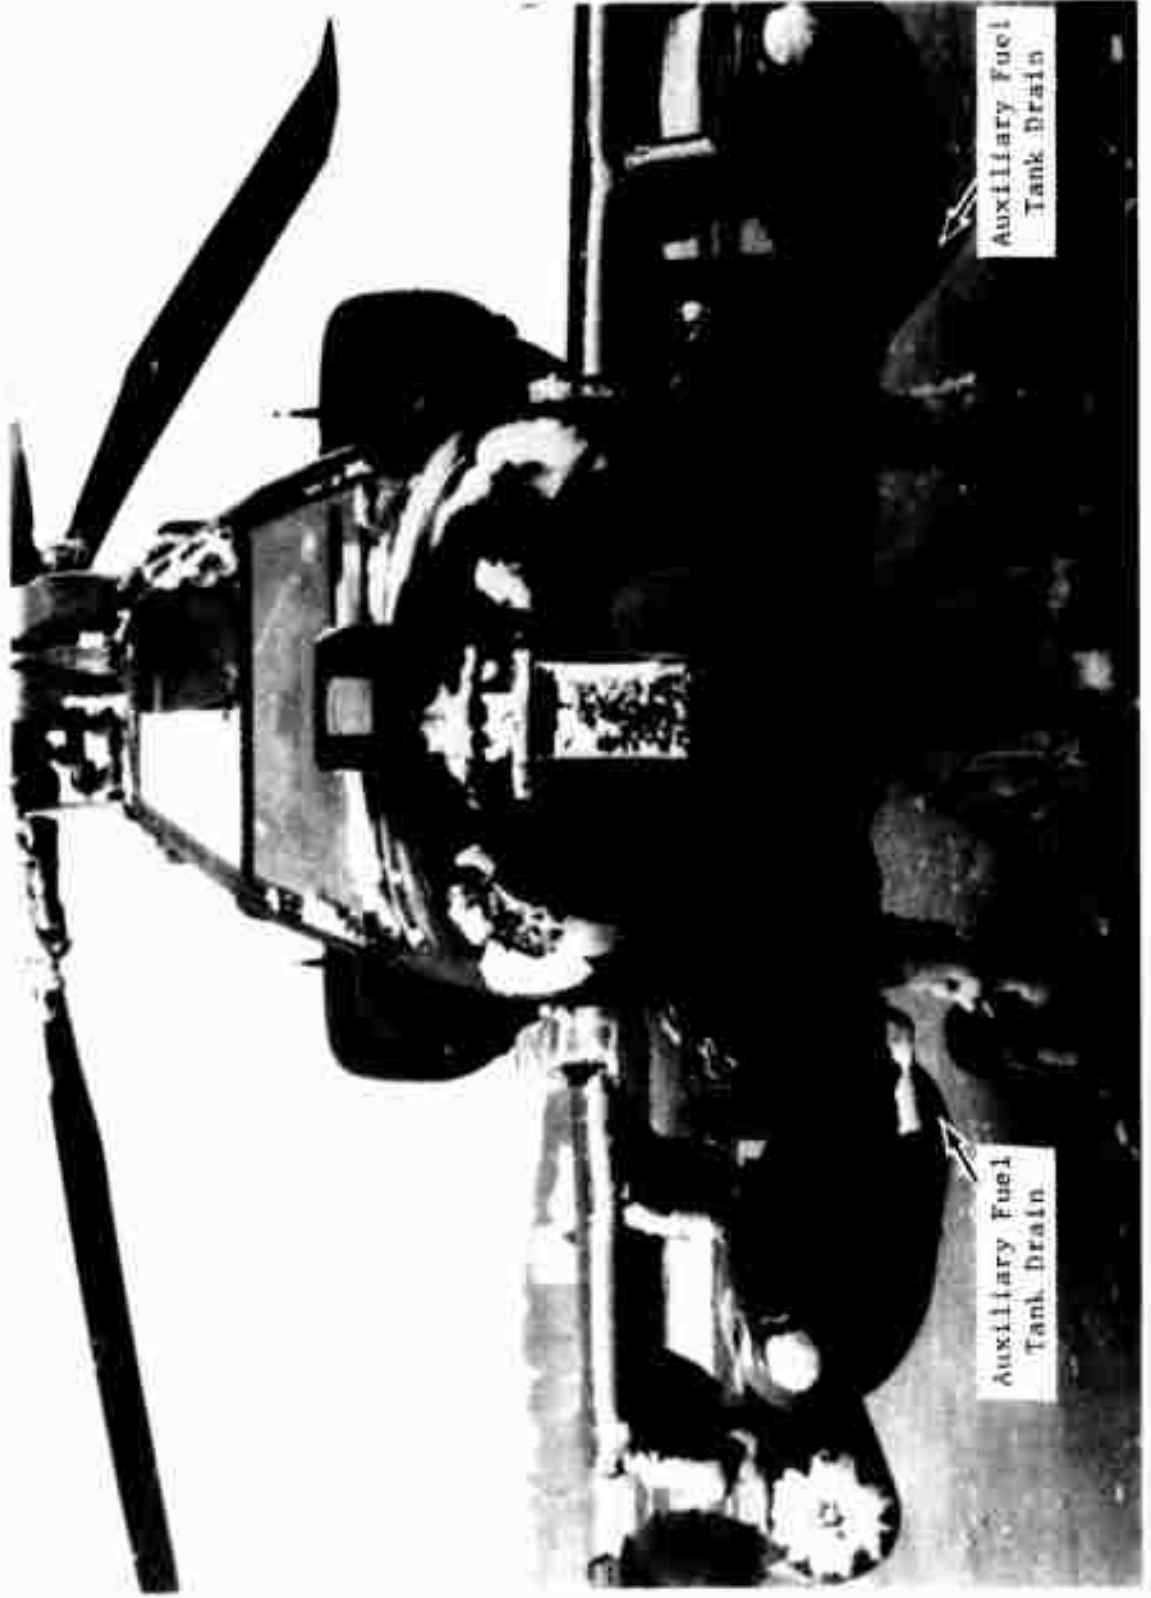
51. External auxiliary fuel tanks were installed on the test aircraft (photo 12). Fuel was transferred from the external tanks by means of the pressurized air system. When the aircraft is shutdown, the external tanks remain pressurized. When the aircraft was hangared for several days with the tanks pressurized, fuel began leaking from the tank access panels (photo 13) and fuel line fittings. The only way to vent pressure from the external tanks was to open the fuel filler caps following each flight. The tendency of the external auxiliary fuel tanks to

Photo 12. AH-64A - Front View

leak when the aircraft is stored after normal shutdown is a shortcoming.

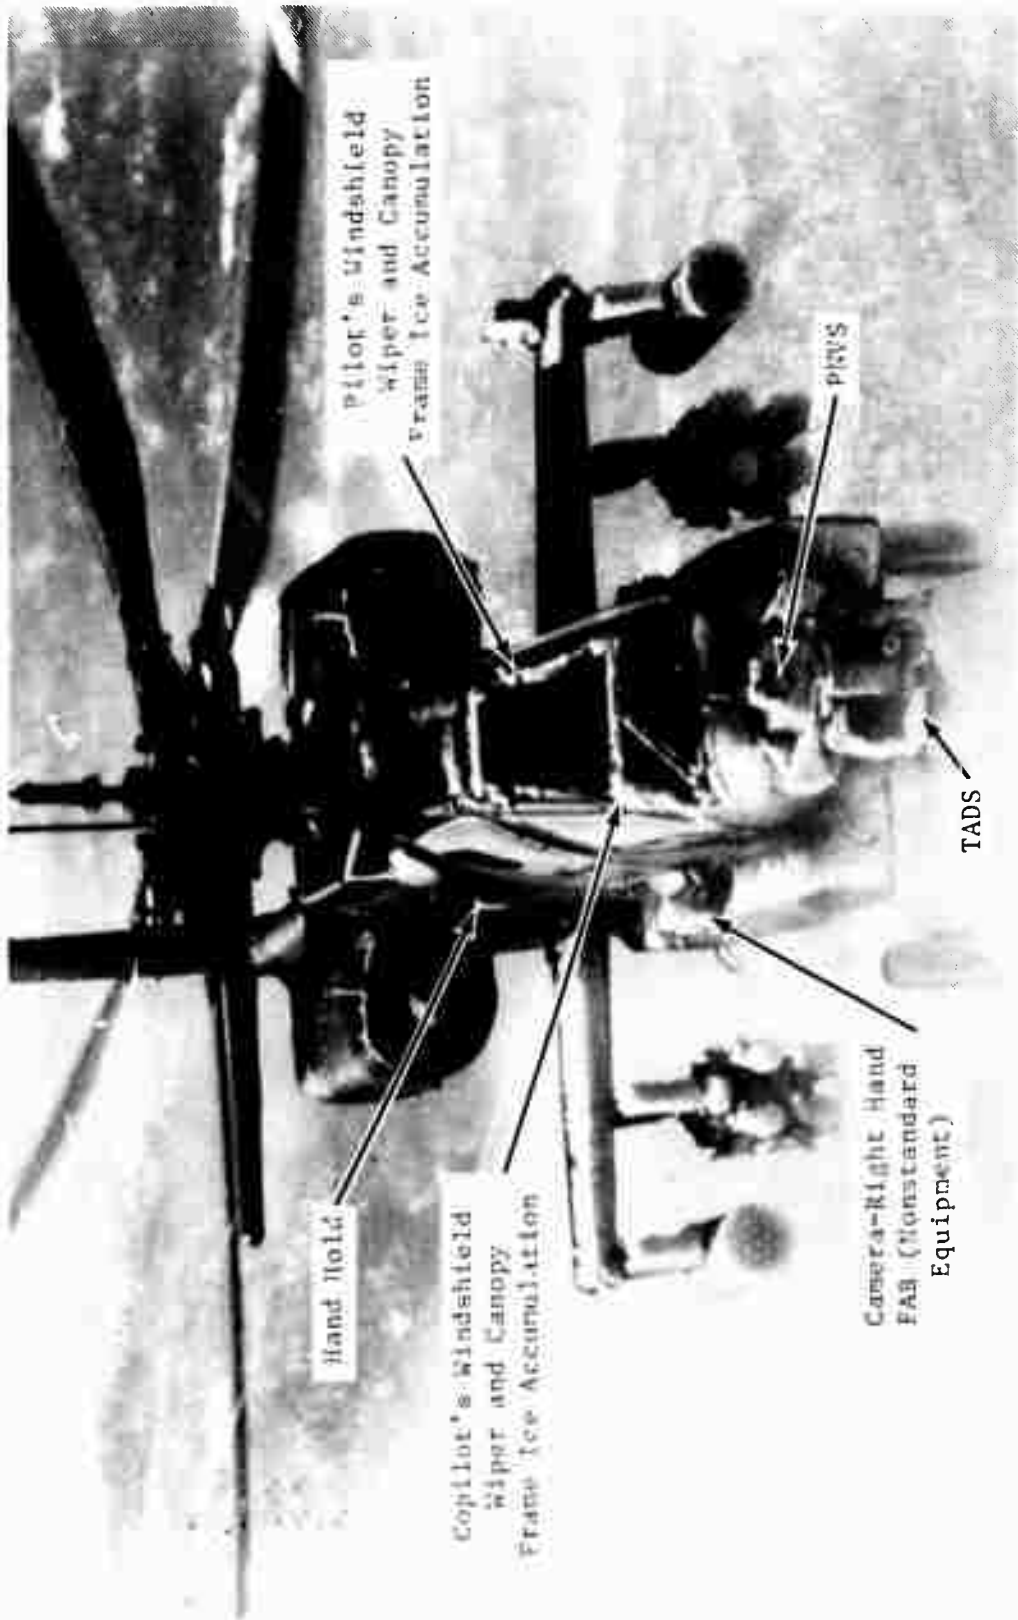
Photo 4. Typical Fuselage Ice Accretions

AVG OAT - -9.5°C
 AVG LWC - 1.02 gm/m^3
 Time in Cloud - 60 minutes
