**REPAIR, EVALUATION, MAINTENANCE, AND
REHABILITATION RESEARCH PROGRAM**

TECHNICAL REPORT REMR-CO-3

**CASE HISTORIES OF CORPS BREAKWATER
AND JETTY STRUCTURES**

Report 1
SOUTH PACIFIC DIVISION

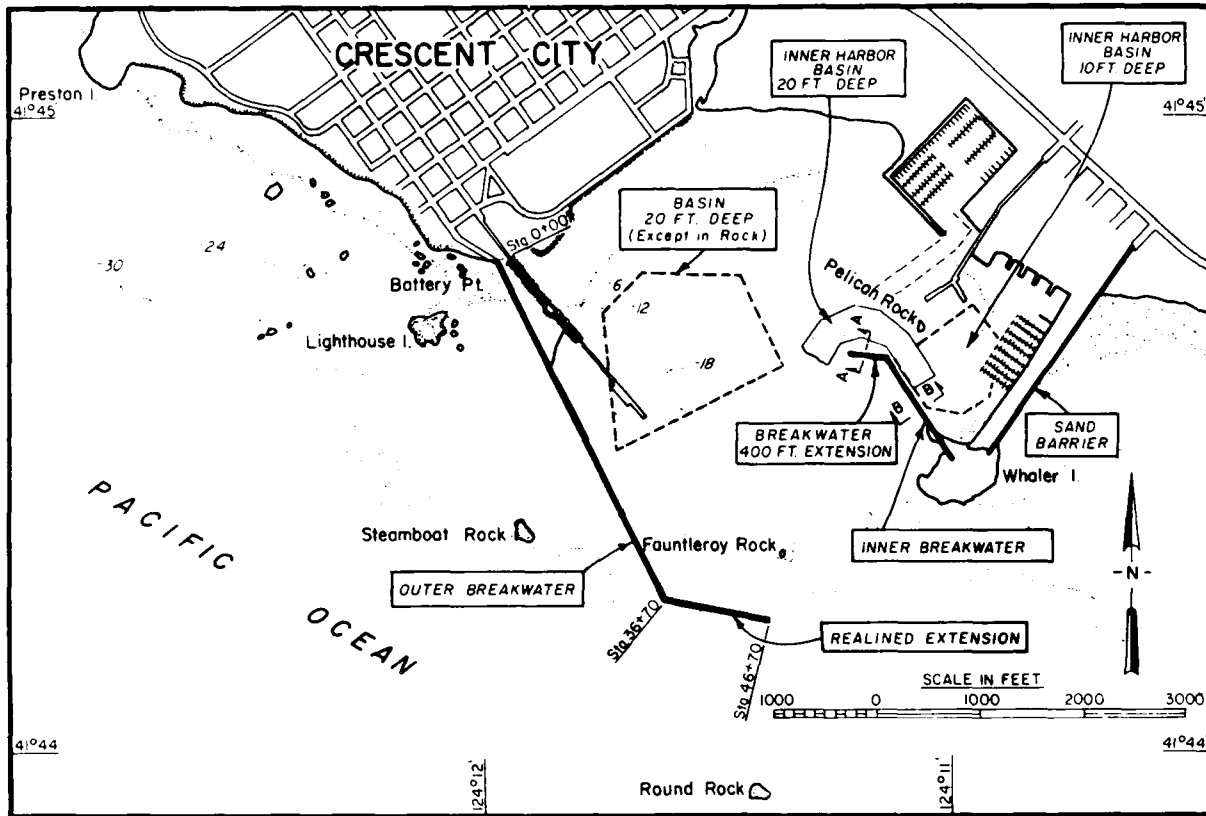
Figure 3. Crescent City Harbor, California

1948	A 1,000-ft-long extension of the original (outer) breakwater extending toward Round Rock (Figure 3) was completed. Ten- to 12-ton armor stones were used.
1948- 1949	During storms of 1948 and 1949, the 1,000-ft-long extension of the outer structure suffered considerable damage.
1950	The crest el of the entire outer breakwater, with the exception of a 300-ft segment (sta 12+50 to 15+50), was raised to +20 ft mllw with a 22-ft-wide concrete cap to prevent overtopping.
1950- 1951	Winter storm seasons resulted in further damage to the outer breakwater. Damages consisted of displacement of the concrete cap and armor stones down to about 0.0 mllw in all of the extension located seaward of sta 37+00.
1952	A modification was authorized which provided for a 1,000-ft-long extension of the outer breakwater on a bearing of S80° E (Figure 3) and for abandonment of the existing structure seaward of sta 36+70.

Date(s)	Construction and Rehabilitation History
1957	The 1,000-ft-long outer breakwater extension, as authorized in 1952, was completed. Twelve-ton stone protection was used from sta 36+70 to 41+20. From sta 41+20 to 46+70, 25-ton unreinforced tetrapods (1,836 units) were placed on the seaward slope (Figure 5). Model tests were conducted (US Army Engineer Waterways Experiment Station (WES), Hydraulics Laboratory (HL) 1953, 1956).
1957-1964	Damages occurred to a portion (sta 36+70 to 41+20) of the outer breakwater, and in 1964 were repaired using 12-ton stones and 140 25-ton tetrapods. The tetrapods were not model tested for their adequacy for placement in this area, and they were destroyed over a period of years.
1973	Repairs were made to the concrete cap of the outer breakwater between sta 35+40 and 37+00.
1974	Rehabilitation of the outer breakwater between sta 34+70 to 37+00 was completed. Two layers of 40-ton unreinforced dolosse (246 units) were placed on the seaward slope.

1974	Construction of a 400-ft-long extension of the inner breakwater was completed (Figure 3). Model testing was conducted to determine optimum wave conditions (Senter and Brasfield 1968, Senter 1971).
1979	Repairs were made to the following reaches of the outer breakwater using 18- to 30-ton stone: sta 19+00 to 20+00, 22+00 to 24+00, 24+60 to 27+20, 28+90 to 29+50, 30+50 to 31+00, and 37+00 to 41+20. Repairs to sta 15+50 through 17+50 also were made using stone in the 14- to 25-ton range.
1983	Major storms in the winter of 1983 resulted in broken dolosse on the outer breakwater. Estimated damage to the structures was \$4,400,000.
1984	Approximately 23,300 tons of stone were placed to repair various sections of the outer breakwater between sta 17+30 to 33+90.
1986	The outer breakwater is presently in poor condition. The problem area is primarily between sta 34+70 through 37+00 where missing and/or damaged dolosse are apparent. A contract was issued to rehabilitate the dolosse section of the outer structure (sta 34+70 through 37+00) with 700 fiber-reinforced 42-ton dolosse. The dolos perimeter used special placement, and the dolosse on the outer portion of the seaward transition were entrenched and buttressed with 25-ton stone (Baumgartner, Carver, and Davidson 1985). About 80 of the constructed dolosse were stockpiled on the leeward side of the jetty for repair contingencies. This rehabilitation effort was also used to gather data on prototype forces on dolosse. Twenty of the dolosse (painted red) were instrumented and placed in the main dolos section at about sta 36+00. As of this date, no data have been received from the prototype dolos study.

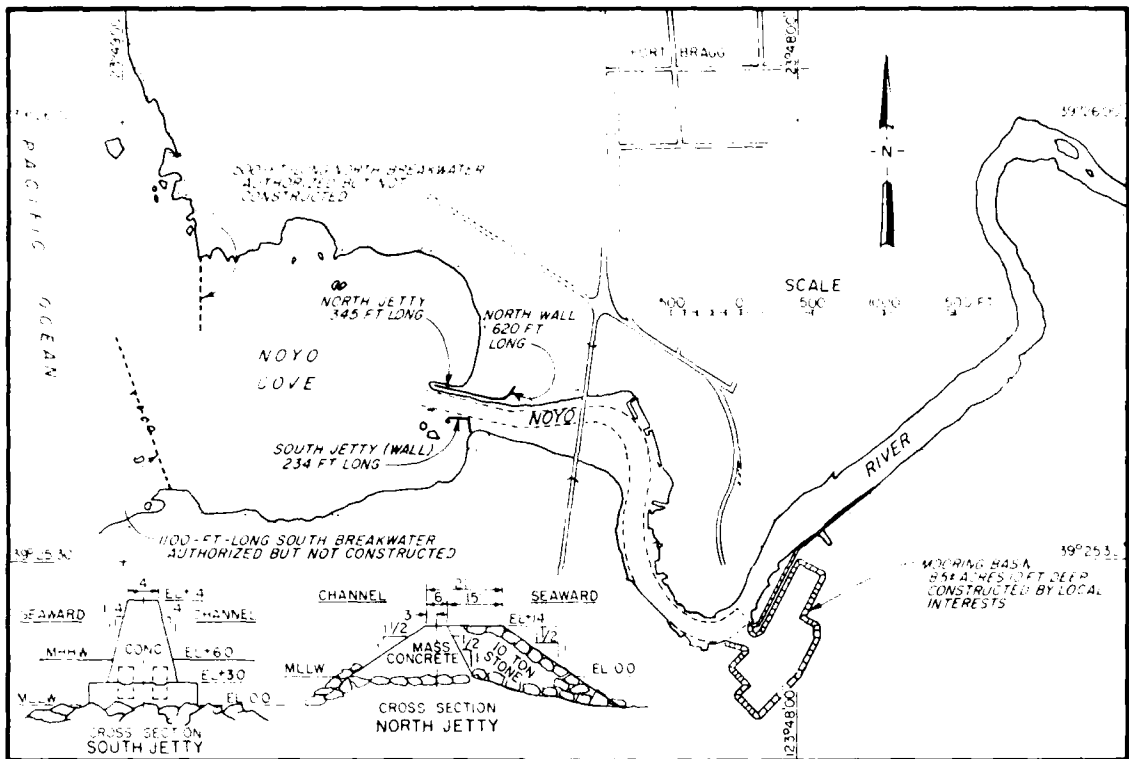
Figure 7. Noyo River and Harbor, California

<u>Date(s)</u>	<u>Construction and Rehabilitation History</u>
1924	Construction of two jetties across a sand bar was completed at the mouth of Noyo River. These were rubble-mound structures spaced approximately 125 ft apart. The initial lengths of the north and south jetties were 648 and 110 ft, respectively.
1931	Work at the Noyo River entrance, which included dredging, rock removal, and reconstruction of the jetties, was completed. The jetties were constructed to their present lengths (Figure 7). The north jetty was constructed of mass concrete. It was 345 ft long and connected to a 620-ft-long concrete wall. The south jetty was constructed 234 ft long with concrete. Both structures had crest els of +14 ft mllw.
1945	A 1,100-ft-long outer rubble-mound south breakwater was authorized (Figure 7). This structure has not been constructed.
1954	Stone (10-ton) was added to the seaward side of the north breakwater (Figures 7 and 8).

1961	Minor rehabilitation of the jetties and north wall was completed.
1962	A 500-ft-long outer rubble-mound north breakwater was authorized (Figure 7). This structure has not been constructed.
1970	The two outer breakwaters authorized by the Acts of 1945 and 1962 were reclassified from an active to inactive category. They were not economically feasible because of the high cost of construction and maintenance. Model testing of the structures was conducted (Wilson 1967).
1983	Restoration of the north jetty head was completed. Materials used consisted of approximately 2,500 tons of capstone, 10 cu yd of concrete, 1,500 cu yd of sandfill, and 4,100 tons of quarystone fill.
1986	The jetties are presently in good condition. Model testing currently is being conducted to optimize the location of a structure in the immediate area of the River entrance (Bottin, in preparation).

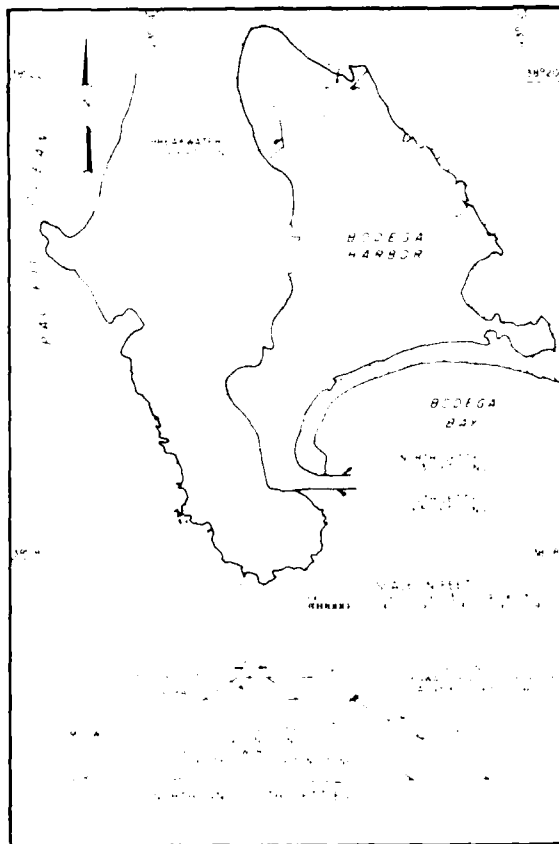
Figure 9. Bodega Harbor, California

Date(s)	Construction and Rehabilitation History
1943	The initial construction of the north and south jetties was completed at the site (Figure 9). The north and south jetties were rubble-mound structures with lengths of 1,130 and 1,650 ft, respectively, with crest els of +12 ft mllw and 1V:1.5H side slopes.
1961	Rehabilitation of the channels and south jetty was completed for a cost of \$399,800. Stone was added to the seaward side of the jetty between sta 14+00 and 16+00. The side slope of the structure over this 200-ft length was changed to 1V:2H.
1985	A 1,268-ft-long baffled-concrete pile breakwater was constructed by local interests in the northern portion of Bodega Harbor (Figure 9) to protect small craft moored there from damages resulting from wave action. The breakwater was approved for maintenance by the CE in November.
1986	The structures presently are in satisfactory condition.

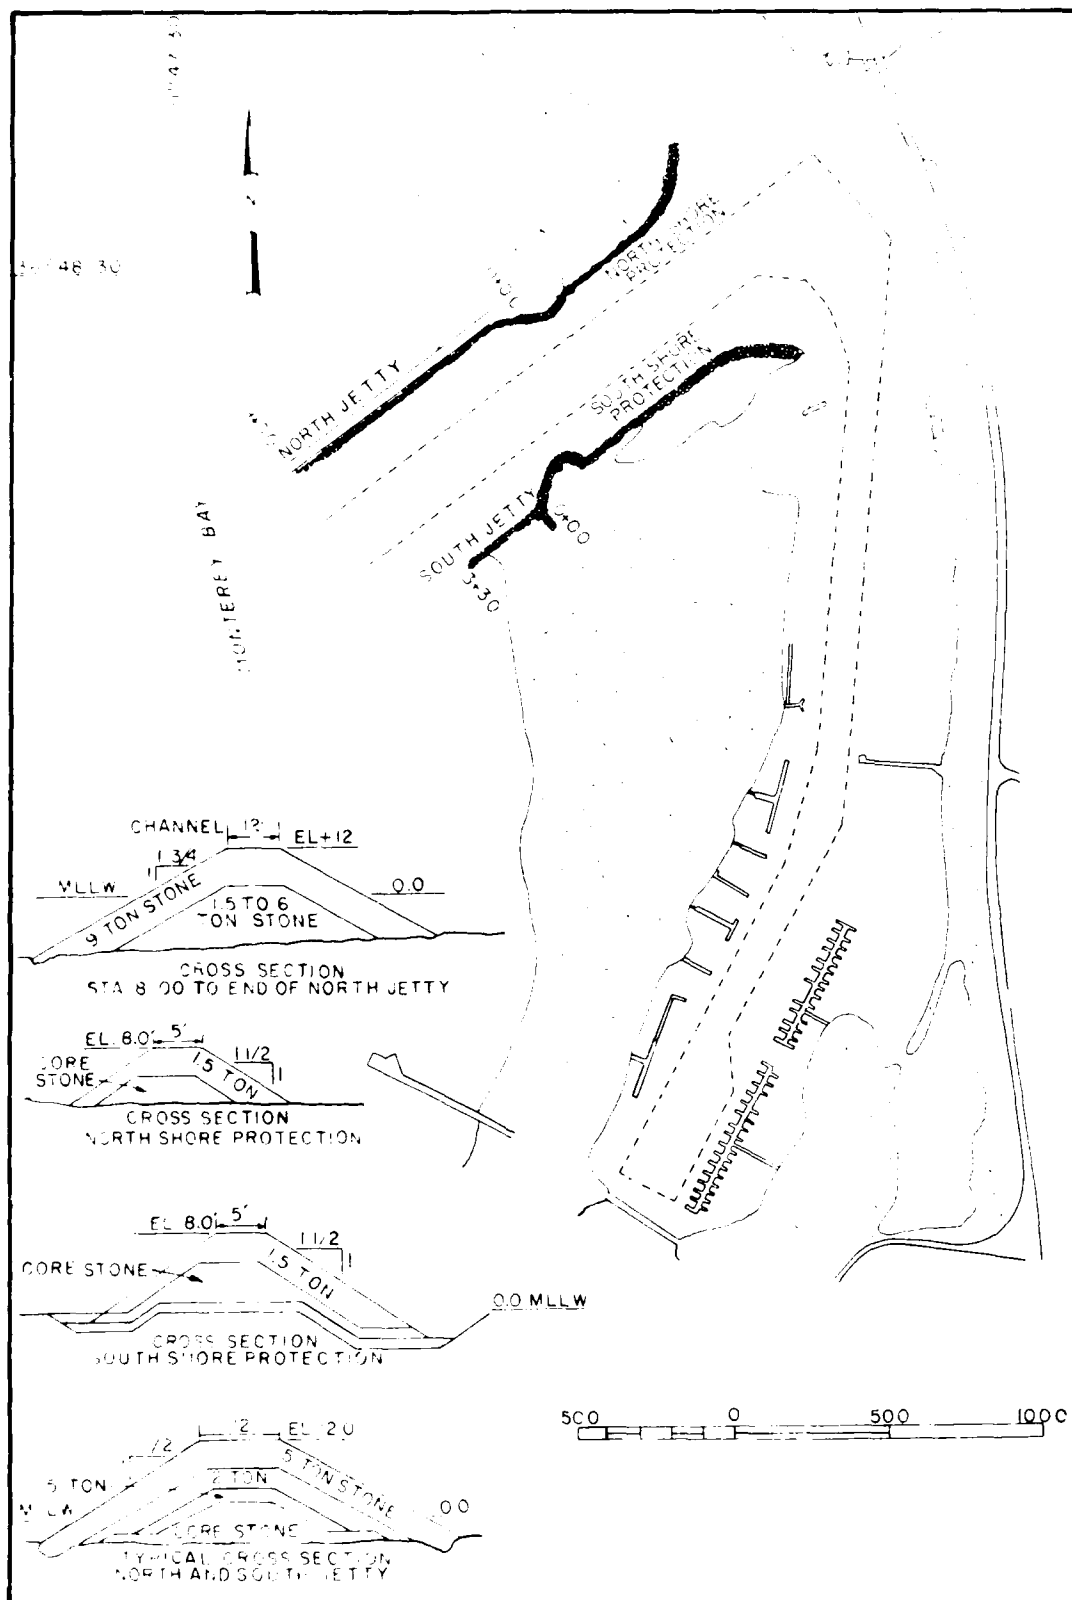
Figure 19. Moss Landing Harbor, California

<u>Date(s)</u>	<u>Construction and Rehabilitation History</u>
1947	Construction of protective jetties at the site was completed to stabilize the entrance (Figure 19). The north and south jetties are 900- and 330-ft long, respectively, and are roughly parallel. Crest els of the jetties range from +8 ft to +12 ft mllw, and side slopes vary from 1V:1.5H to 1V:1.75H. During project construction severe storms resulted in scouring and deep cutting of the sand adjacent to the jetties. Emergency stone placement was undertaken along the south jetty from the shore to a point 320 ft seaward. Stone protection for the north jetty was placed throughout its 900-ft length, and additional placement was made along the north and south shorelines of the jetties. A total of 47,946 tons of stone was required for this work.
1949	To add permanence to the emergency work of 1947, additional armor stone was placed on the previous enrockment. This effort required a total of 24,625 tons of stone.

1949- 1965	Severe erosion around the jetties and the unprotected shorelines adjacent to them was experienced during this time frame.
1966- 1967	Approximately 235 ft of the north jetty and the entire length of the south jetty were repaired. Also about 280 ft of curved revetment work was added to the north jetty and about 380 ft added to the south jetty. This work required the placement of 77,560 tons of stone. The north jetty head was not repaired because of the movement of the canyon head and the possibility that damage may occur to any repairs in that vicinity.
1975	A field inspection revealed the jetties in satisfactory condition except for damage on the seaward ends due to erosion and subsequent stone displacement. The deep submarine canyon head at the seaward end of the north jetty appeared to have stabilized.
1976	A basis for design of repairs to the jetties and revetment was prepared. Estimated cost of these repairs was \$290,000, and approximately 7,400 tons of stone would be required.

1986	Work is still required at the jetty heads. Except for the erosion at these locations, the jetties historically have performed satisfactorily and suffered relatively minor damages.

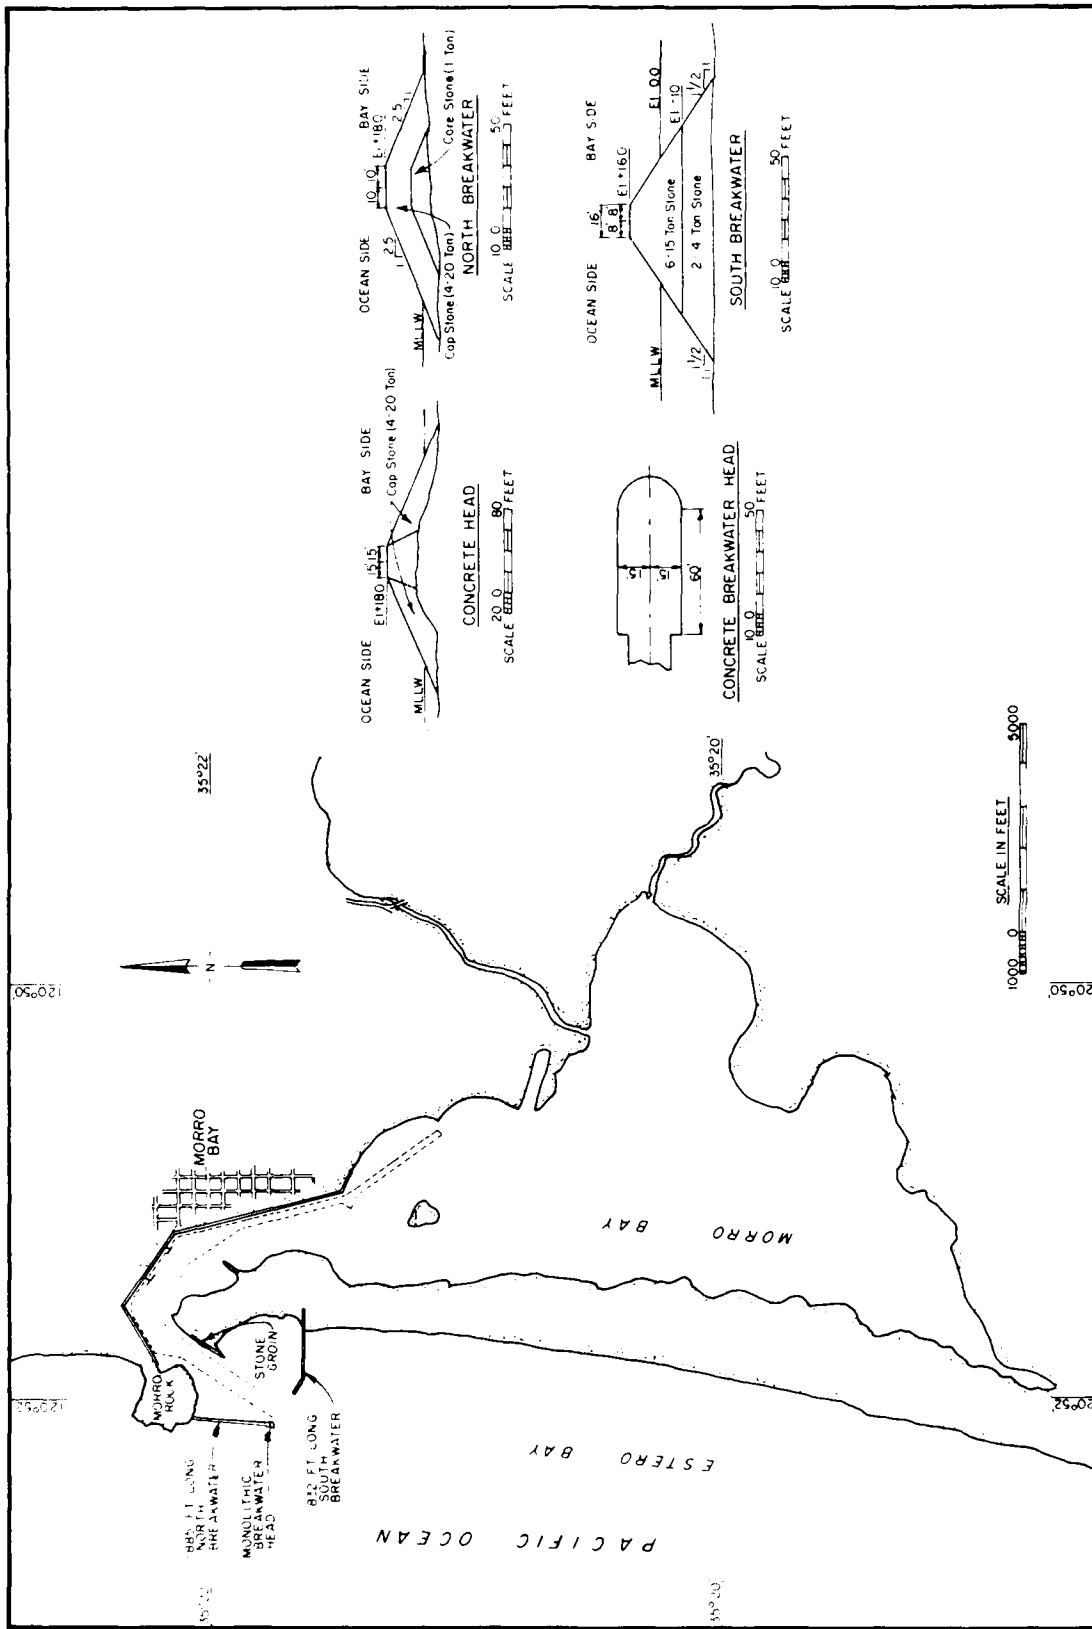
Figure 21. Morro Bay Harbor, California

<u>Date(s)</u>	<u>Construction and Rehabilitation History</u>
1942 1943	A 1,000-ft-long north breakwater was constructed, and a 1,832-ft-long south breakwater was completed at the site (Figure 21) to serve as a base for naval patrol craft. The structures were rubble-mound and built at an el of +16 ft mllw with 1V:1.5H side slopes and a crest width of 16 ft.
1943- 1944	Storm waves during this period damaged the north breakwater. The south breakwater received no appreciable damage.
1945	The north breakwater was repaired and extended to 1,800 ft in length. This work also included widening the crest from 16 to 20 ft. The project was adopted and completed under the supervision of the CE using funds provided by the US Navy.
1946	The north breakwater again suffered damage from storm waves.
1948	Maintenance work was performed on the north breakwater. Damaged sections of the structure were restored, and the cap was bound with concrete across the crest to an el of -2 ft mllw on both sides.

1949- 1960	The north breakwater continued to deteriorate, and shoaling occurred in the channels. The south breakwater still had suffered no observable damage since its construction in 1943.
1964	The north breakwater was reconstructed at a cost of \$1,561,882. The new rubble-mound structure was built at an el of +18 ft mllw, with a 20-ft-wide crest and 1V:2.5H side slopes. The structure was rebuilt about 100 ft bayward of the original north breakwater location and extended to 1,885 ft in length (Figure 21). The breakwater included larger armor stone than the original structure. Also included was a concrete monolithic breakwater head. Model tests were conducted (Jackson 1961).
1983	Major storms resulted in approximately \$1,430,000 in damages to the breakwaters.
1985	Maintenance repair of the north and south breakwaters was completed which included the placement of approximately 18,000 tons of capstone. Capstones ranged in weight from 6-21 tons each.

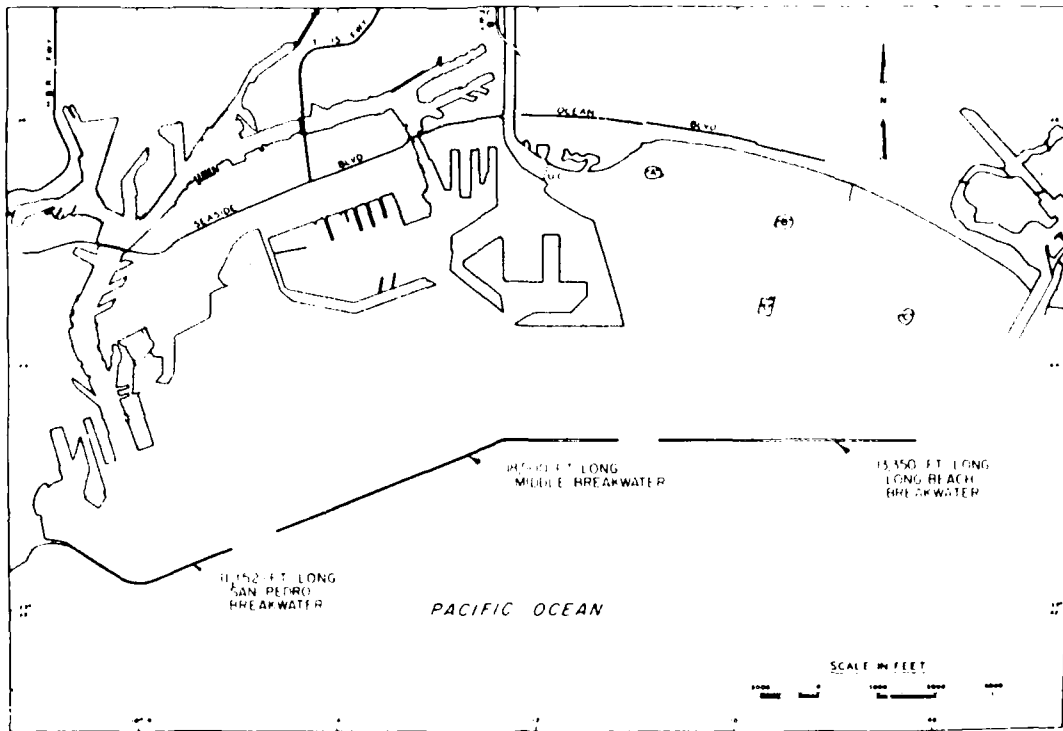
Figure 29. Los Angeles and Long Beach Harbors, California

1942- 1960	Construction of the 13,350-ft-long rubble-mound Long Beach Breakwater (Figure 29) occurred during this period. With the exception of the breakwater core el (Figure 30) the cross section of this structure was similar to that of the middle breakwater.
1947	Repairs to the middle breakwater were accomplished for a cost of \$786,700.
1983	Winter storms resulted in extensive damage to the San Pedro Breakwater. The structure was breached in an area immediately seaward of the curved portion of the breakwater. Model tests were conducted after the damage (Carver 1984, Baumgartner, et al. 1986), and restoration of the San Pedro Breakwater was subsequently completed. Work consisted of the placement of approximately 25,000 tons of salvage stone and new angular stones ranging from 15 to 25 tons each. Where voids occurred on the crest after this stone placement, concrete was pumped into flexible temporary forms to complete the repair.

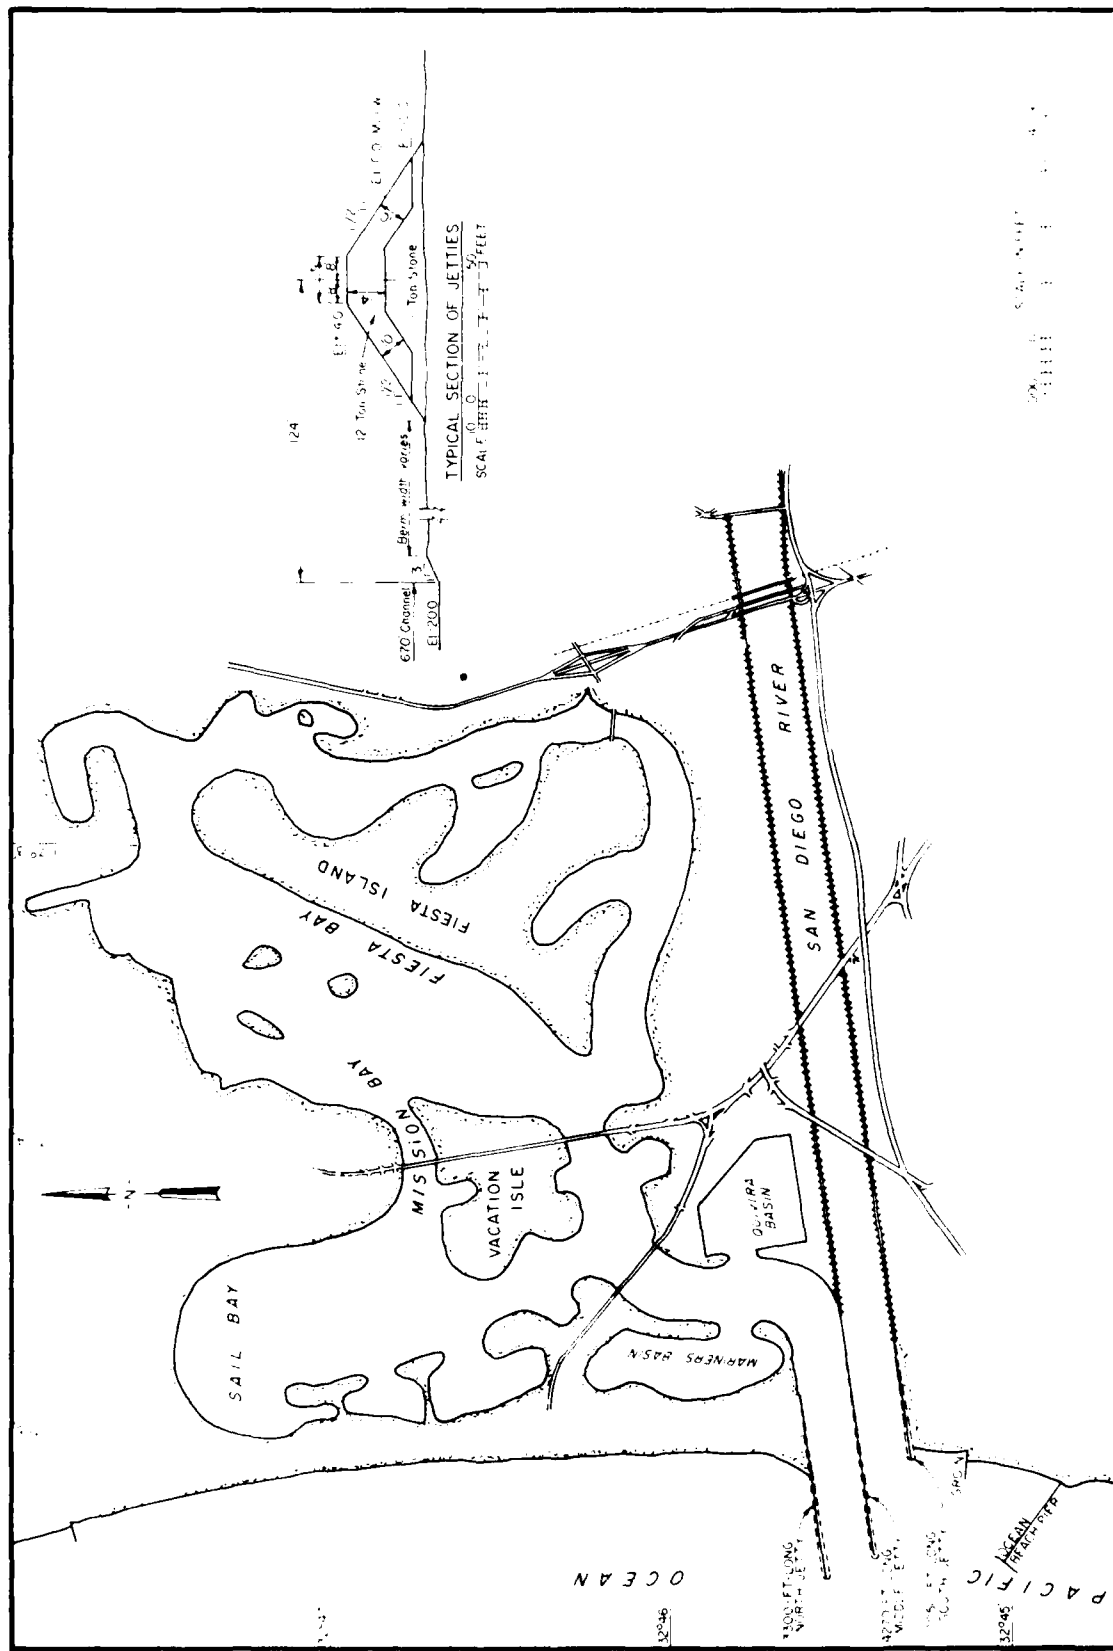
Figure 34. Mission Bay Harbor, California

Date(s)	Construction and Rehabilitation History
1949	Construction of three rubble-mound jetties at the site (Figure 34) was completed. These structures included a 3,300-ft-long north jetty, a 4,270-ft-long middle jetty, and a 950-ft-long south jetty. Typically, the jetties were built with a 16-ft-wide crest at an el of +14 ft mllw with side slopes of 1V:1.5H.
1955	Sediment from the littoral zone was noted passing through the north jetty into the entrance channel. Sealing stones (3,000 tons) were placed on the seaward slope of the jetty. This measure retarded the movement of sand but did not entirely stop infiltration.
1959	Approximately 1,300 ft of the middle jetty and 1,000 ft of the north jetty were sealed with grout to prevent the movement of sediment through the structures. The original core stone of the jetties was constructed at el 0.0 ft mllw. The intruded grout barrier was installed to el +6 ft mllw. The cost of this work was \$78,900.

1970	A 1,100-ft-long extension and sealing of the south jetty were completed. Jetty sealing was accomplished by installing a 3-ft layer of sealing stone in the littoral zone. The head of the middle jetty also was repaired in that the cover stone (12-ton) at the head of the jetty was restored. Total cost of the work was about \$566,000.
1986	The existing jetties currently are in satisfactory condition. Design has been completed for an offshore breakwater located seaward of the north and middle jetties that will provide additional wave protection for Mission Bay Harbor. The proposed offshore breakwater has been model tested (Curren 1983, Markle 1983, Bottin and Acuff 1985) but not yet constructed in the prototype.
