NDE OF BLACK HAWK HELICOPTER ROTARY WING-HEAD SPINDLE
THREADS USING ELECTRIC CURRENT PERTURBATION

Final Report
SwRI Project 15-7958-818

U. S. Army Aviation Research and
Development Command
St. Louis, Missouri

November 1985

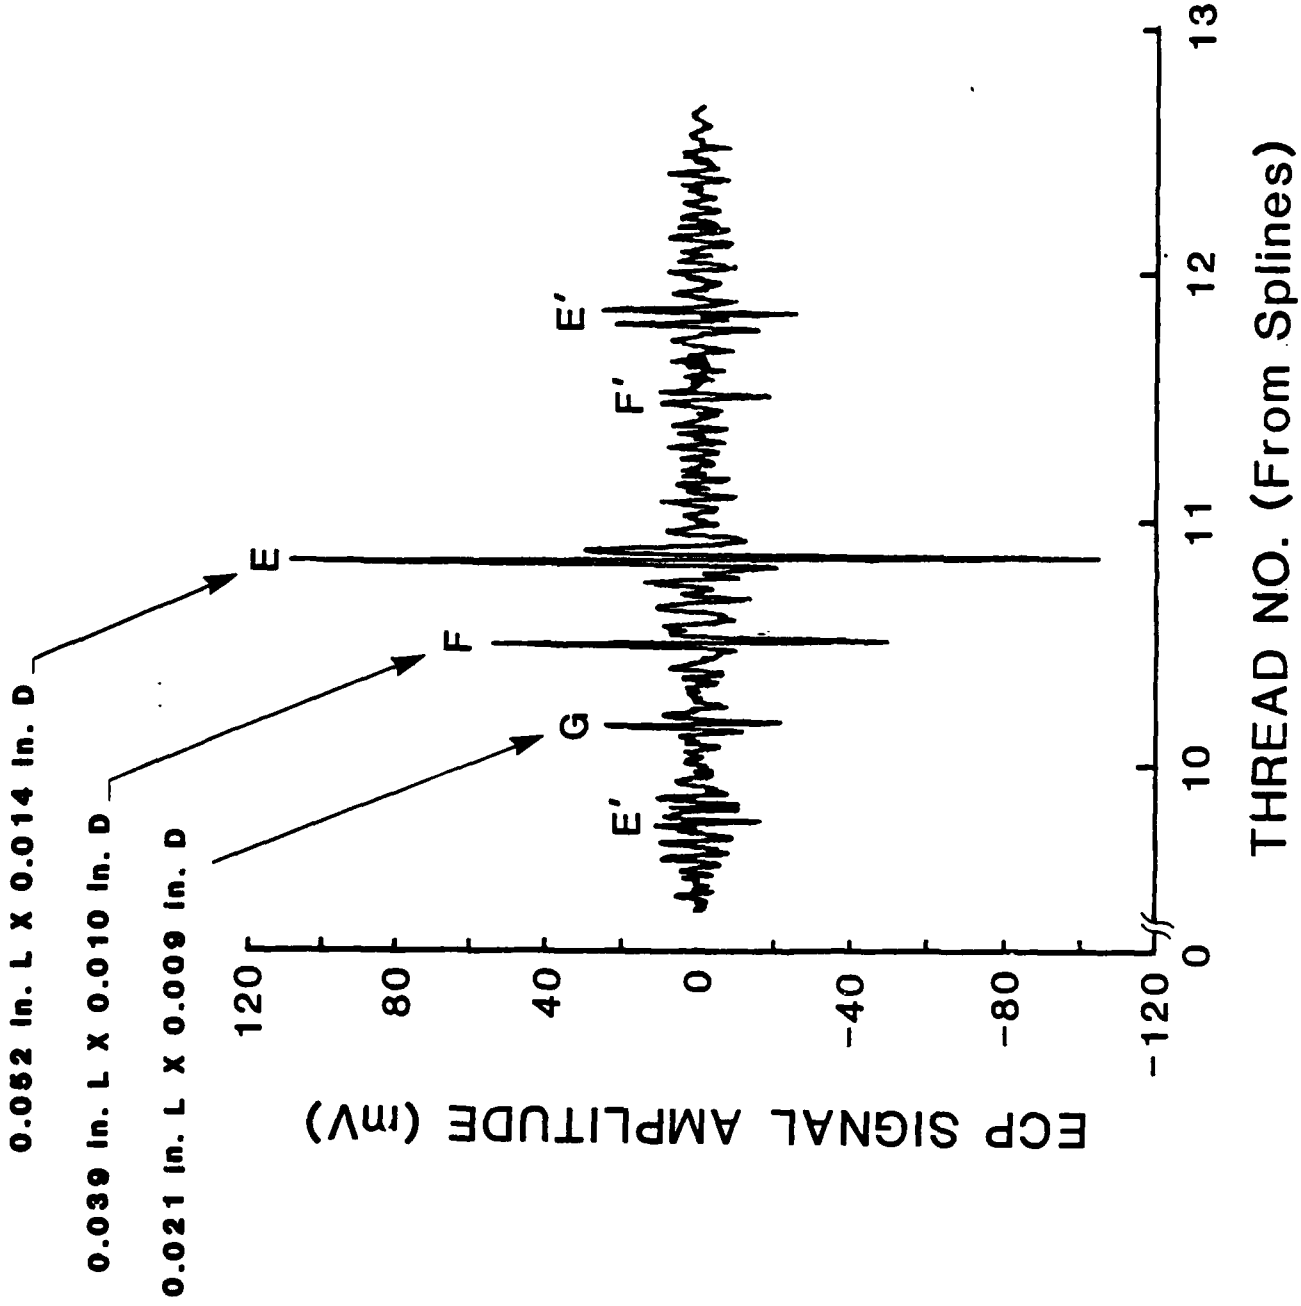
ECP data were initially obtained from "standard" specimen No. 1 (used in the previous project) to establish the laboratory setup. This spindle was of the older design (-102). Only the threads in the area of the flaws were scanned. ECP signals from artificial flaws E, F, and G in specimen No. 1 are shown in Figure 2. Distinct signals are obtained from all three flaws including the smallest (flaw G) which is 0.021 in. long x 0.009 in. deep. Note that satellite signals (E' and F') are obtained from the larger flaws (E and F) when the probe is located over adjacent threads. Flaw F (0.039 in. L. x 0.010 in. D.) gives a signal-to-background ratio greater than 2:1 when compared to the background signals from spindles 1 through 6.

FIGURE 2. ECP SIGNALS FROM FLAWS E, F, AND G IN SPECIMEN NO. 1. SIGNALS OBTAINED WHEN THE PROBE IS LOCATED OVER THE ADJACENT THREAD ARE DESIGNATED E', AND F'. FLAW DIMENSIONS ARE LENGTH X DEPTH.

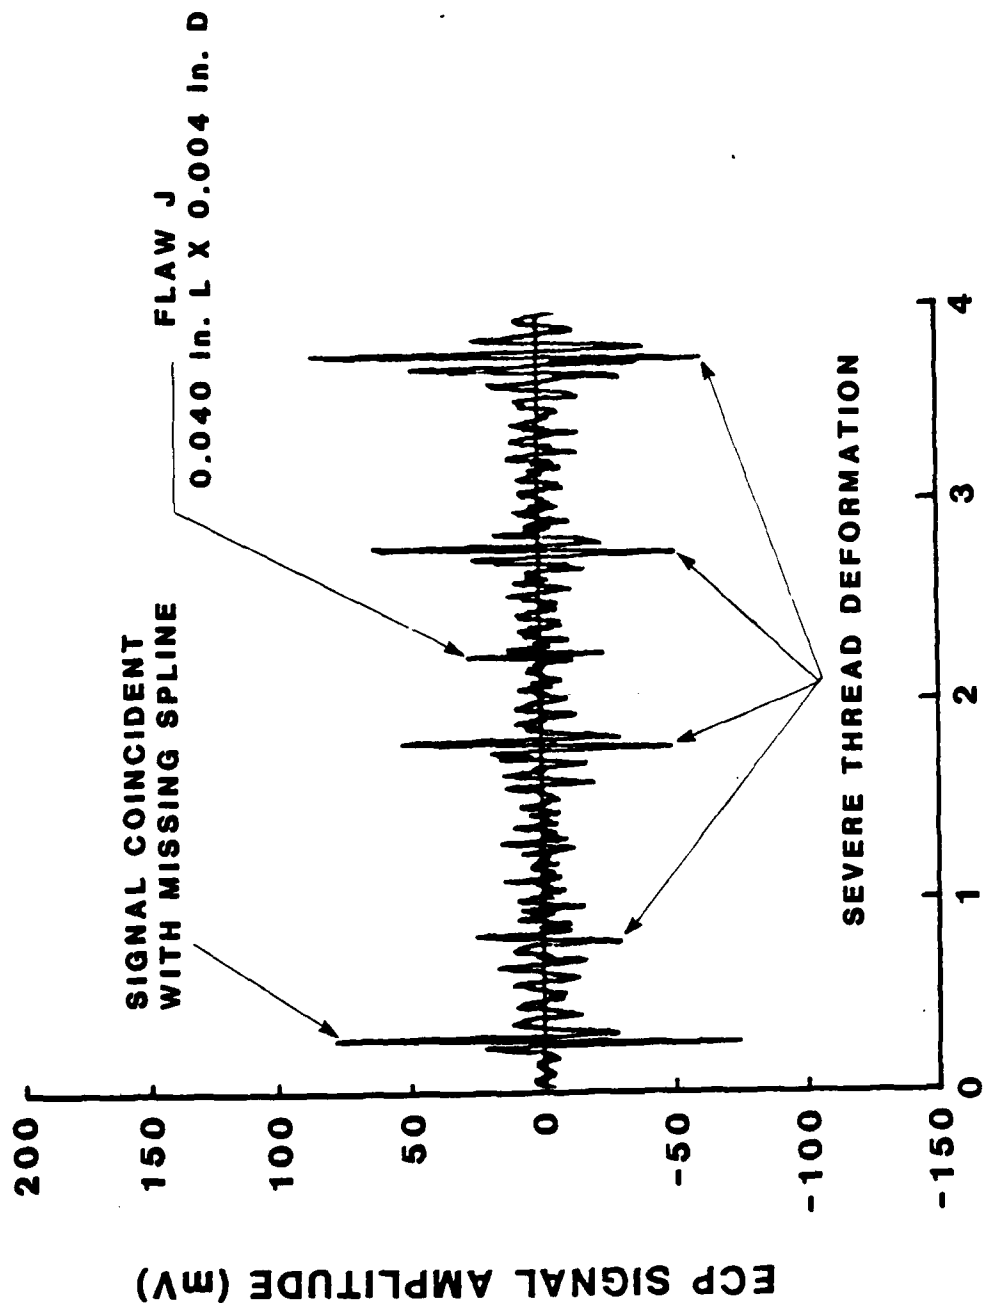
A flaw-like ECP indication was obtained in the first thread at a position corresponding to the missing spline (Figure 3). The source of this indication is not clear; however, it is unlikely that it is caused by a flaw since an indication was obtained at the same location on each of the spindles inspected. It is possible that the ECP probe is actually sensing the missing spline.

A signal from flaw J (0.040 in. L. x 0.004 in. D.) is also shown in Figure 3. Note that the signal amplitude from this flaw is slightly greater than the background signal level in regions where no flaws and no thread deformation are present. ECP signals from flaw K (0.040 in. L. x 0.015 in. D.) are shown in Figure 4. Note that a satellite signal, K', is obtained when the probe is positioned over an adjacent thread.

FIGURE 3. ECP SIGNALS FROM SPECIMEN NO. 2, THREADS 0-4

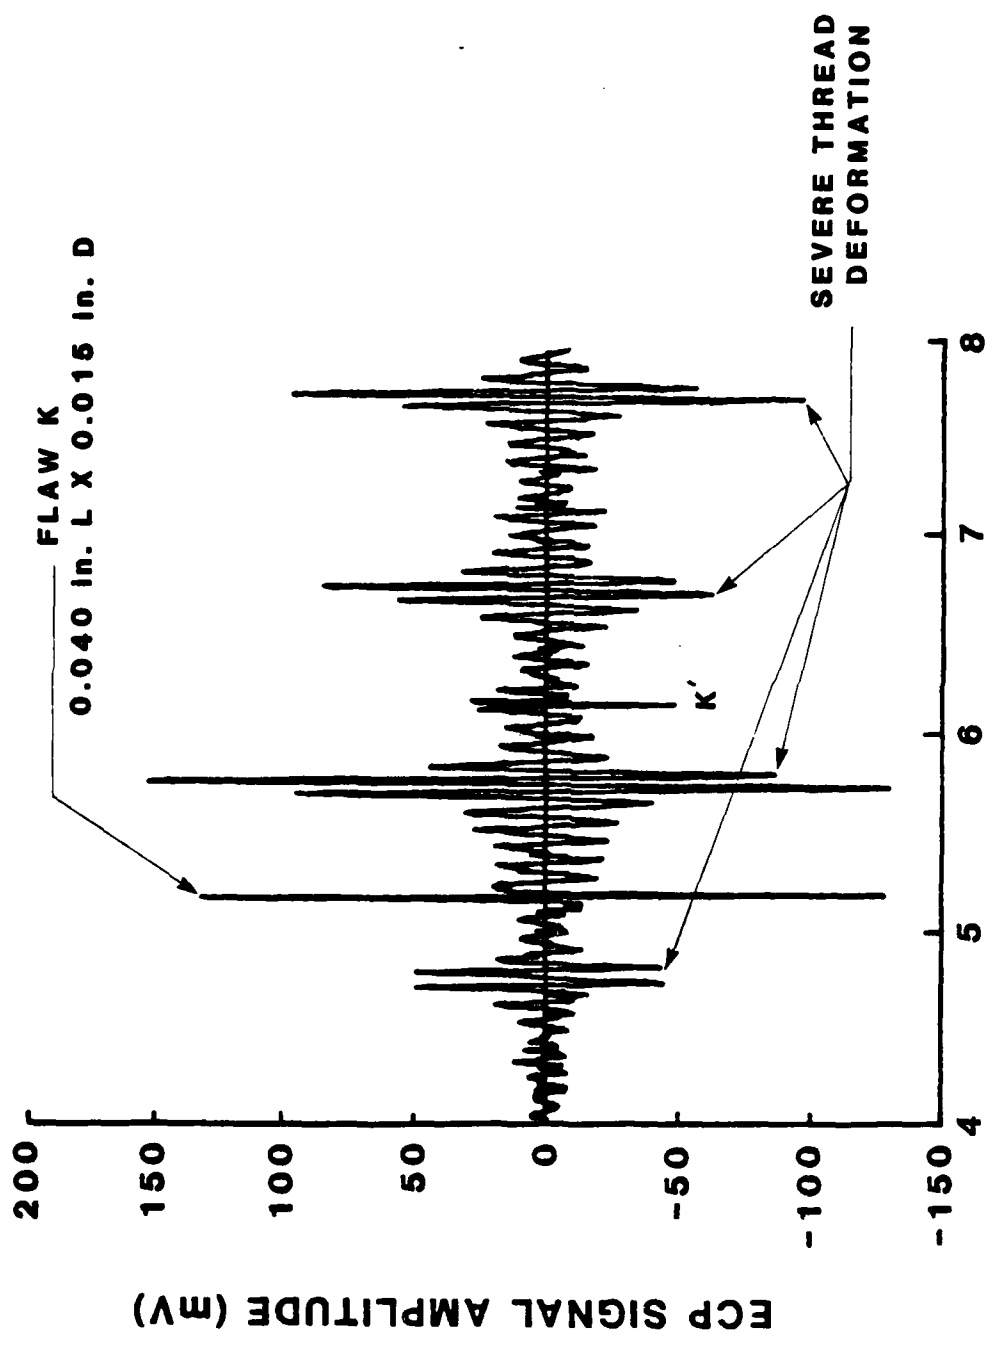
FIGURE 4. ECP SIGNALS FROM SPECIMEN NO. 2, THREADS 4-8

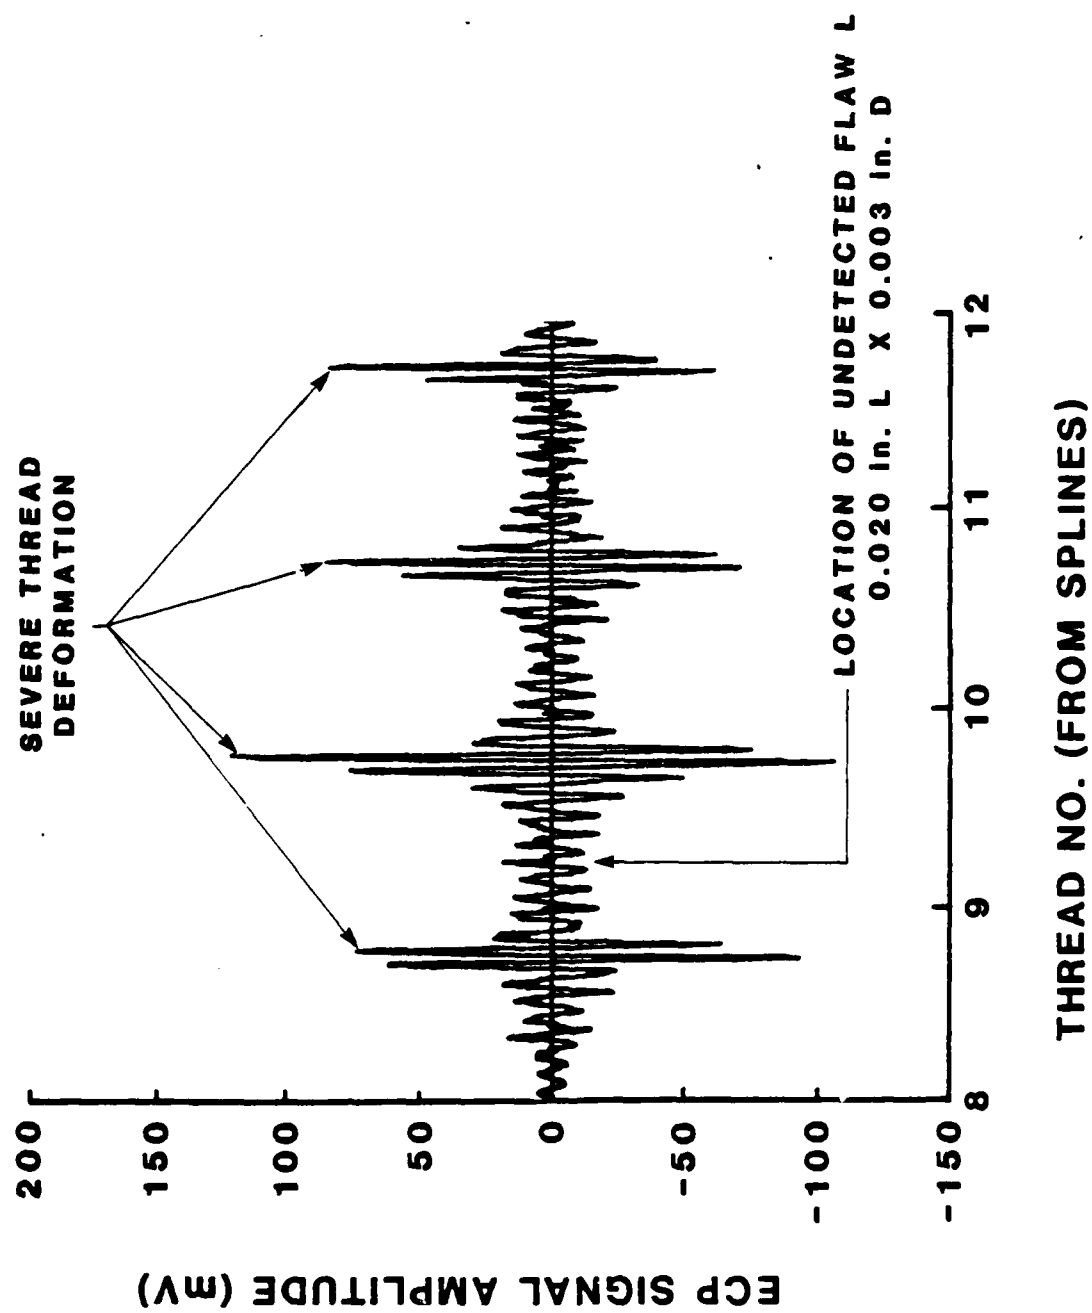
Flaw L (0.020 in. L. x 0.003 in. D.) was not detected (Figure 5). This is not surprising since this flaw is very shallow. Flaw M which is located in thread 15 near the end of the spindle is in a region where the background noise level is high due to mechanical vibration caused by the probe holder extending beyond the end of the spindle (Figure 6). Therefore, a signal from this flaw is not apparent. This problem could be corrected by re-design of the probe bearing block if it is necessary to scan all of the threads. Because of this problem, the last thread was not scanned in all of the spindles.

FIGURE 5. ECP SIGNALS FROM SPECIMEN NO. 2, THREADS 8-12

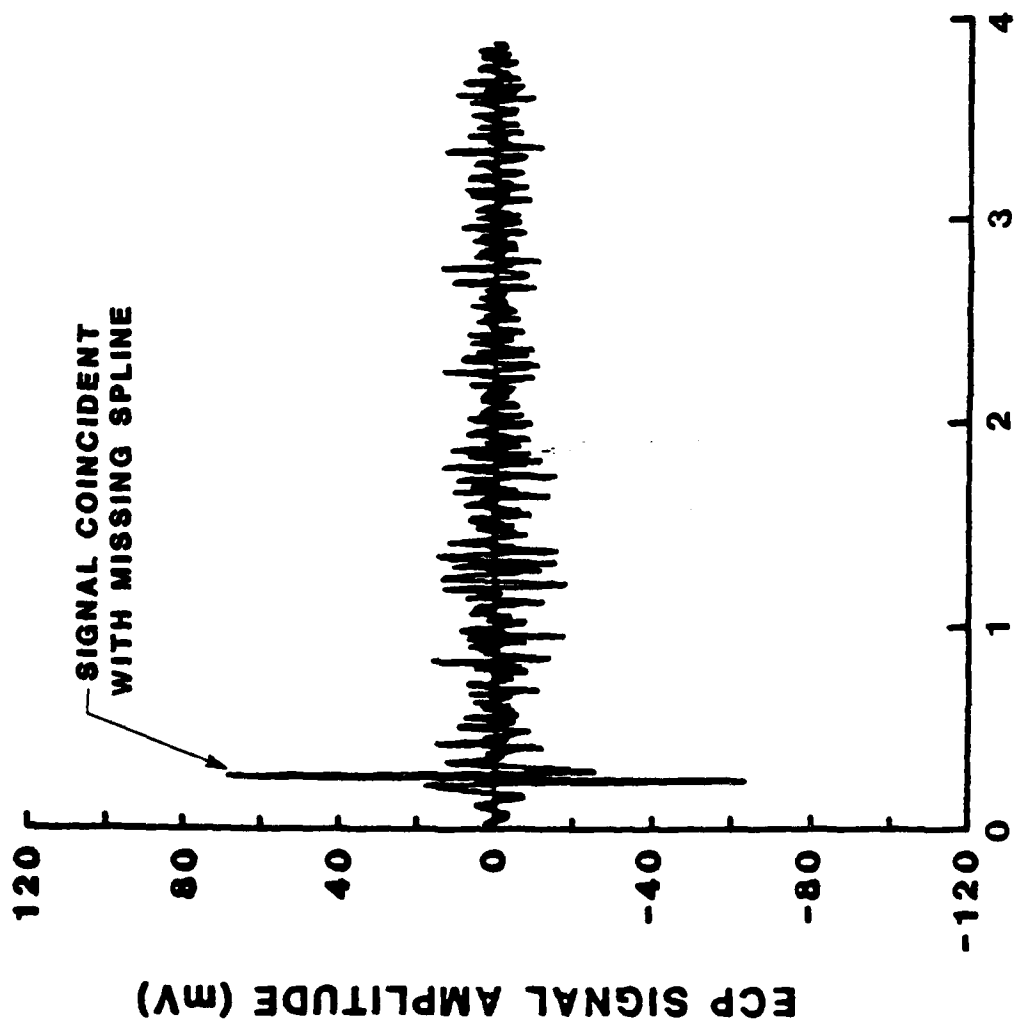
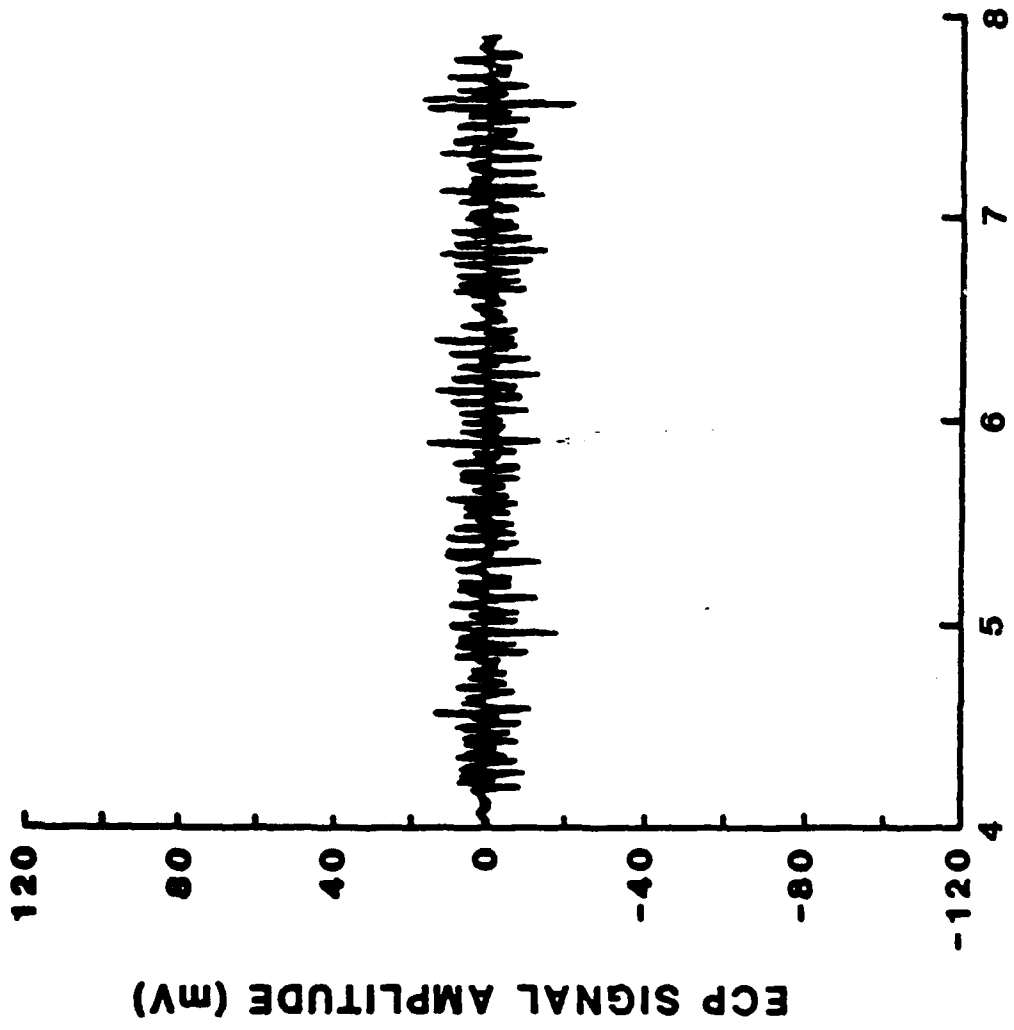
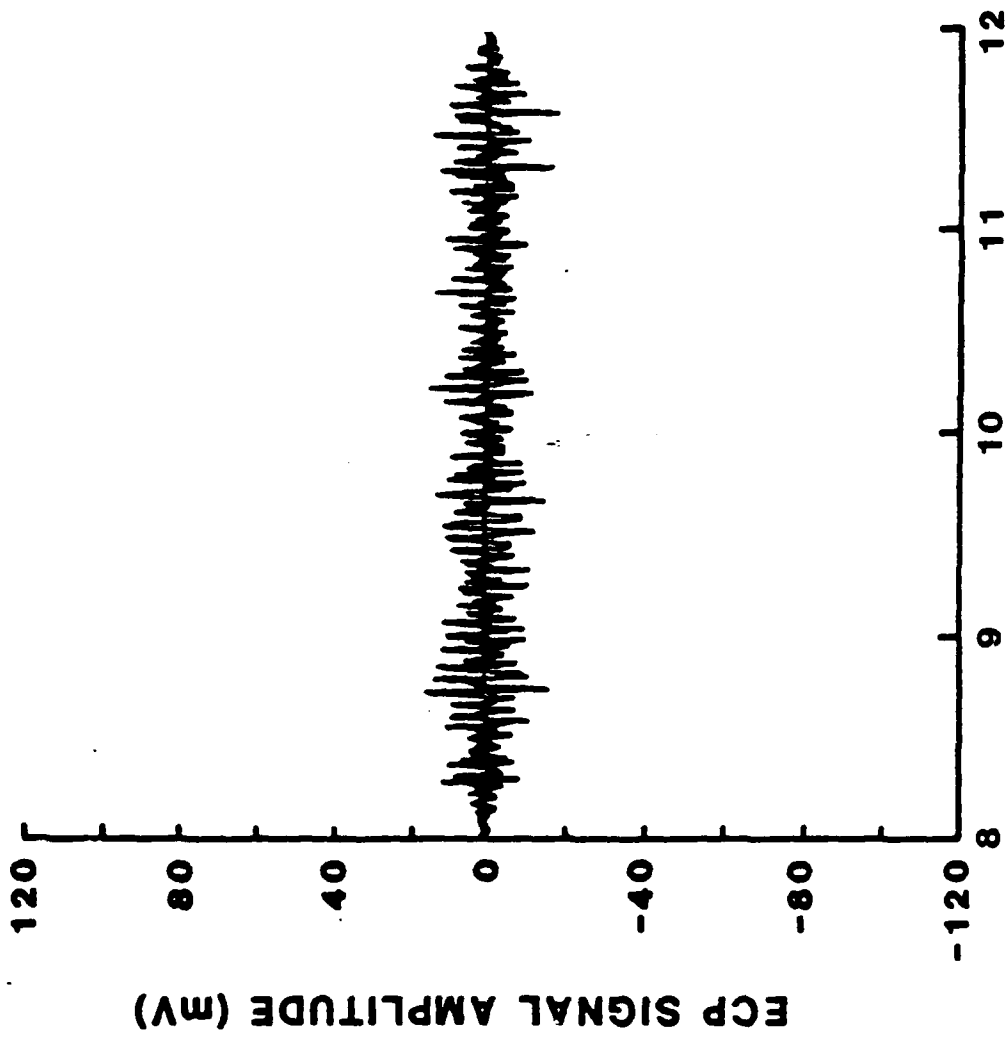
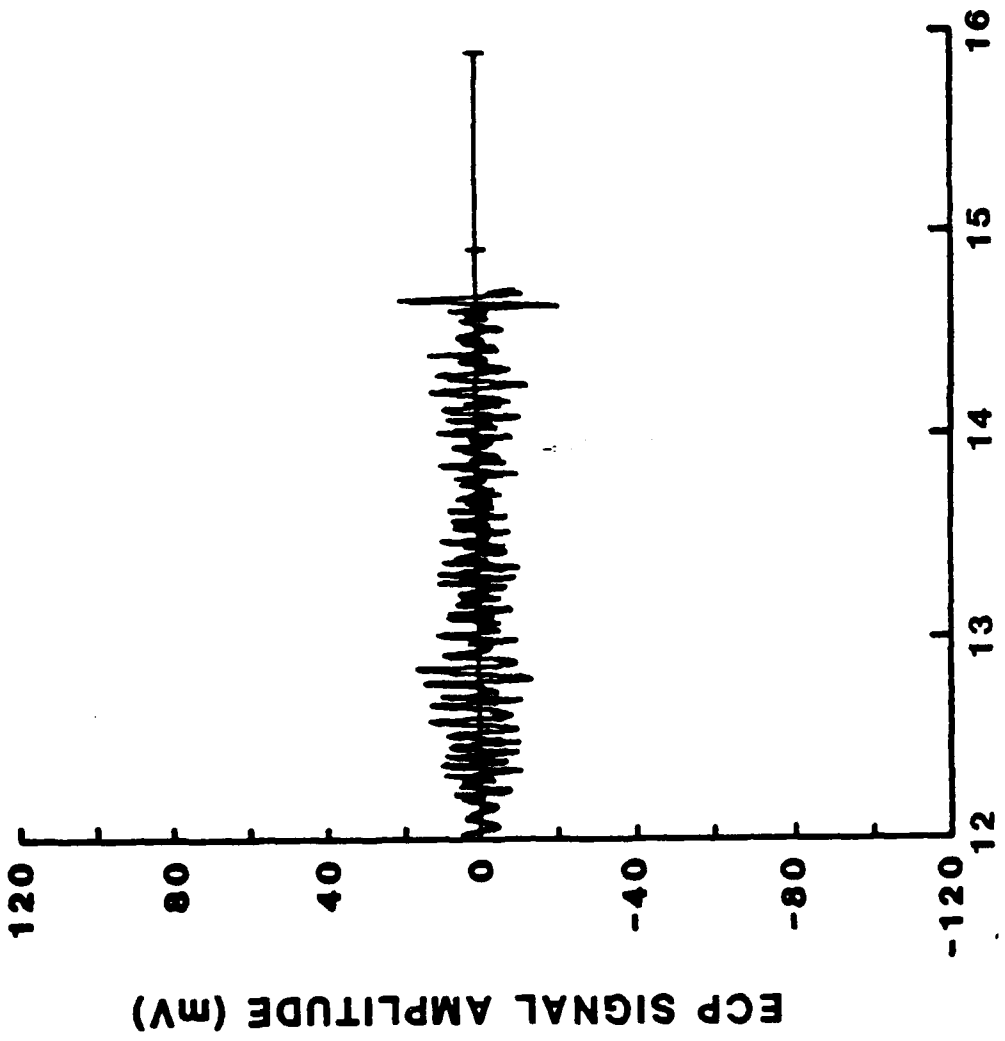
as to the location and other details of the indications; however, the indication was apparently from well below the thread root surface which would indicate that it most likely was not caused by a fatigue crack. No ECP indications were obtained from this spindle except for the signal coincident with the missing spline which was observed on the other spindles as well. The ECP data from spindle No. 3 are shown in Figures 7 through 10. Note that the vertical scale has been expanded compared to Figures 3 through 6. The signal coincident with the missing spline is evident in Figure 7. The background signal level from the remainder of the spindle is relatively uniform and no distinct flaw indications are evident.

Provided an actual subsurface flaw exists as indicated by the ultrasonic inspection, the ECP probe used here would not necessarily be sensitive to it since the probe is designed for detection of surface and slightly subsurface flaws. A metallurgical analysis to determine the source of the ultrasonic flaw indication is apparently planned by Sikorsky Aircraft.

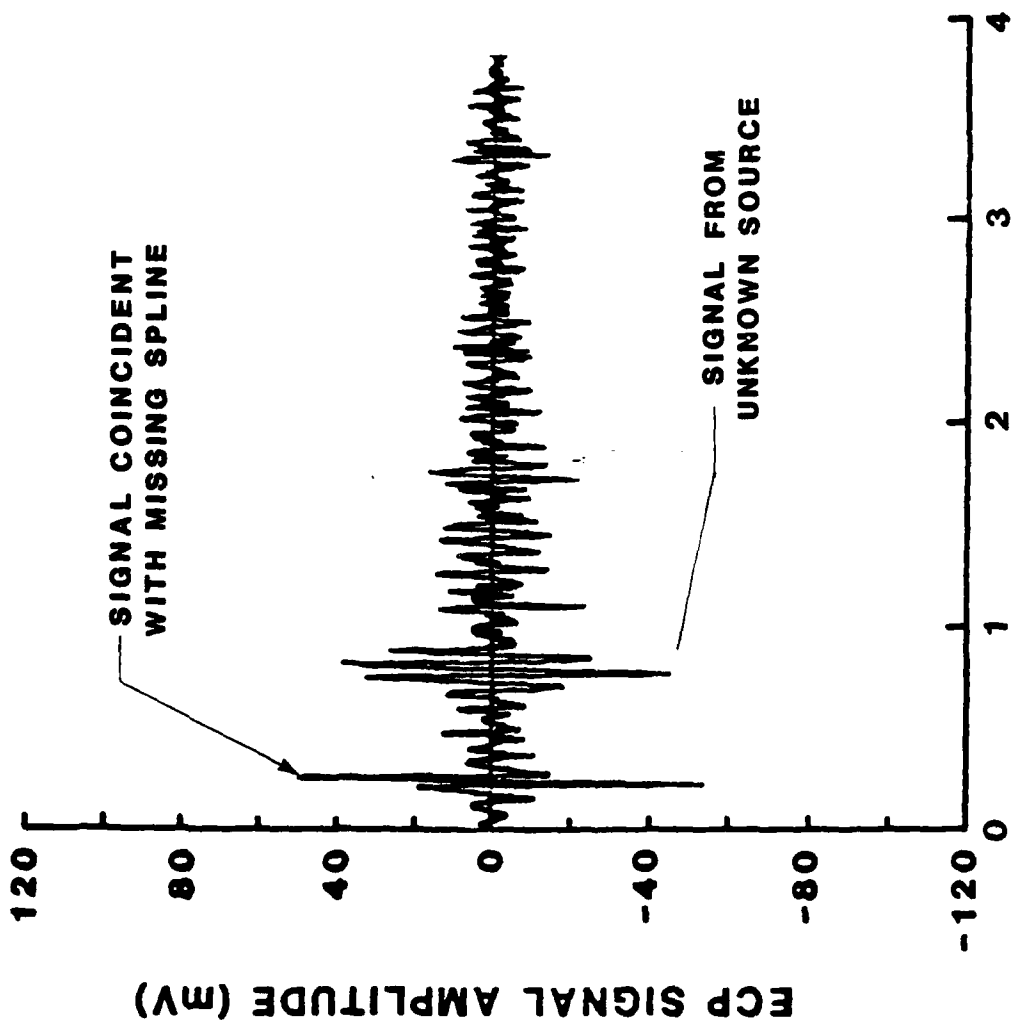
The ECP data from spindle No. 4 which has 12.6 service hours are shown in Figures 11 through 14. This spindle contained a tierod and no effect of the rod on the ECP signal could be determined. A small indication, slightly above background signal level, was obtained in the first thread as shown in Figure 11. The source of the indication was not identified since this was beyond the scope of the project. A comparison with Figure 2 shows that the signal amplitude from this indication is slightly smaller than the ECP signal from a 0.039 in. L. x 0.010 in. D. artificial flaw. No other flaw indications were obtained from this spindle.

FIGURE 11. ECP SIGNALS FROM SPECIMEN NO. 4, THREADS 0-4

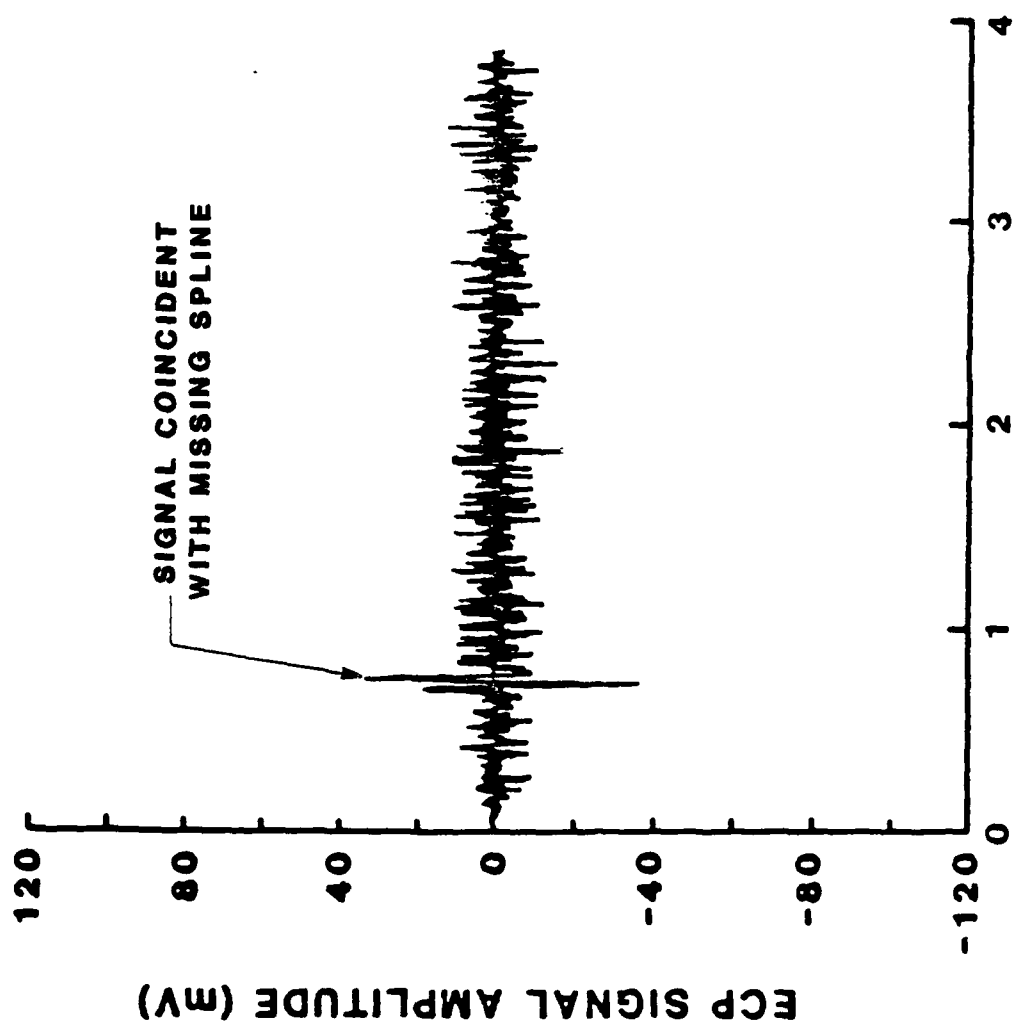
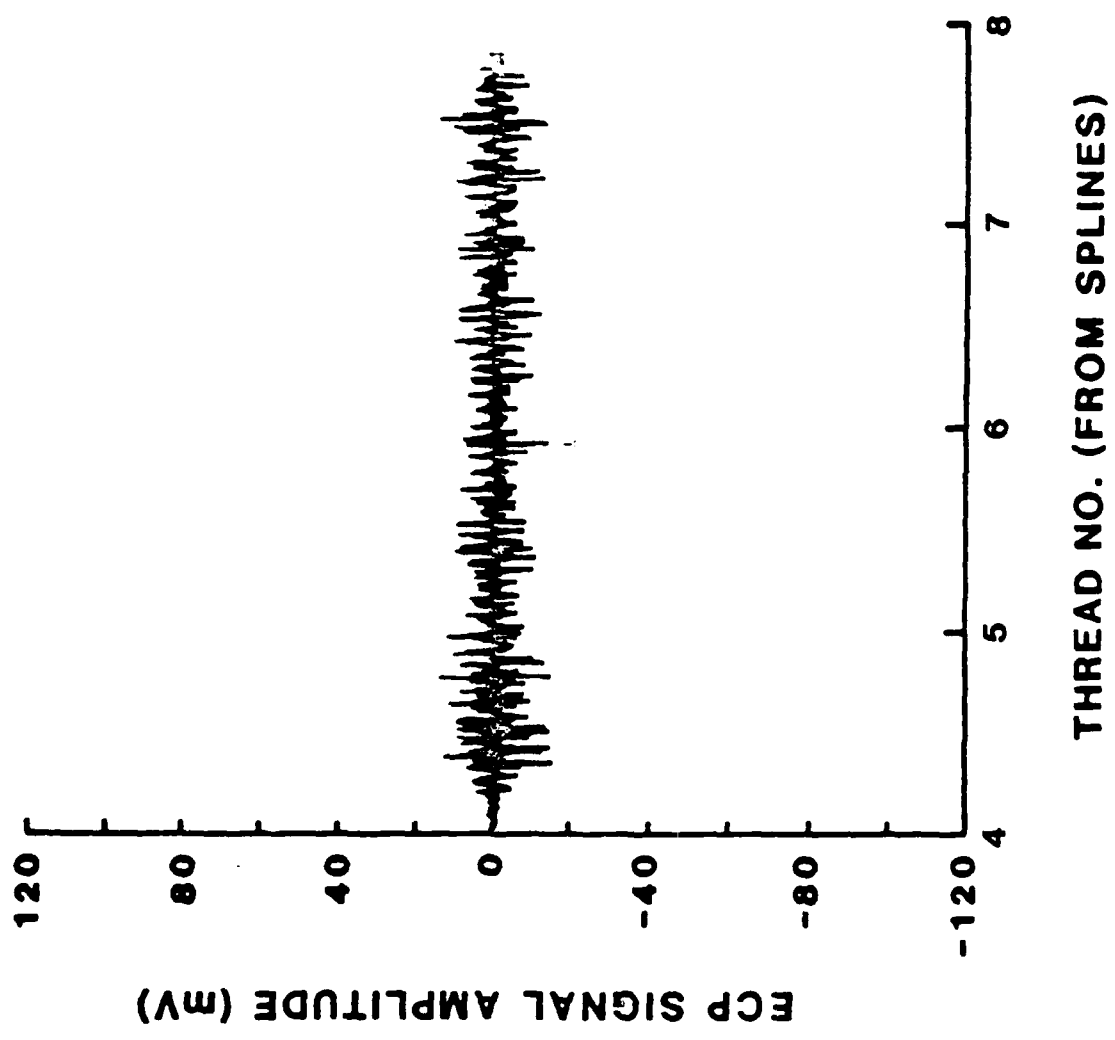
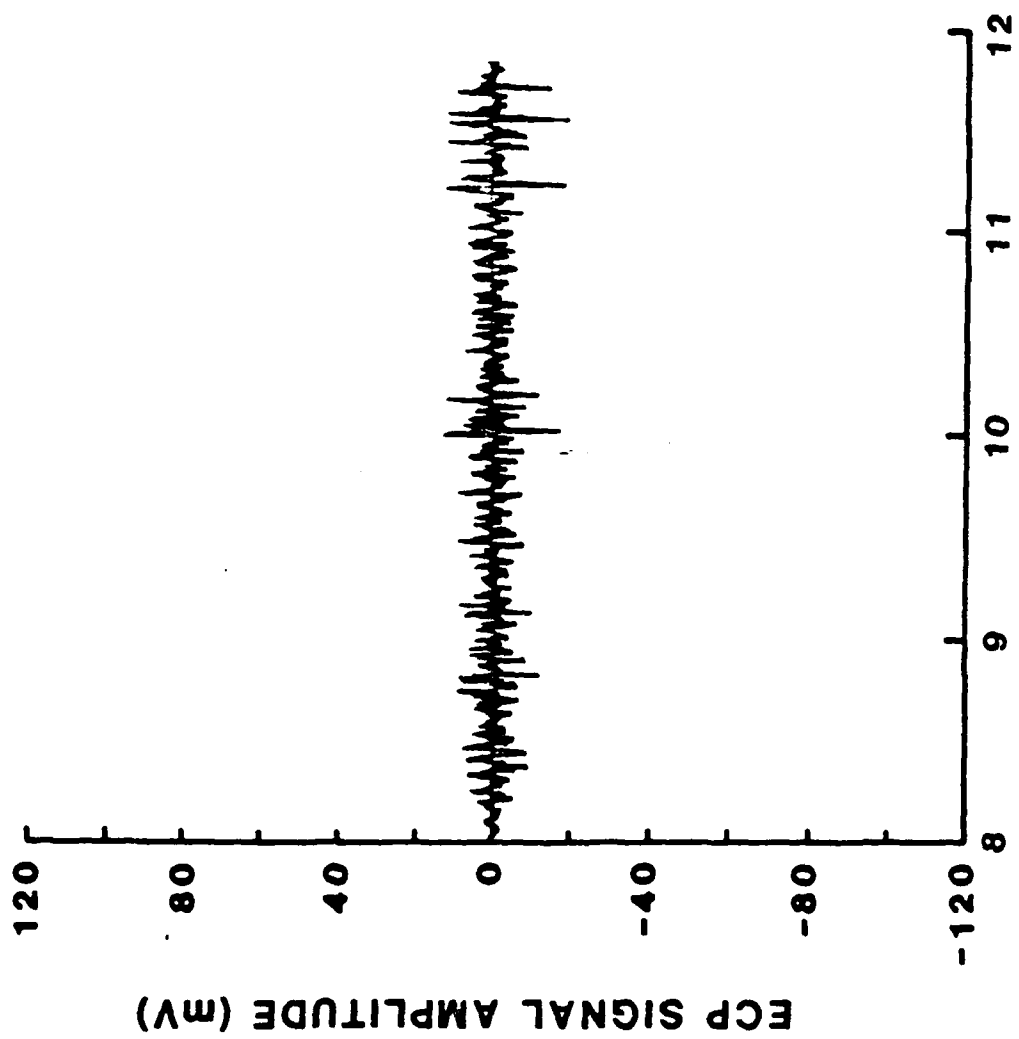
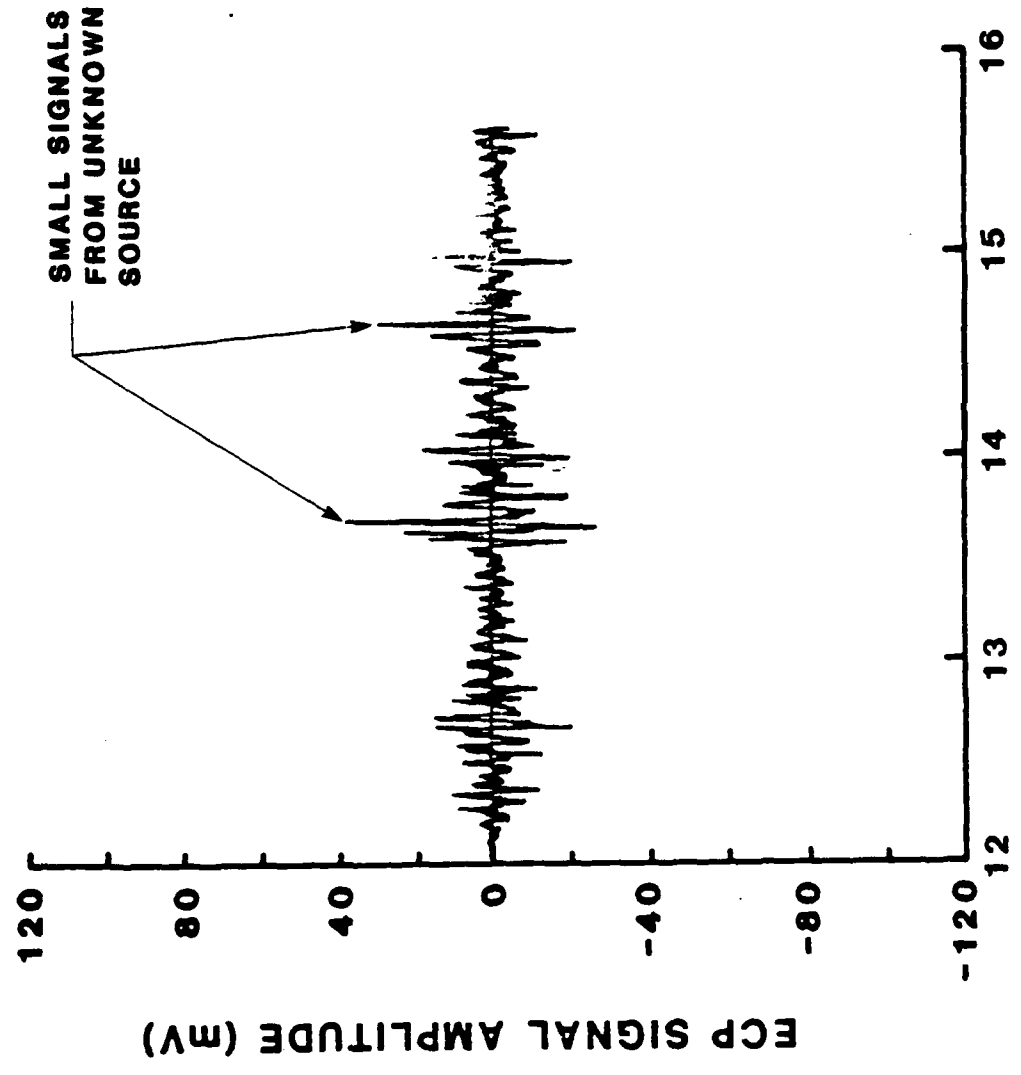
ECP data from specimen No. 5 are shown in Figures 15 through 18. Very small indications, slightly above background signal level, were obtained near the end of the spindle in threads 13 and 14. The angular location of these indications correspond with the location of the "0" stamped on the end of the spindle. The source of these indications was not determined.

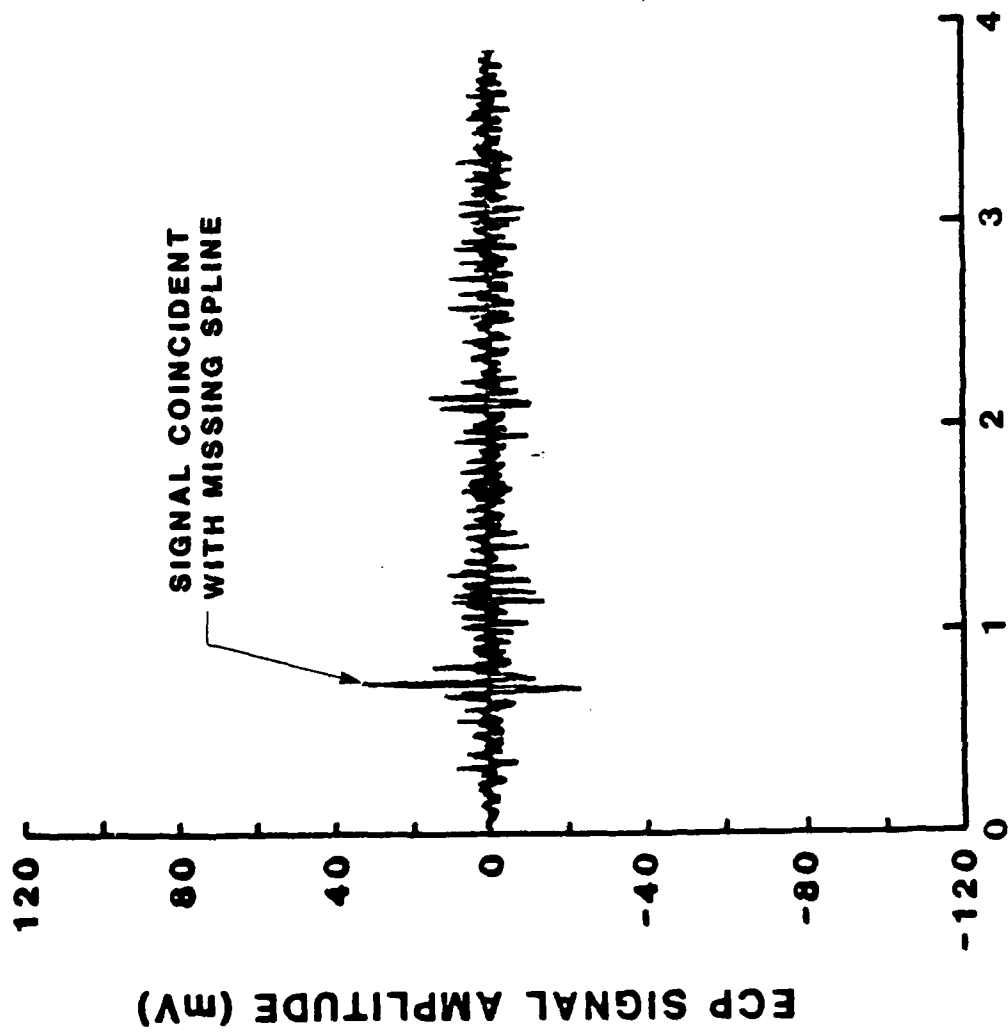
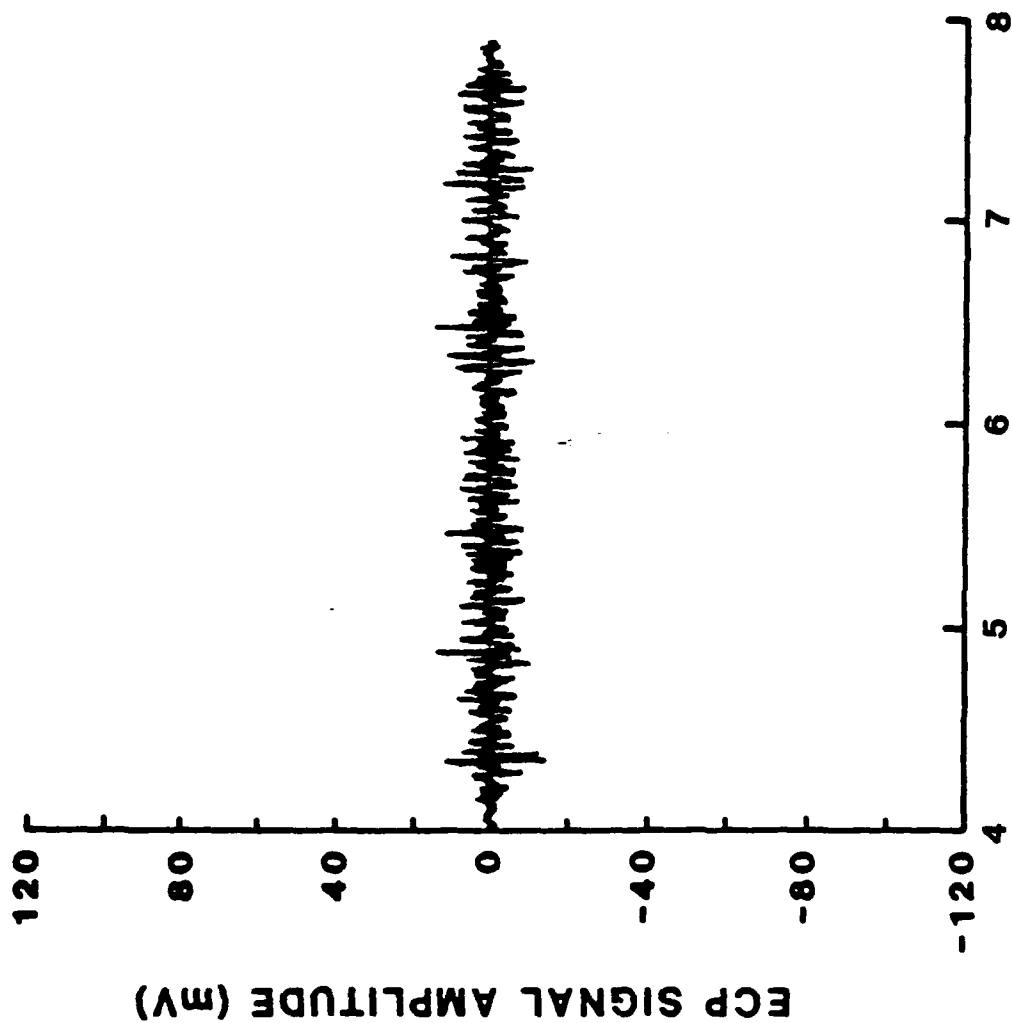
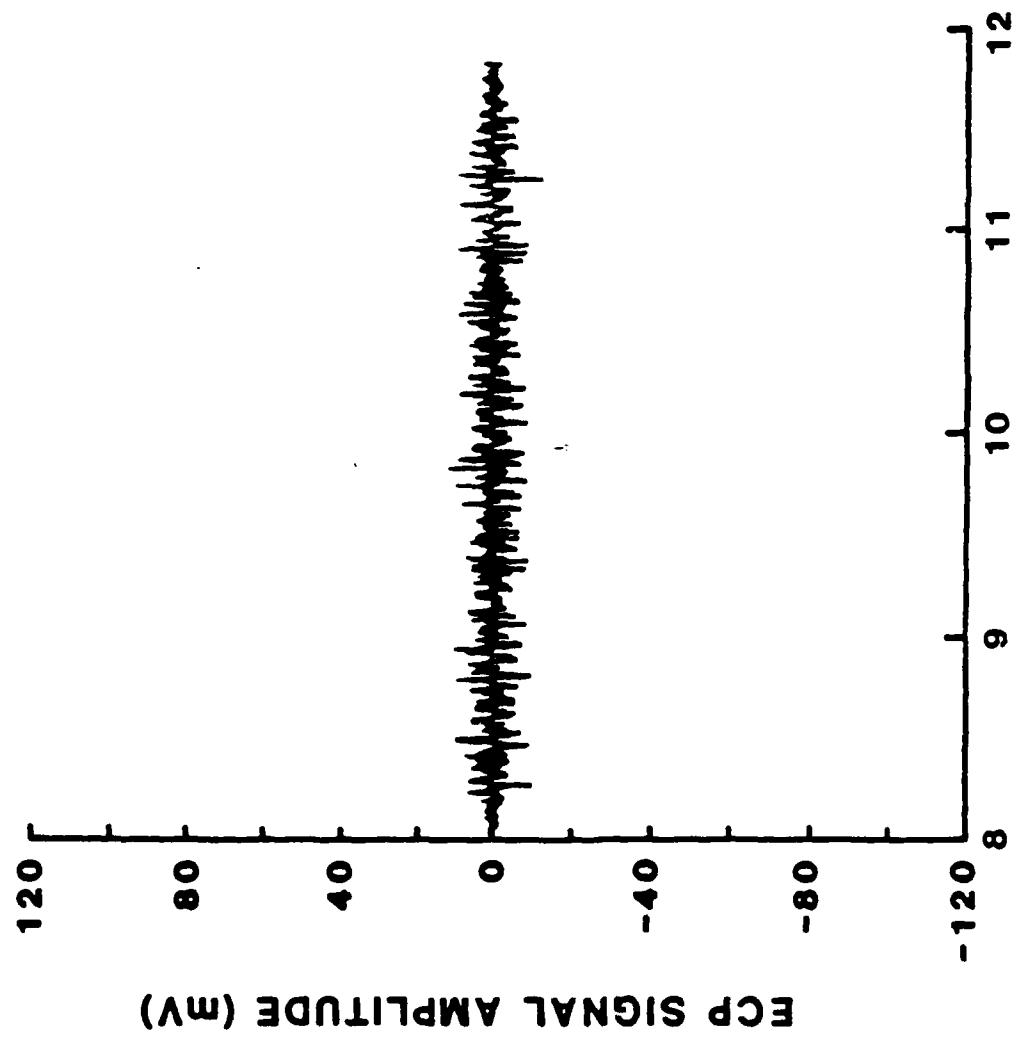
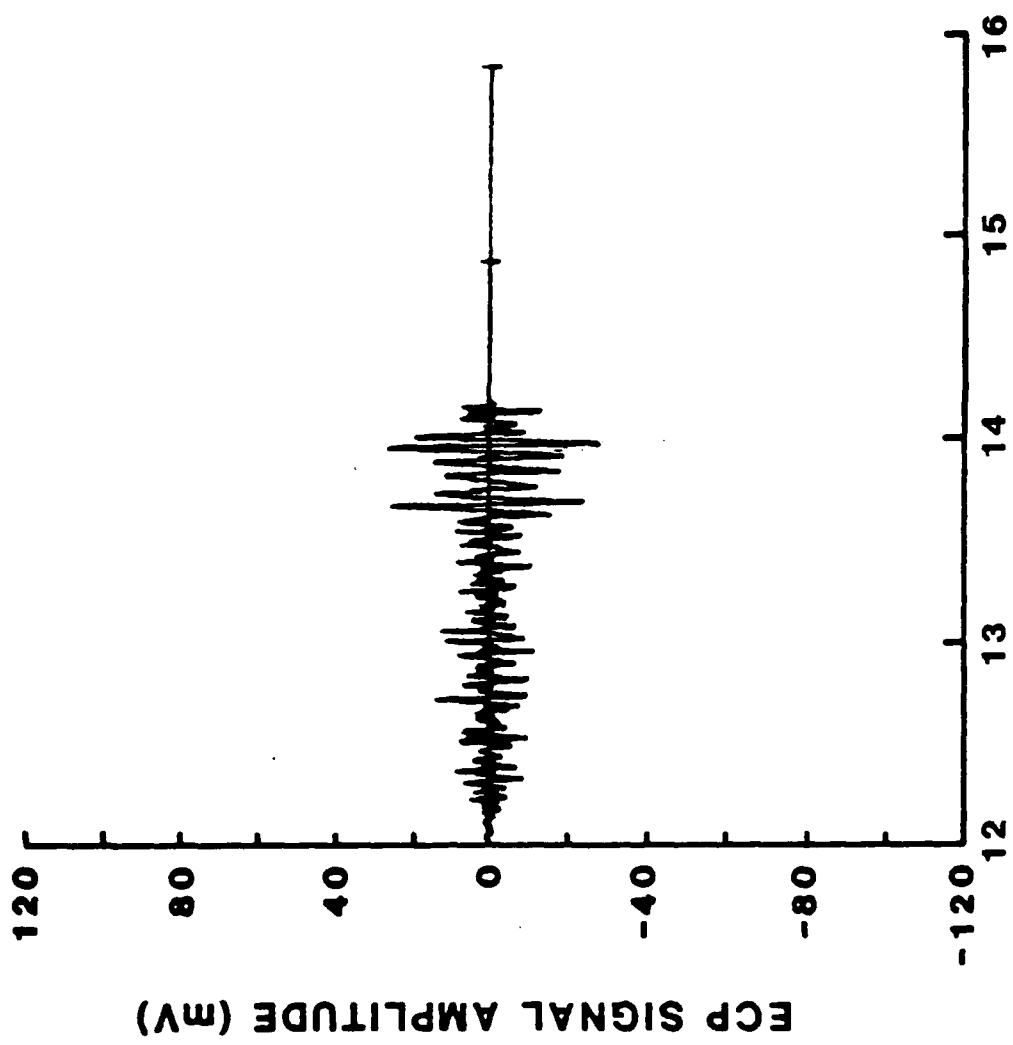
The ECP signals from specimen No. 6 are shown in Figures 19 through 22. No distinct flaw indications are evident in these data. The slightly higher background level in thread No. 13 was apparently caused by mechanical noise due to the probe holder extending beyond the end of the part.
