Aero Propulsion Technical Memorandum 440

**AN INVESTIGATION INTO LOW FUEL PRESSURE WARNINGS**  
**ON A MACCHI-VIPER AIRCRAFT (U)**

by  
D.E. Glenny

May 1988

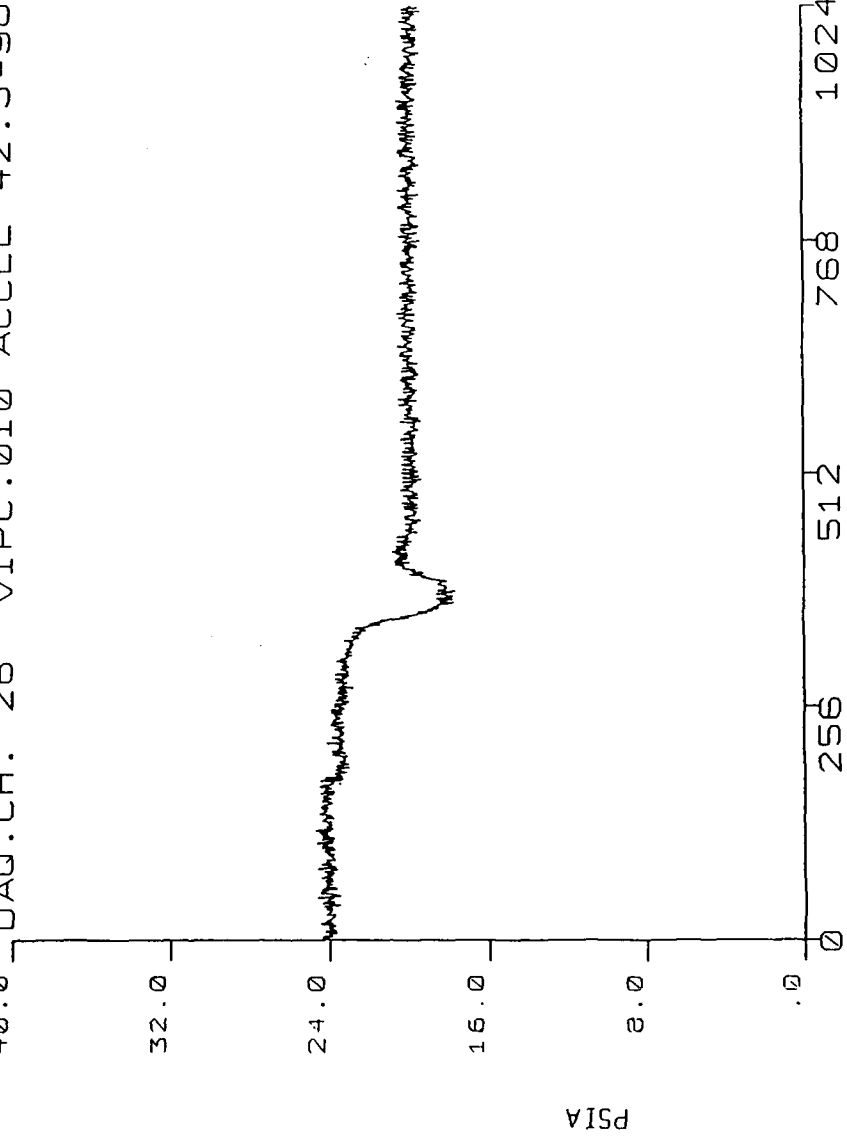
FIGURE 3

An analysis of the data acquired from block VIPC.010 indicates that the minimum pressure level as recorded by the transducer located downstream of the fuel filter was 17.3 psia or 2.6 psig. The level as indicated in Figure 3 occurred during the transient or acceleration phase, and was sufficient to activate the low pressure warning light. The pressure switch is normally set to a differential of between 2.5 - 3 psi. Partial illumination\* of the light is indicated in Figure 4. More definite results for light illumination will be seen later in the analysis of the rough handling tests. The effect of the HPFP in "sucking down" or reducing pressure levels in the low pressure fuel line, especially during the acceleration phase, can be seen in Figures 5, 6 and 7 for different locations in fuel supply line. An "impulsive" drop in pressure of the order of 6 psig from the steady state idle values (or 2 psig below the final steady state value) is readily apparent. The pressure level then rises to a level consistent with operation at maximum engine speed. It is this transient reduction in low fuel pressure levels that is responsible for the warning light illumination, and not operation at any given steady state engine speed. The fuel flow response, consistent with the output from the HPFP, is given by the traces of Figure 8. The signal, at low fuel flow rates, exhibits considerable noise due to the low frequency signal from the turbine impeller. Unfortunately the engine speed signal was incorrectly connected and no records were available. From Figures 3, 5 and 6 it is immediately apparent that the delivery pressure from the low pressure boost pump is low. At an engine speed of 42.5% with minimum demand from the HPFP the level is about 24.7 psia or 10 psig; it is not known, at this stage, what minimum acceptance value is specified in the maintenance manual. It should be noted that overall pressure levels in the low pressure line are dependent, not only on the boost pump performance and pressure drops in the fuel pipes and filter but are also dependent on the suction demand imposed by HPFP during acceleration, or transient operation. The steady state suction values are highly dependent upon engine speed; at 100% the low fuel pressure level is 19.8 psia or 5.1 psig, just on the limit recommended in the maintenance manual. Operation in this condition gives only a 2.1 psig margin for light illumination, if the pressure switch is set at 3 psig, and gives little scope for extra pipe or filter losses when the suction demand or depression from the HPFH is imposed on the low pressure fuel system during rapid accelerations.

PRESSURE, FILTER OUTLET

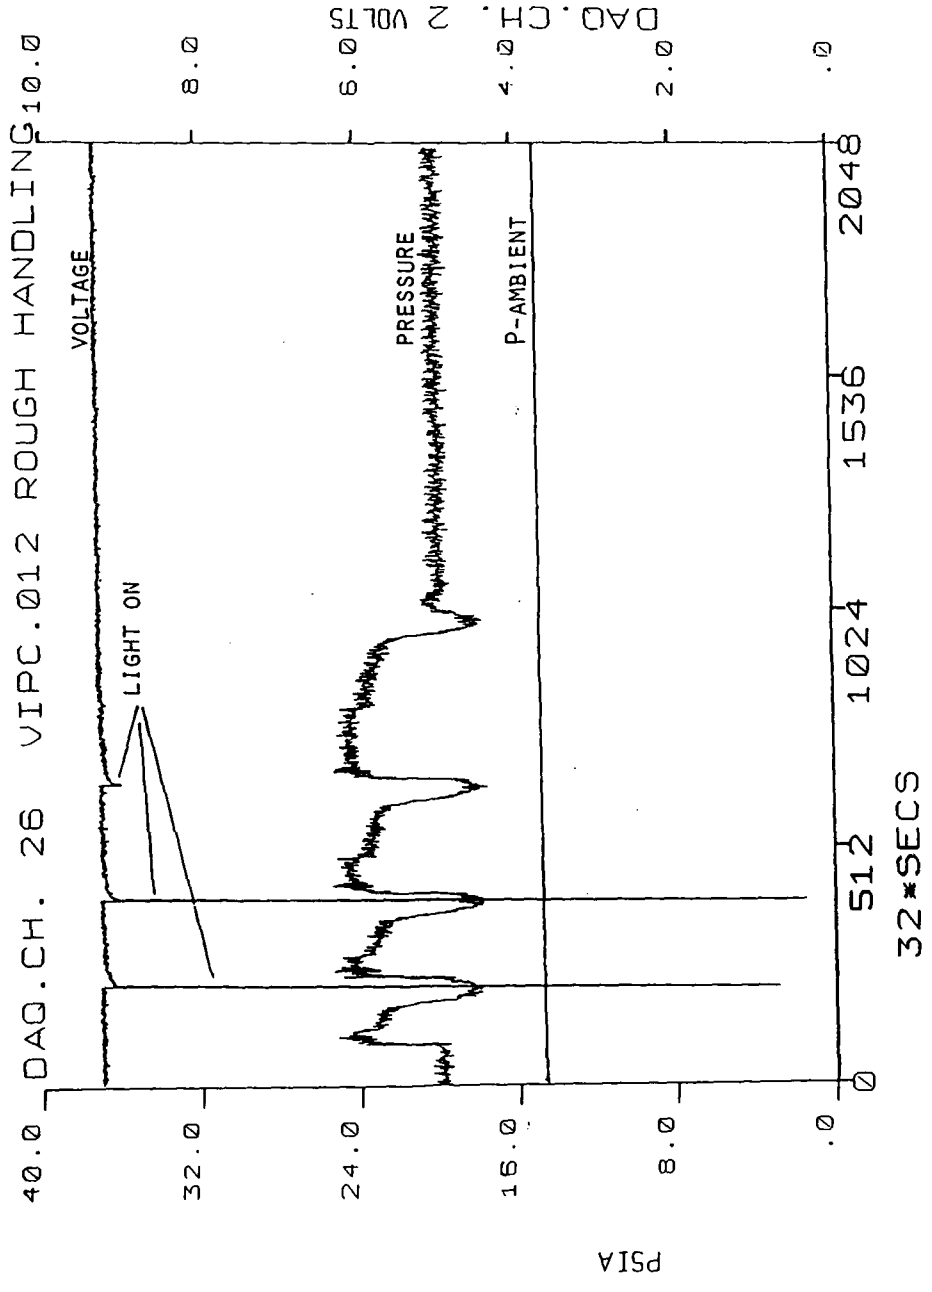
FIGURE 9

The performance of the low pressure fuel system can be seen more dramatically in the results for the rough handling tests. Composite pictures for fuel pressure levels after the filter and HPFP, light illumination and ambient pressure, are given in Figures 9 and 10. Immediately apparent are the small operating margins, 2.5 psig, under which the fuel system operates and the poor low pressure fuel pump performance on aircraft A7-097. There is also no doubt about the coincidence of light illumination and the low fuel pressure levels. Data output for the remaining channels recorded during the tests are given in Figures 11 - 15, Figures 13 and 14, in particular, indicate that the low fuel pressure warning light illumination is not

FUEL FILTER EXIT PRESSURE & CAUTION LIGHT VOLTAGE

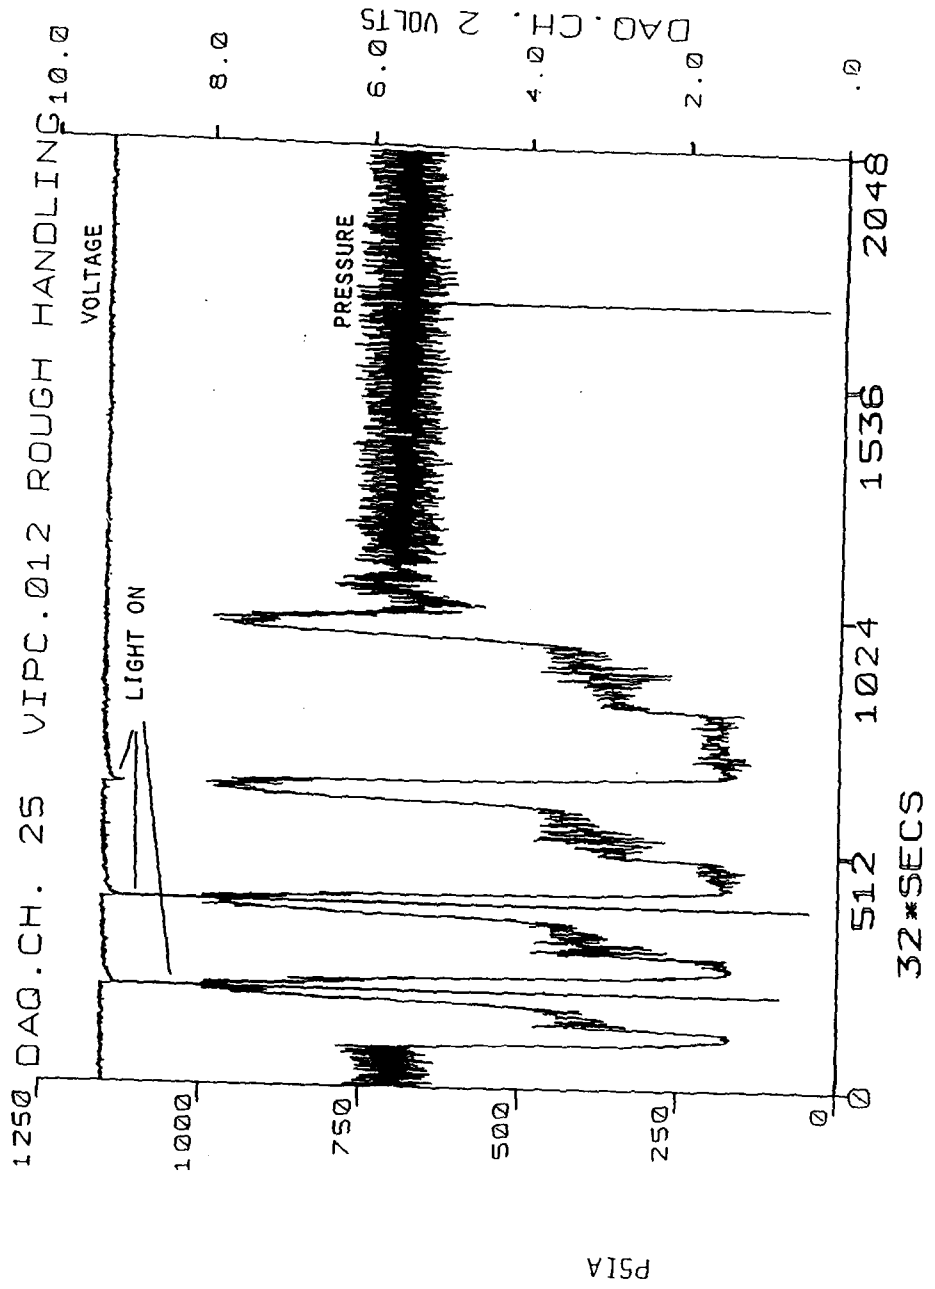
FIGURE 10

HIGH PRESSURE PUMP OUTLET PRESSURE & CAUTION LIGHT VOLTAGE

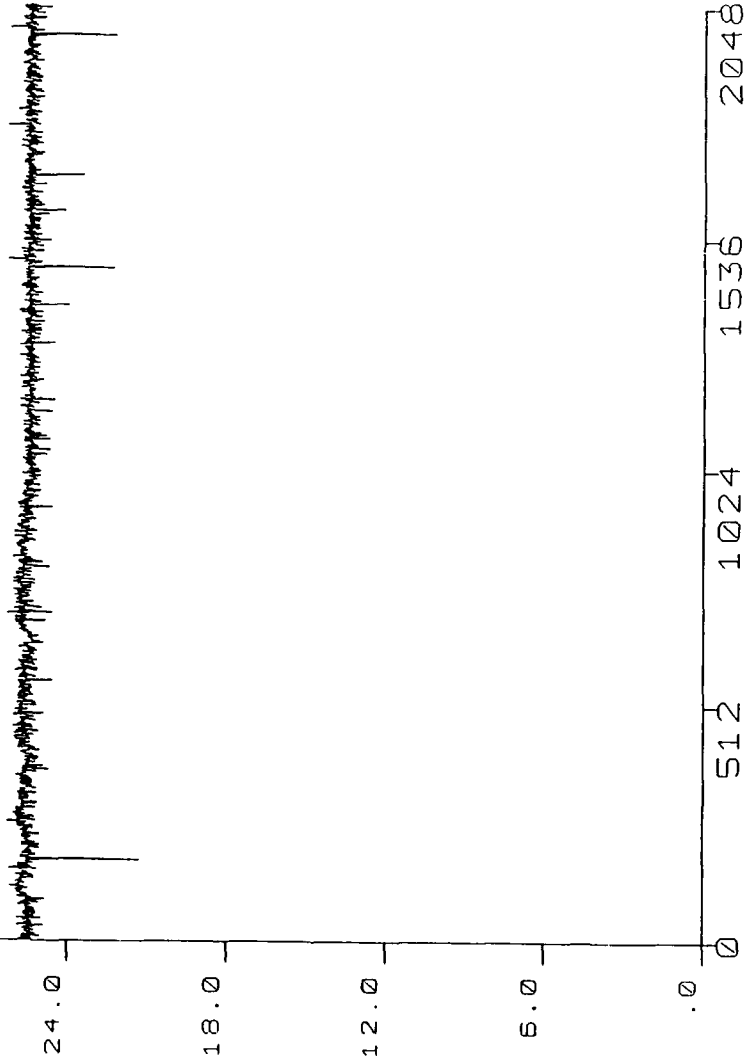
FIGURE 13

related to a variability in boost pump voltages, or stray voltages at the solenoid valve resulting in its unscheduled closing.

BOOST PUMP VOLTAGE

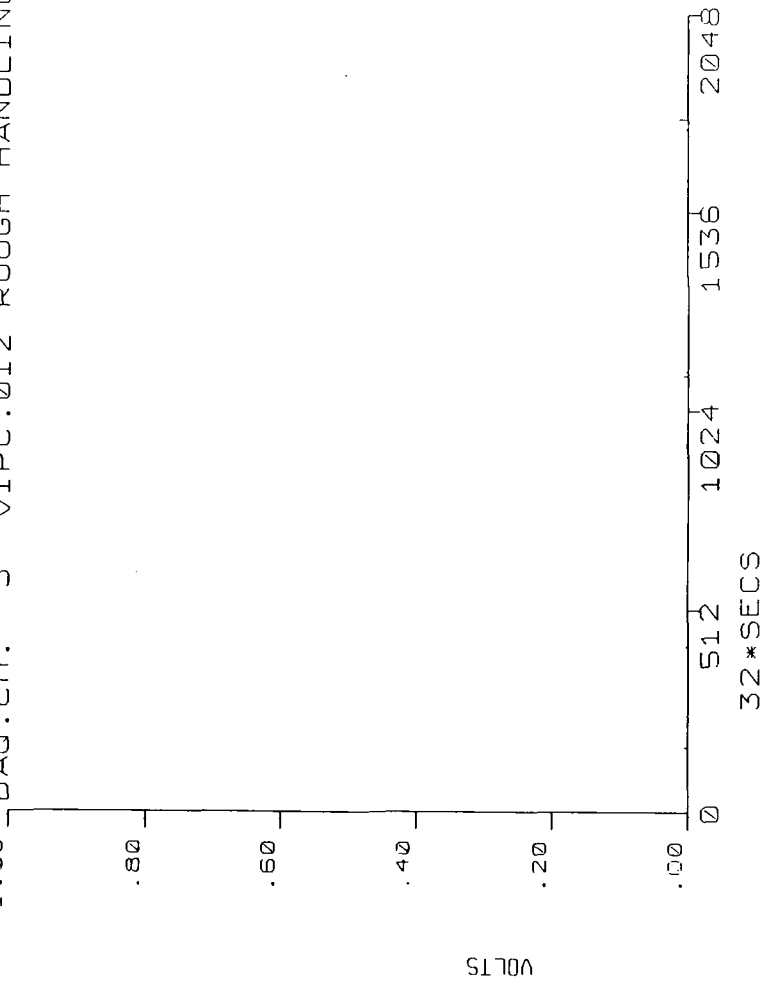
FIGURE 14

SOLENOID VALVE, "STRAY" VOLTAGES

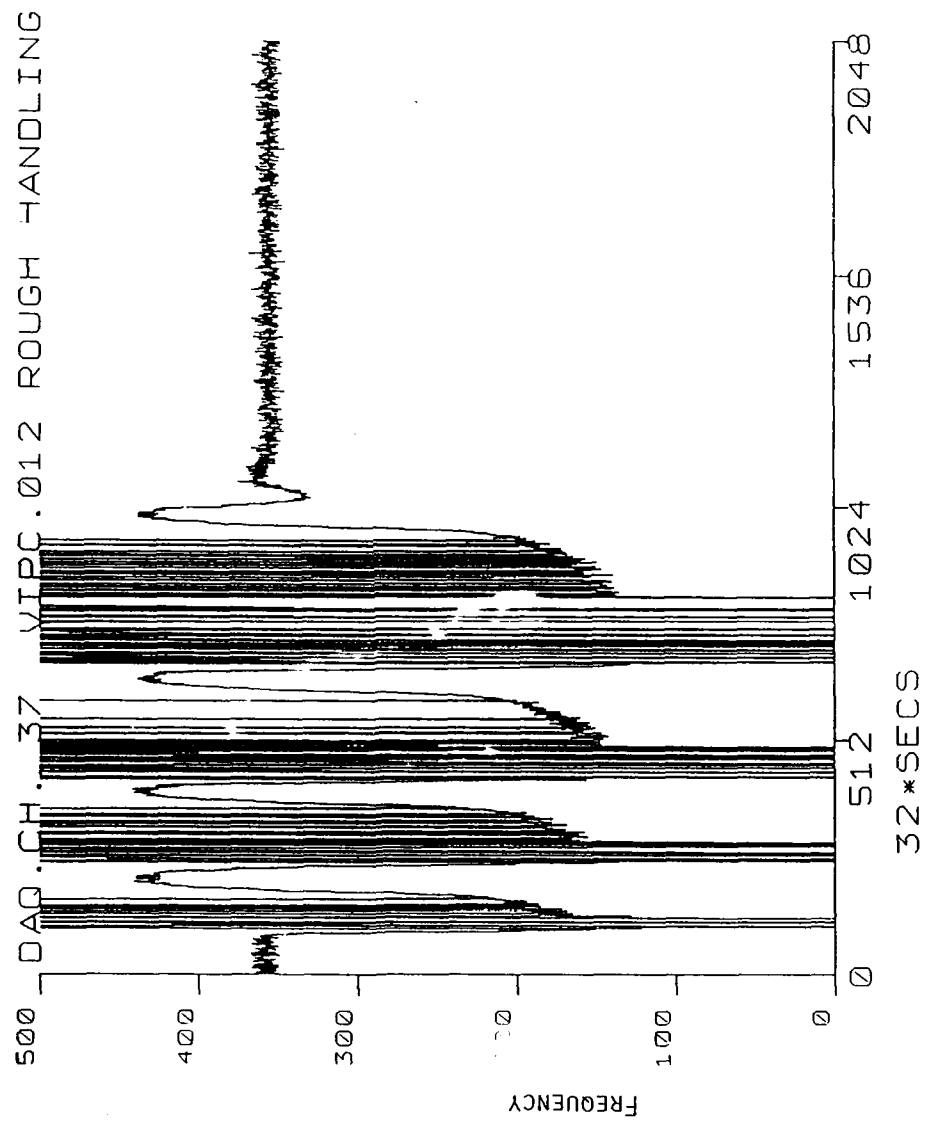
FIGURE 16

A direct comparison of the differences in the low pressure fuel system performance of aircraft A7-11 and A7-097 can be seen in Figures 16 and 17, in which a superposition of pressure levels after the filter and HPFP has been made for similar controlled accelerations. The difference in low pressure pump supply, and delivery levels after the filter for both aircraft, Figure 16, is self evident, whilst for all purposes the pressure drops across the filters are equal. There is little difference in the relative performances of the HPFPs, Figure 17, notwithstanding the different (low pressure) inlet conditions. There are however minor differences in signal to noise ratios and acceleration times for both sets of traces, but considering the relatively crude and hurried test procedures used, on the tarmac at RAAF Base East Sale, this was to be expected. A more direct comparison of data could have been made if a power level angle (throttle) position or rotor rpm record had been acquired. More specific performance characteristics of the aircraft fuel systems can be obtained by determining absolute pressure levels, and pressure drops in the fuel pipework, at stations 14, 1 and 26, for a range of engine speeds. Figures 18, 19 and 20 respectively gives examples of the raw data, for the fuel systems of both aircraft for the three nominated stations for an acceleration from 70% - 100%. Using these types of data traces, pressure levels at the beginning and end of each acceleration were determined by sampling up to 256 nominally steady state points (8 seconds of data) and calculating the signal mean  $\bar{x}$ , its standard deviation  $\sigma$  and the coefficient of variations CVA. Sample values of  $\bar{x}$ ,  $\sigma$  and CVA are presented in Table 3 for data in Figures 18 - 20. Using the steady state values of pressure,  $\bar{x}$ , system pressure levels and filter pressure drops were plotted as a function of engine speed. Figure 21 gives the pressure drop in the fuel piping and the low pressure filter, stations 14 - 1 and 1 - 26 respectively. As mentioned earlier there is a degree of uncertainty about these levels as they are differences between two numbers of similar magnitude. Notwithstanding the method of analysis the data and trends appear to be consistent. From the data it appears that there is little if any difference in pressure drops across the filter for both aircraft, with the pressure drop increasing from 0.2 psi to 0.65 psi as the "steady state" speed increases from idle to maximum. There is however a minor difference in pressure drops across the pipework from the solenoid valve to the filter. The ducting in Aircraft A7-097 (warning light illuminated) having an approximately 0.1 psi larger pressure drop: no explanation can be given for this difference. A comparison of the fuel boost pump pressure levels with engine speed (steady state) for both aircraft is given in Figure 22 at station 14, just after the solenoid valve. As indicated earlier in Section 4.1, the fuel boost pump pressures are consistently lower for aircraft A7-097 than for A7-011, a difference of at least 7 psi existing across the speed range. The absolute level for A7-011 is approximately 32 psia (17 psig) at idle and 28 psia (13 psig) at maximum engine speed: the values for aircraft A7-097 are 25 psia (10 psig) and 20 psia (5 psig) respectively. This later value gives only a 2 psig margin for suction pressures imposed by the HPFP during accelerations if the pressure switch is set between 2.5 - 3 psig. Any untoward pressure resistance in the fuel delivery line and filtering system would soon erode this margin, remembering that accelerations from any speed level can impose suction pressure drops of the order of 2 psig lower than the final steady state value: this would leave only a small margin for induced cavitation at the inlet of the HPFP.

PRESSURES, FUEL FILTER OUTLET

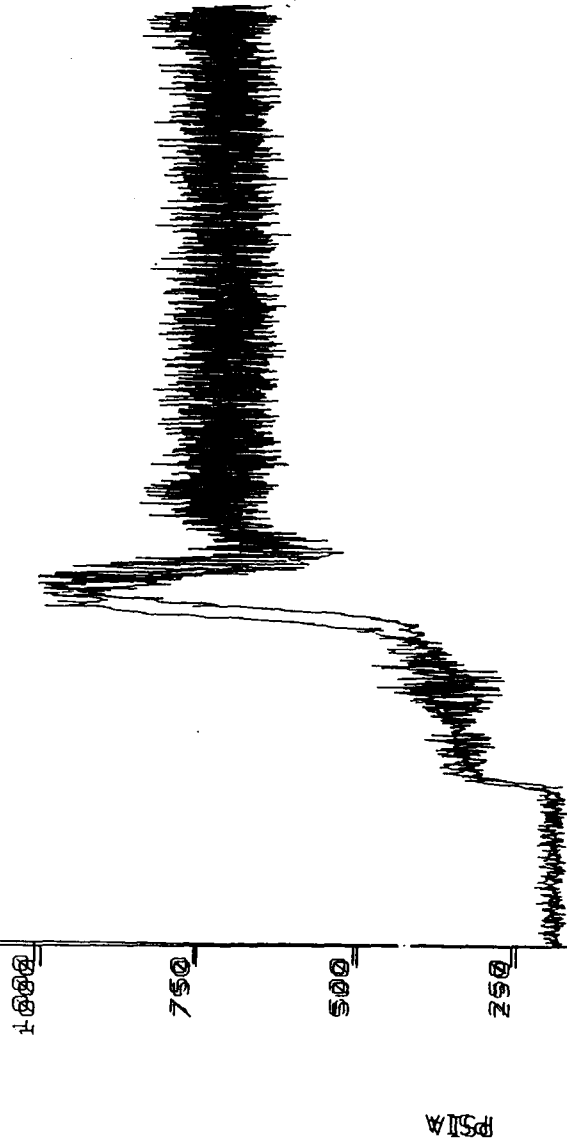
FIGURE 17

PRESSURE, HIGH PRESSURE PUMP OUTLET
