**TECHNICAL REPORT ARCCB-TR-88041**

**FRACTOGRAPHIC ANALYSIS  
OF A FAILED CRANE BOLT**

**A. A. KAPUSTA**

**NOVEMBER 1988**

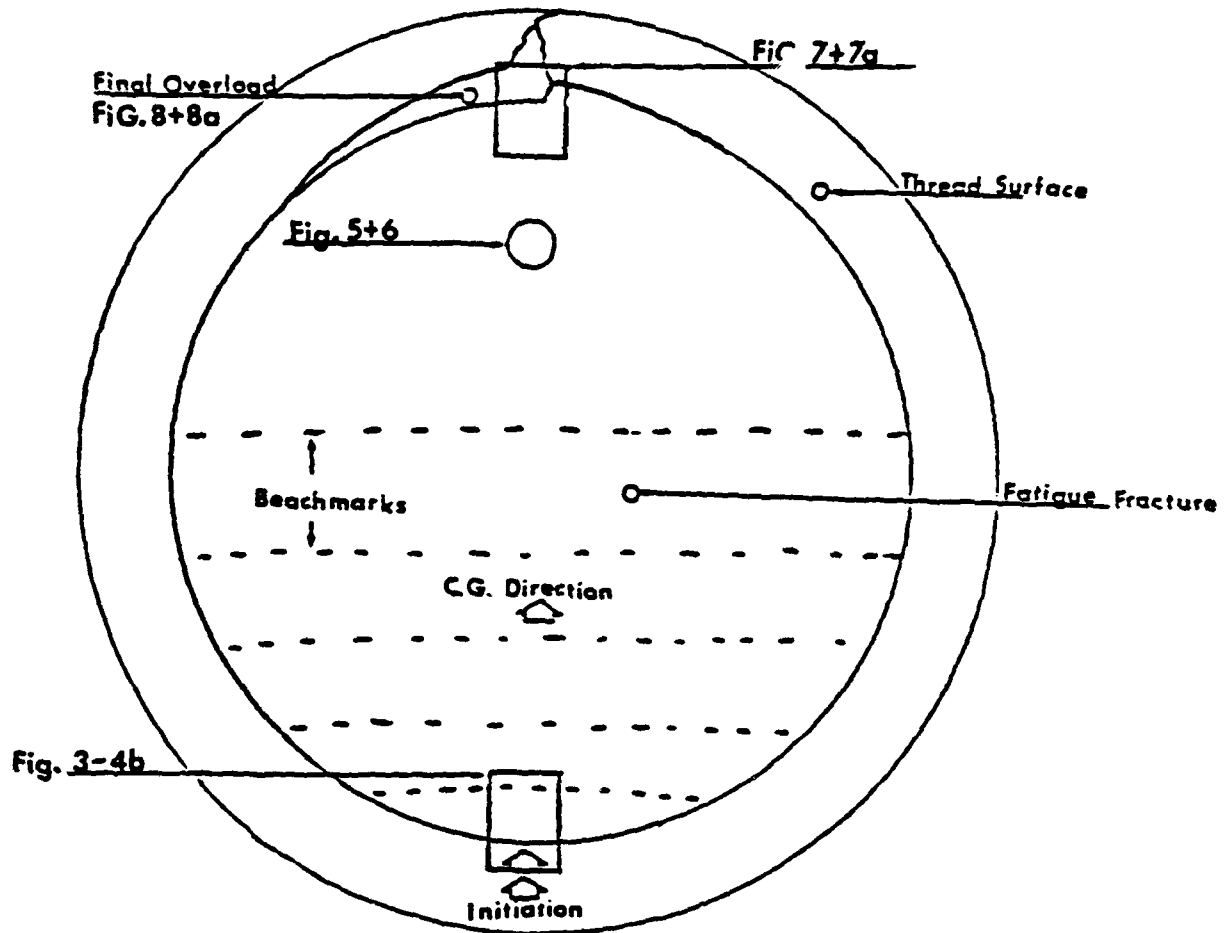
Viewing the fracture surface under oblique illumination revealed faint beach marks shown in Figure 1, indicative of initiation from a single site.

of a mode I tensile separation. Fatigue crack growth direction, determined from striation orientation, was consistent with crack initiation from a single site and subsequent propagation as noted in Figure 1.

Figure 1. Schematic of fracture surface.

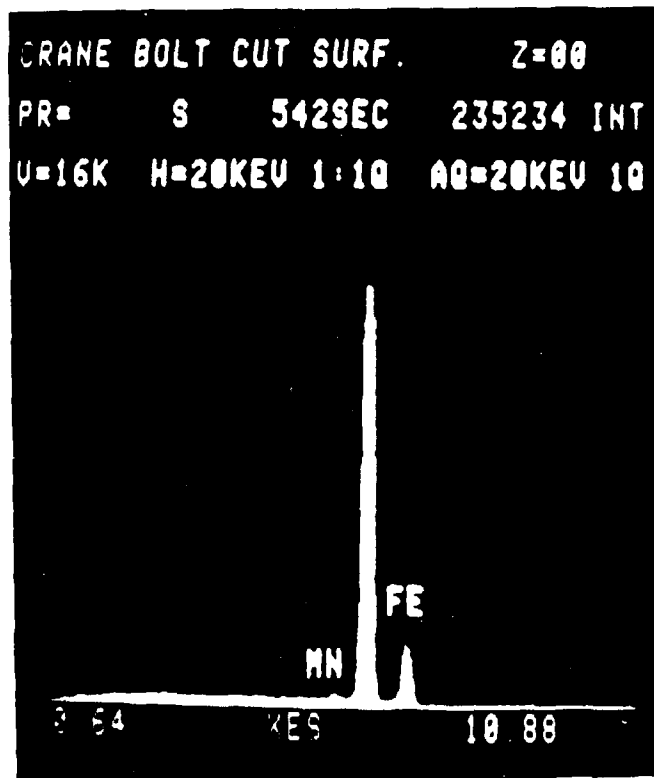
An EDX spectrum, Figure 2, from a "clean" cut surface of the bolt shows that it is made from plain steel.

Figure 2. Energy dispersive x-ray spectrum of crane bolt.

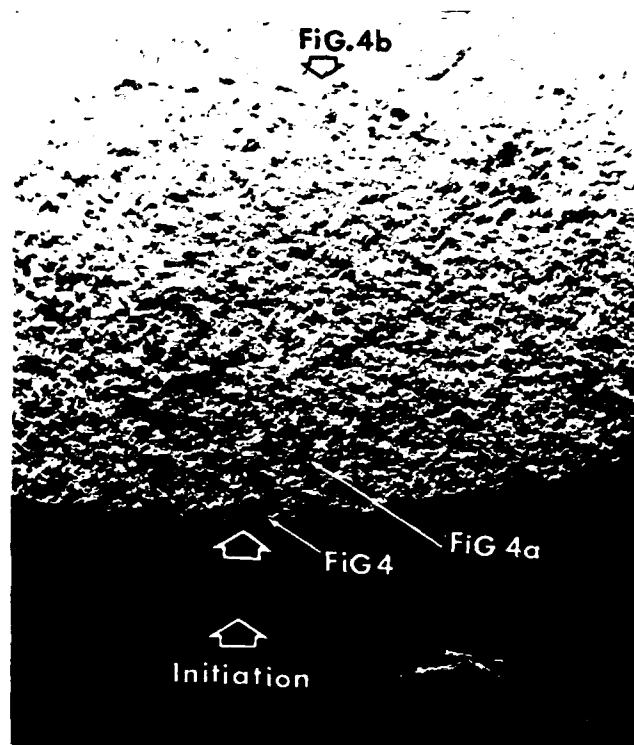
SEM, Figure 3, shows the initiation region, while Figure 4, at higher magnification shows this region to be free of any material defect. The fracture surface was essentially transgranular (Figures 4, 5, and 7), and stage II fatigue striations were found across its entire length (Figures 4a, 4b, 6, and 7a), except for the very small region labeled in Figure 1. This small region was all transgranular dimpled (Figure 8a) consistent with and indicative of final fast overload fracture. Most of these dimples were equiaxed, indicative

Figure 3. Fatigue fracture initiation as indicated by the white arrow (12X).

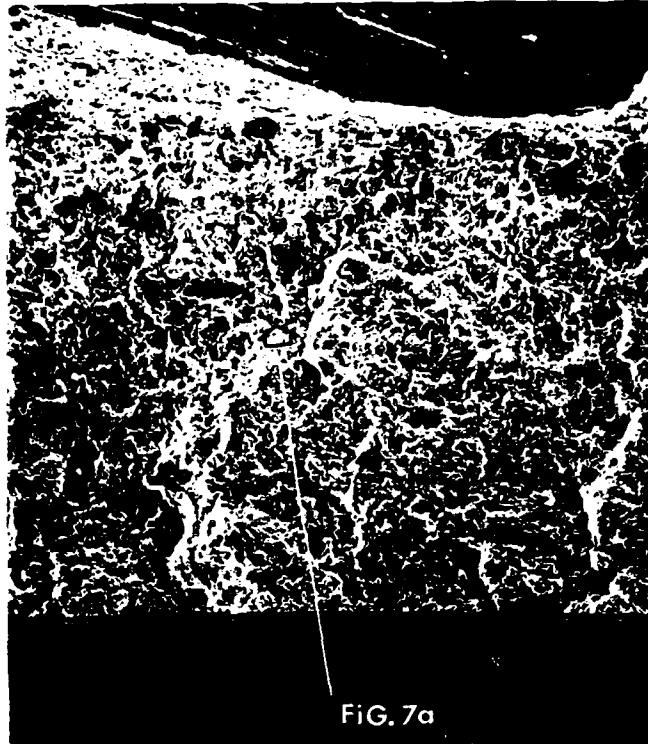
Figure 7. Fatigue fracture propagation (30X).

Figure 7a. Fatigue striations (2000X).

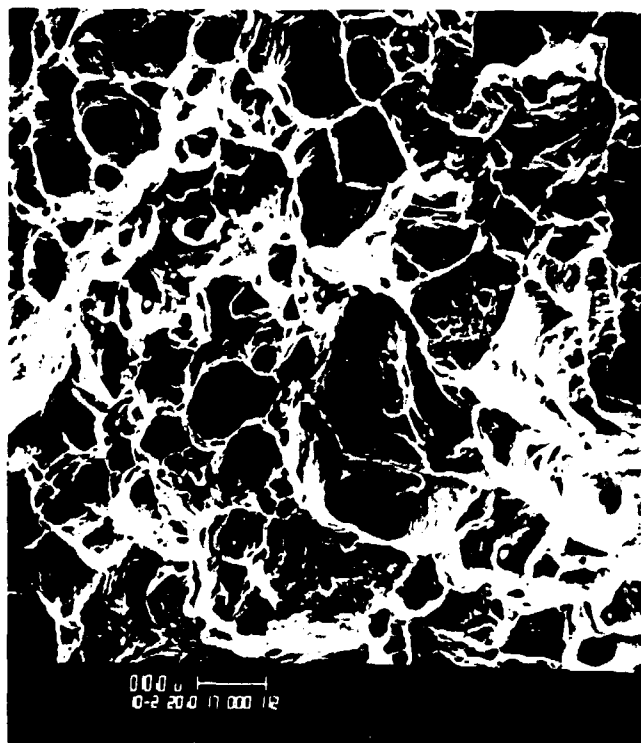
Figure 8. Final tensile overload separation (100X).

Figure 8a. Microvoid mode of fracture in final tensile overload (1000X).

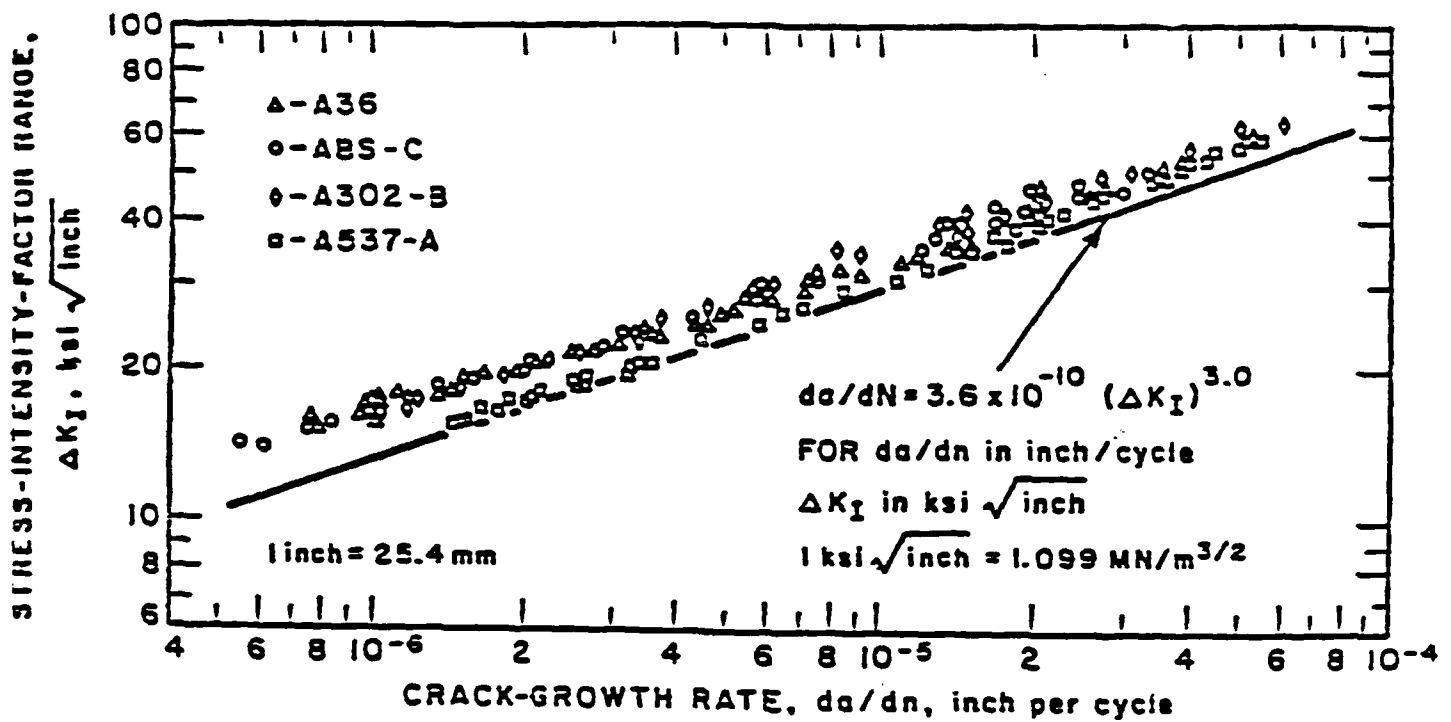
Of the several empirically derived fatigue crack growth rate (FCGR) versus  $\Delta K$  relationships in the literature, that shown in Figure 9 (ref 1) is relevant to this sample, since it was derived for ferrite/pearlite steels. Using the crack growth versus stress intensity plot in Figure 9, a  $\Delta K$  of ~ 34 Ksi $\sqrt{\text{in.}}$  was derived for this bolt.

4. Estimates of the acting  $\Delta K$  were made using the measured  $da/dN$  from the micrographs and FCGR- $\Delta K$  relationships in the literature for ferrite/pearlite steels. The acting  $\Delta K$  for this ferrite/pearlite bolt, from Figure 9, was calculated to be  $\sim 34 \text{ Ksi}\sqrt{\text{in}}$ .

Figure 9. Fatigue crack growth data for pearlitic/ferritic steels (ref 1).
