**BOAT HULL BLISTERS: REPAIR TECHNIQUES
AND LONG TERM EFFECTS ON
HULL DEGRADATION**

FINAL REPORT

**The American Boat Builders and Repairers Association
Boston, MA**

**Department of Chemical Engineering
The University of Rhode Island
Kingston, RI 02881**

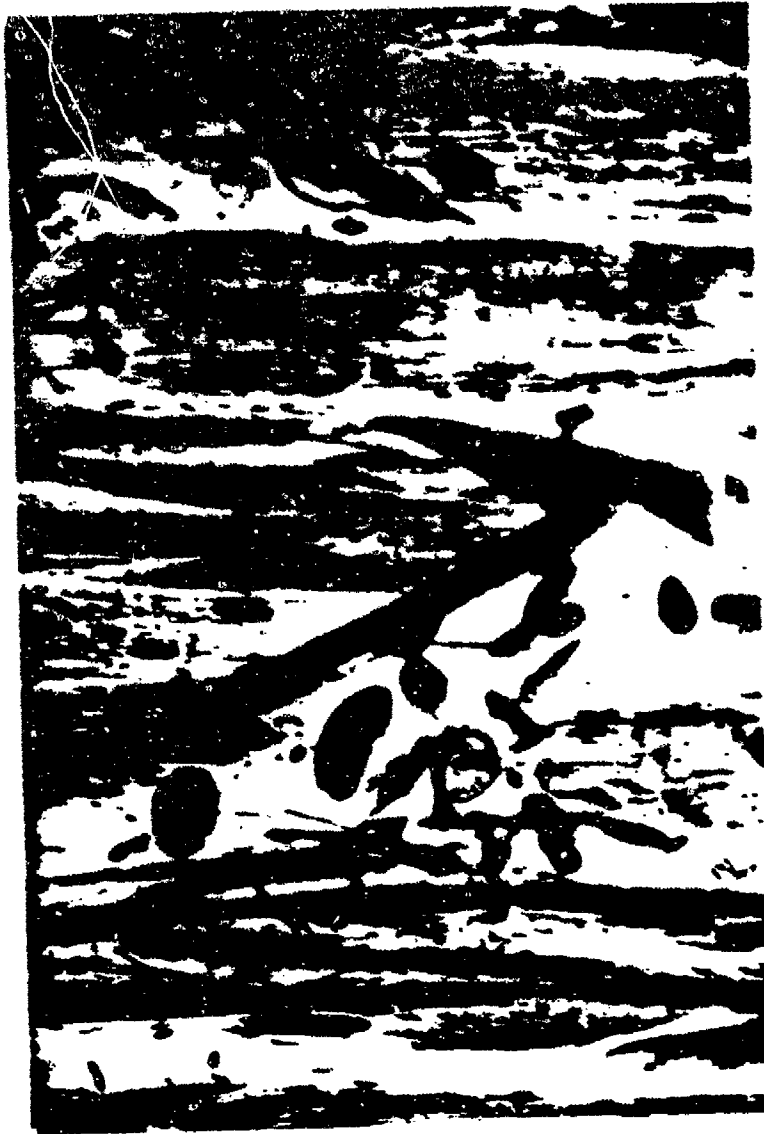
A third type of long-term damage observed is extensive disk cracking throughout the laminate. Examples of extensive disk cracking are shown in figures six and seven. Figure six shows a micrograph of an isophthalic gel coat and resin sample produced by a local boat manufacturer tested in our laboratory. The sample was exposed to water at 65°C for one year and 25°C for another year. Figure seven shows a micrograph of a sample with a type of vinyl ester based gel coat and orthophthalic laminating resin. This sample, as well, was produced by a boat manufacturer and was tested in the laboratory. It was exposed to water at 65°C for about a year. Another observation shows disk cracking below veil mat blisters. Under one of the near surface blisters, a zone of numerous stress produced disk cracks was observed. The zone radiated hemispherically from the bottom of the blister. The cap of the blister had cracked allowing water directly into the blister cavity. This has a major effect on the water uptake of the resin beneath the blister

Figure 6. Photomicrograph Showing Extensive Disk Cracking in an ISO/ISO Laminate, Following Exposure to water at 65 C for One Year and Another Year at 25 C.

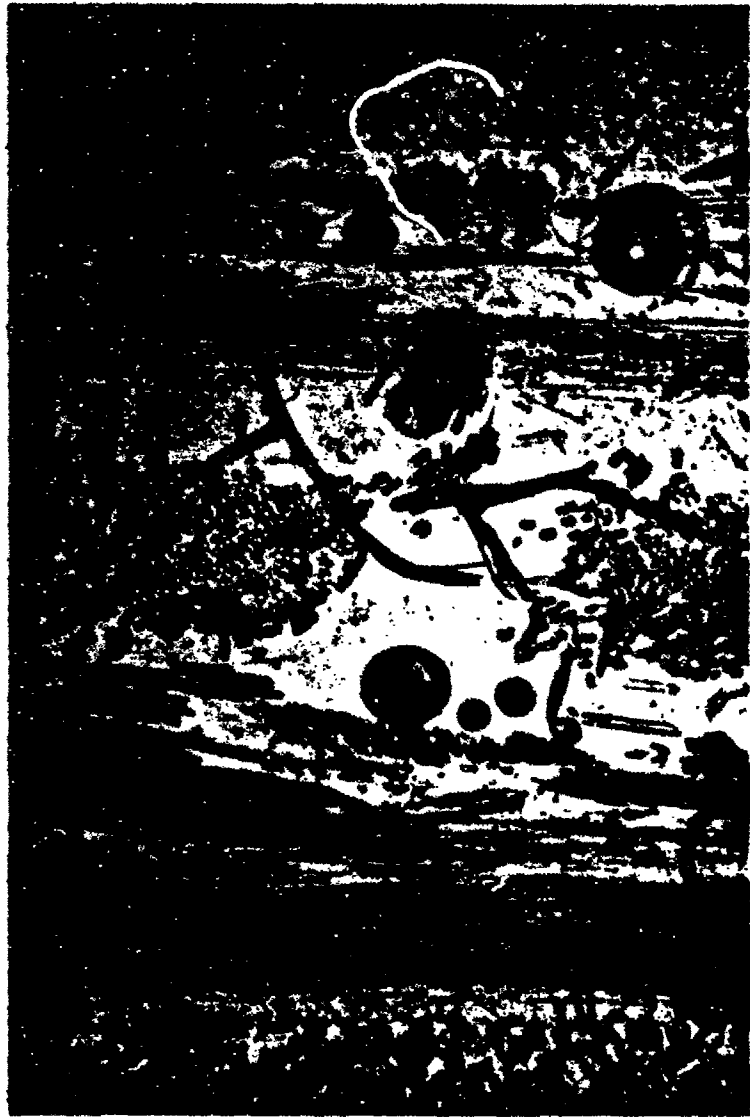
Figure 7. Photomicrograph Showing Extensive Disk Cracking in a Composite Constructed with a Type of Vinyl Ester Gel Coat and Ortho Laminating Resin, Following Exposure to Water at 65 C for Approximately 1 Year.

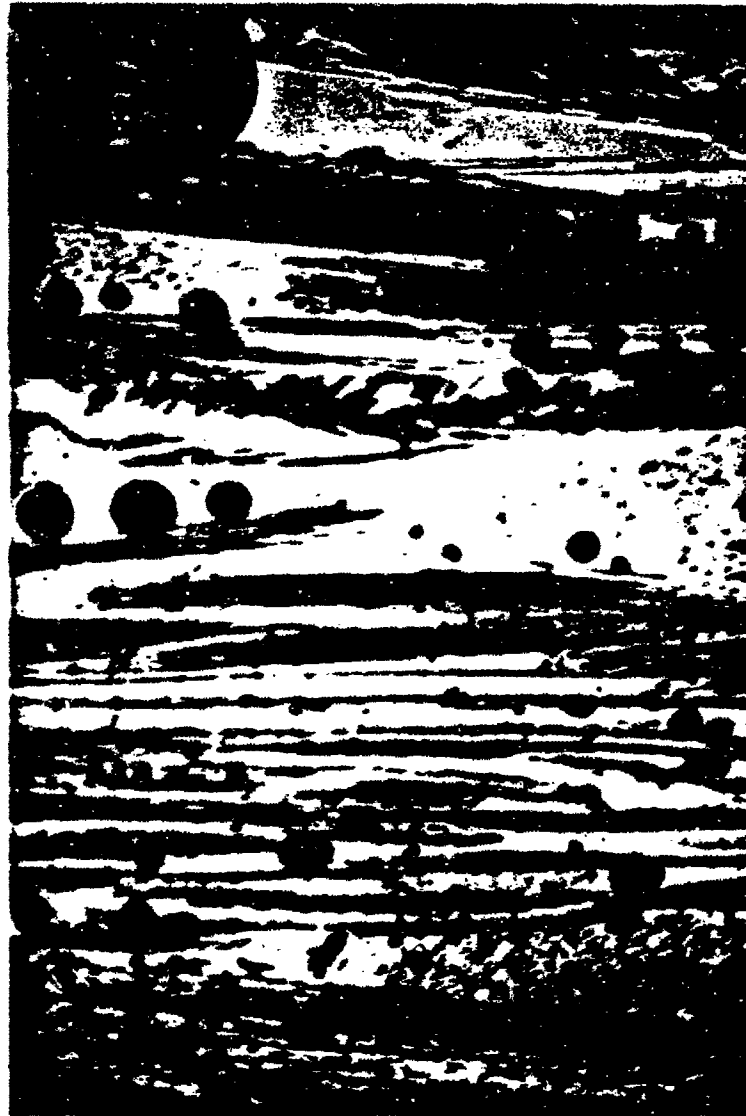
Figure 8. Photomicrograph of "Deep Seated" Blisters Found in an ORTHO, ORTHO Composite after 4106 Hours of Exposure to 65 C Water.

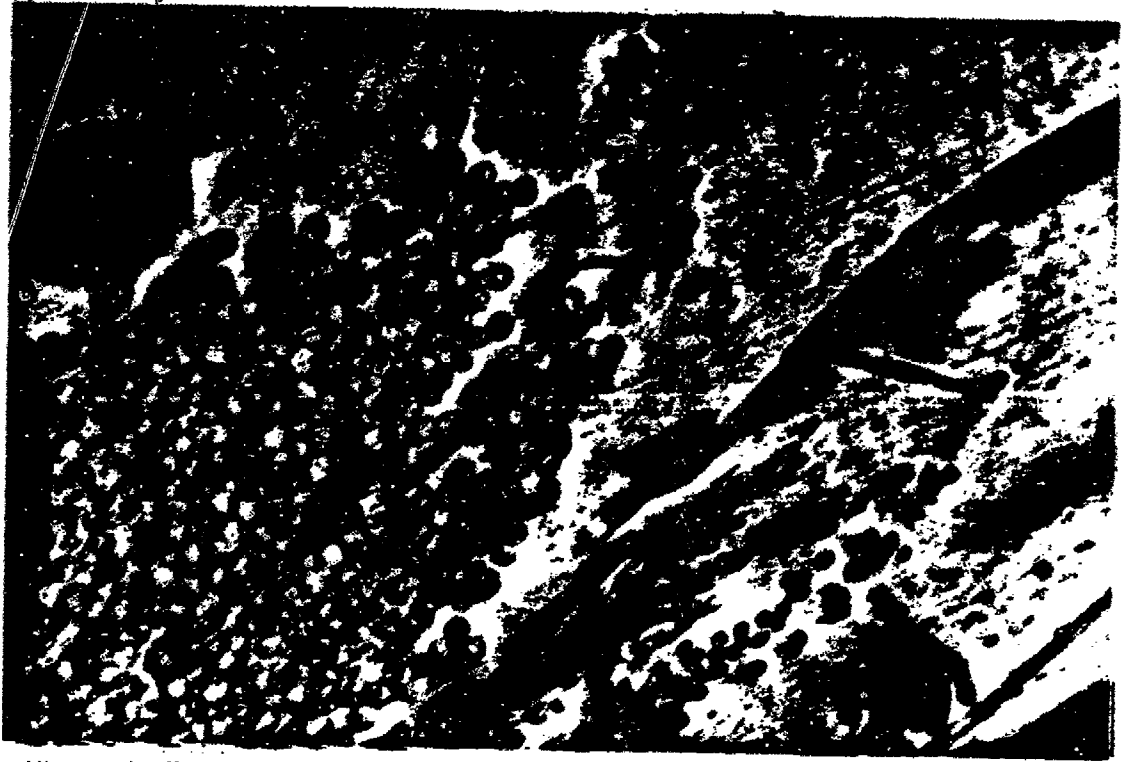
Figure 9. Photomicrograph of Disk Cracks Near Glass Fibers Leading to Debonding.

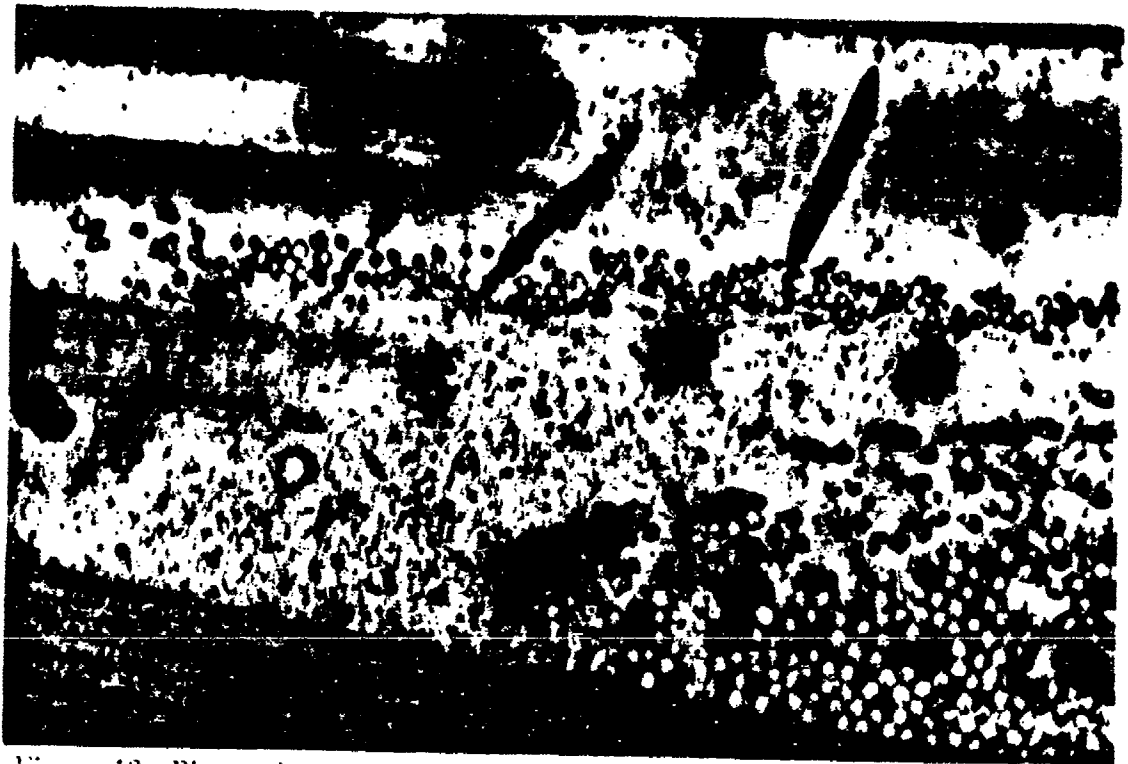
Figure 10. Photomicrograph of Disk Cracks Near Glass Fibers Leading to Debonding.

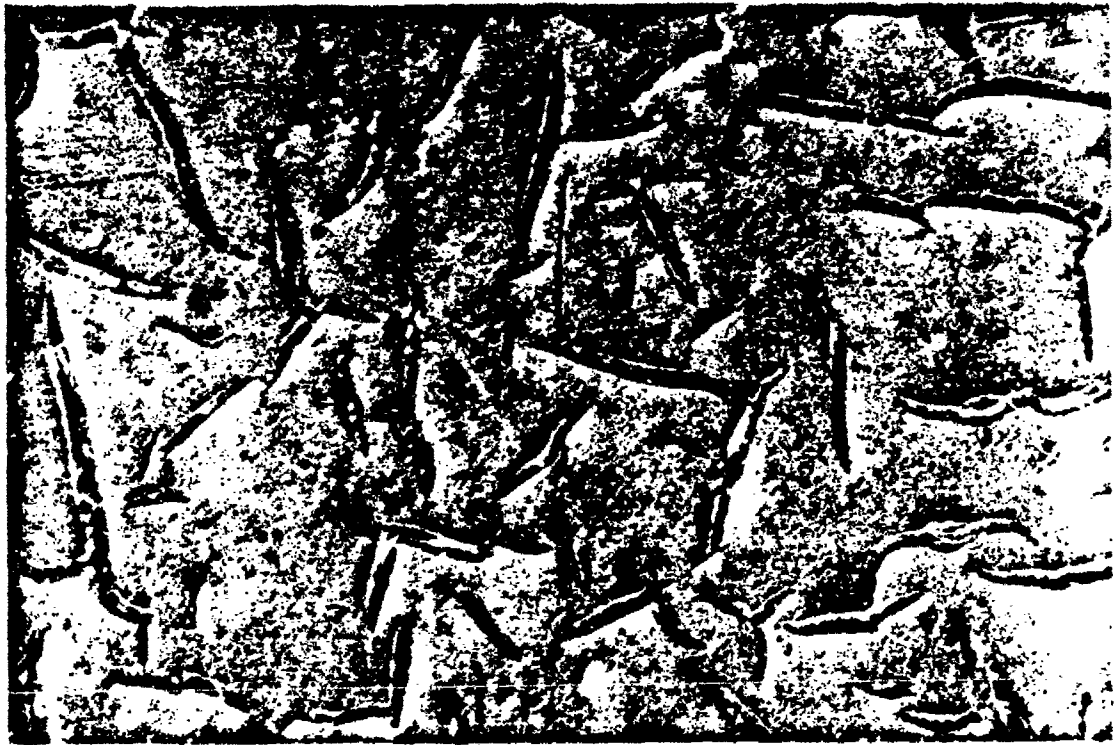
Figure 15. Photomicrograph of the Resin Rich Backside of a Composite that Has a.) Not Been Exposed to Water b.) Been Exposed to 65 C Water .

Figure 15 also shows the importance of keeping the bilge as dry as possible. This point has already been emphasized. The physical damage to the resin which weakens it, speeding up saturation of the hull and the increased osmotic cracking is shown dramatically in these photographs. Also, the data leave no doubt that the pigmented gel coat does act as an effective barrier in keeping water out of the fiberglass laminate.
