STRAIN ANALYSIS OF HMMWV FRONT LIFT PROVISION

March 1989

US ARMY
LABORATORY COMMAND
MATERIALS TECHNOLOGY LABORATORY

REPORT DOCUMENTATION PAGE		READ INSTRUCTIONS BEFORE COMPLETING FORM
1. REPORT NUMBER MTL TR 89-24	2. GOVT ACCESSION NO.	3. RECIPIENT'S CATALOG NUMBER
4. TITLE (and Subtitle) STRAIN ANALYSIS OF HMMWV FRONT LIFT PROVISION		5. TYPE OF REPORT & PERIOD COVERED Final Report

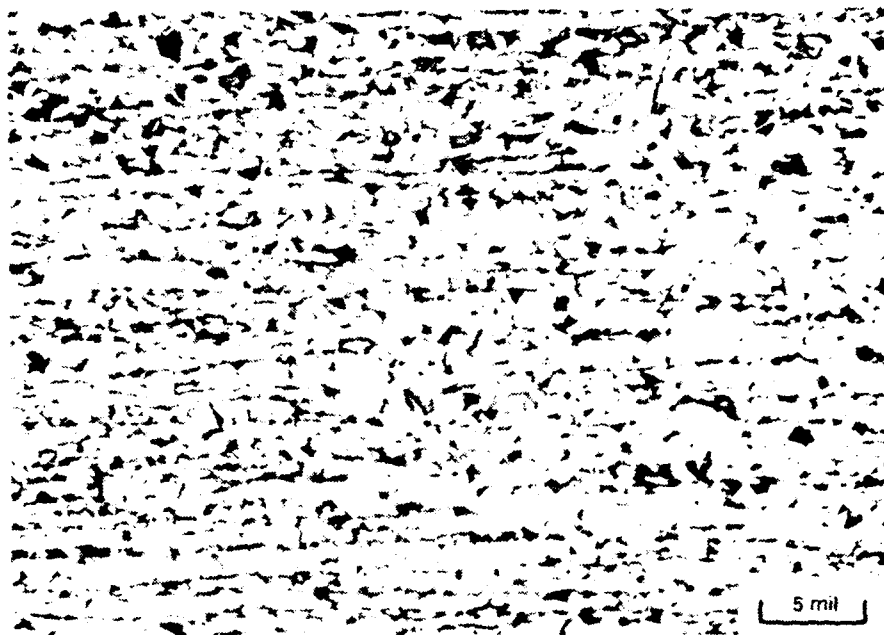
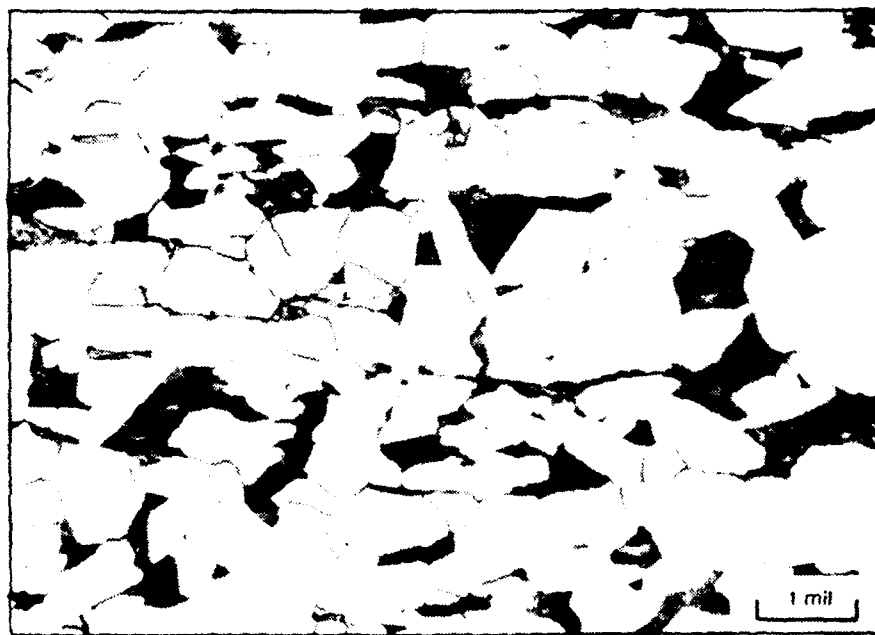
The microstructure of the HMMWV provision material is shown in Figure 5. This sample was sectioned parallel to the axial direction. Significant banding can be seen in the micrographs, and the level of cold work in the material is estimated to be less than 50 percent.² The dark regions of the microstructure are fine pearlite, and the amount is typical of a slow-cooled 1020 steel.³

Figure 5. Microstructure of provision material, Nital etch. Banding can be seen in microstructure. Dark regions are pearlite.

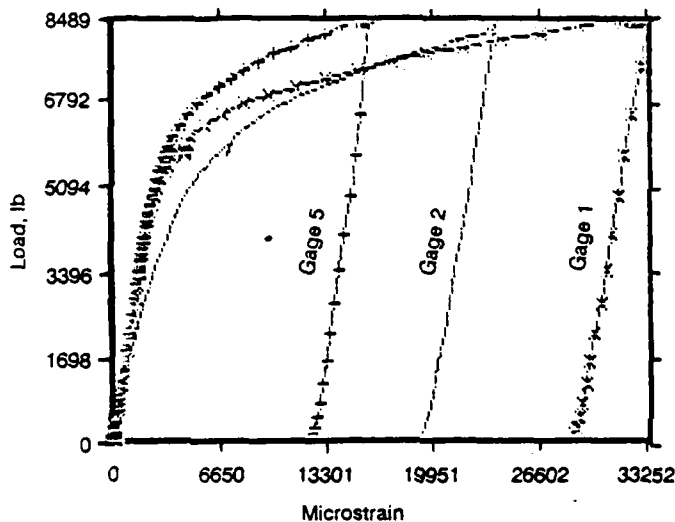
Figure 6 shows the load-strain data for three of the strain gages for the first pull of the provision tested at 8650 lb/20 degrees. Upon unloading, it is obvious that permanent strain has resulted. The largest plastic strain measured, 2.9 percent, was found at gage number 1 (Figure 1), and all of the gages showed some signs of plastic flow. Gage number 3, directly above the loading point, experienced approximately 1-percent strain before the gage debonded. This provision was visibly deformed.

Figure 6. Load versus strain data for the initial loading of a provision to 8650 lb at 20 degrees. Gages correspond to Figure 1.

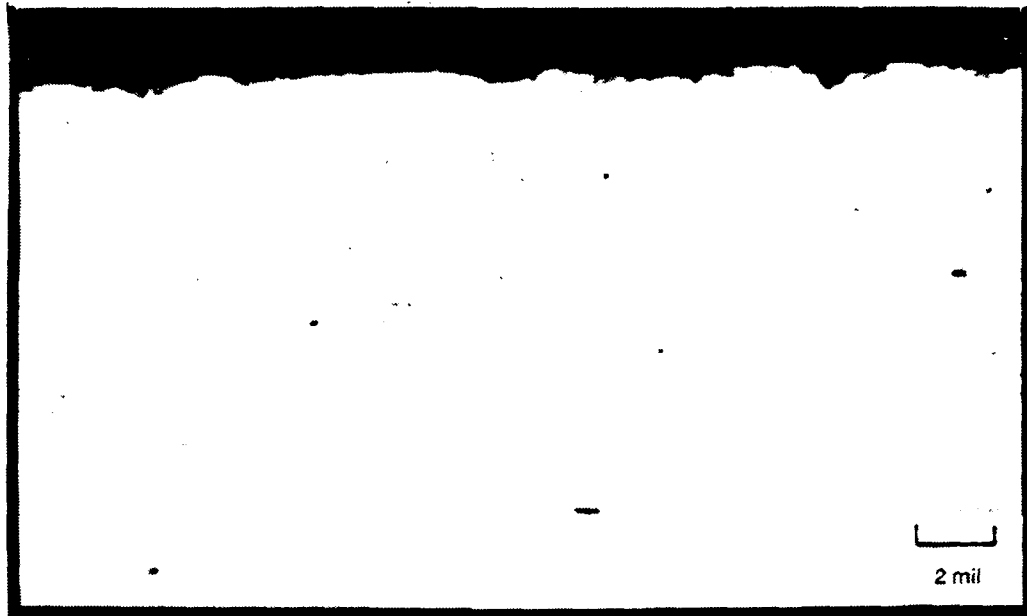
These statically-tested provisions were sectioned near each strain gage for metallographic analysis to detect flaws introduced by the static tests. Figure 8 shows a section at the outer surface. No unusual flaws or cracks were detected in either provision.

Figure 8. Section of provision tested statically to 8650 lb at 20 degrees. No unusual flaws or cracks are seen. Unetched.

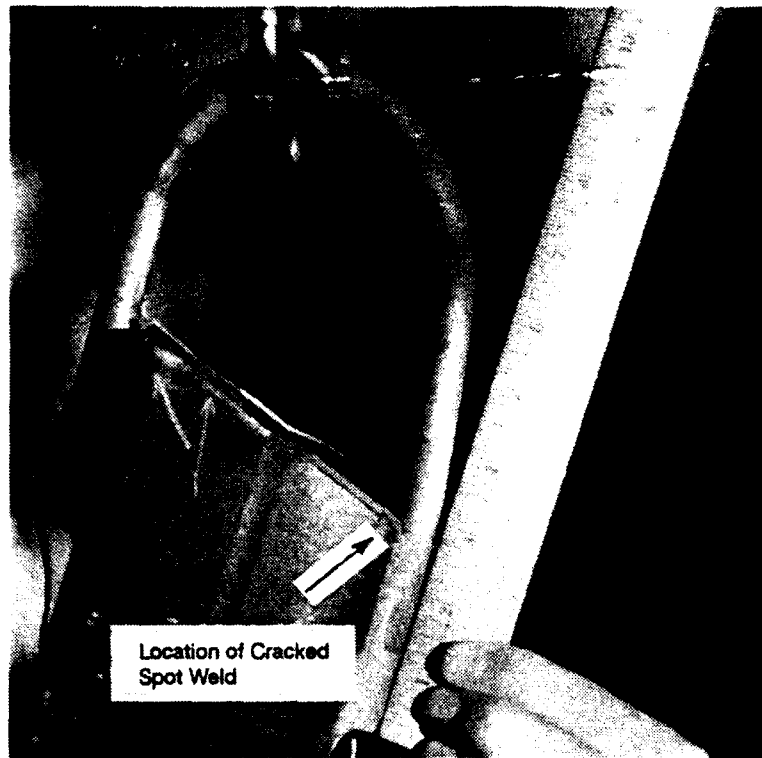
Figure 10. HMMWV provision at fatigue test conclusion.

Because only the 3.2G loads were producing significant hysteresis, the second, more severe, test used only the 3.2G loads. An additional 5,332 cycles of the 3.2G load were applied, and the provision continued to function properly. At this point, the test was stopped to allow for NDE and metallographic examinations. The provision at the conclusion of the fatigue test is shown in Figure 10. A small crack was visually detected in one of the spot welds that holds on the top cover plate. The location of this crack is shown in Figure 10a.

(a) Deformed provision and location of cracked spot weld

The spot welds are used to hold the cover plate in position, but the cover plate is not a major load-bearing component. Therefore, this crack, confined to the spot weld, was considered to be unimportant.

3. Two cracks were discovered in the provision after the fatigue test was completed: (1) a crack formed in an indentation caused by one of the chains used for loading the provision, and (2) a spot weld at the corner of the top cover plate fractured. The evolution of the small indent crack is not fully understood, nor is its significance resolved, and NRDEC may want to consider a separate study of the chain indent phenomenon. The spot weld crack on the cover plate allowed for some redistribution of stress. However, this spot weld is not a critical load-bearing component; therefore, this flaw is considered to be unimportant.

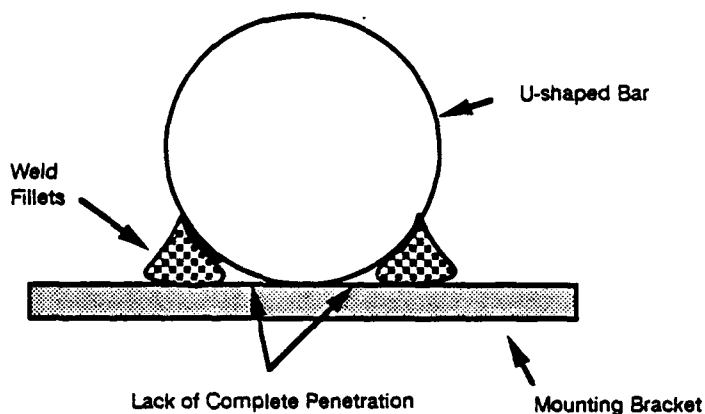
The fatigued provision was examined using radiography and the dye penetrant NDE techniques. The dye penetrant indicated the presence of a surface crack within an indentation caused by the loading chain. No other surface flaws could be detected on the bar. Radiography was used to examine the weld area. A weld on one side of the provision had undergone two welding passes. Though lack of complete weld penetration was observed, the weld showed no signs of fatigue failure. A schematic of the weld area as revealed by the radiographs is shown in Figure 11.

Figure 11. Schematic of welds as revealed by radiography.

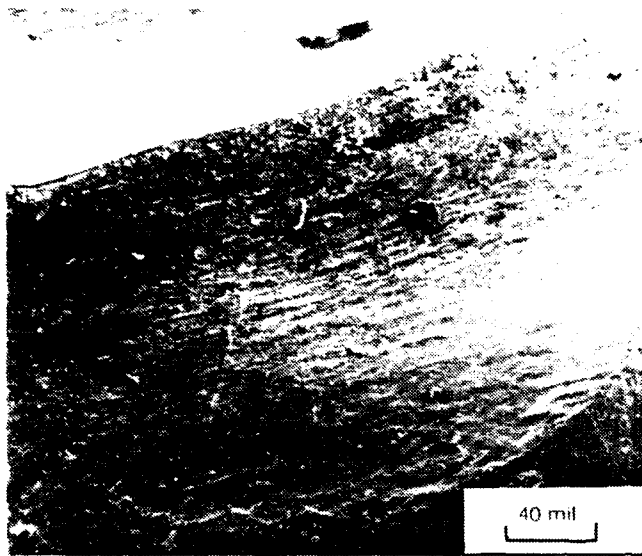
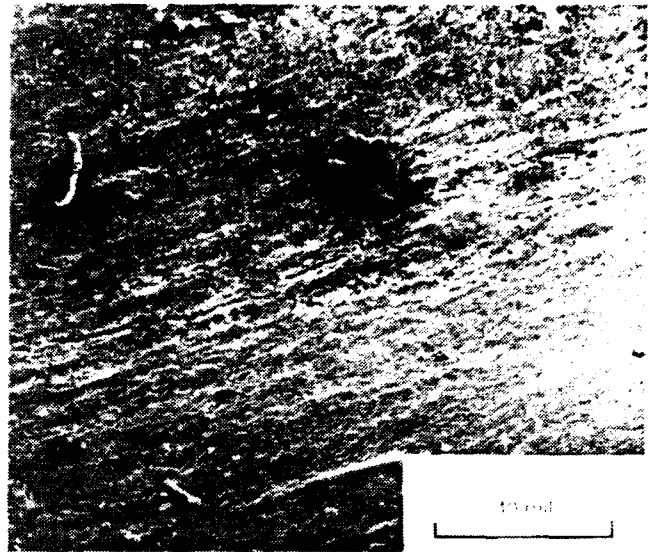
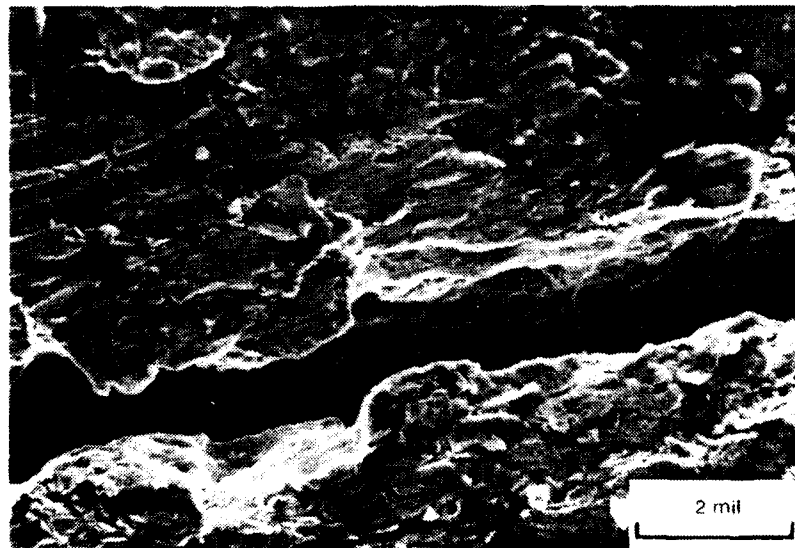
Figure 12. Crack found in chain indentation as viewed by SEM.

After the nondestructive examination of the fatigue test sample was complete, the region with the indentations and flaw was sectioned and examined by scanning electron microscopy. A crack was observed in the location specified by the dye penetrant test, and is shown in Figure 12 (a-c). The crack has a surface length of about 120 mils, but the depth of the crack cannot be determined from SEM photos. This sample was sectioned transverse to the crack near the center of its surface length. This sectioned view is seen in the optical micrographs of Figure 13. The depth of the crack at this point is about 40 mils, giving the crack front a semicircular shape. Further examination of the crack tip after etching the sample revealed a blunt crack tip. This demonstrates that the full crack depth was accurately measured from Figure 13. It was not determined when the crack was initiated during the fatigue test. Whether this was a critical crack that would have resulted in the eventual failure of the provision under continued cycling is also unresolved.

The formation of this crack within the indentation was somewhat unexpected, as the underside of the provision is nominally under compressive/compressive cyclic bending stresses. Possible mechanisms of formation include: (1) the interaction of residual tensile stresses from the indentation with the nominal bending stresses, causing tension/tension fatigue crack nucleation and propagation; (2) the formation of the crack upon initially indenting the material, with fatigue crack growth into the residually stressed region; and (3) the initiation and growth of the crack by contact fatigue. Other mechanisms may also be possible. Knowledge of how and when the crack formed is vital to assess its severity; both of these questions remain unanswered. It would require further experimental studies to separate out the possible mechanisms.

(a) Indentation on underside of bar where load is applied
(crack is not visible)

(b) Crack is just below foreign matter

(c) Crack at higher magnification

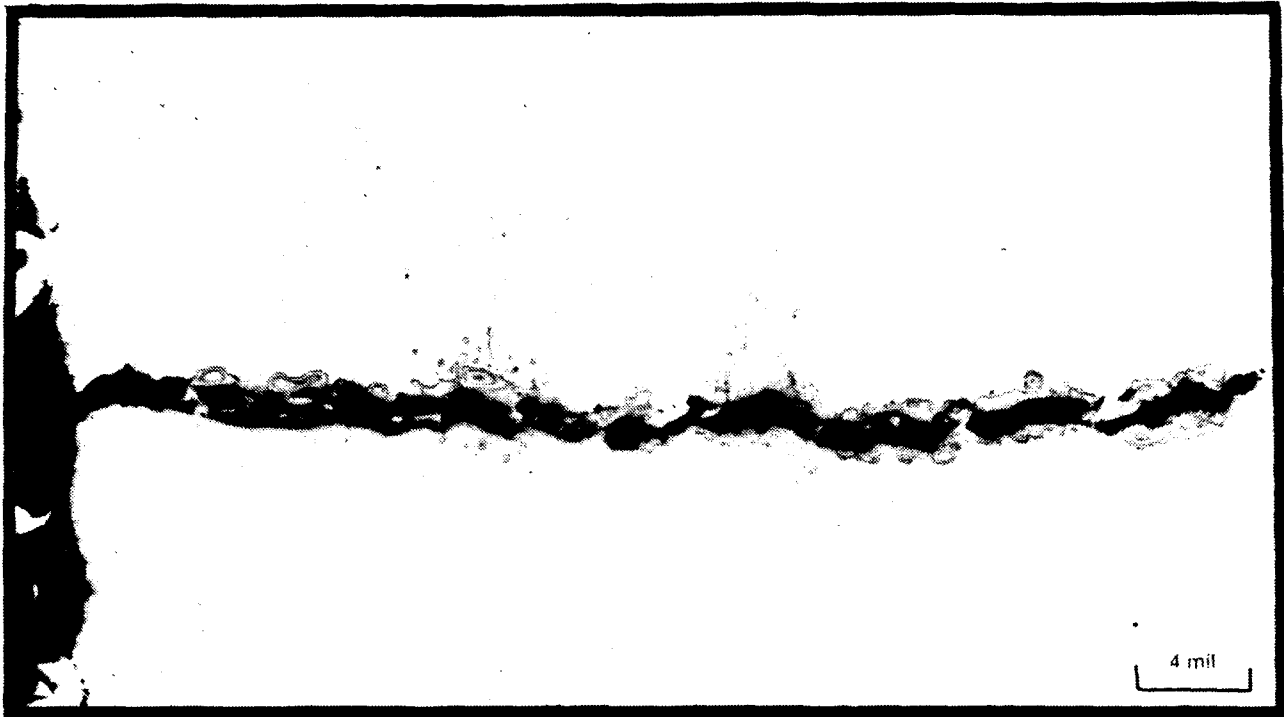
Figure 13. Crack in chain indentation sectioned transversely. Crack depth is approximately 0.040 in.

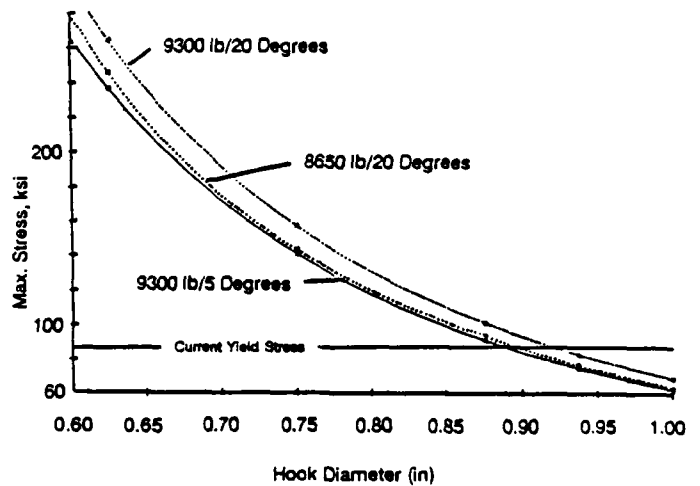
The FE model can also be used to specify the minimum bar (hook) diameter necessary to prevent plastic deformation. Linear-elastic analyses were performed for five different hook diameters. These analyses produce a maximum stress versus hook diameter curve (Figure 15) which can be used to determine the yield strength-diameter combinations required to avoid plastic deformation. Using the current material's yield strength of 87.5 ksi, a hook diameter of 0.925 inch would preclude yielding beyond 0.2-percent strain for the most severe case, case number 1. The present hook diameter is 0.625 inch.

Figure 15. Linear-elastic FE analyses giving maximum stress versus hook diameter for the three different load cases. The provision's yield strength is given by the horizontal line, which shows that a 0.925-inch diameter would be required to prevent significant yielding. The current bar diameter is 0.625 inch.

5. The finite element study showed excellent agreement with the actual deformation of the provision. To prevent significant yielding, a bar of 0.925-inch diameter with a yield strength of 87.5 ksi (the material currently used for the provisions) would be required. The differences between this analysis and the study by NCEL arose from the use of different material properties and the addition of plasticity to the finite element model. The properties used in the current study were measured on actual provision material, and are, therefore, more reliable than handbook values.
