# USAF PRAM PROGRAM FINAL REPORT

28 FEBRUARY 1987

## PRAM PROJECT

FLASHLAMP DEPAINTING SYSTEM

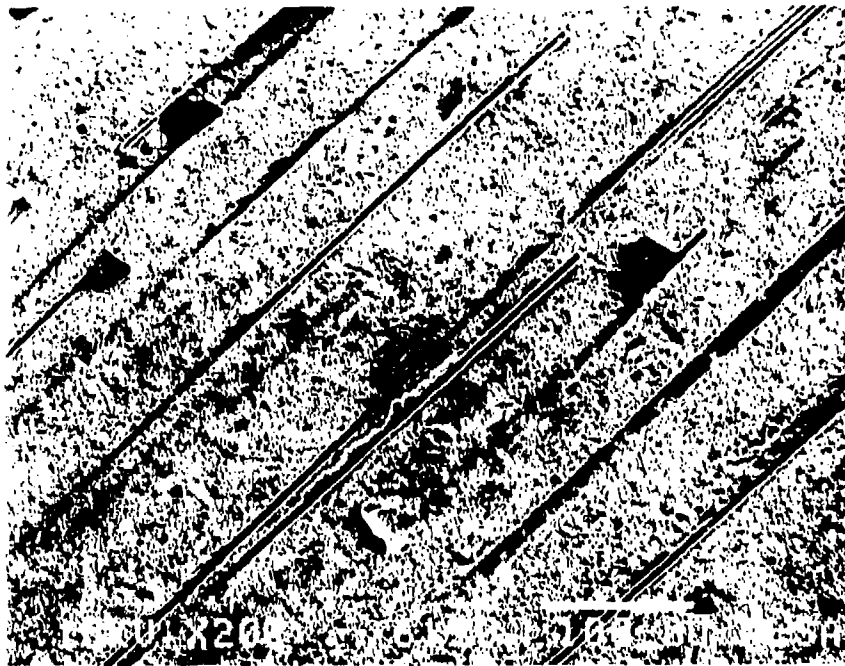
On this specimen, a thin layer of the paint/primer system still covered most of the composite surface, but in some areas the 45 degree surface ply was visible. See Figure 15. In the areas in which the coating was generally removed, there was some damage to the surface ply in the form of broken fibers, fiber/matrix debonding and possible matrix degradation on the surface. See Figures 17 and 18. In the remaining areas where the coating was thin, the coating was generally confined to the matrix rich region formed from the peel ply. See Figure 16.

Figure 17.  
Photomicrograph of surface of specimen #9 showing matrix morphology and 45 degree fibers. (200x)

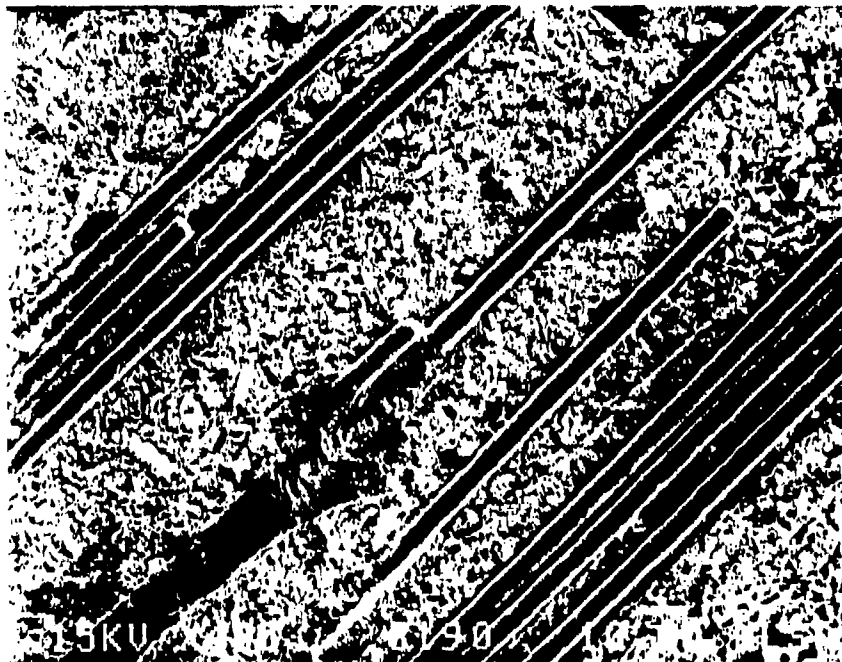
Figure 18.  
Higher magnification of the surface of specimen #9 showing bare and broken 45 degree fibers. (480x)

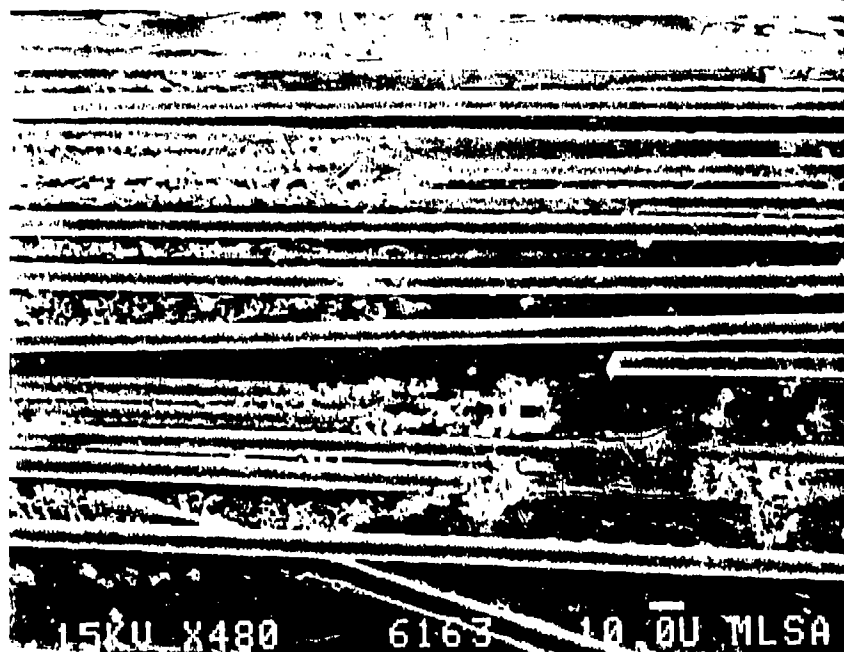
On these specimens, the paint/primer system was generally removed and the surface of the composite was visible. The surface plys were exposed and there was some surface damage in the form of broken fibers, matrix cracking, fiber/matrix debonding and the loss (and possible degradation) of the resin in the top few fiber layers. See Figures 19 to 22, 23 to 26 and 27 to 30.

Figure 21.  
Further magnification of the surface of specimen #1 showing  
bare and broken fibers and matrix cracking. (480x)

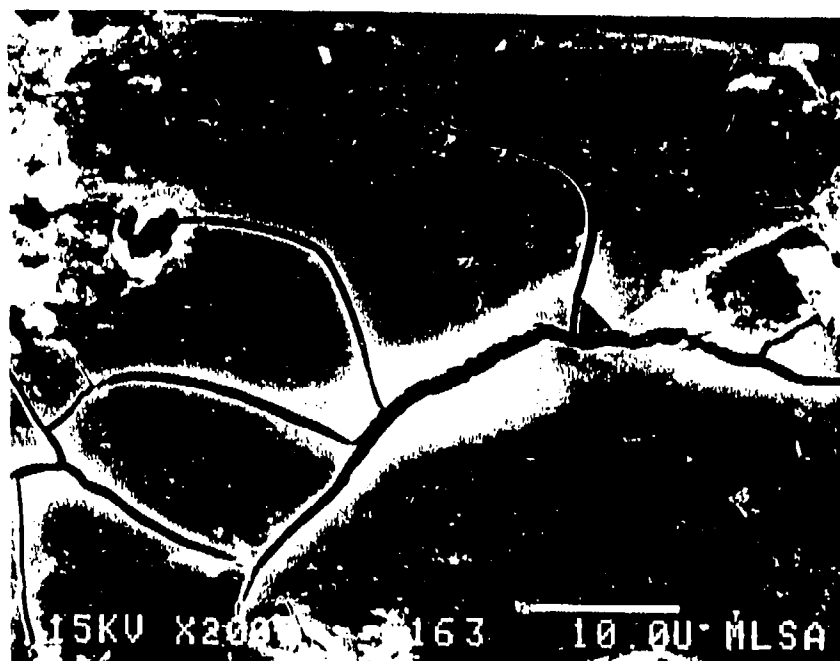
Figure 22.  
Higher magnification of matrix cracking found in specimen #1. (2000x)

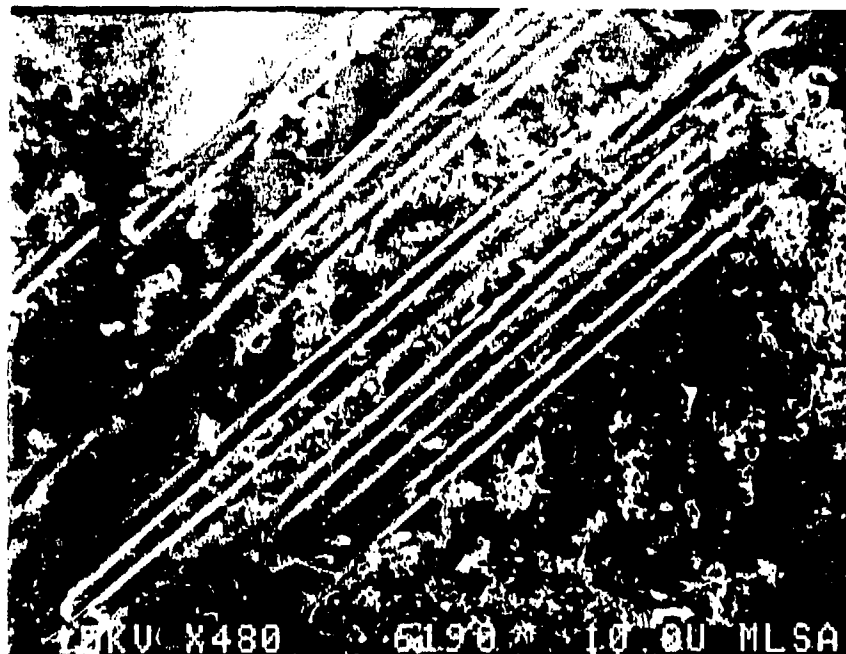
Figure 25.  
Further magnification of the surface of specimen #11  
showing bare 45 degree surface fibers. (480x)

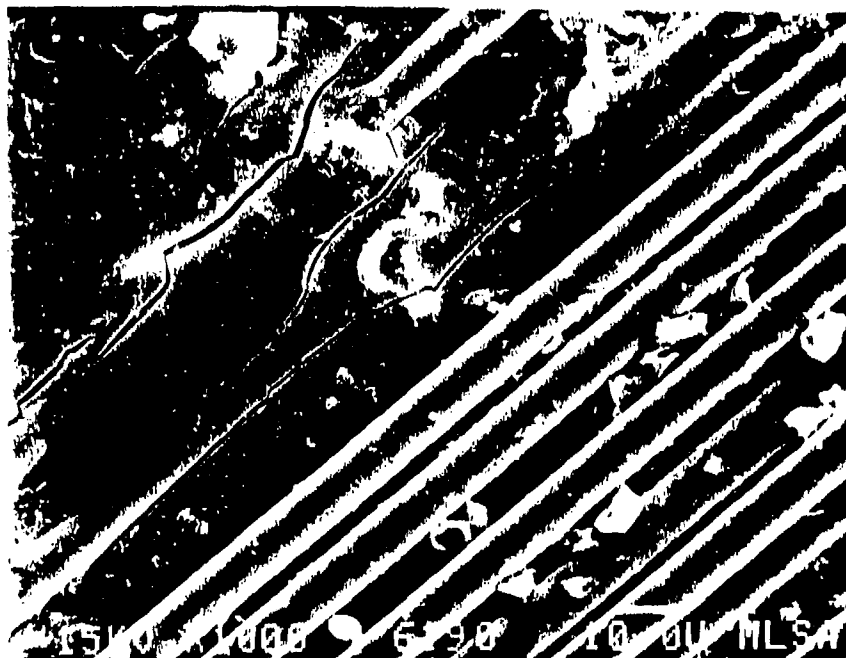
Figure 26.  
Higher magnification of the surface of specimen #11 showing loss of matrix  
and broken matrix pieces between fibers, bare fibers and matrix cracking. (1000x)

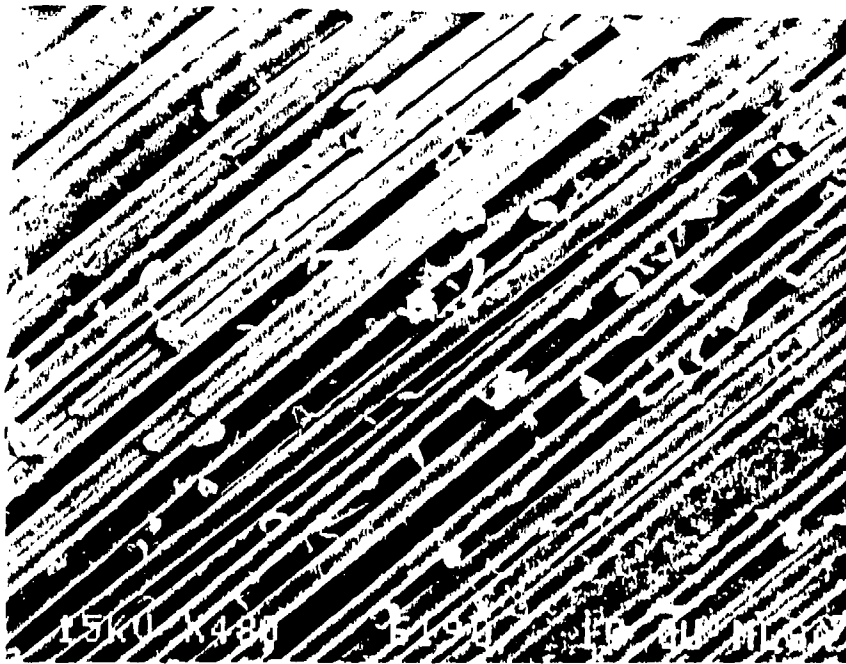
Figure 29.  
Further magnification of the surface of specimen #12 showing bare fibers and missing and broken bits of matrix between fibers. (480x)

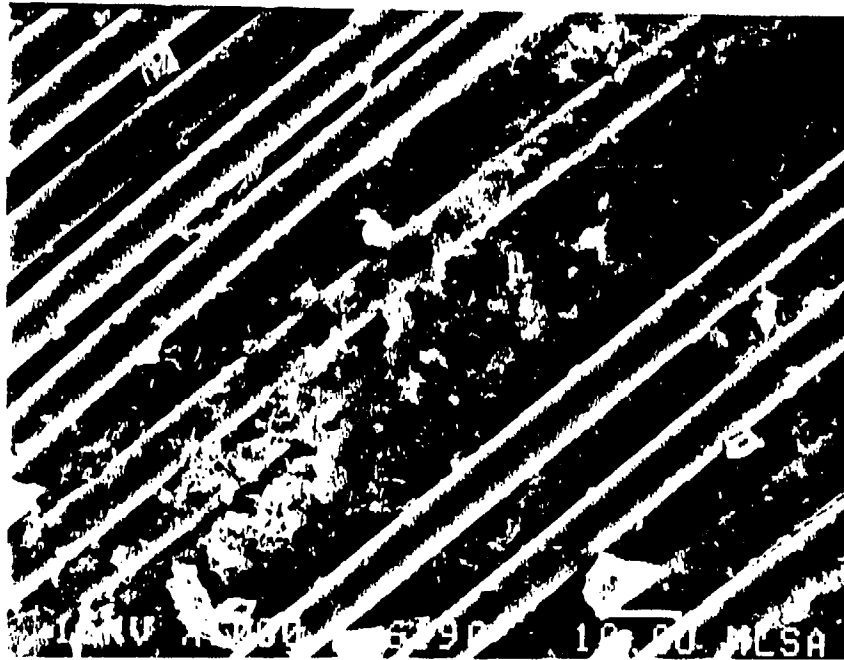
Figure 30.  
Further magnification of the surface of specimen #12 showing matrix morphology, bare fibers and missing and broken bits of matrix between fibers. (1000x)

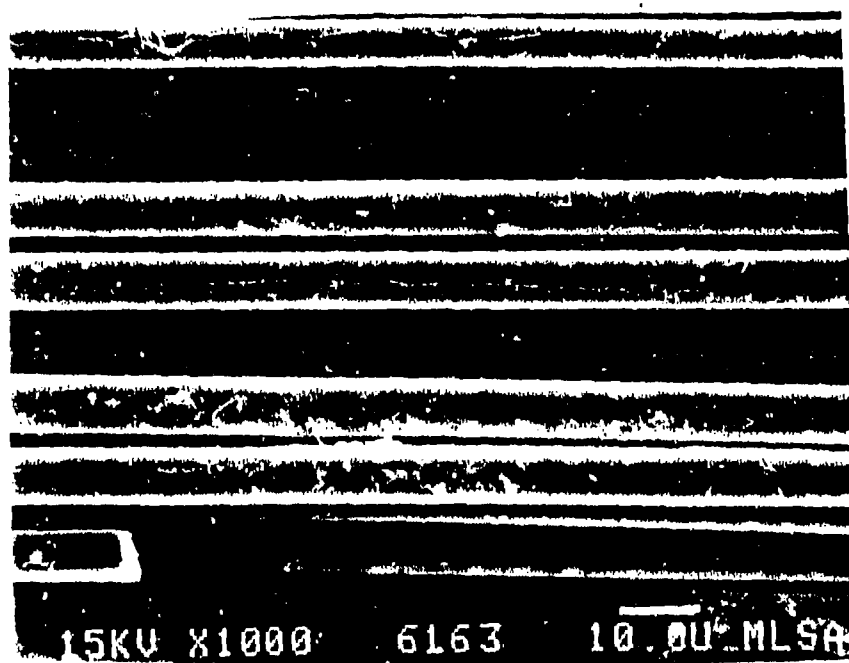
On this specimen, the paint/primer system was totally removed and the composite surface was visible. There was considerable damage to the surface in the form of broken fibers, fiber/matrix debonding with subsequent fiber pullout and loss of matrix between the fibers. See Figures 31 to 34.

Figure 34.  
Further magnification of the surface of specimen #5. (1000x)

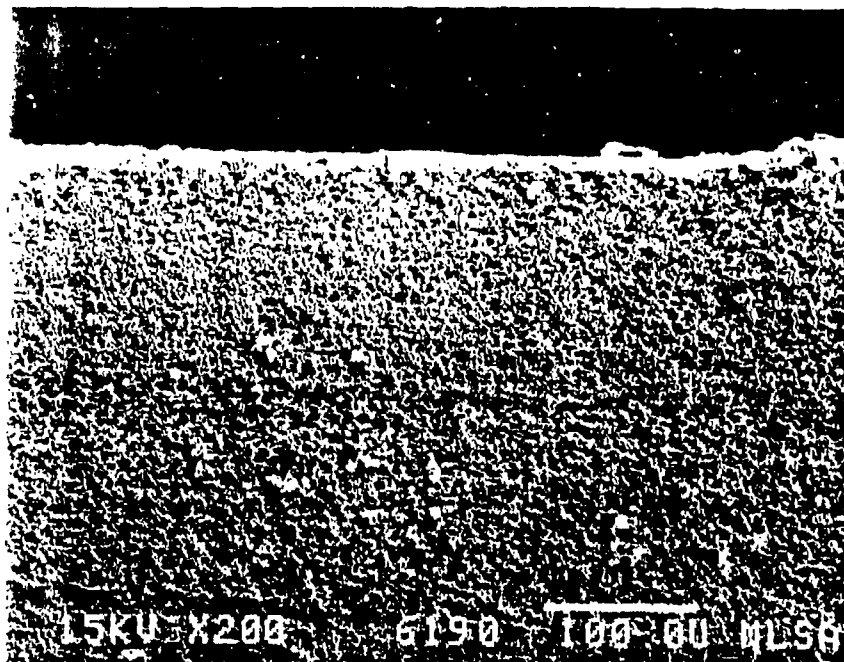
Figure 35.  
Cross-section photomicrograph of specimen #9 showing no material degradation through the thickness of the sample. (200x)

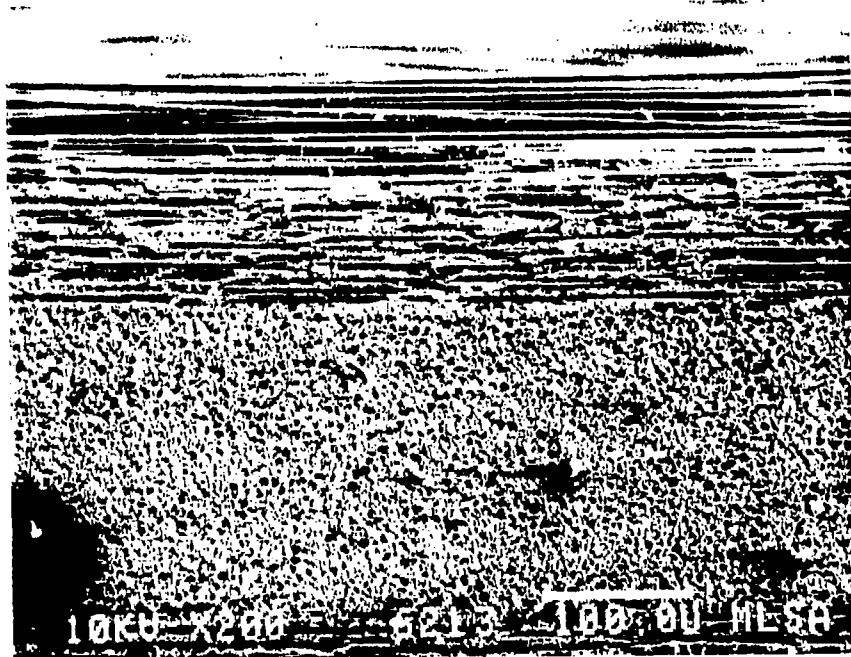
Figure 37.

Examinations were conducted on all of the cross-sections taken from the thick and the thin panels in this study. The results indicated that, except for specimen #5, there was no significant damage to the composite through the thickness due to the flash lamp paint removal process on any of the sections examined. Figures 35 and 36, which were taken from specimen #9, are representative of most of the specimens. Damage to specimen #5 consisted of fiber/matrix debonding and loss of matrix between the fibers up to about 4 to 6 fiber diameters in depth. See Figures 37 and 38.

5. The reason for the damage to specimen #5 is unknown as the test conditions were not available.

Cross-section photomicrograph of specimen #5 showing some loss of matrix material down in the first few fibers layers. (200x)

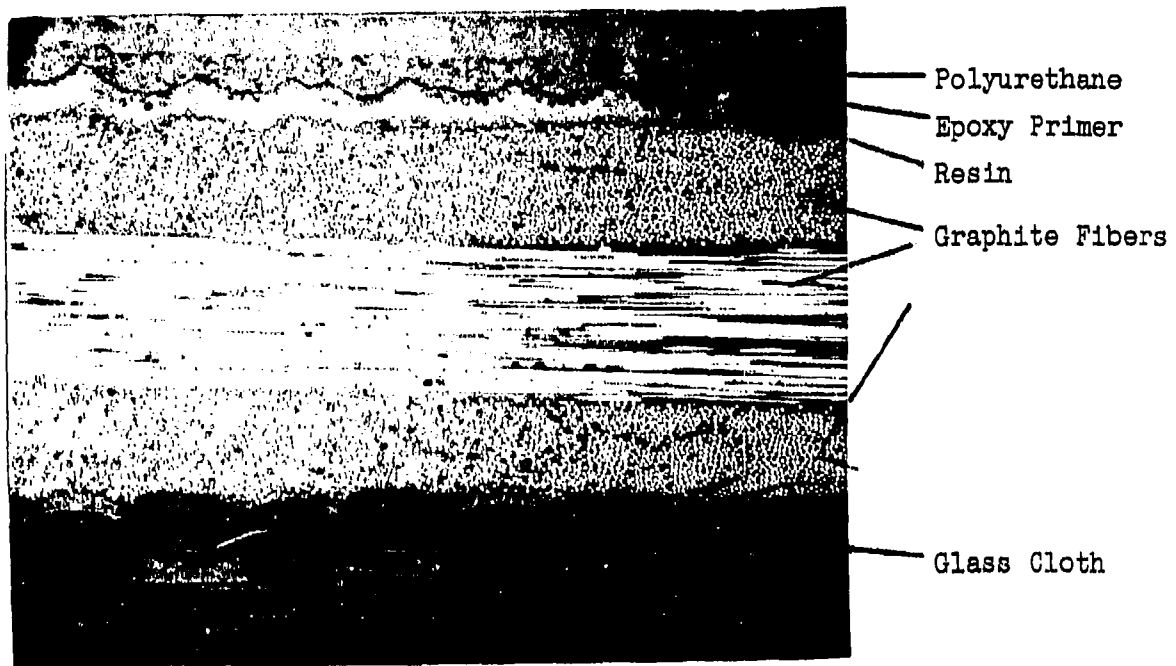
Figure 2. Laminate after paint removal. MAG. 100X  
Chemical Analysis:  $\text{Si}^{4+}$ ,  $\text{Fe}^{2+}$ , Al, Si, Cr

Figure 2 is a photograph taken after approximately 1.0 mils of the polyurethane was removed. None of the remaining paint layers appear damaged as a result of heat. This photograph shows a sharper image of the peel ply impression.

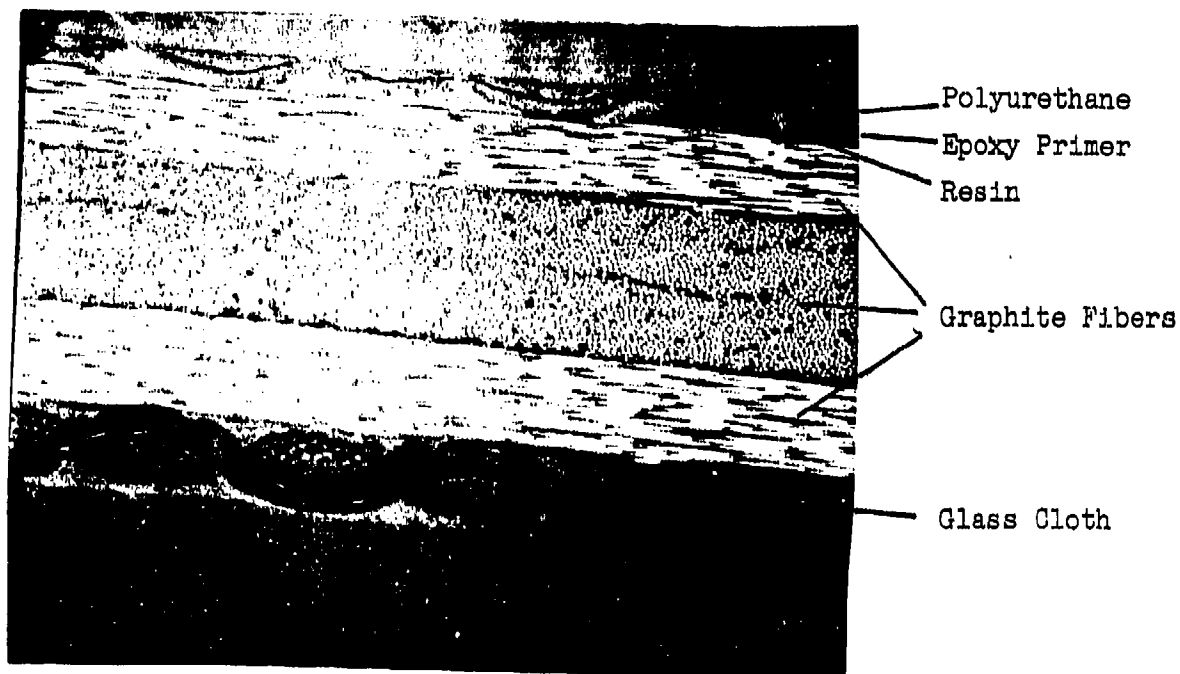
Figure 4. Laminate after most of the top coat is removed. MAG. 100X  
Chemical Analysis: Fe<sup>+</sup>, Si<sup>+</sup>, Ba, S, Cl

Figure 4 is a photograph taken after most of the polyurethane topcoat was removed. The primer and resin layer appear to be left intact by the flashlamp system. In addition, no signs of delamination are evident in any of the photographs.
