# The Prevention and Repair of Gel Coat Blisters

Thomas J. Rockett, Ph.D.  
Vincent Rose, Ph.D.  
Andra Kirsteins

9. Performing Organization Name and Address Department of Chemical Engineering University of Rhode Island Kingston, Rhode Island 02881				10. Work Unit No. (TRAVIS)

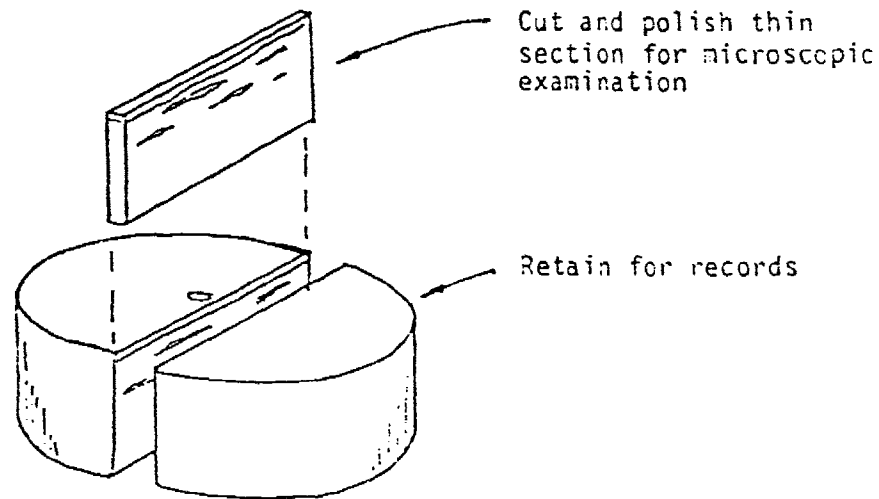
A. Thin Section Test

A core plug sample must be taken in a representative area. This plug may then be sectioned by making two parallel cuts, one to two millimeters apart, so that a thin cross section of the hull can be obtained for microscopic study. While this is the best method, an alternative is to cut the plug in half and sand the plug perpendicular to the hull surface to expose a flat cross-section. (See Fig. 1) After sanding, a red dye penetrant (such as Spotcheck, Magnaflux Corporation, Chicago) should be sprayed on the surface. Let the surface dry and sand to remove superficial red dye. Observe the cross-section and the damage (blisters, osmotic disk cracks, delaminations, and extensive glass debonding) will be strongly marked in red.

Figure 1. Preparation of core samples for damage evaluation
