FLOOD PROOFING TESTS

Tests of Materials and
Systems for Flood
Proofing Structures

August 1988

Prepared by
Structures Laboratory
US Army Engineer Waterways Experiment Station
for
Corps of Engineers
National Flood Proofing Committee

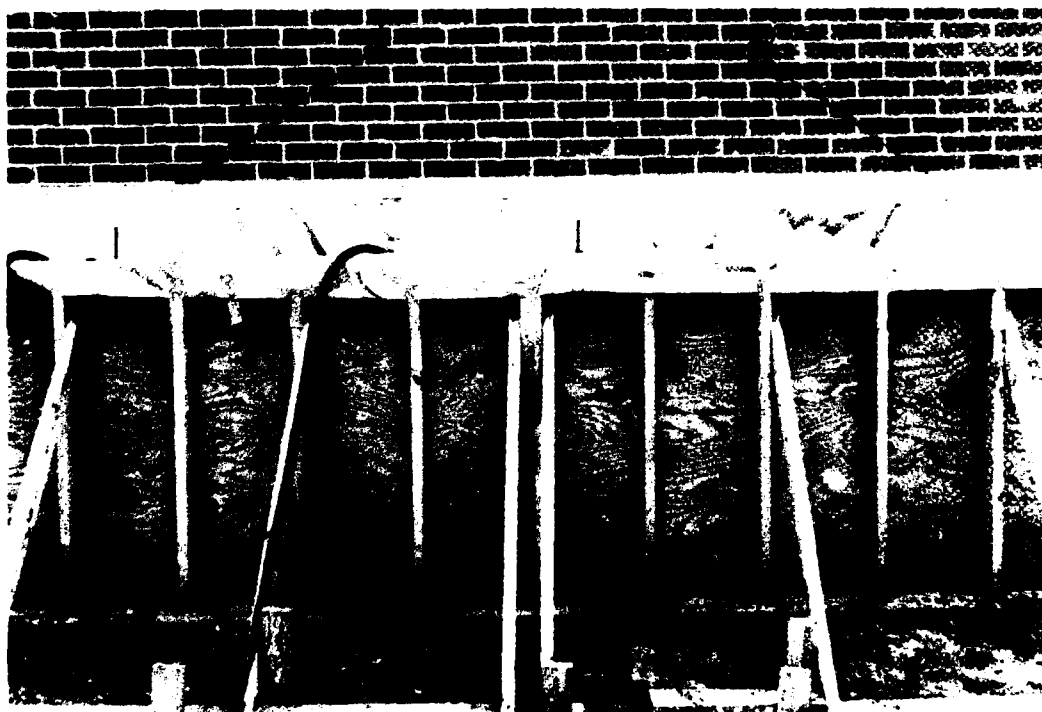
Figure 10. Wall 1. Failure pattern of wall

A severe loss of integrity began at 2 ft of water with complete loss occurring at 2.4 ft (Figure 8). The failure at 2.4 ft of water is presented in Figures 10 and 11.

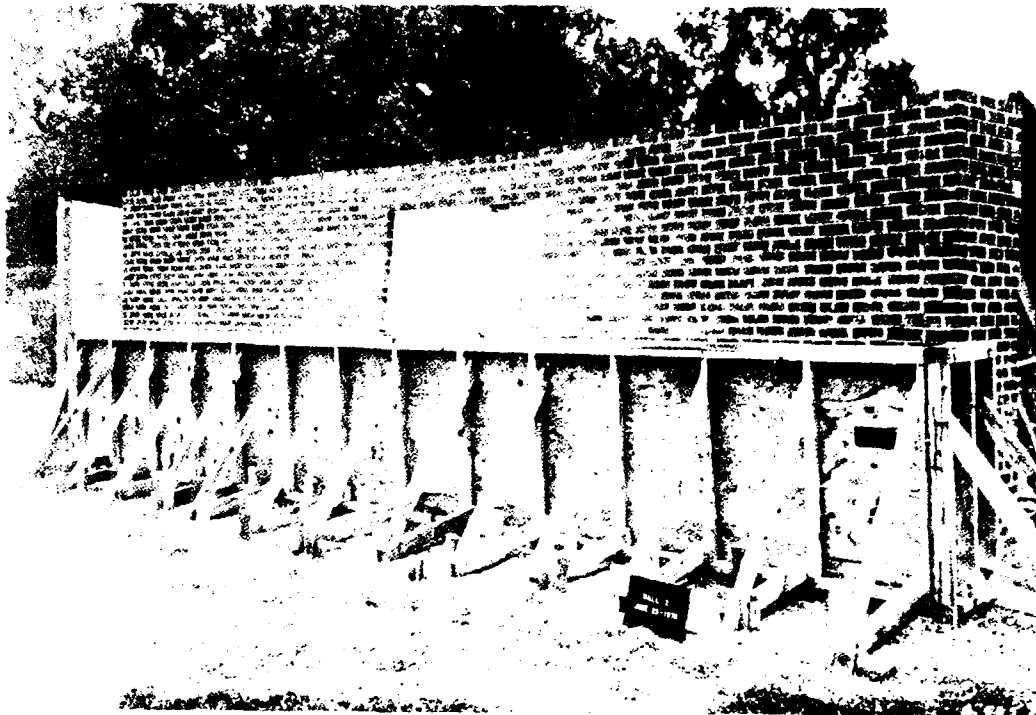
Figure 13. Wall 2. Wall failure, front view

The wall deflected forward for low water loads because cord lengthening in the vicinity of the loading caused the upper part of the wall to cup forward. In an actual home, the finishing materials on the inside of the studs will give support to the wall and allow it to experience a deeper water loading than indicated by these tests. Computer solutions could be used to determine the effect of such restraints. The significant point is that the deflections recorded for Wall 2 at a given water depth should be an upper bound of deflections experienced in an actual brick-veneer house under the same loading. The failure of Wall 2 is shown in Figures 13 and 14.

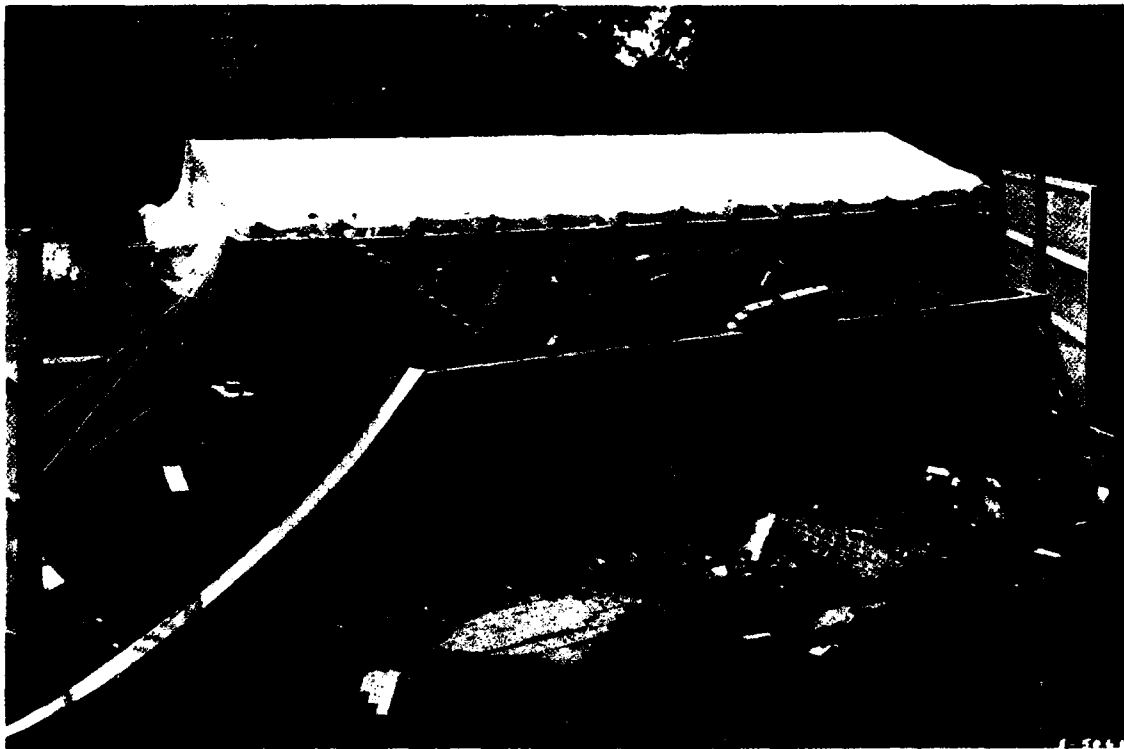
Figure 16. Wall 3. Wall failure, front view

Total collapse of the brick-veneer wall occurred at a depth of 57 in. and at a total applied force of 18,300 lb. This failure was sudden and resulted from the failure of the supporting studs. The remains of the brick-veneer wall after failure are presented in Figures 16 and 17.

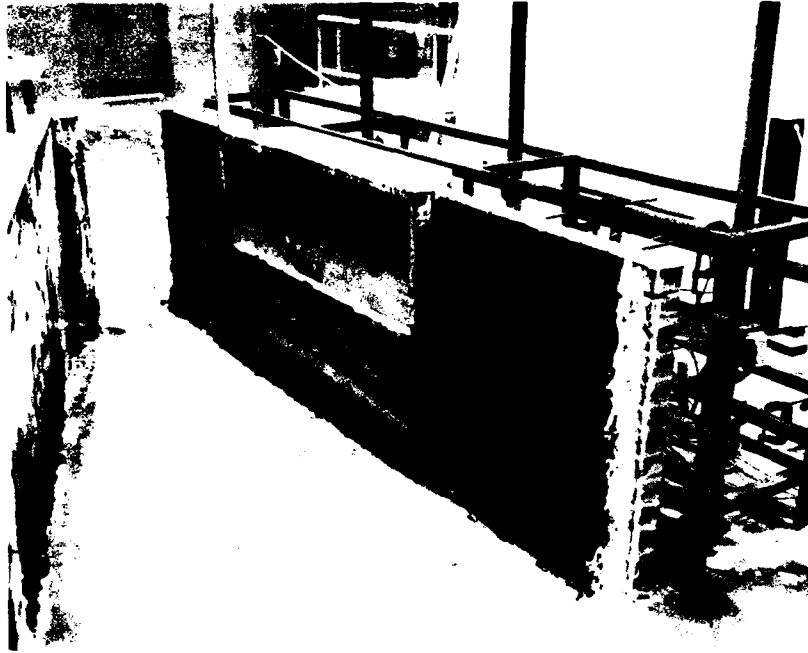
3	Same as Tests 1 and 2.	Coated with asphalt cement. Figure 37 shows the wall after the test.	The wall continued to leak in a couple of places. After the bulkhead was removed, no flaws could be observed in the asphalt cement coating in areas where the wall leaked. This implies that great care must be exercised, even if asphalt cement is put on the wall, or water will penetrate the house. The wall leaked so badly that the closure was not tested for water.

Figure 37. Brick walls coated with asphalt cement

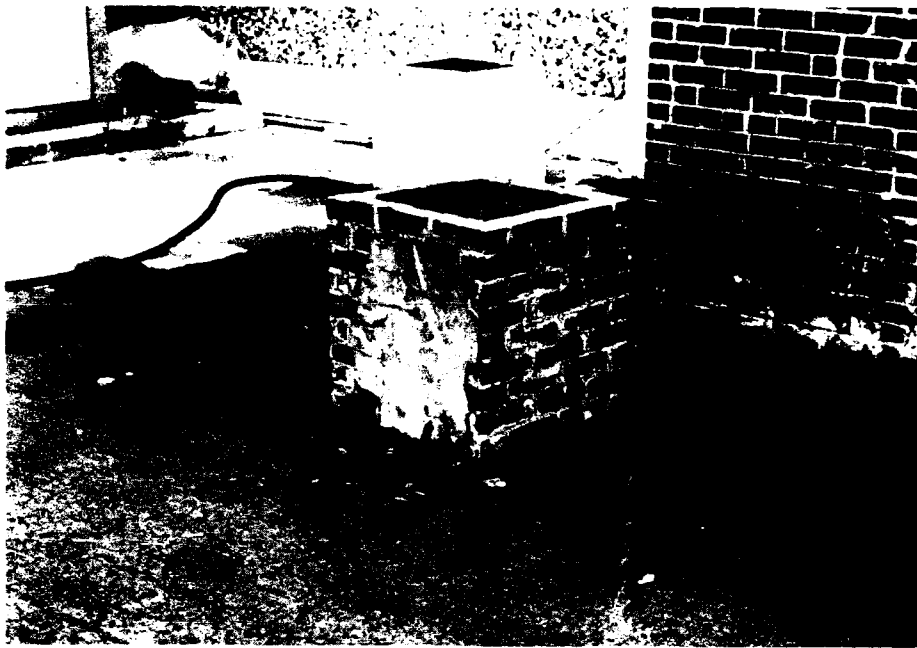
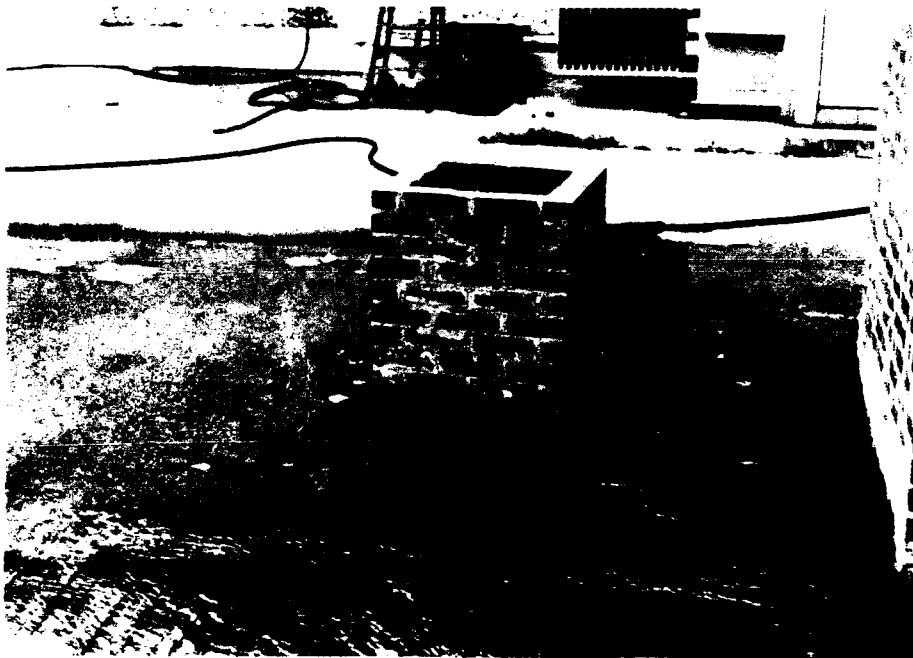
Figure 46. Failure of coating 4

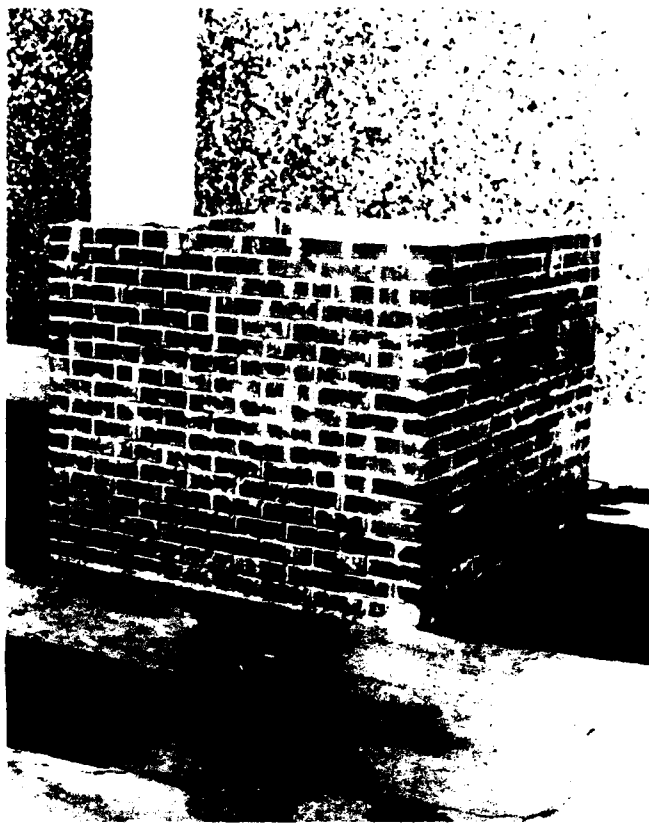
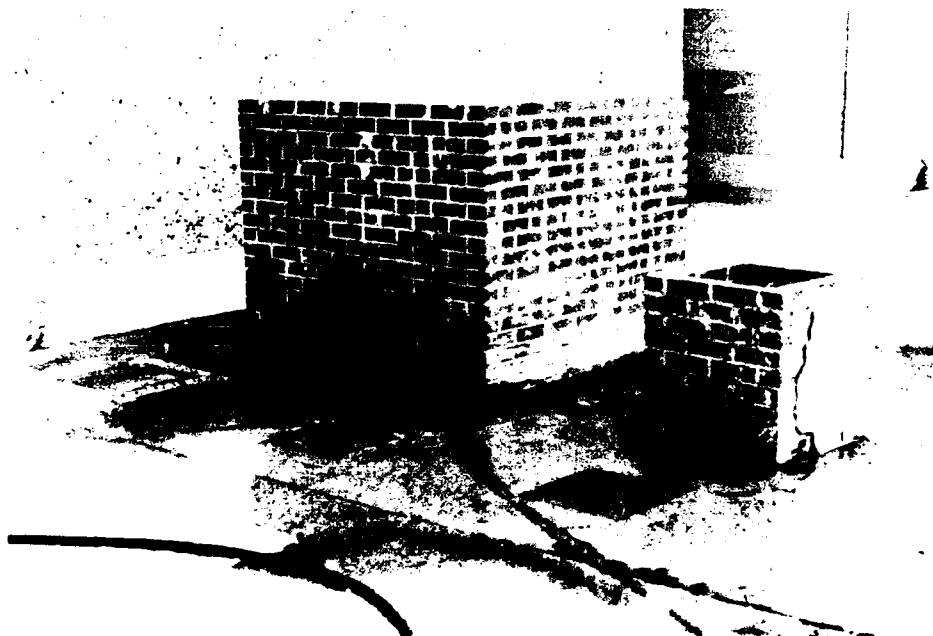
Figure 52. Dye in water leaking from large brick cube

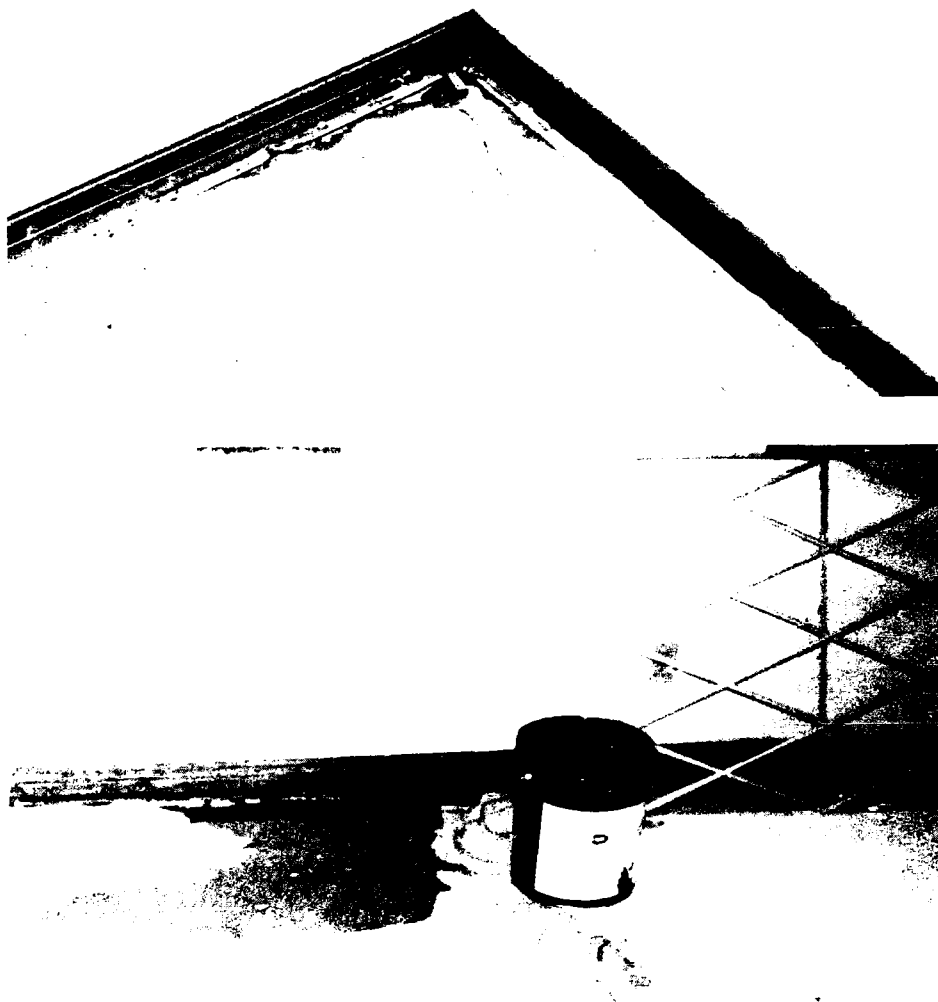
Figure 74. Seepage along baseboard due to leak in
lap of fabric
