# CRREL REPORT 89-10

*Definition of research needs to address  
airport pavement distress in cold regions*

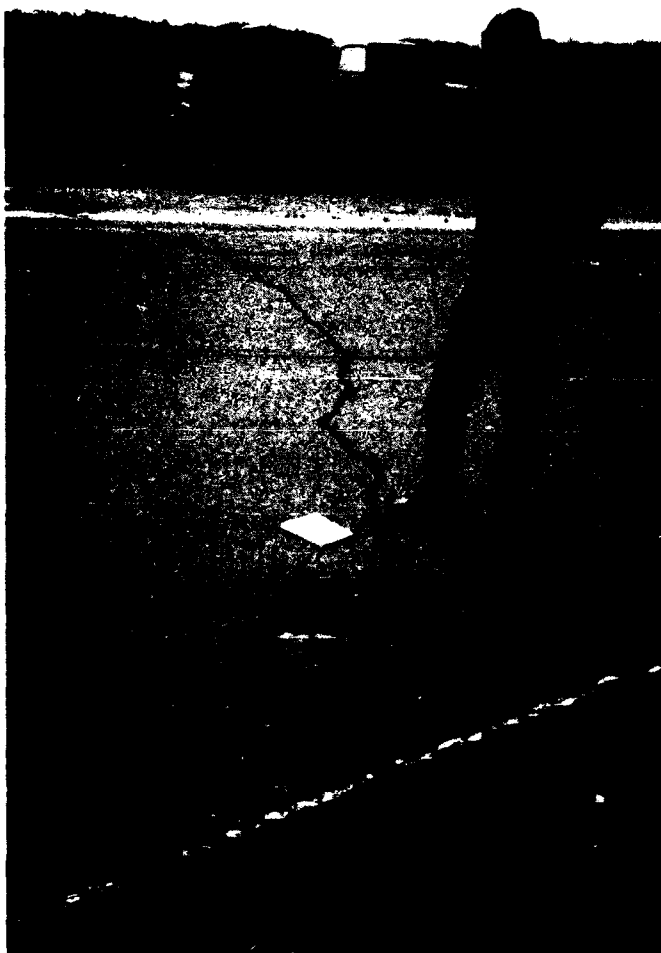
Figure 20. Transverse cracks in AC pavements caused by low temperatures.

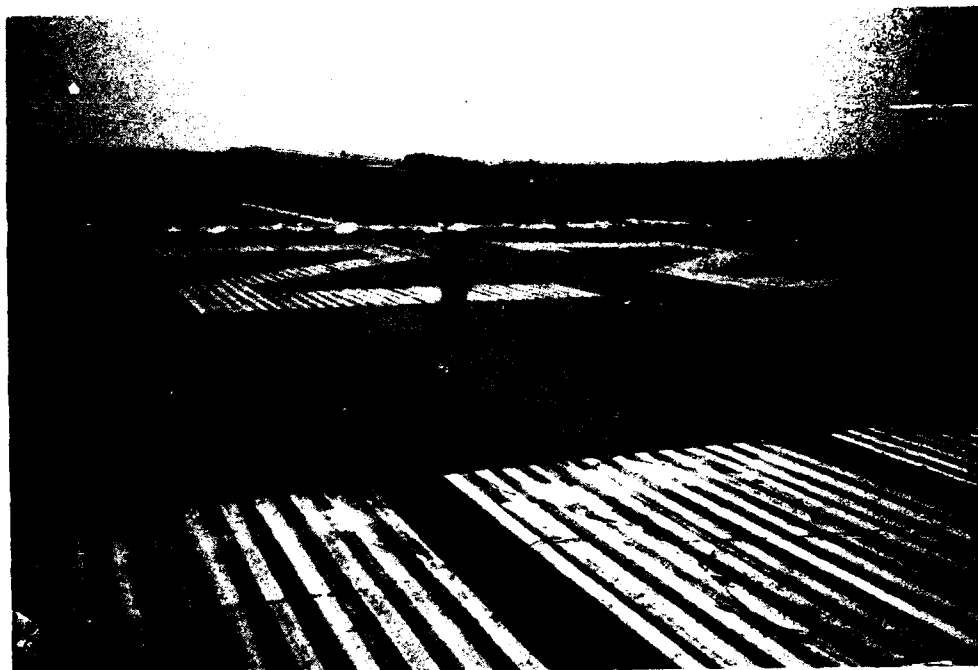
ed with 1) lower temperatures, or 2) the fact that the asphalt cement hardens with age and changes the properties of the surface layer. With time, the crack spacing may decrease substantially and eventually create a complex pattern of transverse cracks exemplified in Figure 23.

*Figure 23. Decrease in crack spacing and increase in complexity of transverse crack spacing.*

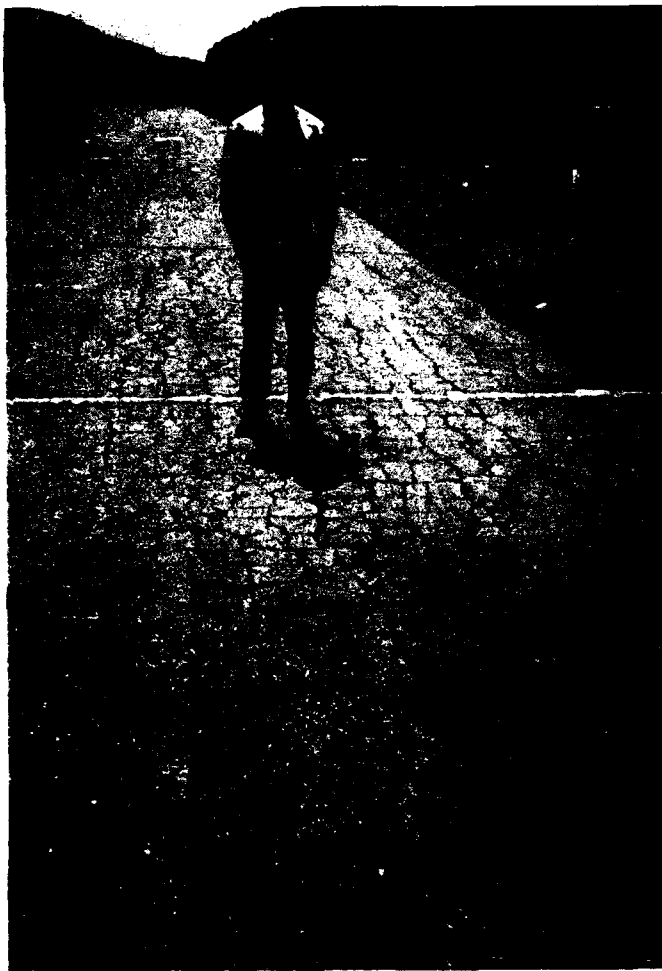
*Figure 24. Thermal fatigue cracking.*

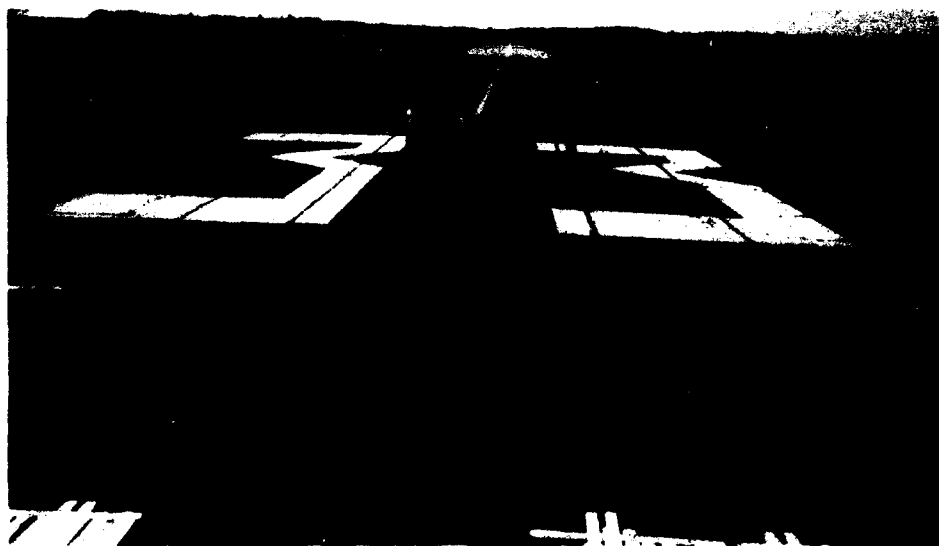
*Figure 25. Longitudinal cracks associated with contraction of AC and/or improperly constructed lane joint.*

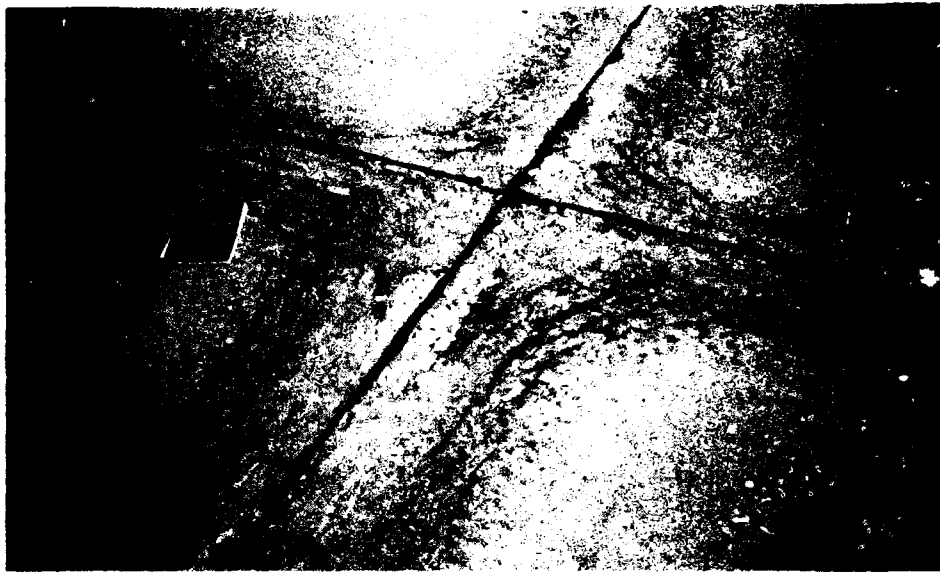
*a. Characteristic pattern of "D" cracking in the vicinity of slab corners.*

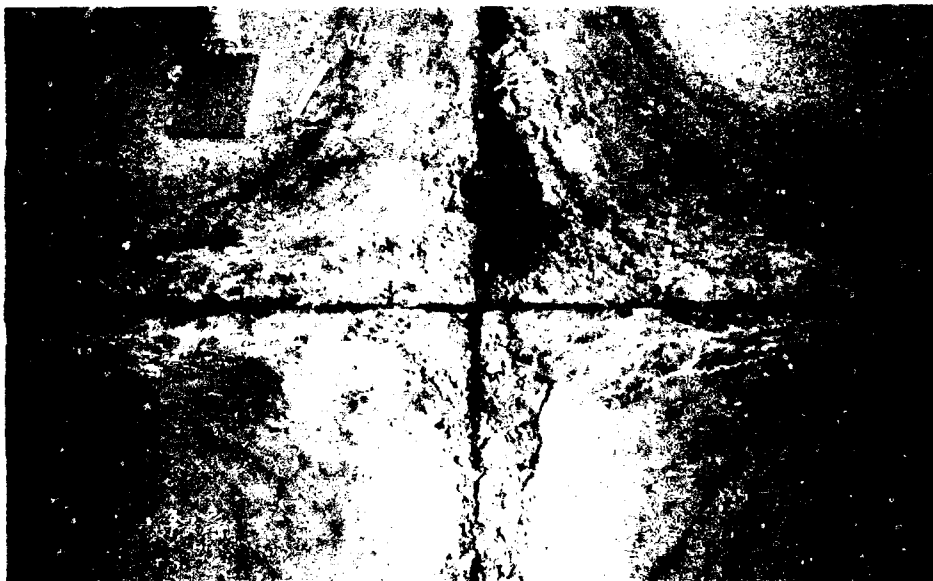
*b. Disintegration of concrete related to "D" cracking.*

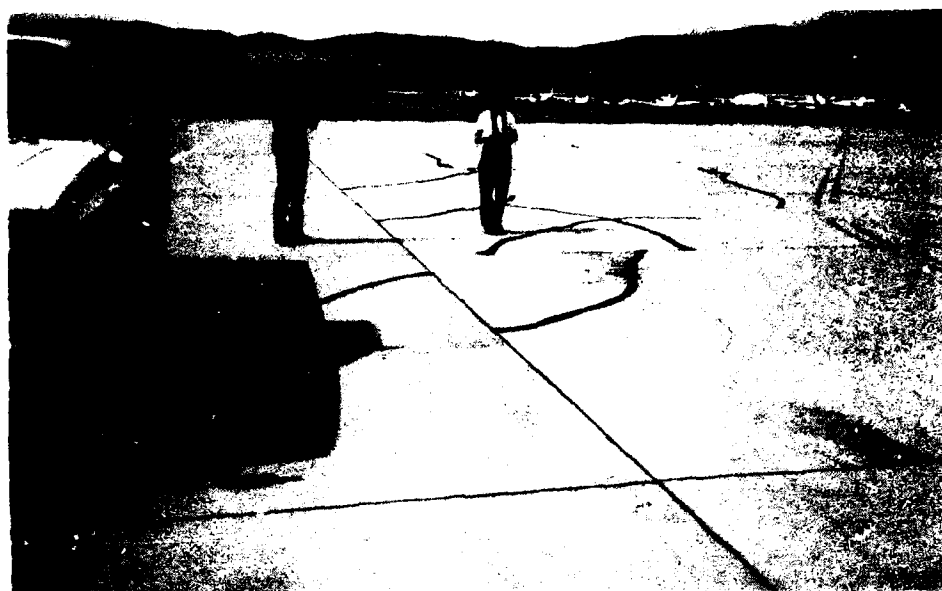
*Figure 31. Corner breaks associated with loss of slab support and applied load.*

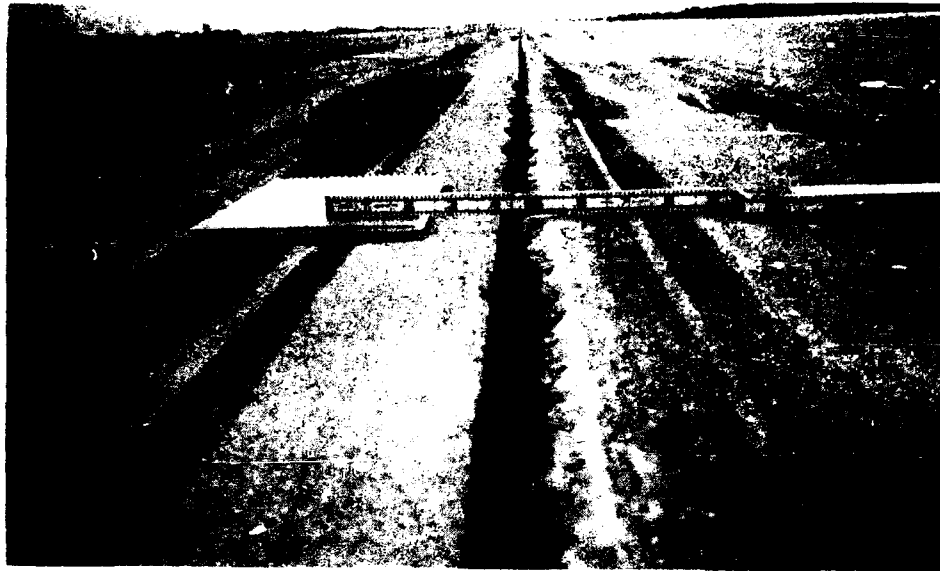
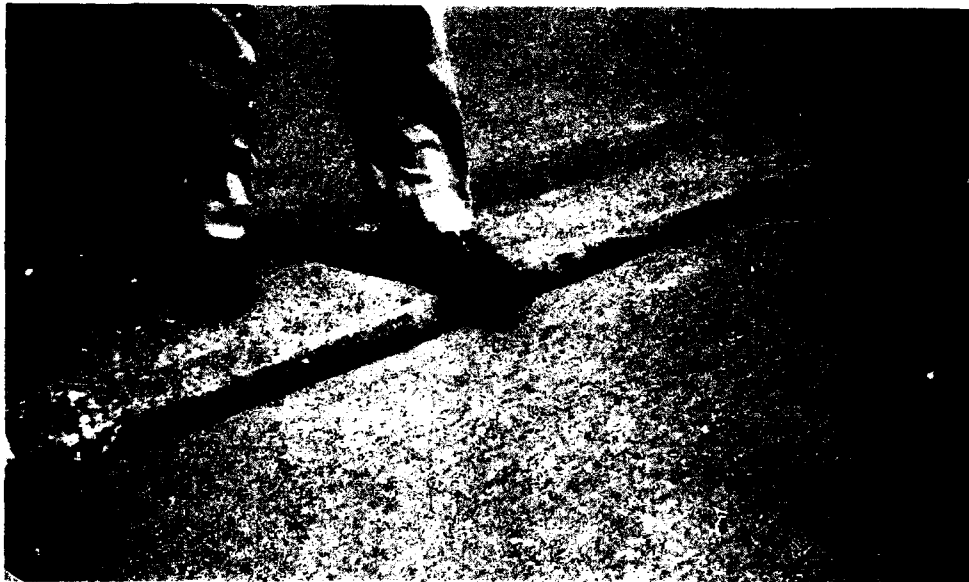
*Figure 33. Distortion of PCC pavement surface caused by frost heave.*

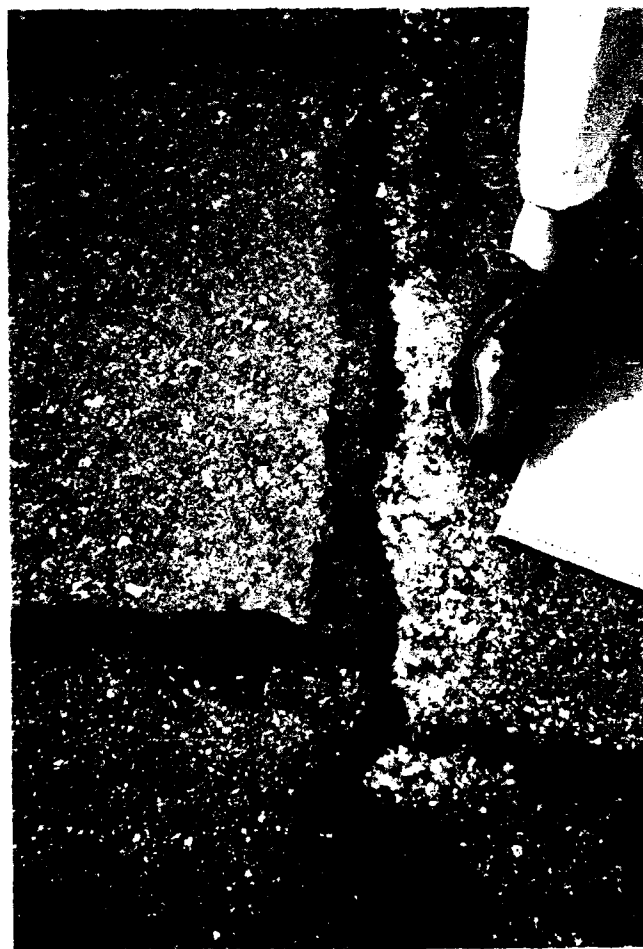
*Figure 34. Distortion of AC pavement surface caused by frost heave.*

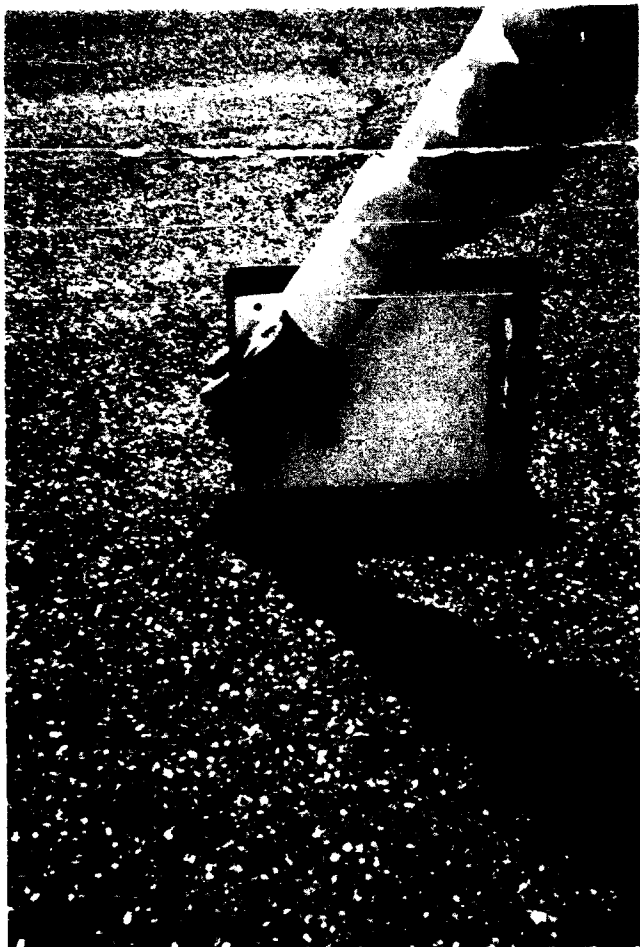
*a. "Lipping" at a crack.*

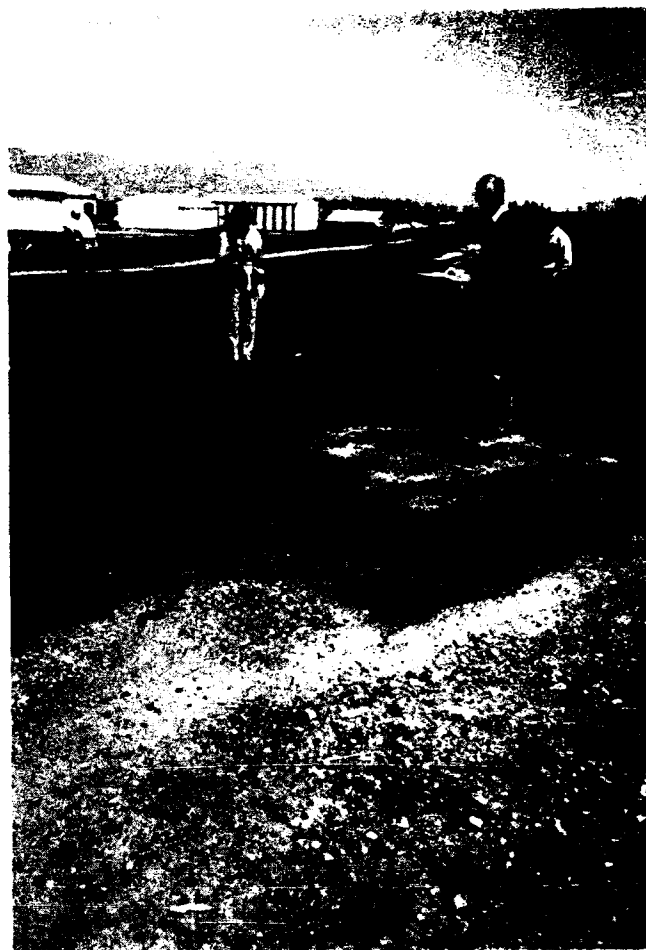
*b. Residual "birdbath."*

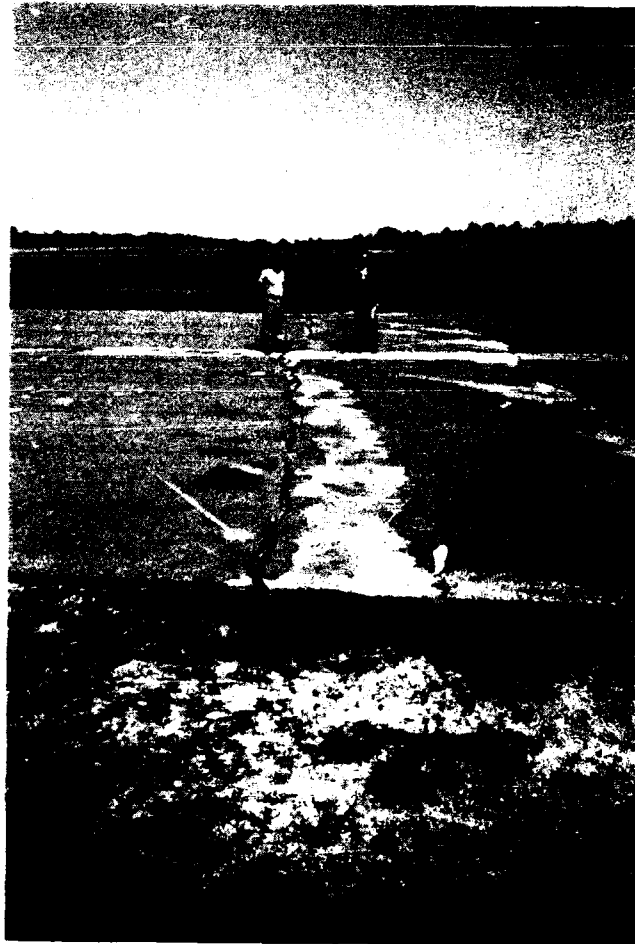
The greatest differential movements observed were often associated with differences in soil frost heave response. Figure 38 shows evidence of a difference in soil response between the backfill material in a culvert trench and the adjacent soil underlying the pavement. The backfill material appears to exhibit greater frost heave than

Figure 38. Damage caused by differential frost heave across a backfilled culvert trench.

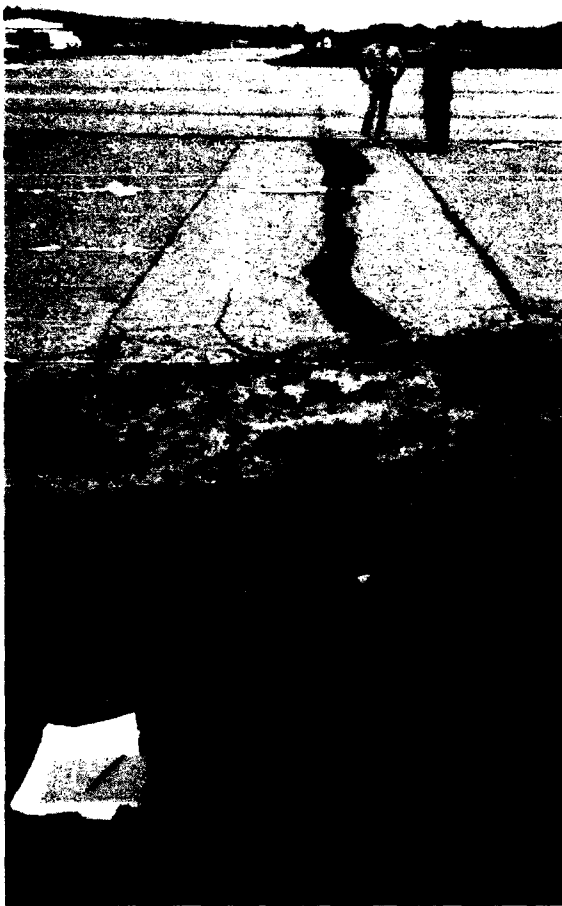
Figure 39. Consequences of differential frost heave in the vicinity of an abandoned culvert trench backfilled with material "matching" surrounding subgrade soils.

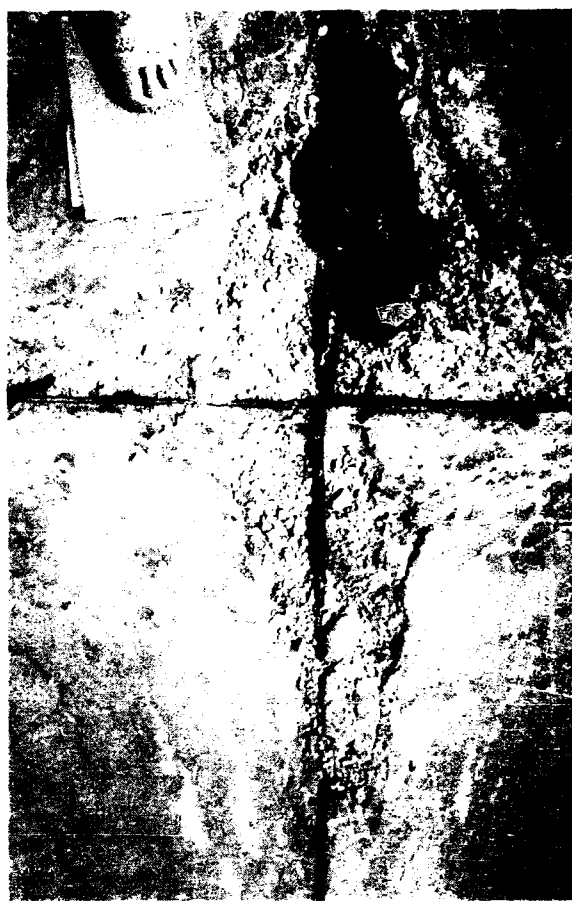
Figure 42. Disintegration in the vicinity of the corner of a PCC pavement.

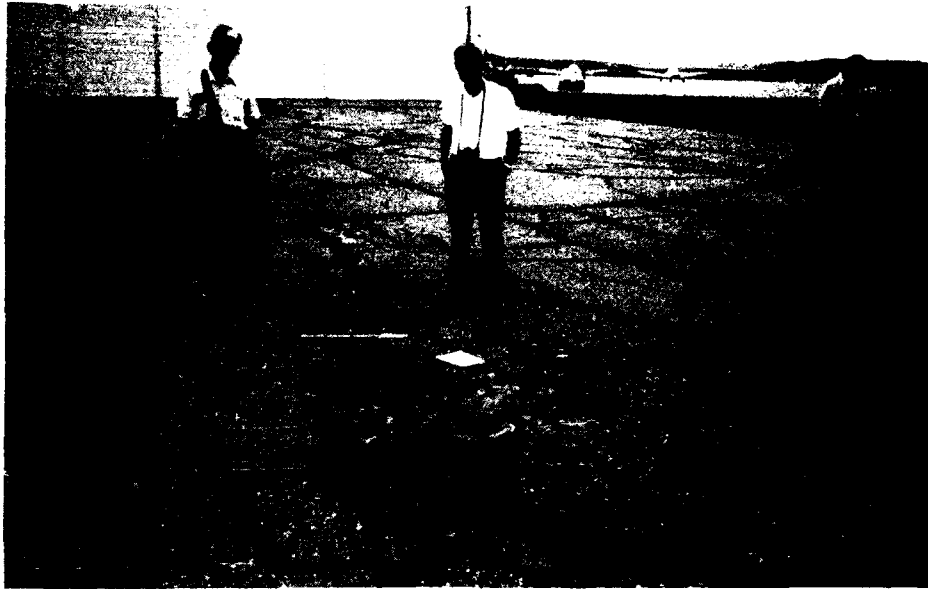
*Figure 43. Disintegration in an AC parking apron.*

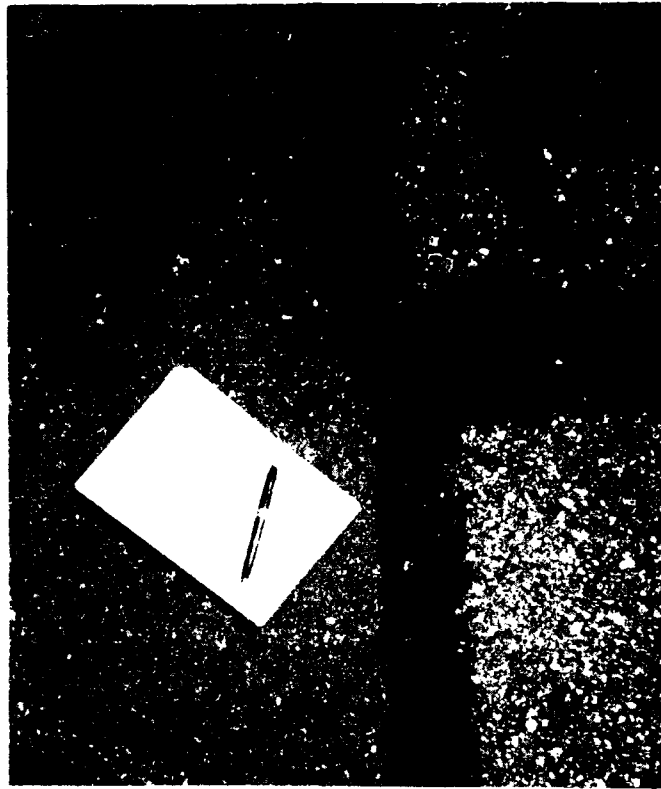
*a. Crack at construction joint between replaced pavement section and old pavement structure.*
