SETA Contract Number
F11624-88-D-002
Delivery Order 6K04
CDRL A004

Technical Report - Study/Services
Analysis of PC-2001 NIC Backplane Adapter

18 October 1989
Cargo Movement Operation System (CMOS)

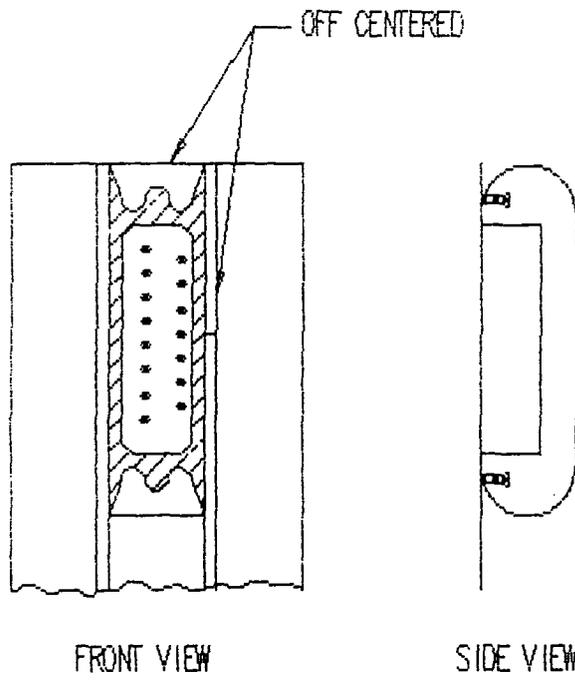
PC-2001 NETWORK INTERFACE CARD

INTRODUCTION: This report describes a deficient engineering design in the Ethernet transceiver drop cable connector on the PC-2001 NIC. (See Attachment 1)

SUMMARY: Problems in the sliding lock and connector mechanism on the PC-2001 NIC (Network Interface Card) can prevent the terminal from accessing the network and can lead to premature failure of the NIC.

ANALYSIS: During the installation of the PC-2001 NIC in the Z-248 microcomputers, we observed that the sliding lock mechanism (see Attachment 1) used to secure the transceiver drop cable seemed to be too wide for the slot in the back of the computer. Closer examination showed the assembly width was not the problem, but rather it was not properly placed on the card's mounting bracket. This connector and lock assembly placement was incorrect on all PC-2001 NICs used in the lab installations. The improper placement prevents the card from being installed squarely on the microcomputer's mounting plate. Since the card cannot be correctly aligned, the board is flexed which can lead to early component or trace failure. Additionally, we observed that the sliding lock mechanism is prevented from working correctly as it binds on the microcomputer's mounting plate. Since the locking mechanism binds, it does not securely hold the transceiver drop cable. In two instances, the drop cable fell out of the assembly under its own weight. Any additional strain simply aggravated the condition.

CONCLUSION: The PC-2001 NIC must be modified to properly locate the connector assembly to ensure proper card placement in the computer. This will prevent early NIC failure and help ensure the terminal has access to the network. This modification would be difficult to implement in the field.

RECOMMENDATION: This problem can only be corrected by increasing the distance between the actual connector and the NIC component board. The relationship between the NICs connecting bracket and the printed circuit board is correct. Once the actual connector is raised above the printed circuit board, the metal connecting bracket will have to be remounted.
