MTL TR 89-90

# FAILURE ANALYSIS OF A MISSILE LOCKING HOOK FROM THE F-14 JET

VICTOR K. CHAMPAGNE, Jr. and GARY WECHSLER  
MATERIALS TESTING AND EVALUATION BRANCH

September 1989

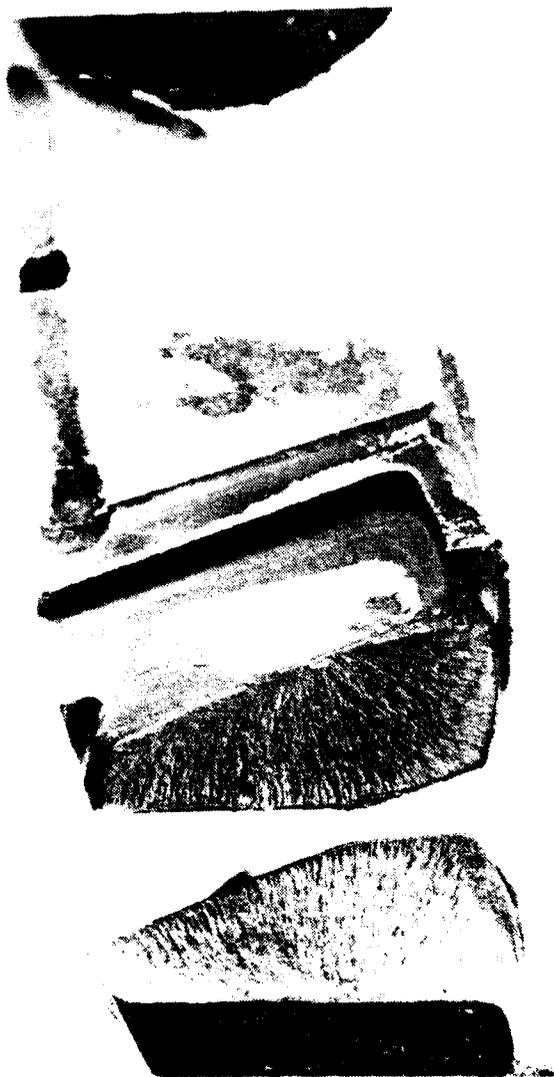
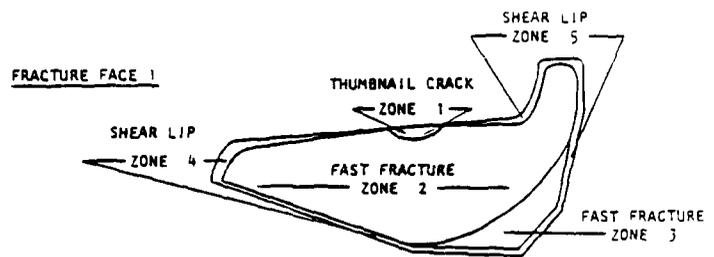
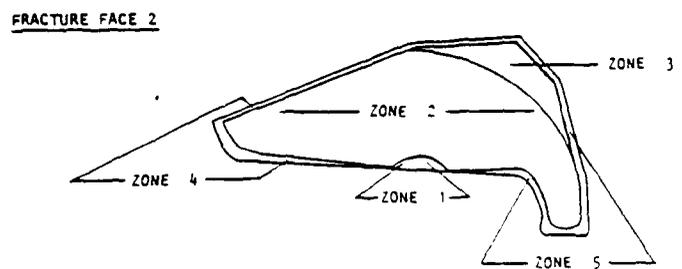
Figure 2 shows the area of concern on the missile hook, at low magnification. The failure occurred along the lower radius of the machined lip. Radial marks were easily distinguishable on the fracture faces. These lines resulted from the intersection and connection of fractures propagating at different levels. The crack initiation site was identified when these lines were traced back to the point of convergence (refer to Zone 1). Some of the outside edges of the fracture faces contained shear lip zones which were characterized by their gray, silky appearance. At the crack origin, a typical "thumbnail" crack could be seen extending outward (refer to Zone 1) which suggested that an older crack may have existed before final, fast fracture occurred. This was later verified by further examination.

Another notable feature of the fracture surface was an area that resembled a "quarter moon" (refer to Zone 3). Scanning electron microscopy (SEM) was utilized to obtain additional metallurgical information from this region as well as the remaining fracture surface. These results are included as part of the fractographic analysis of this report. Fracture Face 2 appeared to have less corrosion and surface debris than Fracture Face 1. It was later discovered that Fracture Face 2 was recovered from the deck of the aircraft carrier after the failure occurred and placed in storage, protecting it from the elements. Fracture Face 1, however, was still attached to the aircraft and was removed at a much later date. The salt water environment caused additional corrosion to take place on the unprotected fracture surface.

Figure 2. Macrograph of the failed missile hook showing the fracture faces. The schematic to the right identifies different regions of the fracture which were examined.

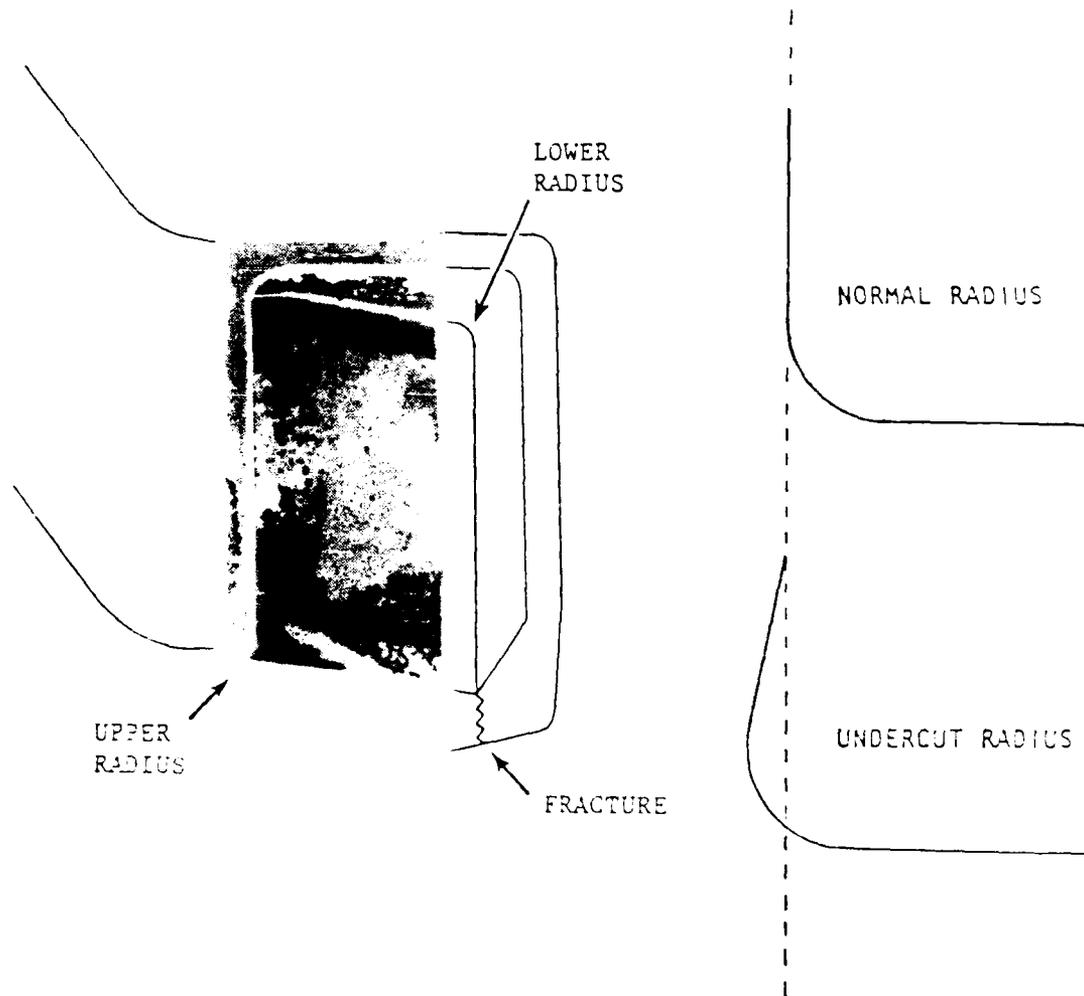
The upper radius of the machined lip, as shown in Figure 7, was measured and found to be approximately 0.015. The engineering drawing of the missile hook, as depicted in Figure 5, specified a radius of 0.02 to 0.03. This measurement might serve as an indication that the lower radius was also machined slightly sharper than specifications allowed, since both radii are continuations of each other, having the same specified measurements and tolerance ranges. The lower radius, where the fracture originated, could not be measured accurately because the material had been deformed in this area as a result of the failure.

Another notable feature of the radius along the machined lip was the fact that it was undercut, as revealed in Figure 7. The schematic located adjacent to Figure 7 illustrates this point. An undercut radius reduces the cross-sectional area of the load-bearing region, decreasing its strength. A sharp radius will serve as a stress concentration area and have a detrimental effect on the fatigue life of the component.

Figure 7 Macrograph showing the undercut radius of the missile hook, Mag. 3X.

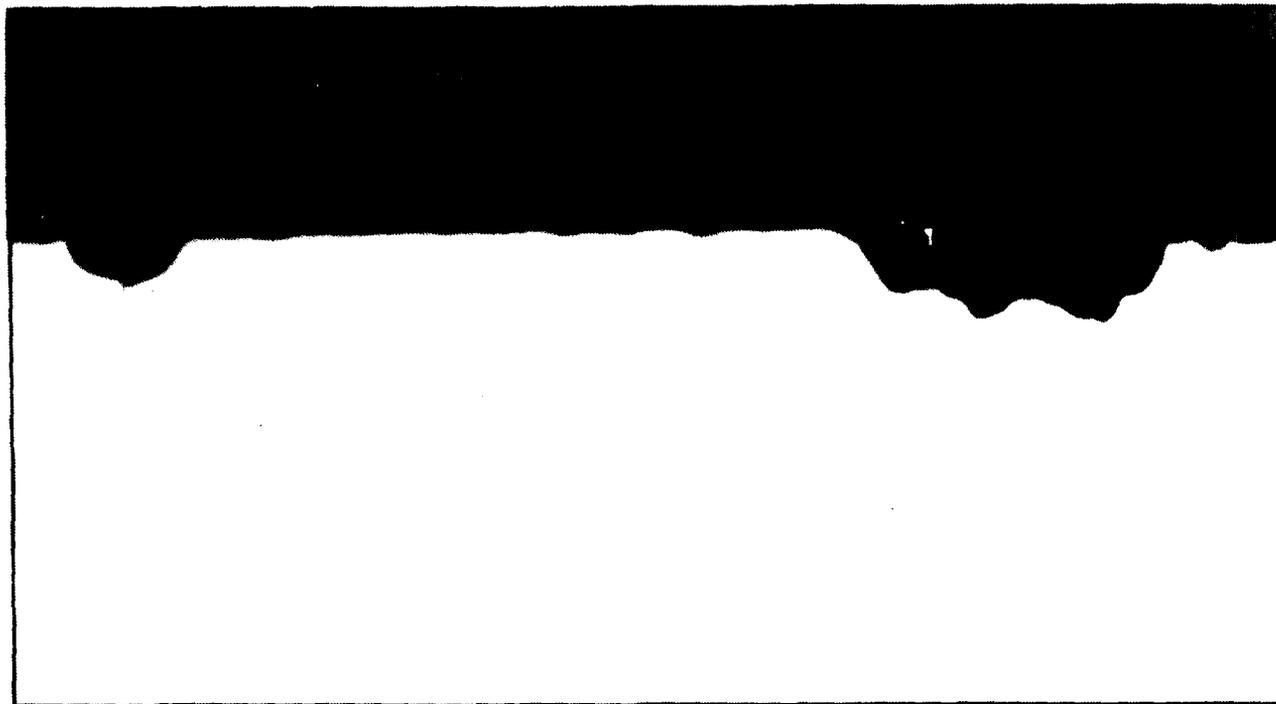
Pitting may also be detrimental to the useful service life of the component because the root of a pit is an area of high stress concentration where a fatigue crack could initiate and propagate. Figures 12 through 14 show transverse cross-sectional views of specimens in the as-polished condition that contained pits.

Figure 12. Micrograph revealing evidence of pitting attack. Pit depth is 0.002 to 0.005 inches, Mag. 100X.

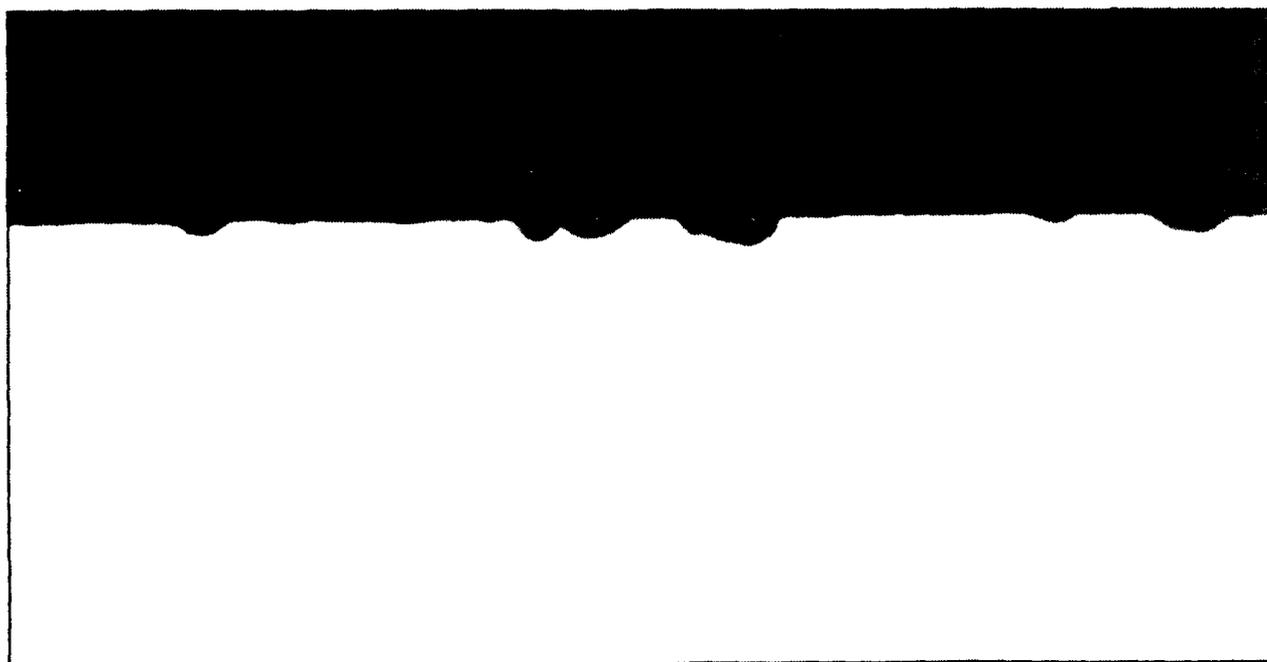
Figure 13. Micrograph showing a number of isolated pits. Maximum pit depth is 0.002 inches, Mag. 100X.

The amount of pitting found on the surface near the fracture varied. Some areas contained pits that were isolated, as shown in Figure 13. Other regions developed pits that were so close together that they resembled a rough surface, as seen in Figure 14.

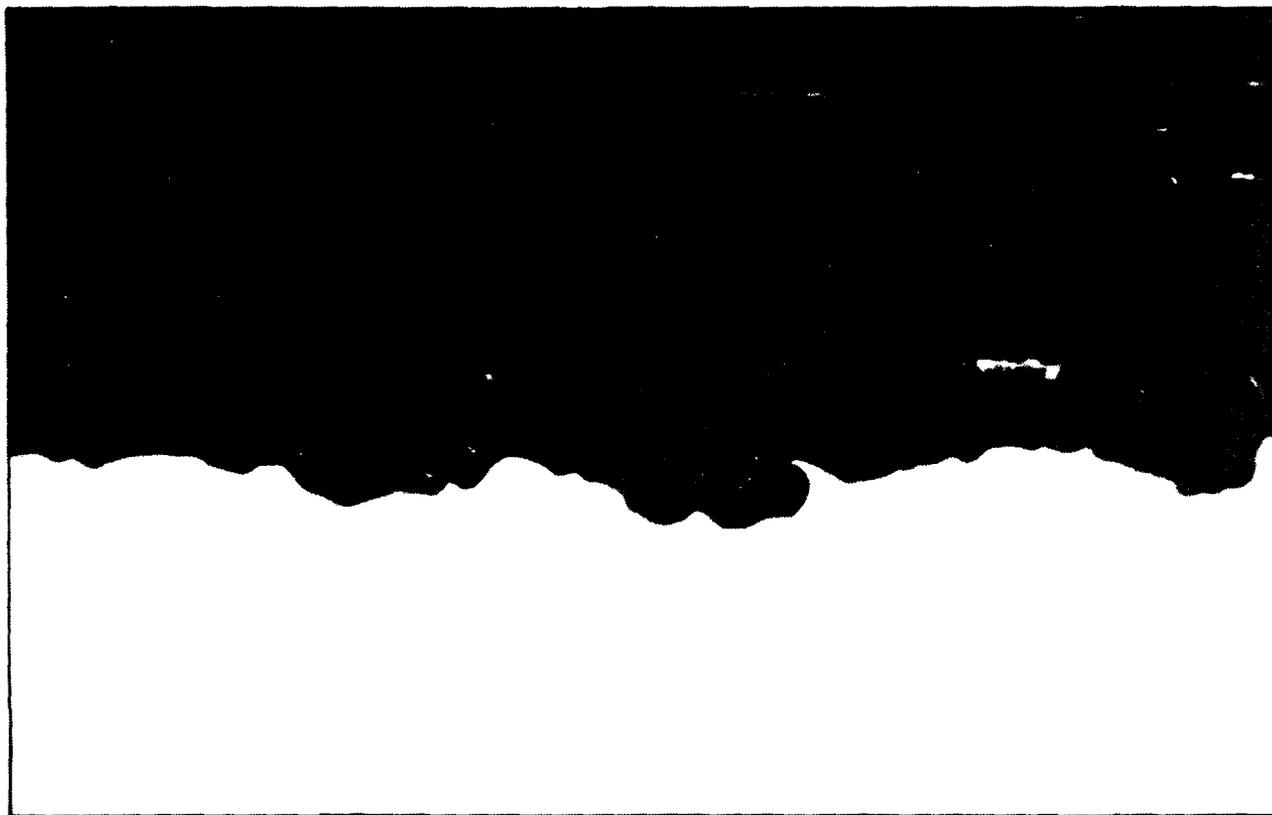
Figure 14. Micrograph of a region which contains extensive pitting damage, Mag. 100X.

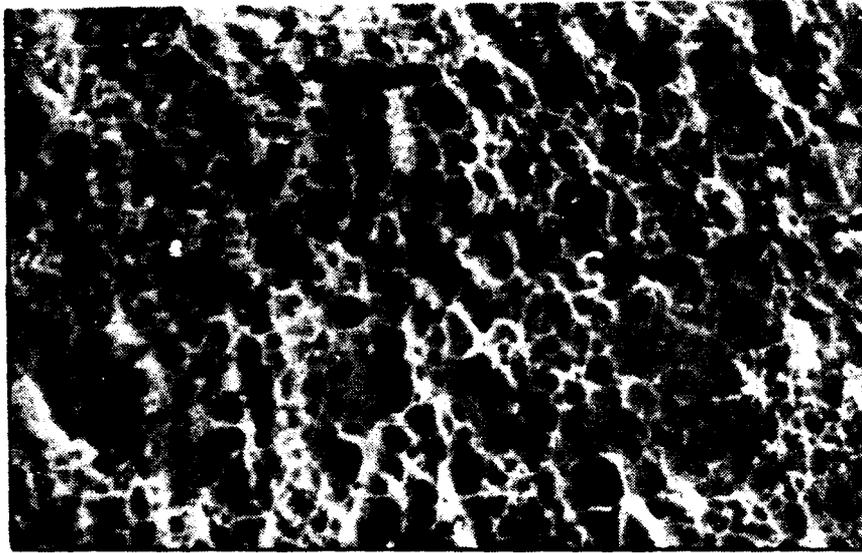
The surface topography of Zone 2 is represented by Figure 21. Well-developed conical equiaxed dimples indicative of microvoid coalescence can be seen in this figure. This type of fracture mode occurs under a primarily uniaxial tensile stress and is most commonly associated with an overload condition.

The area previously described as resembling a "quarter moon" was examined and labeled as Zone 3. This region was most likely the result of a brief interruption of the advancing crack front (such as a shift or a change in loading) which later resumed its course until final rupture occurred. The single progression mark that outlines Zone 3 remains as evidence supporting this conclusion. Zone 3 also contained a conical equiaxed dimpled surface, confirming that the fracture mode was similar to that of Zone 2, as depicted in Figure 21.

Figure 21. SEM fractograph representative of Zone 2 and Zone 3 showing a surface consisting of conical equiaxed dimples, Mag. 2000X.

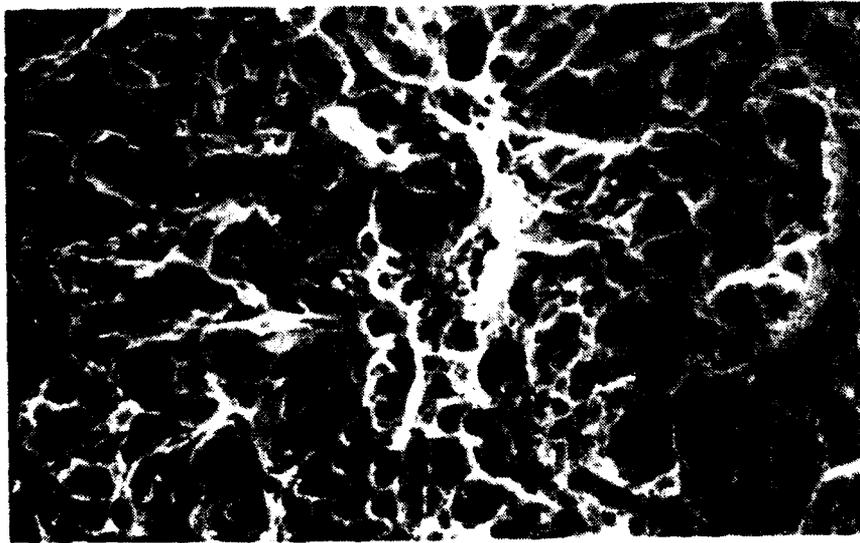
The fracture regions identified as Zones 4 and 5 were determined to be shear lips. These areas were the result of a stress change to macroshear, forming fractures approximately 45° to the plane of the fracture. Figure 22 reveals the surface morphology of these shear lip regions. Dimples which are directional can be seen in this SEM fractograph.

Figure 22. SEM fractograph containing slightly directional dimples indicative of Zone 4 and Zone 5, Mag. 2000X.

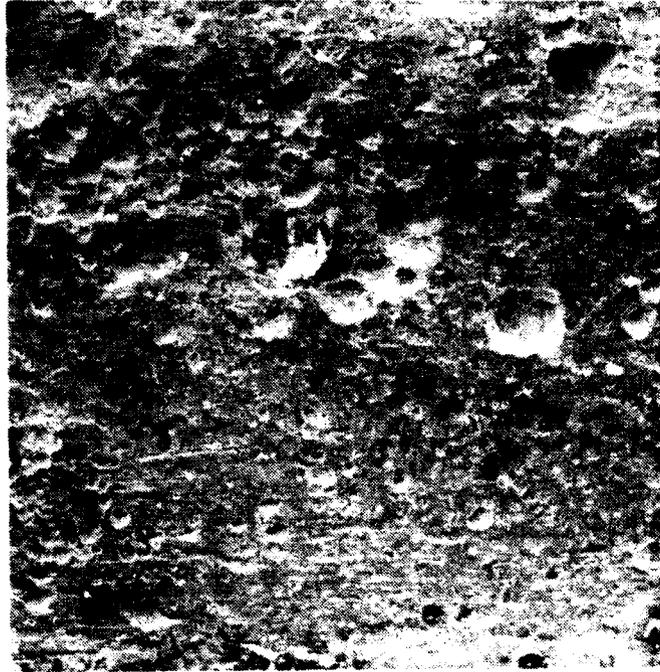
The surfaces adjacent to the fracture were also examined utilizing the SEM. Figure 23 is representative of many of the locations observed. The absence of a protective coating in these regions allowed extensive pitting to take place. Pits act as localized stress concentration areas and may initiate a crack. Figure 24 shows an example of how a crack initiated at the root of a corrosion pit.

Figure 23. SEM micrograph of the severely pitted surface adjacent to the fracture site, Mag. 100X.

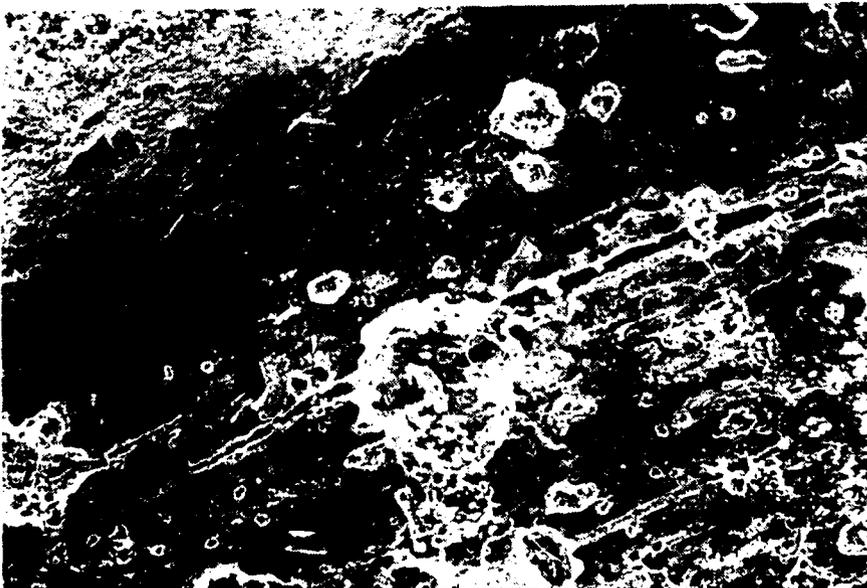
Figure 24. SEM micrograph of a crack that has initiated from the root of a corrosion pit located on the machined surface adjacent to the fracture, Mag. 250X.

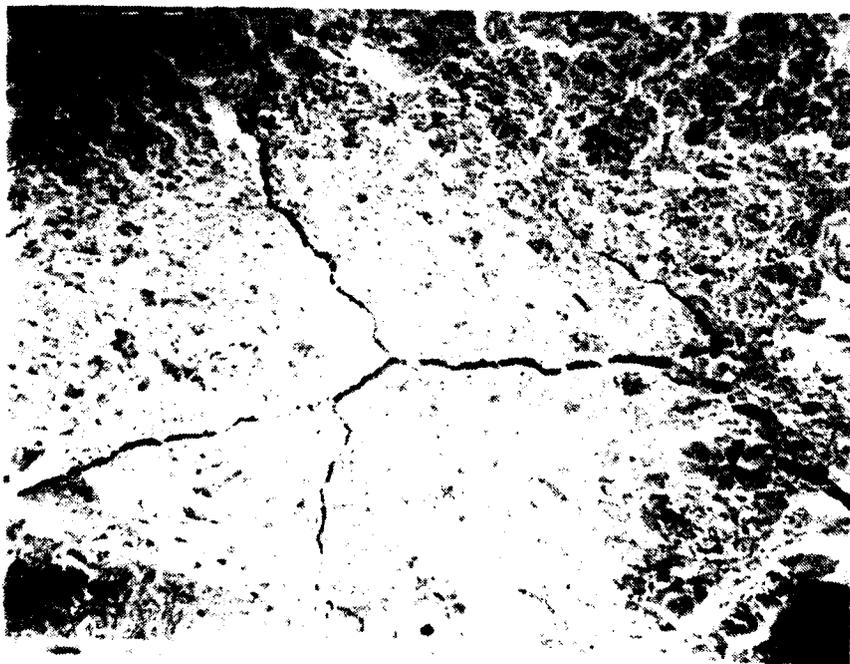
Figure 26. SEM fractograph showing the cracked region outlined on Figure 25, at higher magnification, Mag. 260X.
