Applied Report 84

RAAF ORION AIRCRAFT A9-300
OXYGEN FIRE(U)

This report summarizes the findings of the investigation into the nature and cause of the fire in RAAF Orion aircraft A9-300. This aircraft was destroyed by fire which initiated in the oxygen system as the result of an explosion caused by metal ignition.

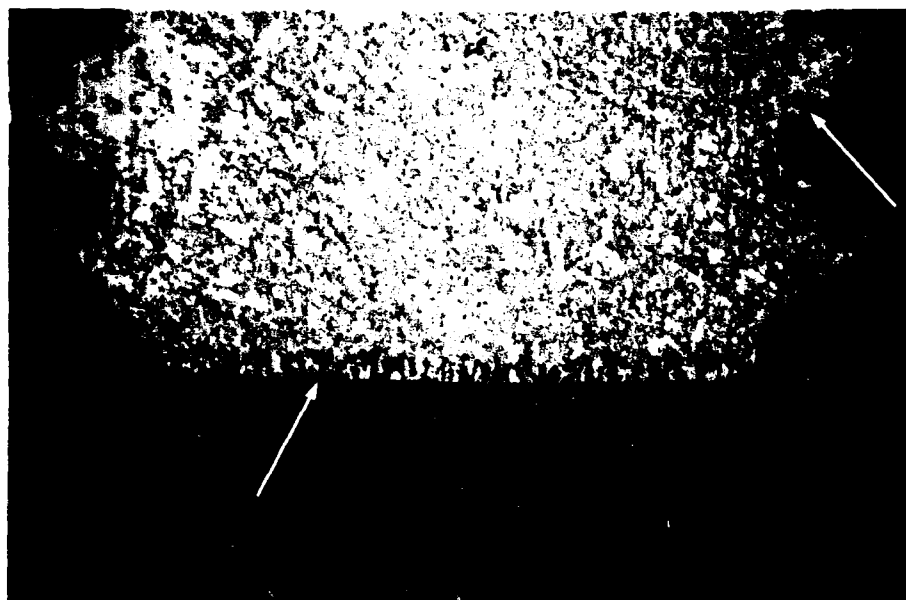
Inspection of the poppet valve from No. 3 inlet poppet chamber (Figure 8), showed that the head of the brass screw (Figure 3, detail A, item 5), which holds the poppet seal (item 7) in place, was missing. A cross-section of the screw was examined (Figure 9a) to determine whether the missing head was due to fire damage or another mechanism. This revealed that dezincification corrosion had occurred. Dezincification is the localized corrosion of brasses which leaves a spongy, structurally weakened mass of the more noble element, copper, partially bonded in place at the site of the corrosion to the corrosion products (in this case mainly zinc oxide). This form of corrosion is promoted by water with a high oxygen content. Some of the remaining copper had oxidized and was concentrated near the surface of the corroded material. The net result of this form of corrosion was that sound metal was slowly changed to a brittle, porous mass of copper. The corrosion extended to the base of the screw (Figure 10) indicating that it had occurred prior to the fire.

FIGURE 10. SECTION THROUGH BRASS SCREW OF POPPET VALVE FROM No. 3 CHAMBER (FIGURE 3, DETAIL A, ITEM 5). NOTE THE CORROSION (EXAMPLES ARROWED) ALONG THE EDGES OF THE SCREW THREAD AND THE BASE OF THE SCREW AS A RESULT OF DEZINCIFICATION

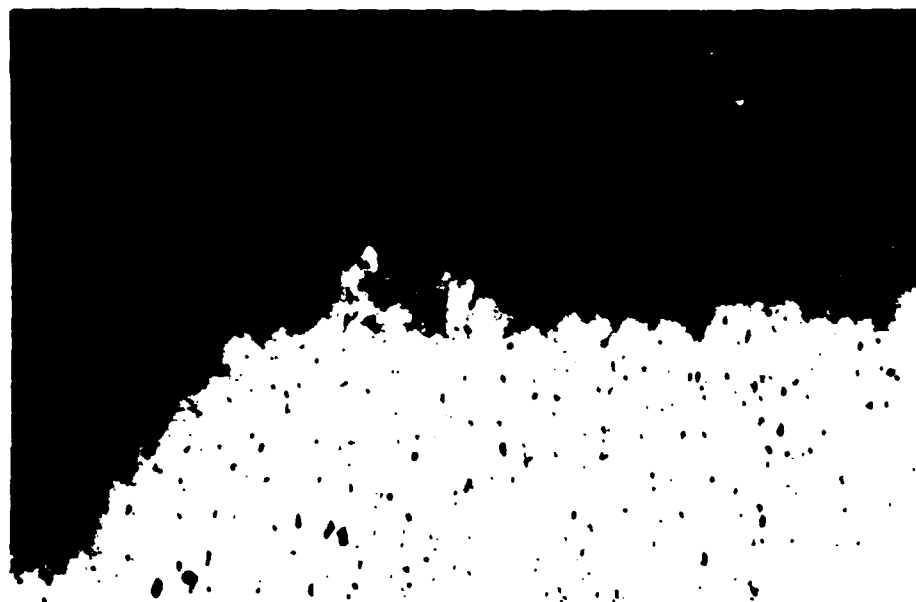
The top surface of the screw is shown enlarged in Figure 11. The rough surface is consistent with an advanced state of oxidation/corrosion. The adjacent aluminium poppet valve seal retaining washer (Figure 3, detail A, item 6) had received only superficial damage (Figure 8) during the fire, with no evidence of washer melting (i.e. the temperature was below approximately 650°C). The brass screw has also received only very minor fire damage and the silicone rubber seal was still complete, although distorted by the heat and gas flow. The location of the damage to these various parts suggests that, if the head had been damaged principally by the initial fire, the screw head would have been left concave rather than convex, due to protection afforded by the surrounding material. Concave damage had occurred to the brass screw in the No. 1 poppet from A9-300 and was clearly the result of the fire.

FIGURE 11. SECTION THROUGH THE BRASS HEAD OF POPPET VALVE FROM No. 3 CHAMBER (FIGURE 3, DETAIL A, ITEM 5). THE ROUGH NATURE OF THE SURFACE, WHICH IS COPPER RICH DUE TO SELECTIVE LEACHING, IS CONSISTENT WITH AN ADVANCED STATE OF CORROSION/OXIDATION.

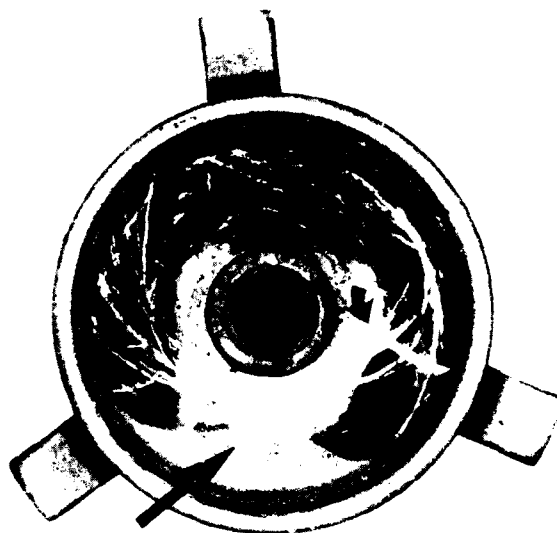
Inspection of the poppet valve seat from No.3 chamber showed evidence of score marks on the aluminium alloy face (Figure 12). These score marks were present prior to the fire and would have allowed a slow gas leakage under the silicone rubber washer (Figure 13). In combination with the defective brass screw the score marks

FIGURE 12. POPPET VALVE FROM No. 3 CHAMBER (FIGURE 3, DETAIL A, ITEM 5) WITH POPPET SEAL, SEAL RETAINER, AND SCREW REMOVED. NOTE LIGHT AREA (LONG ARROW) WHERE POPPET SEAL WAS NOT BONDED TO THE ALUMINIUM BODY AND THE NUMEROUS SCRATCH MARKS. (SHORT THICK SCRATCH ON RHS (CURVED ARROW) IS POST FIRE DAMAGE.)

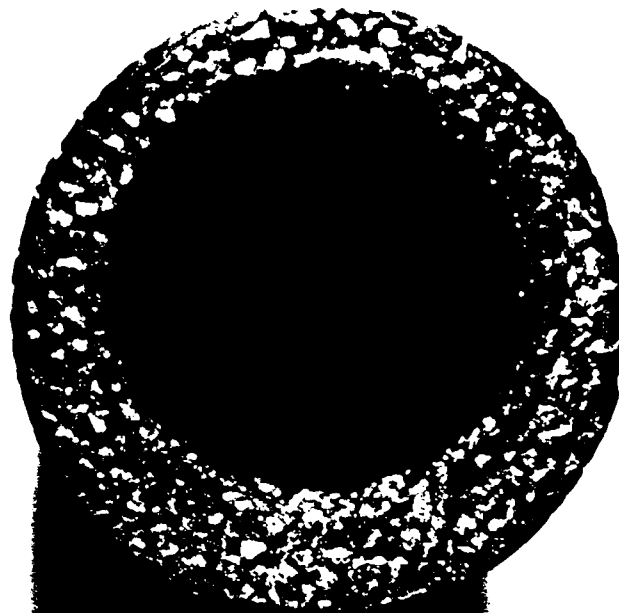
Filters from a number of Orion aircraft were examined. These were taken from the charging valve assemblies, and all showed signs of fretting, indicating that the element was not sealing properly and had oscillated during charging of the oxygen system. This movement had led to damage of the filter body, removal of material from the filter element and an imperfect seal between the filter body and the filter element. As a result the filters were incapable of effectively removing particles and

FIGURE 14 A COURSE FILTER FROM AIRCRAFT A9 755 NOTE
FRETTING AROUND THE EDGE (ARROWED)
MAGNIFICATION: 9 APPROX

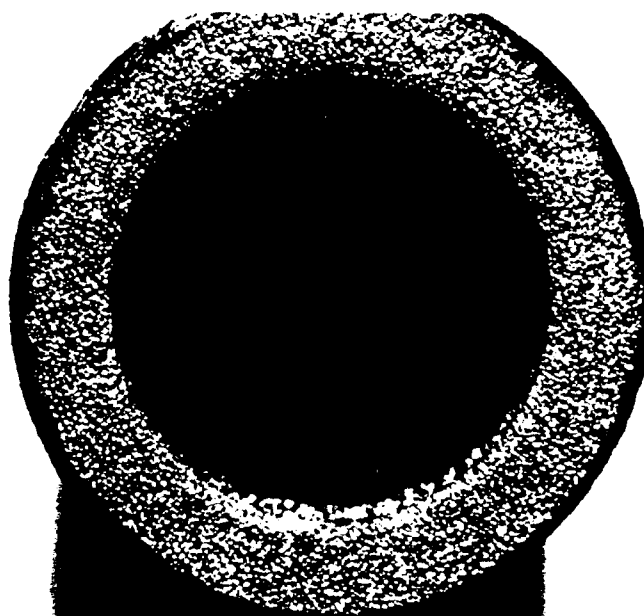
FIGURE 15 A FINE FILTER FROM AIRCRAFT A9 760 NOTE FRETTING
AROUND THE EDGE (ARROWED)
MAGNIFICATION: 9 APPROX

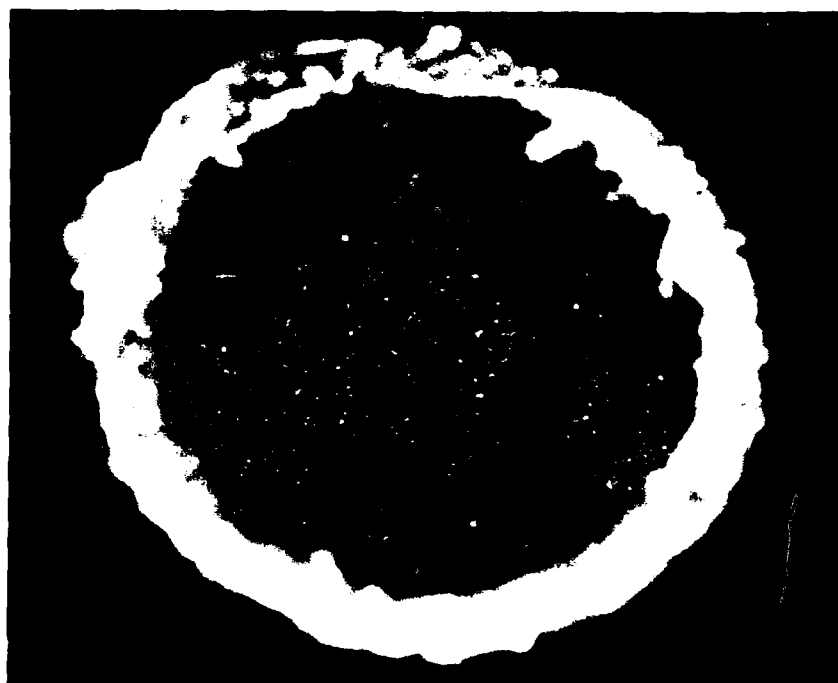
FIGURE 18 A SECTION THROUGH THE CENTRE OF THE STAINLESS
STEEL PIPE SHOWN IN FIGURE 17 SHOWING THE EXTENT
OF THE RUST DEPOSIT
