WRDC-TR-89-3075

FULL-SCALE BIRDSTRIKE TESTING OF IN-SERVICE
AGED F-111 ADBIRT WINDSHIELD TRANSPARENCIES

University of Dayton Research Institute
300 College Park Avenue
Dayton OH 45469

Interim Report for Period May 1985 - November 1987

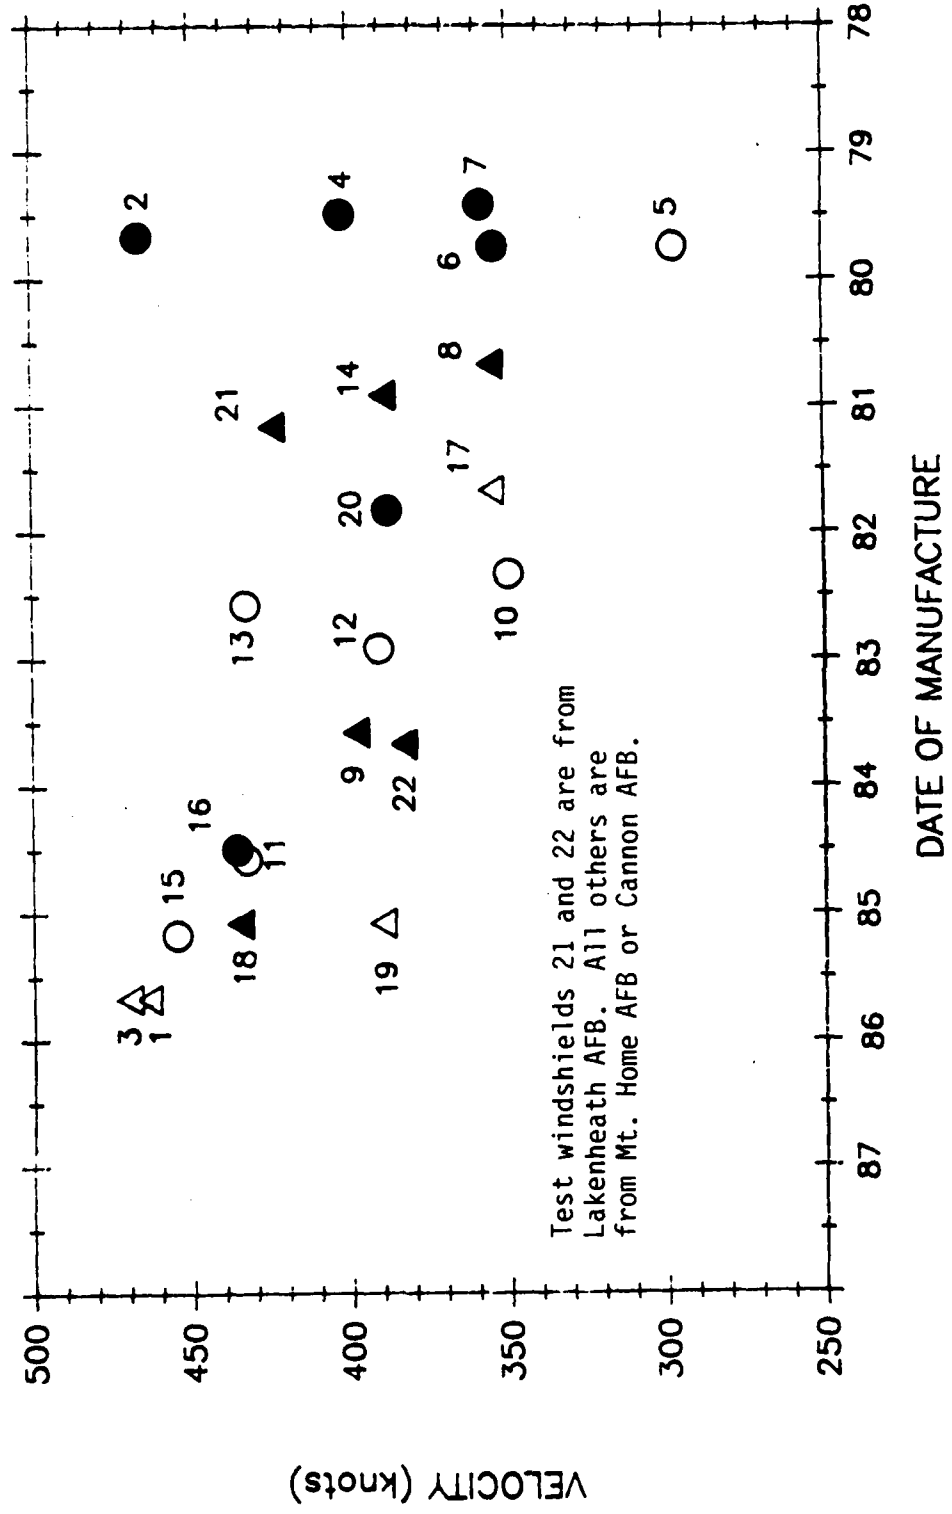
Figure 14. Test Data Summary, Velocity vs. Date of Manufacture.

degradation is related only to the date of manufacture. Figure 14 is a plot of birdstrike resistance capability versus date of manufacture. No trend is evident from this plot, although at least one source in the literature indicates a reduction in bare polycarbonate impact strength with absolute age.⁷ A plot of birdstrike resistance capability versus installed age (date of installation subtracted from date of removal) is presented for each vendor in Figure 15. (Note that a predicted capability curve for 0.725 inch stretched acrylic is included.*) This plot indicates a definite relationship between installed age and degradation. The actual cause of degradation may be a complex combination of extrinsic factors including absolute age, installed age, geographic location, and more specific intrinsic factors such as total UV exposure, thermal history, fatigue, hydrolysis, and molecular attack. Table 4 presents a comparison of baseline and in-service aged windshield birdstrike resistance.
