FAILURE ANALYSIS HANDBOOK

C. R. Walker, K. K. Starr

Pratt & Whitney
P.O. Box 109600
West Palm Beach, FL 33410-9600

August 1989

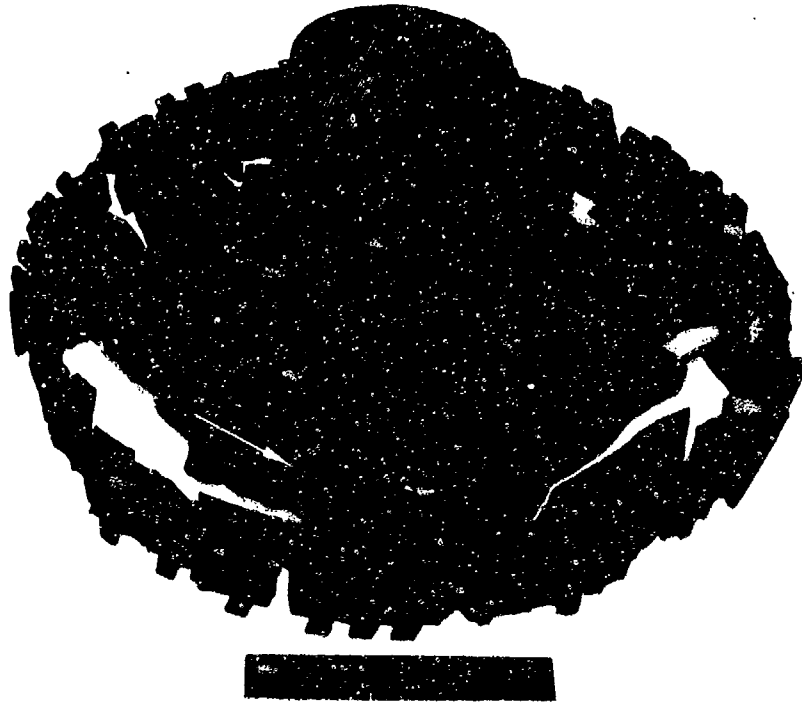
FIGURE II-3: Arrest marks on the opened surface of a fatigue crack. The spacings between arrest marks become narrower as the crack progresses through a thicker section (arrow).

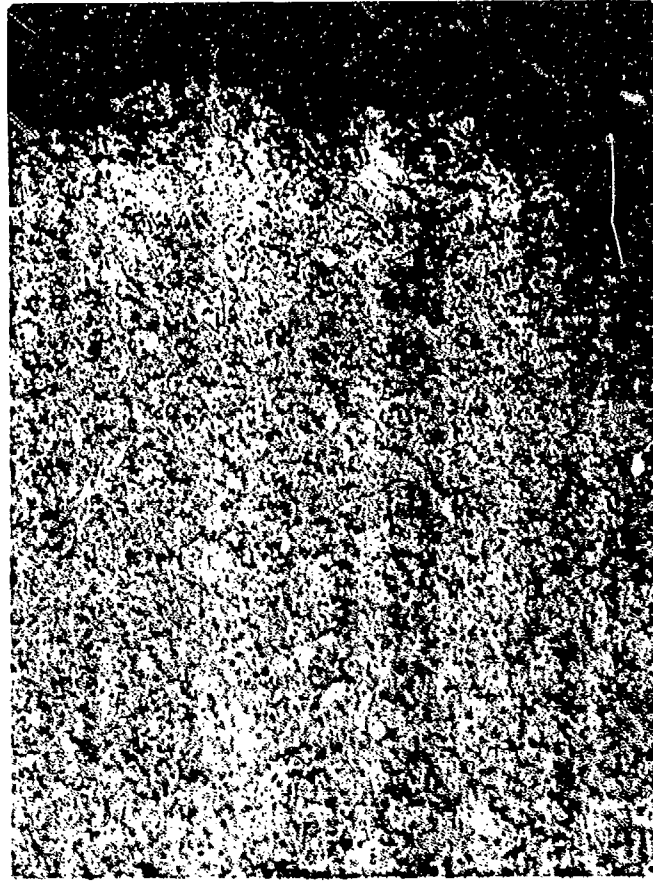
FAM 99741

FIGURE 1-1: Test results and fractography of M-50 room temperature notched tensile test. The fracture surface exhibits directionality appearing to propagate from bottom left to top right of the photograph (arrow).

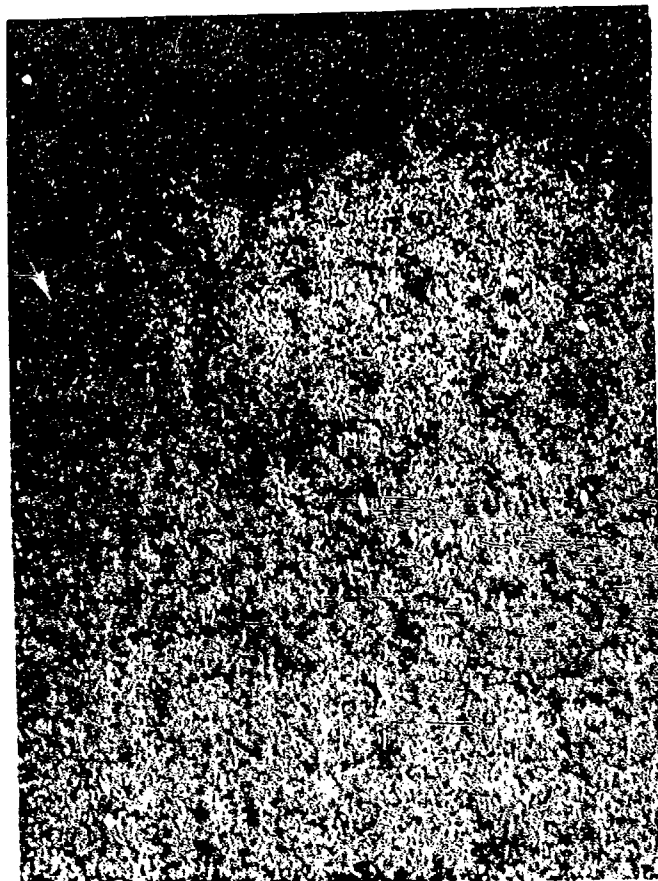
FAM 99746

FIGURE 1-7: Test results and fractography of M-50 316°C (600°F) notched tensile test. The fracture surface appears to exhibit deeper features than the room temperature specimen. See Figure 1-1. No clear origination area is visible.

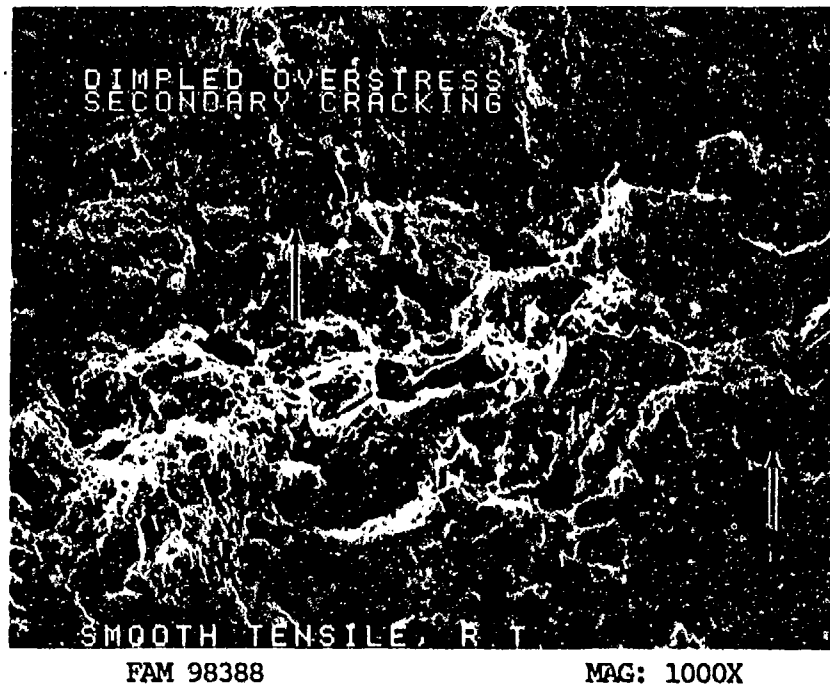
FIGURE 3-5: Dimpled overstress, secondary cracking (arrows A) and fractured carbides (arrows B) in the primary fracture area.

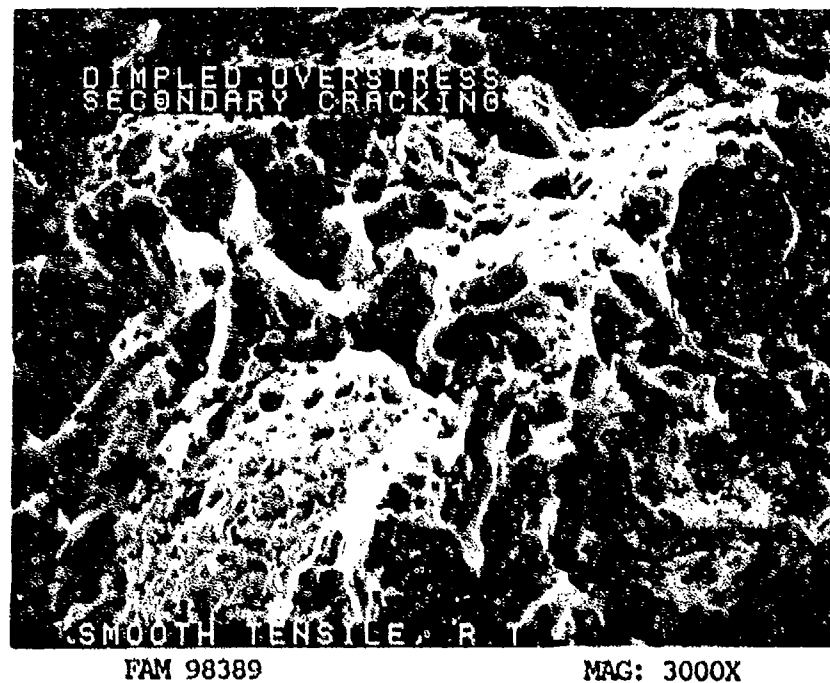
FIGURE 3-6: High magnification photograph showing fine dimpled overstress and fractured carbides in the primary overstress area.

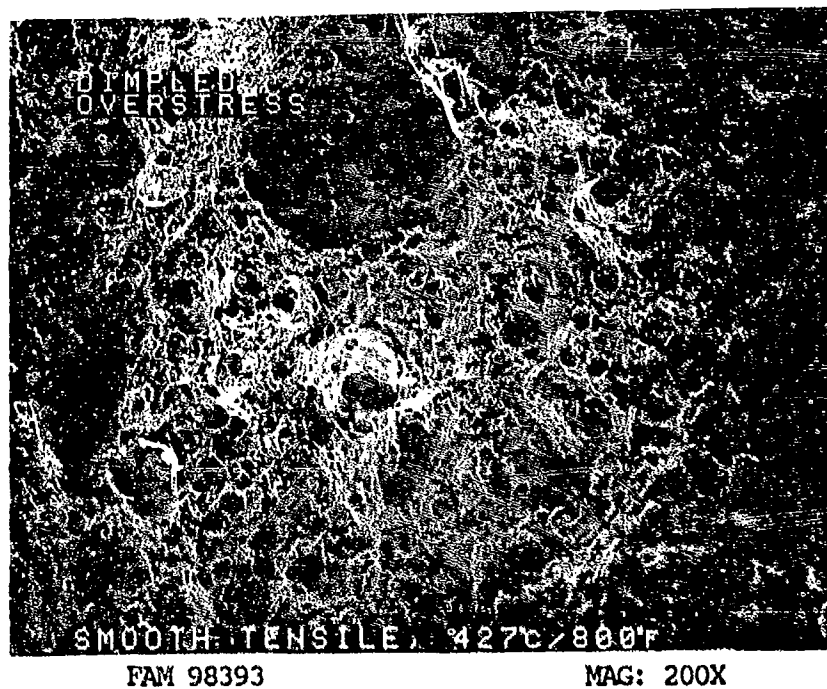
FIGURE 3-12: Dimpled overstress and void coalescence in the primary fracture area.

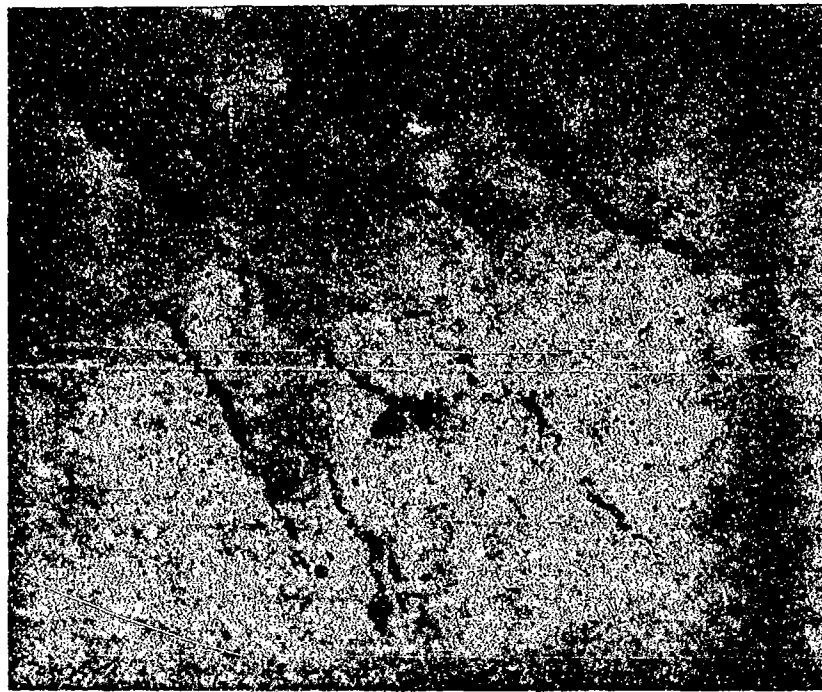
FAM 100268

FIGURE 3-59: Test results and fractography of Custom 455 stress corrosion test flat plate specimen. The fracture is shown from the tension (left) and compression (right) sides. The tension side exhibited extensive attack and deposition of corrosion products. The compression side was relatively free of attack.

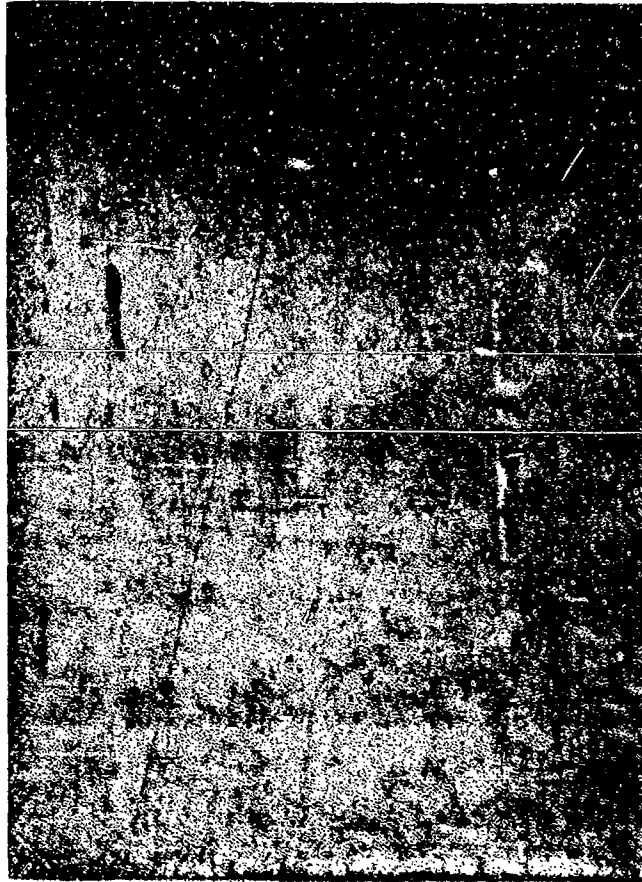
FAM 100272

Figure 4-47: Test results and fractography of 347 SST 427°C (800°F) smooth HCF test. The fracture propagated from two origin areas (arrows A). Arrest marks are visible near the end of the fatigue thumbnail (arrows B).

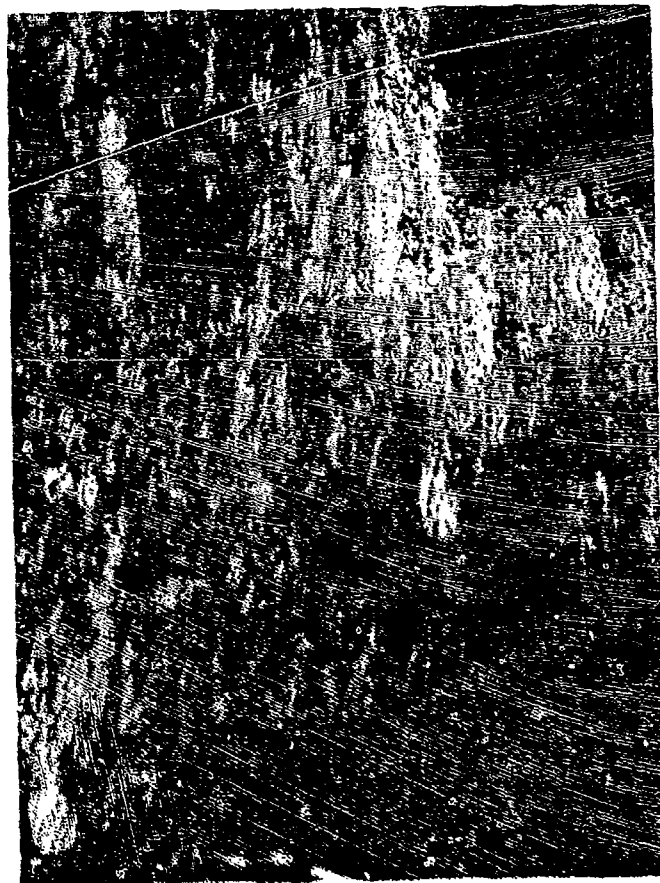
FAM 99791

FIGURE 7-9: Test results and fractography of Incoloy 909 649°C (1200°F) smooth tensile test. The fracture surface appears completely different from the room temperature specimen, Figure 7-1, not having an intergranular appearance. While the room temperature fracture was roughly perpendicular to the stress axis, this fracture occurred on several planes.

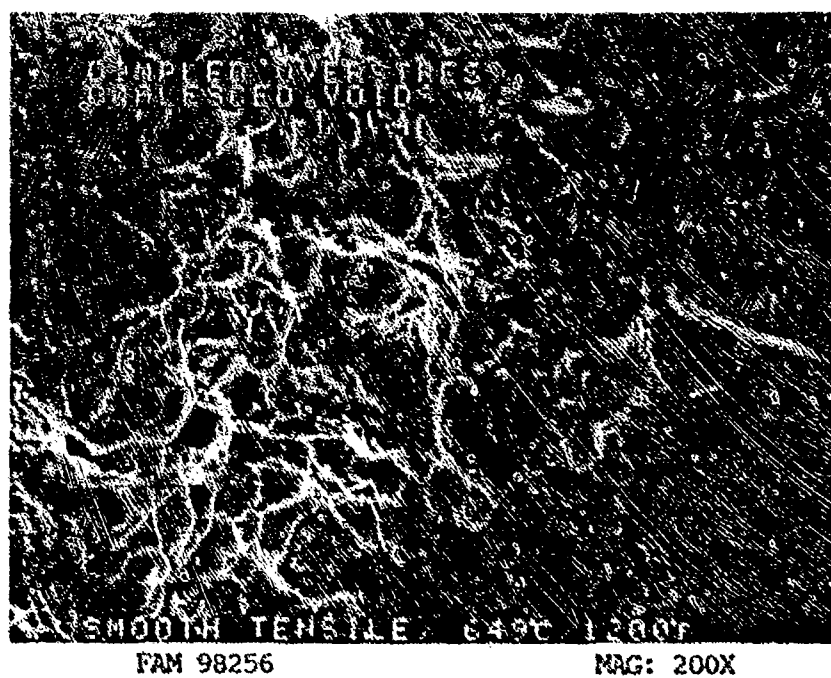
FIGURE 7-12: Dimpled overstress with void coalescence (arrows).

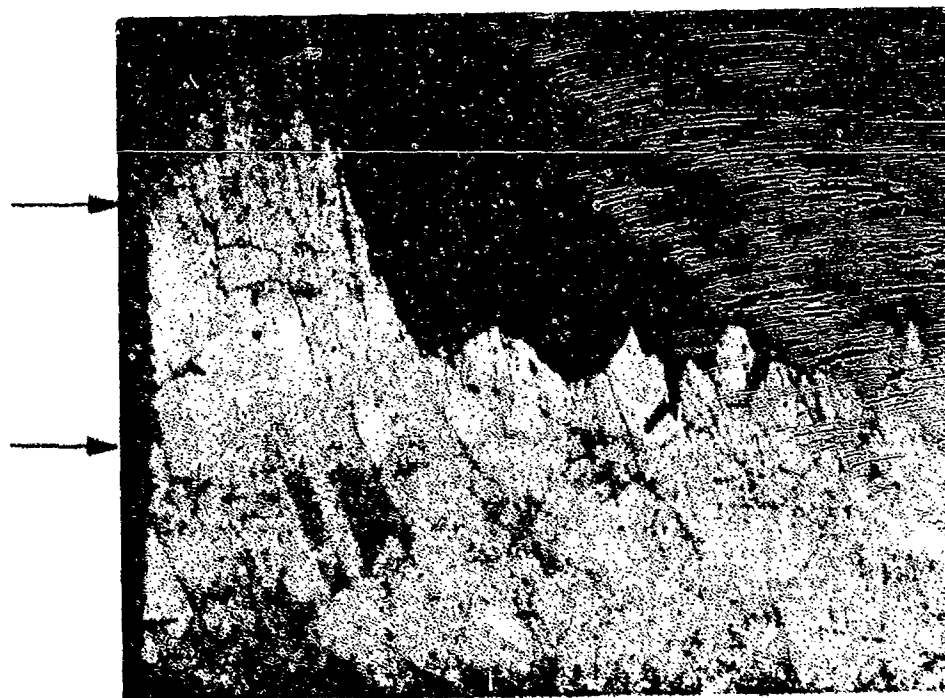
FAM 98985

FIGURE 7-29: Test results and fractography of Incoloy 909 649°C (1200°F) stress rupture test. The fracture surface has a coarse intergranular appearance with no shear lip.

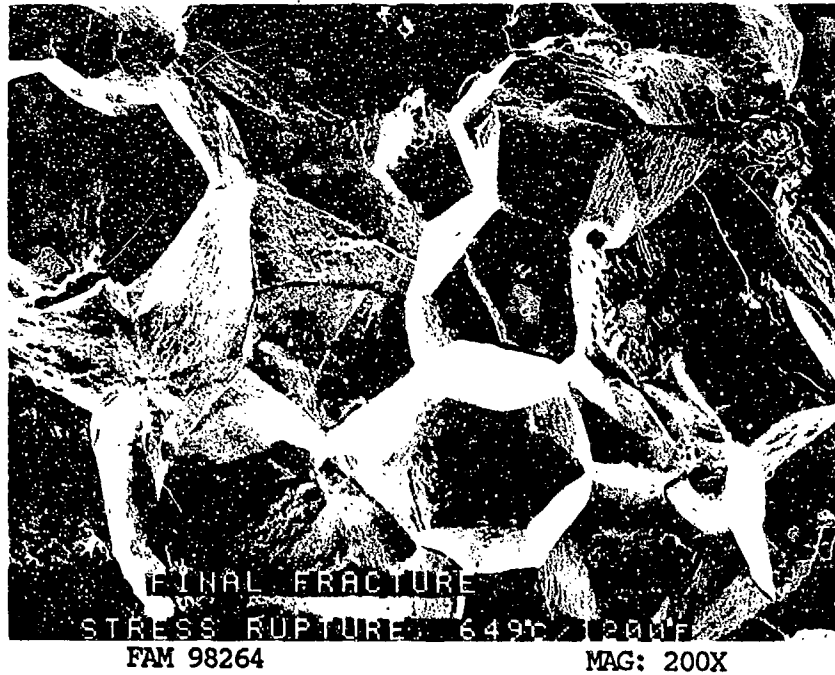
FIGURE 7-35: Intergranular overstress with some grain boundary separation in the final fracture area. The fracture surface is only lightly oxidized.

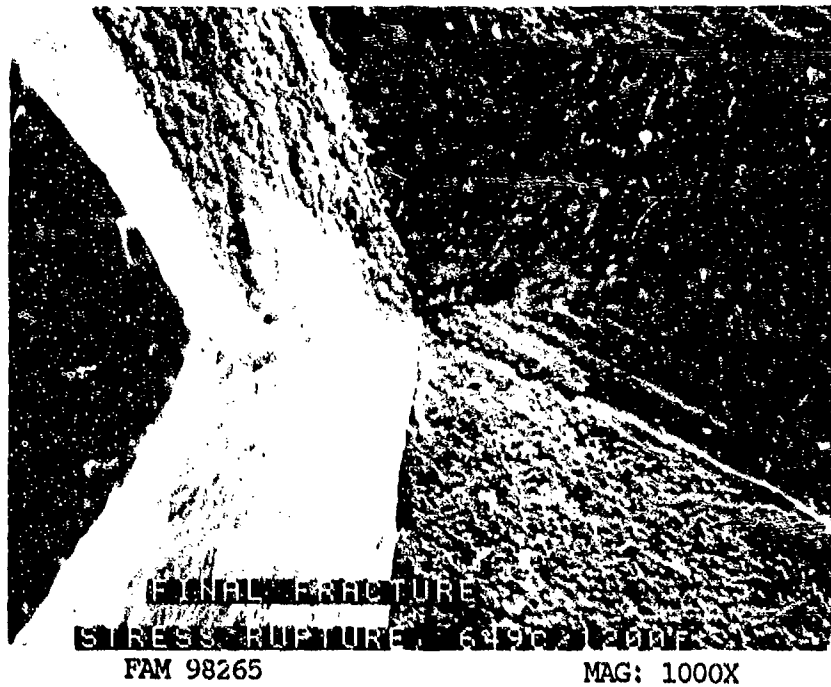
FIGURE 7-36: Higher magnification photograph of a grain boundary quadruple point (arrow) in the final fracture area shown in Figure 7-35.

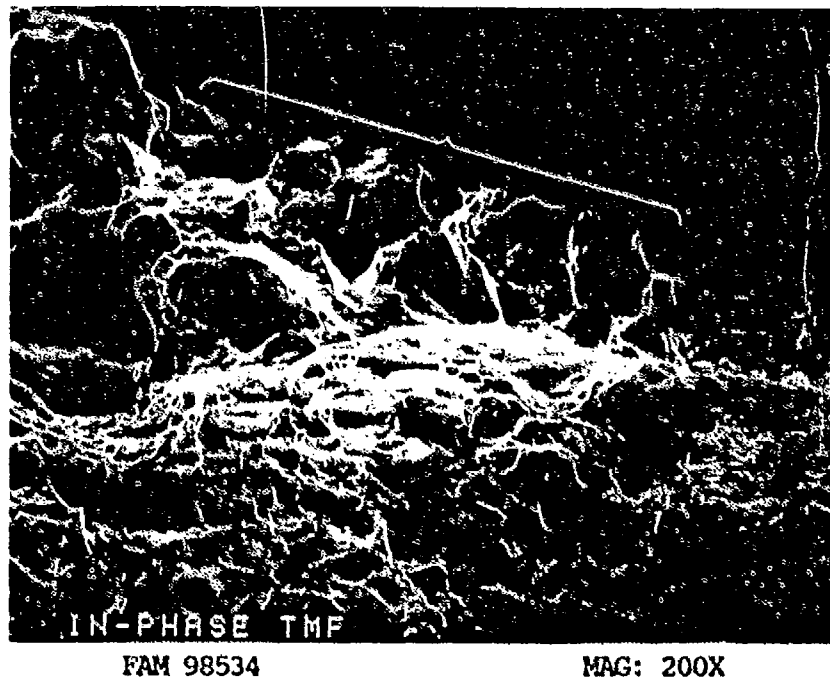
FIGURE 7-62: Faceted fatigue area at the I.D. surface of the specimen (brackets) and dimpled overstress near the center of the fracture surface.

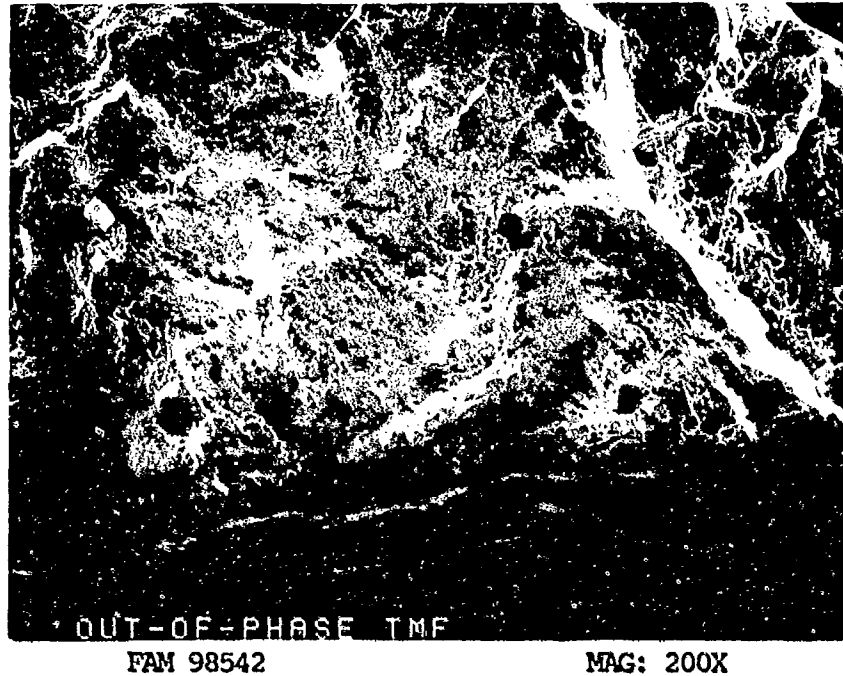
FIGURE 7-72: Fatigue area near an origin. The fracture surface is relatively flat and oxidized.

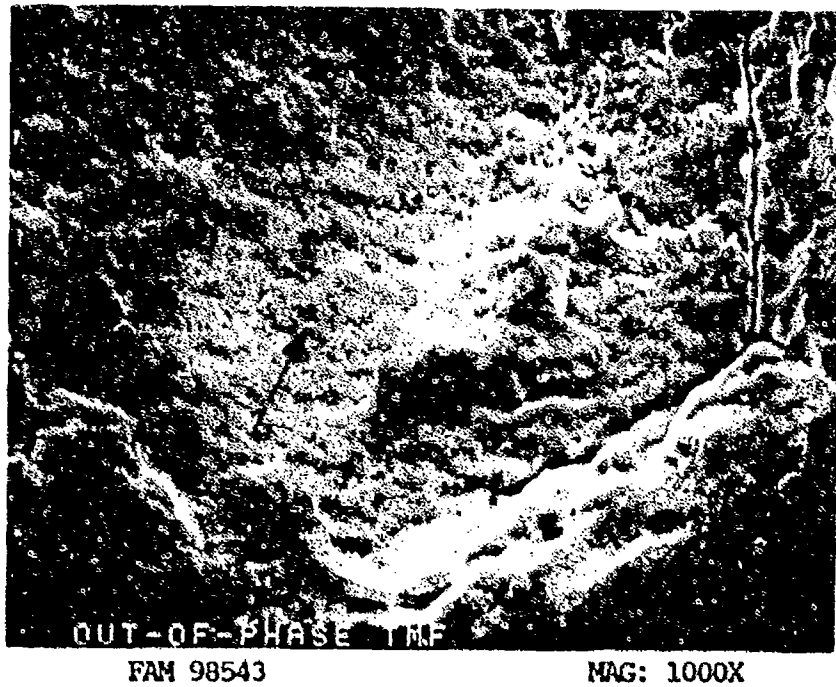
FIGURE 7-73: Possible remnant striations in the fatigue zone. An arrow shows the direction of propagation.

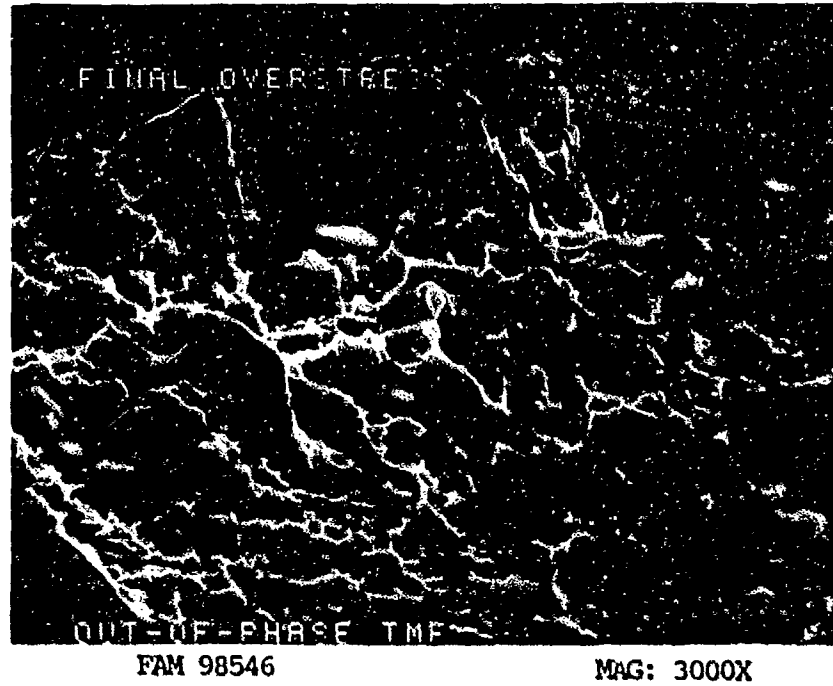
FIGURE 7-76: Very fine dimples in the final overstress area.

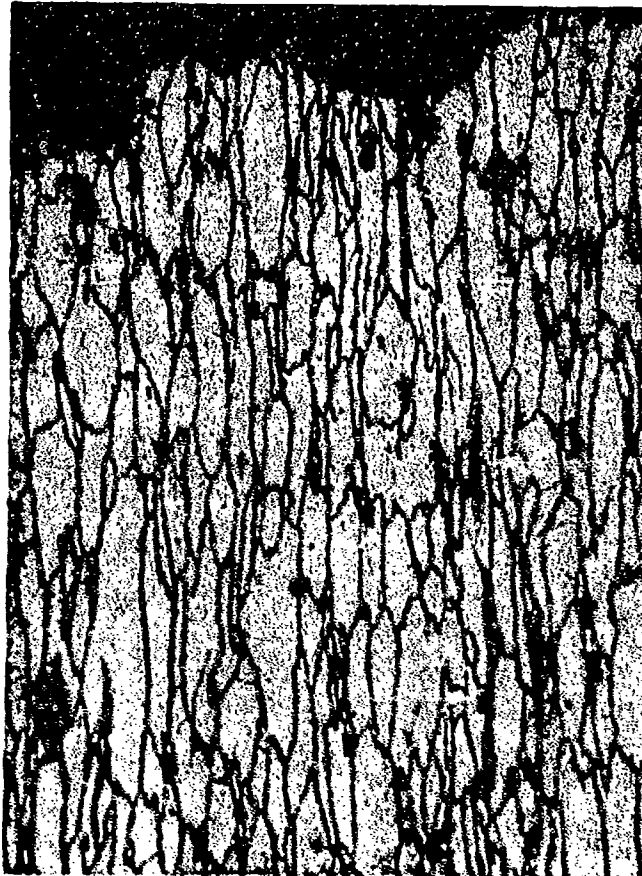
FAM 99839

FIGURE 8-1: Test results and fractography of Inconel 600 room temperature smooth tensile test. The fracture surface is dominated by a very large shear lip (bracket). Compare with the 1300 F smooth tensile specimen (Figure 8-9) that has no shear lip.

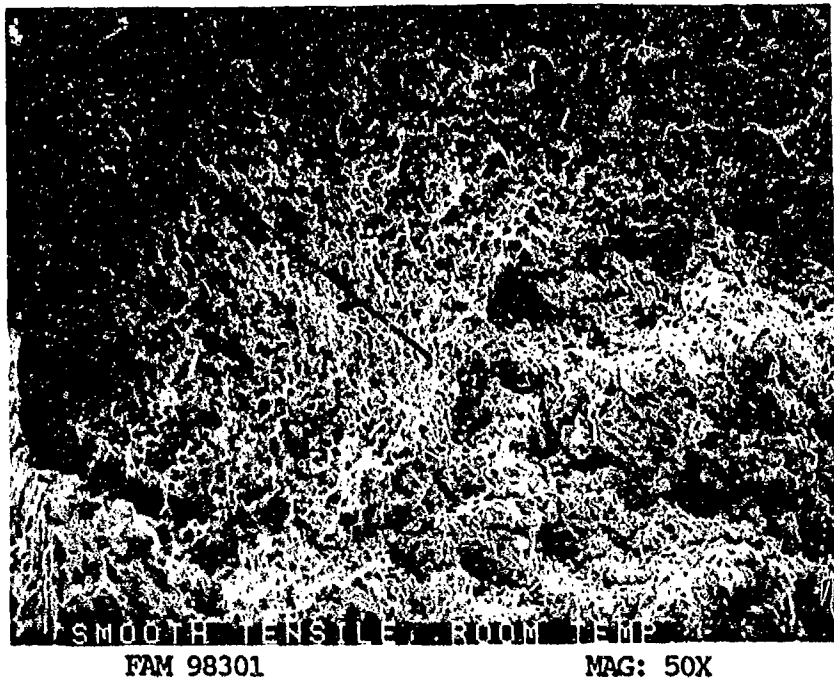
FIGURE 8-3: Low magnification view showing the large shear lip (bracket).

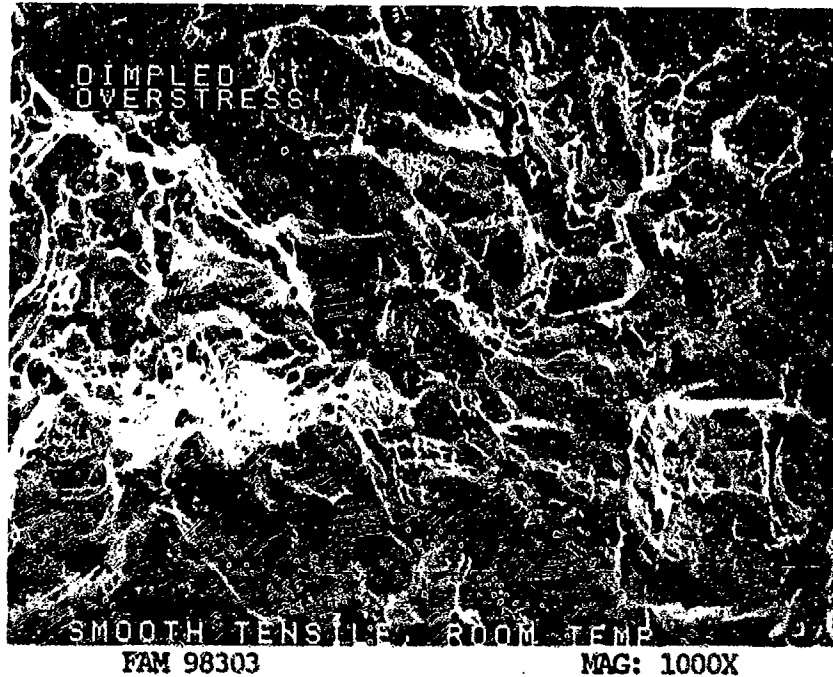
FIGURE 3-5: Dimpled overstress with grain boundary separation. An arrow shows a triple point between three grains.

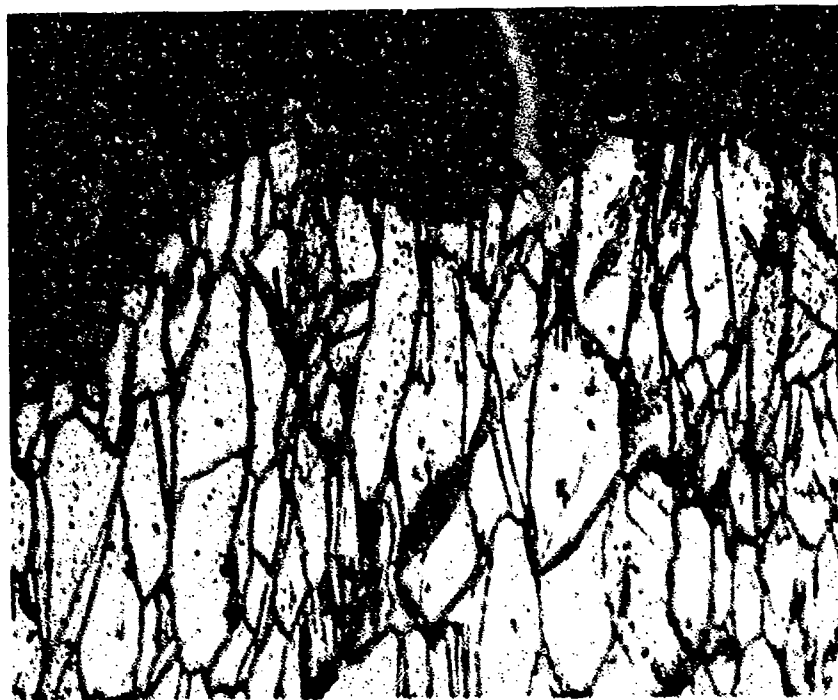
FAM 100466

FIGURE 8-9: Test results and fractography of Inconel 600 704°C (1300°F) smooth tensile test. The fracture surface is generally perpendicular to the stress axis. No shear lip is visible. The percent elongation and reduction of area values are similar to the room temperature specimen values.

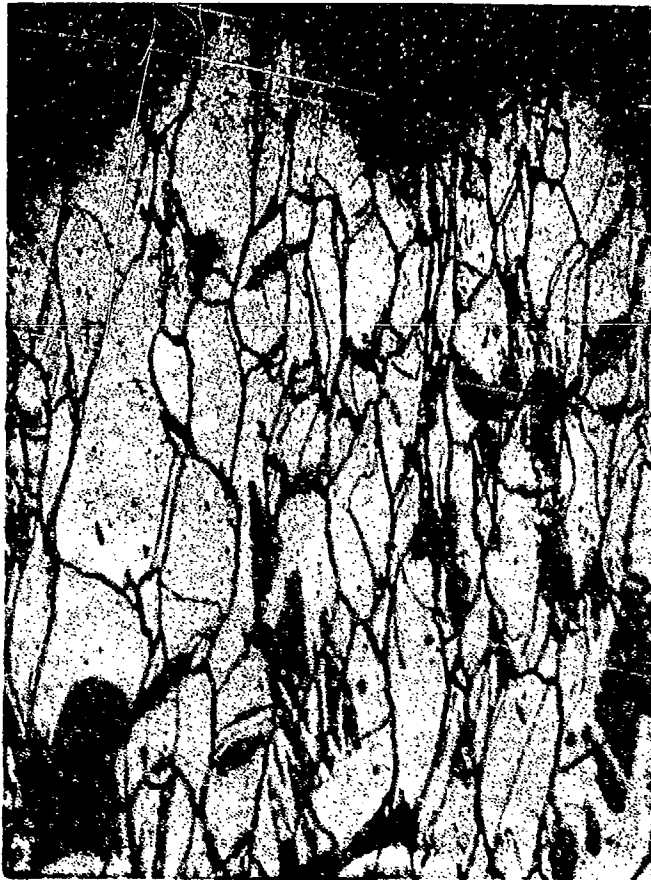
FAM 99841

Figure 8-29: Test results and fractography of Inconel 600 stress rupture test. The fracture appears heavily oxidized and is oriented at an angle to the stress axis.

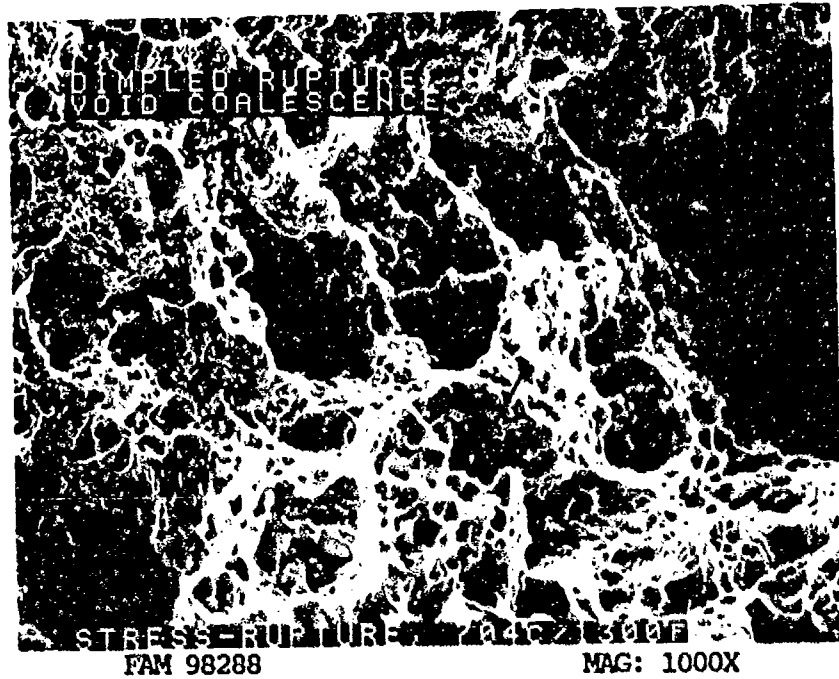
FIGURE 8-33: Oxidized dimpled rupture (black arrow). A void is visible on the right side of the photograph.

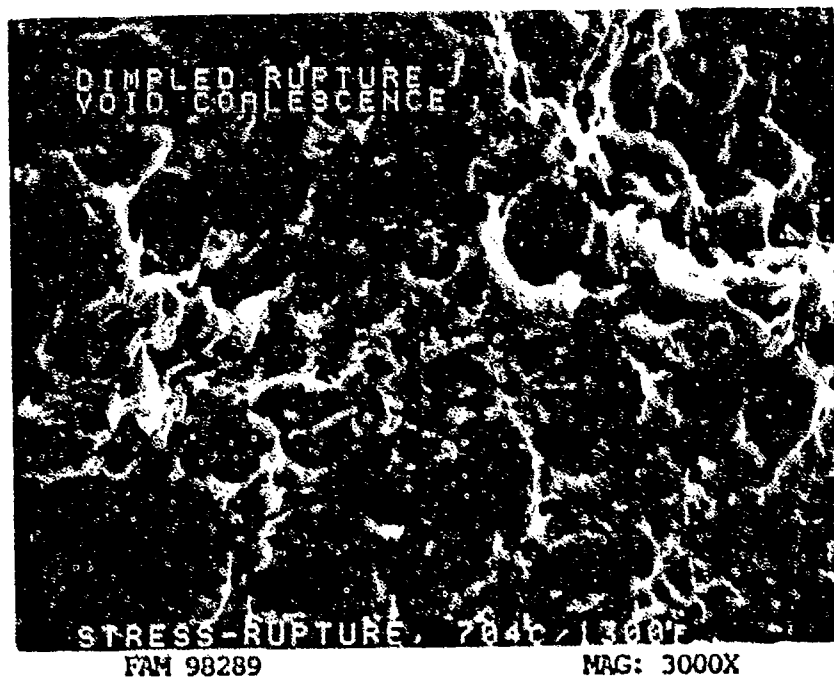
FIGURE 8-34: Oxidized dimpled rupture.

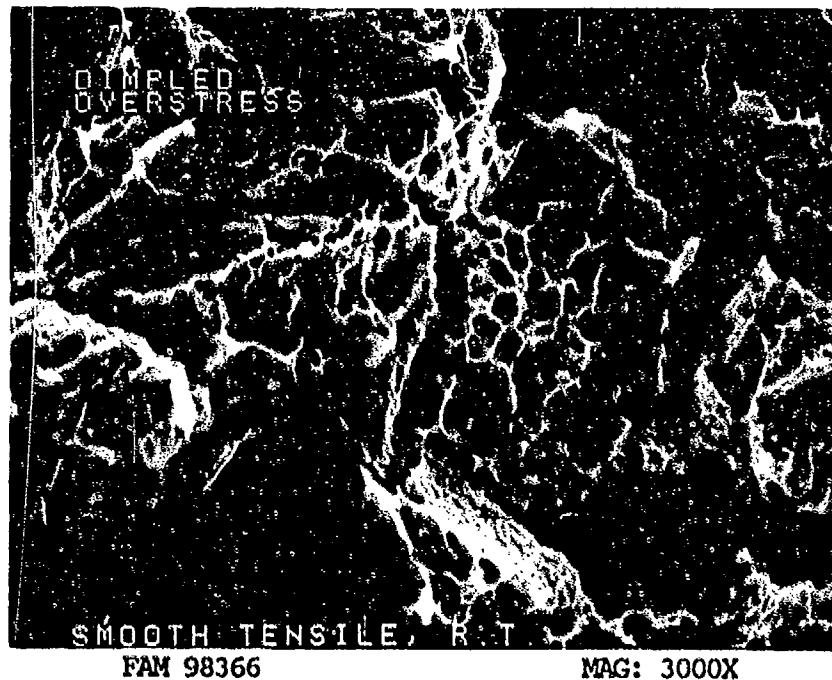
FIGURE 9-6: Higher magnification photograph of the area shown in Figure 9-4 showing fine equiaxed dimples and fractured carbides.

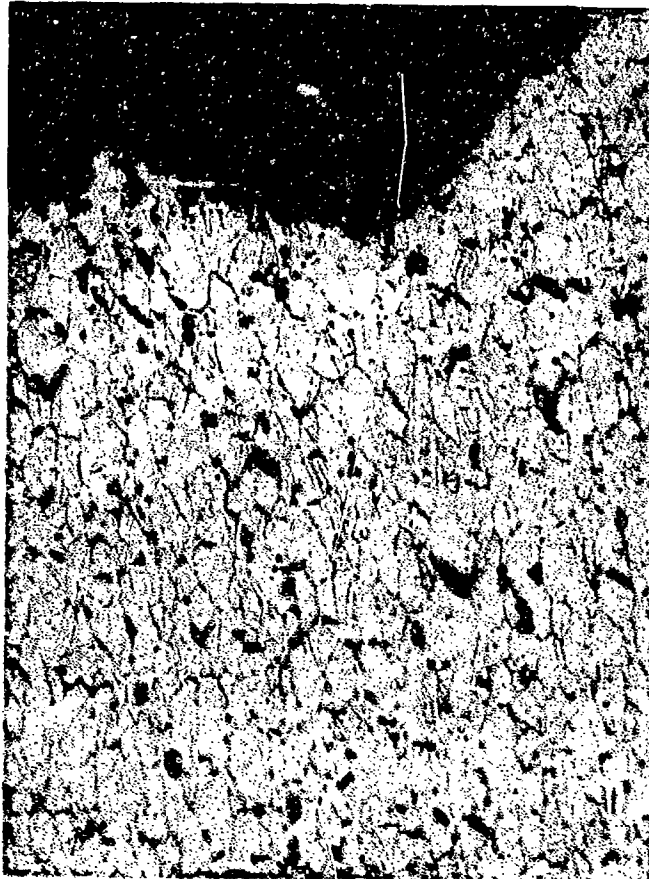
FIGURE 9-10: Optical photomicrograph showing the primary fracture area, exhibiting a predominantly transgranular fracture path. Carbides and voids are visible in the microstructure.

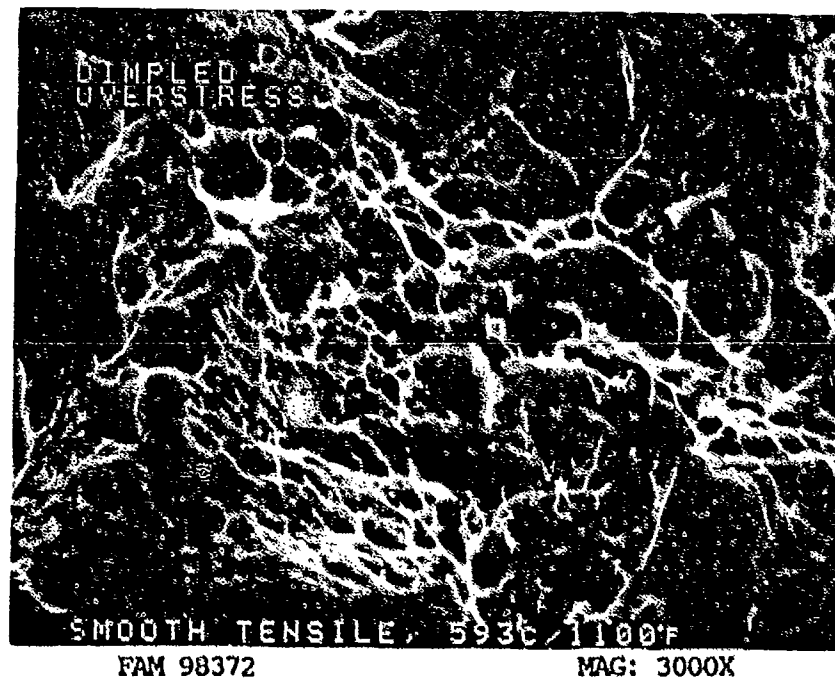
FIGURE 9-14: Higher magnification photograph of the area shown in Figure 9-13, showing fine equiaxed dimples in the primary fracture area.

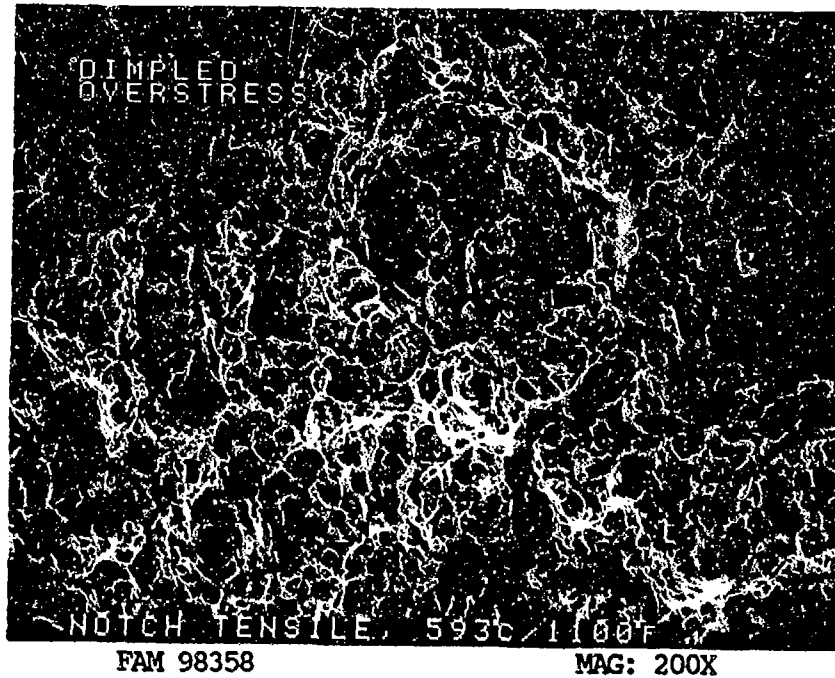
FIGURE 9-27: Equiaxed dimpled overstress in the primary fracture area. The fracture has a slightly intergranular appearance.

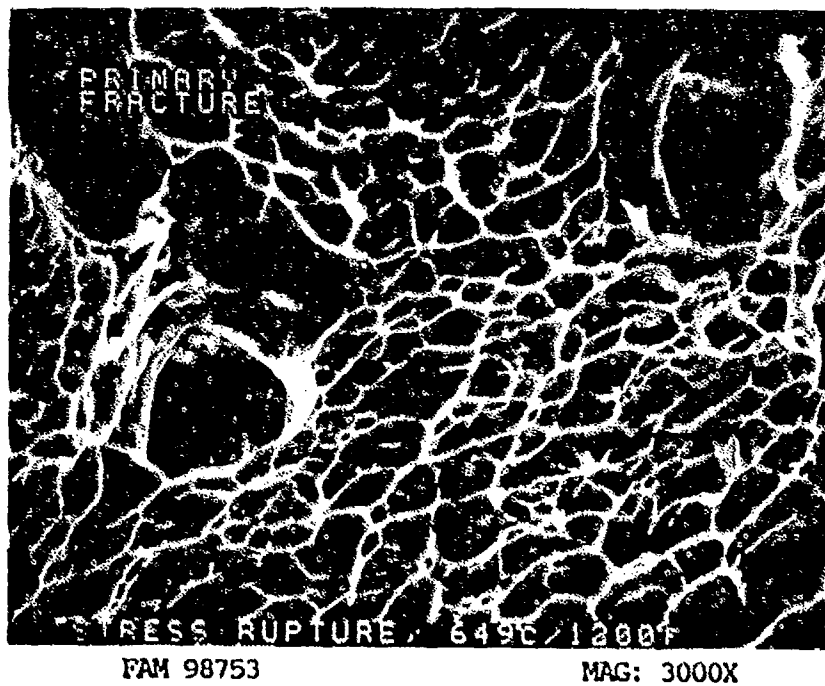
FIGURE 11-19: Higher magnification photograph of the area shown in Figure 11-18, showing overstress dimples and coalesced voids.

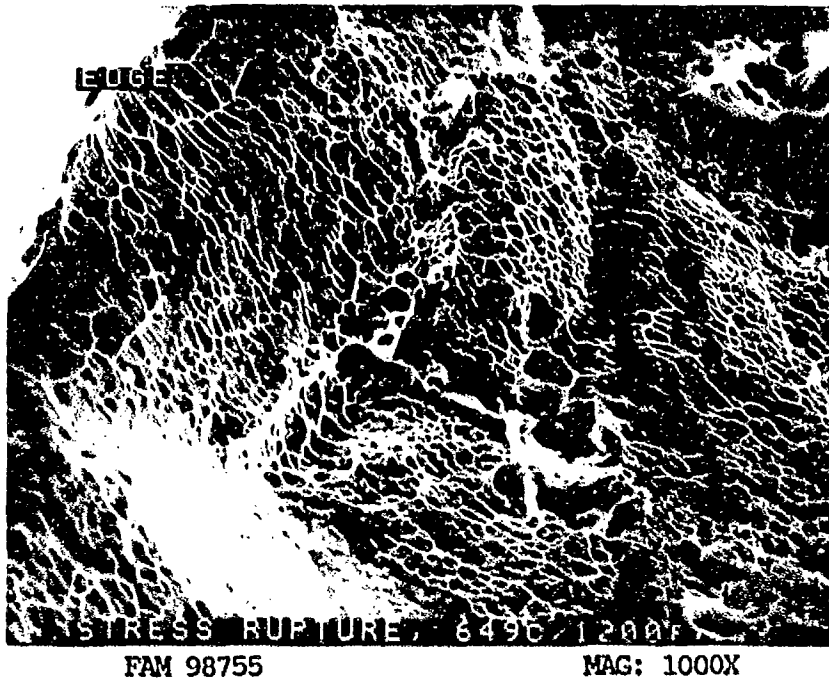
FIGURE 11-20: Final fracture area near the edge of the specimen, exhibiting shallow dimples.

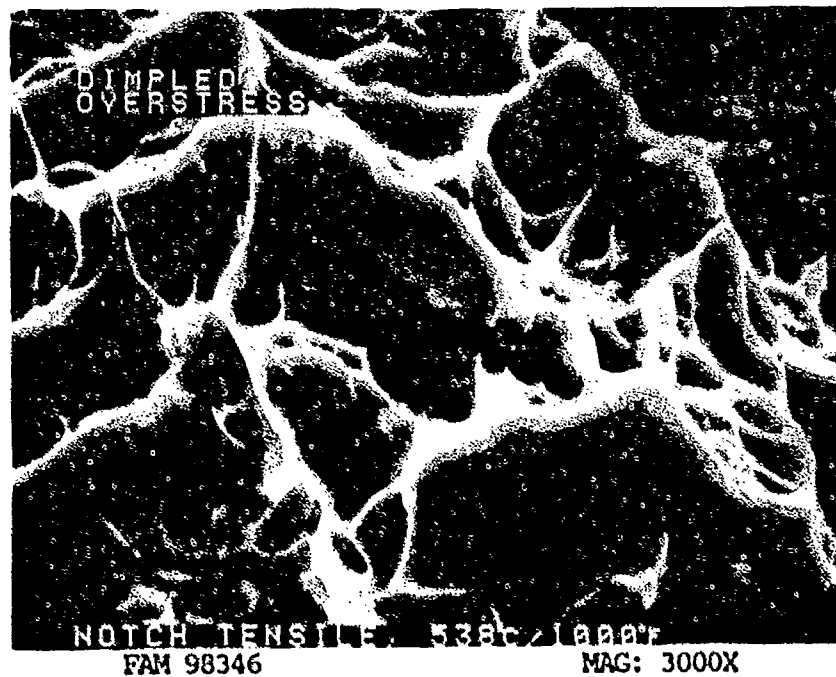
FIGURE 12-28: Equiaxed dimpled overstress with various sized dimples.
