USACERL TECHNICAL REPORT P-90/11
April 1990

Five-Year Summary of Fort Irwin, CA, Family Housing Comparison Test: Operation and Maintenance Costs of Manufactured vs. Conventionally Built Units

by
Robert D. Neathammer

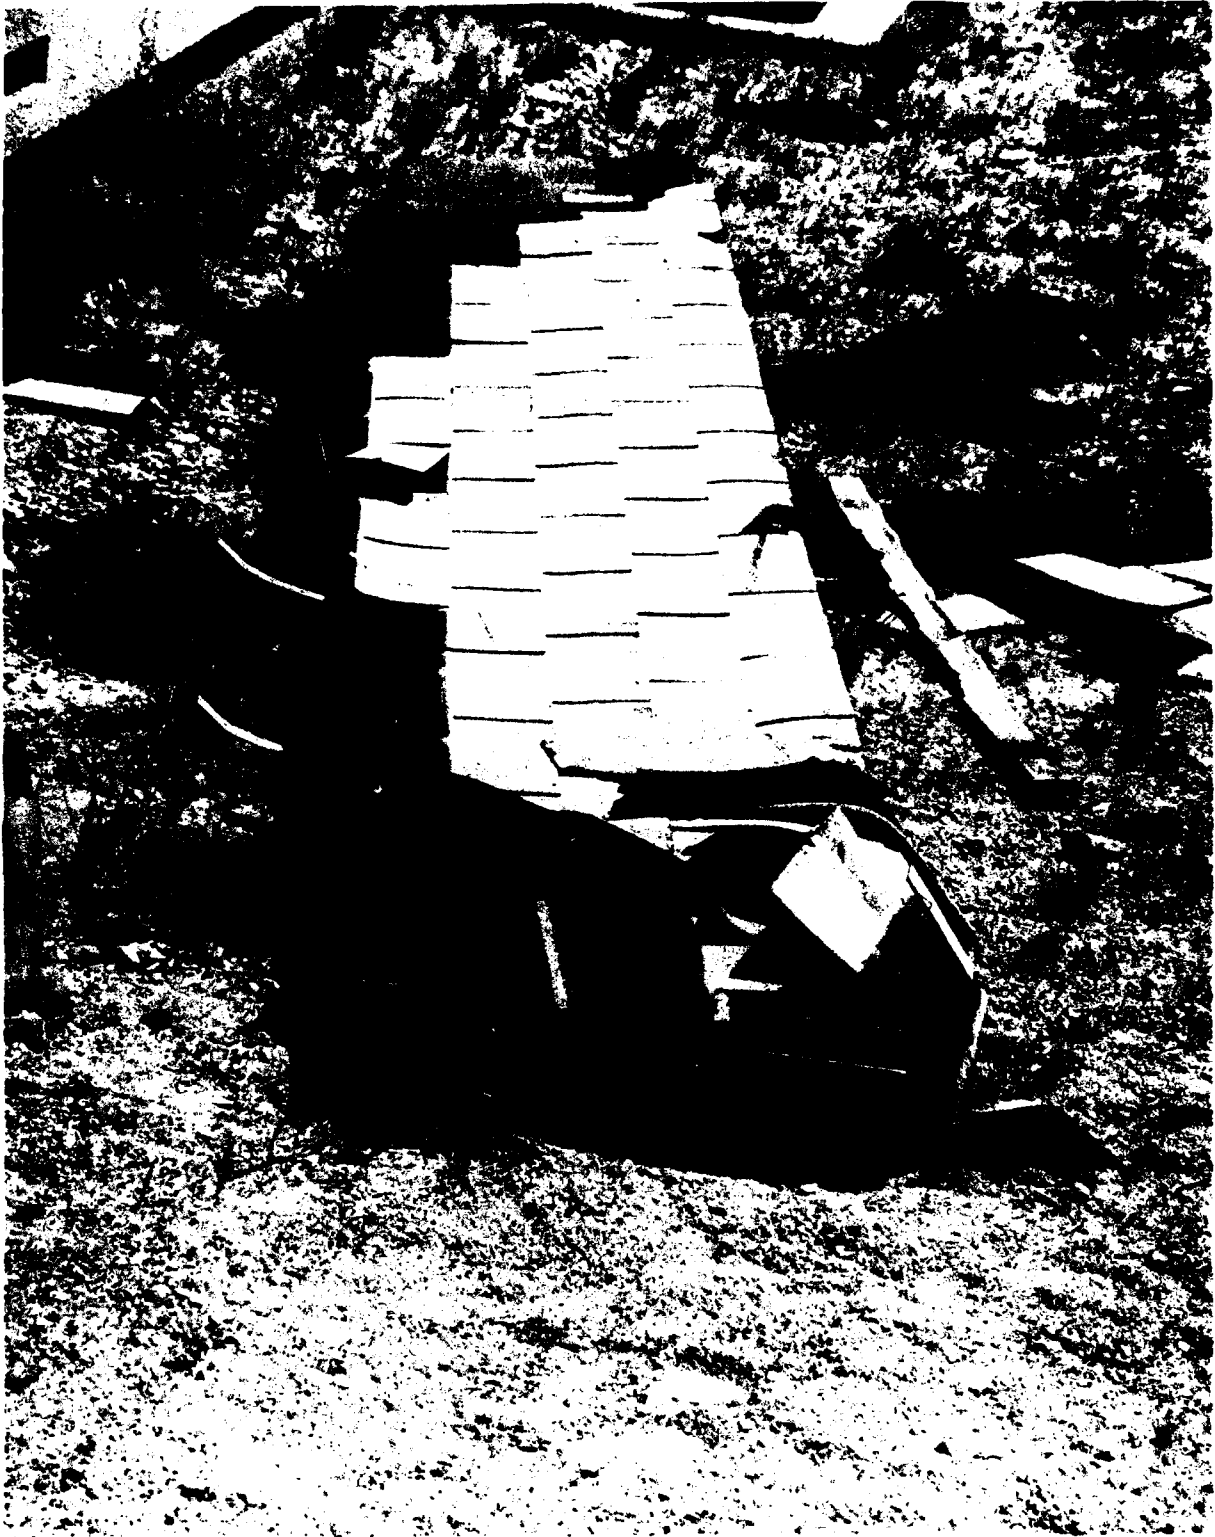
The major problem with these buildings was the eaves. These units were manufactured about 200 miles from Fort Irwin and transported by truck. Evidently, in order to meet highway width restrictions, the eaves could not be built on the modules. Rather, they were fastened to the roof with metal straps and folded onto the roof for transportation. At Fort Irwin, they were folded down. No permanent method of securing them to the building was used. As a result, in 1988, the straps began to deteriorate and one eave fell to the ground. Figures 9 through 12 show the problem. Those appearing in poor condition were temporarily fixed by putting up bracing. Then a contract was let to refasten all of them permanently. This cost is shown in Table 26 and is about \$1,673 per dwelling unit. This problem was not necessarily attributable to the manufactured housing process, but to poor design and quality assurance.

Figure 10. Eave section which fell off a manufactured unit.

- The "fold over" eaves method did not provide a permanent method of securing the eaves on site. This defect cost the government more than \$300,000 to correct.
- The use of inadequately fixed asphalt shingles, in combination with insufficiently pitched roofs, subjected roofing materials to damage from the high winds and heat of the desert environment.
- Gutters and downspouts, routinely affixed during construction, had little utility in the arid climate, and were subject to damage from high desert winds.

- The "fold over" eaves method must also provide a permanent method of securing the eaves on site.
- In a desert environment with high winds, buildings designed with a shallow roof pitch should not be constructed with asphalt shingles.
- No gutters or downspouts should be used in a desert environment, with the exception of small gutters over stairwells.
- Thermal pane windows should be used.
- Access panels should be provided for major plumbing junctures such as supply line "tees."
- Specifications for garage doors should be tightened to prevent the warping caused by substandard garage door materials experienced at Fort Irwin.
- Patio floors should be of either 6 in. or reinforced concrete. Quality assurance on patio and driveway concrete should be increased.
- Lawn sprinklers should be located so that they do not spray water on the air-conditioning condenser or the building walls.
