GILLHAM LAKE

COSSATOT RIVER, ARKANSAS

EMBANKMENT CRITERIA AND PERFORMANCE REPORT

OCTOBER 1987

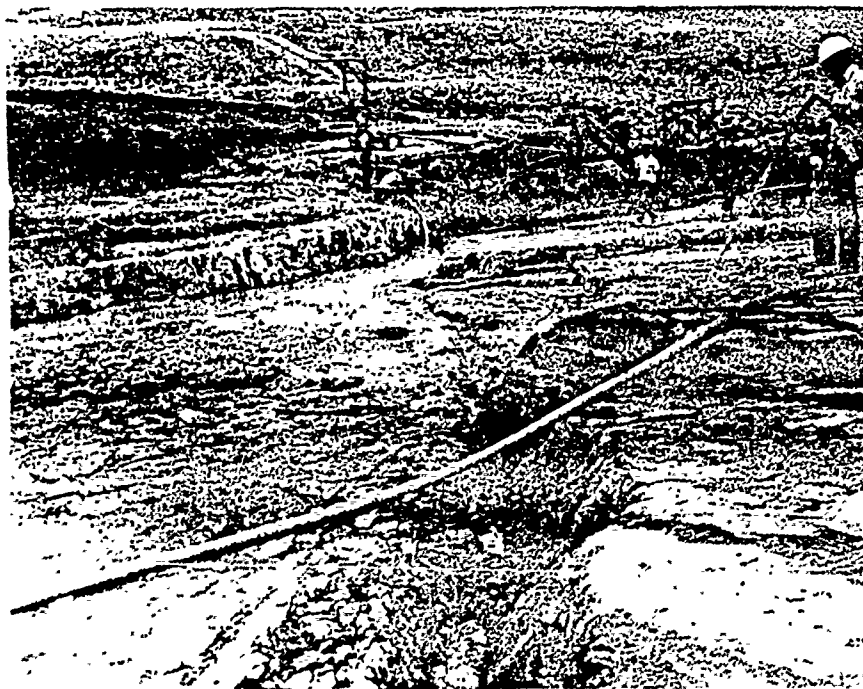
Photo. No. 10

View SW along a minor fault which crosses centerline at approx. Sta 28+40.

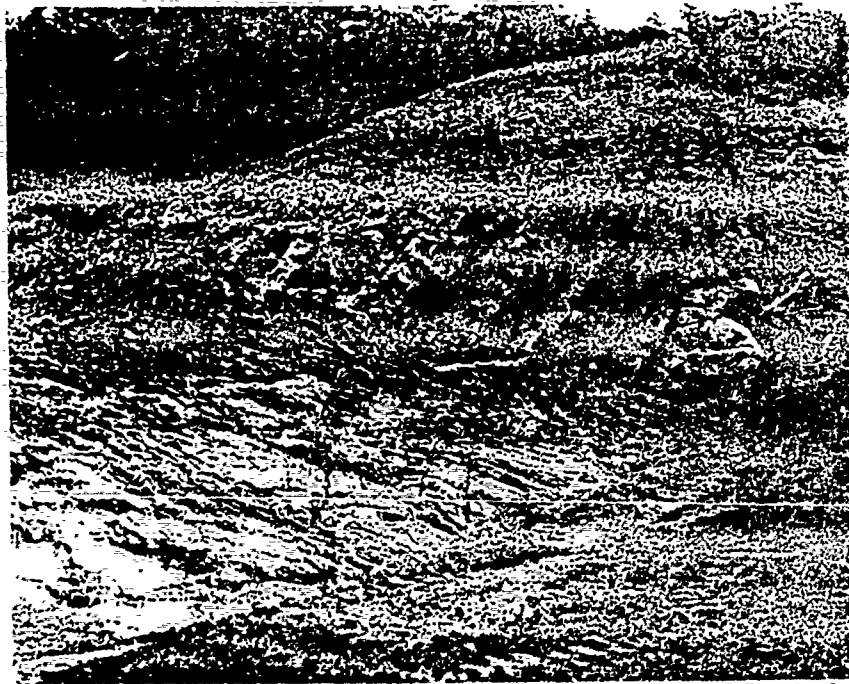
Photo. No. 14

Foundation under impervious and U/S random zones at Sta 34+40. Note shale-sandstone contact.

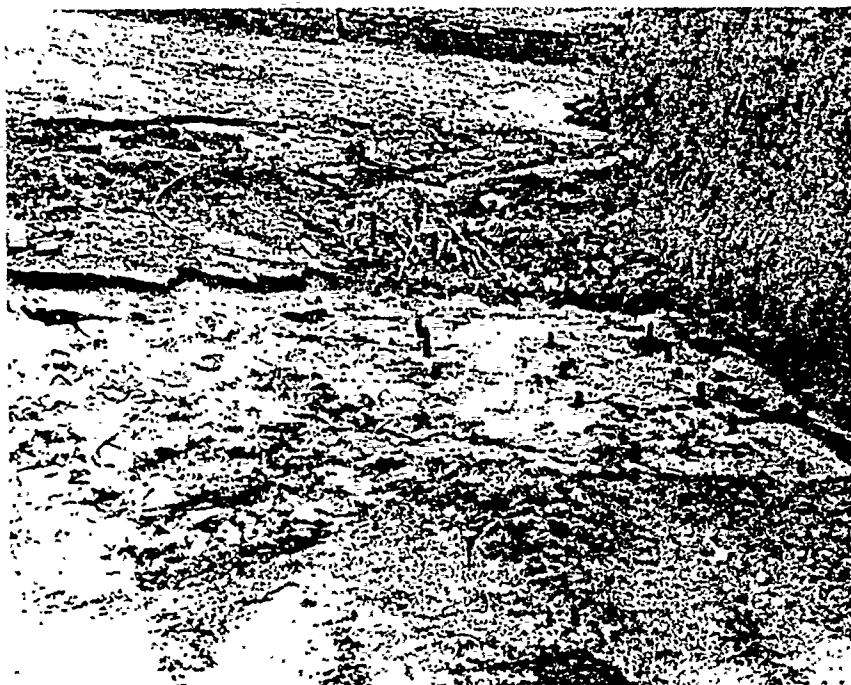
Photo. No. 41

Foundation along centerline at Sta. 25+50 to 25+70. Note three lines of grout holes in this area.
