REPAIR, EVALUATION, MAINTENANCE, AND
REHABILITATION RESEARCH PROGRAM

TECHNICAL REPORT REMR-CS-30

IN SITU REPAIR OF DETERIORATED CONCRETE
IN HYDRAULIC STRUCTURES: EPOXY INJECTION
REPAIR OF A BRIDGE PIER

R. P. Webster, L. E. Kukacka, D. Elling

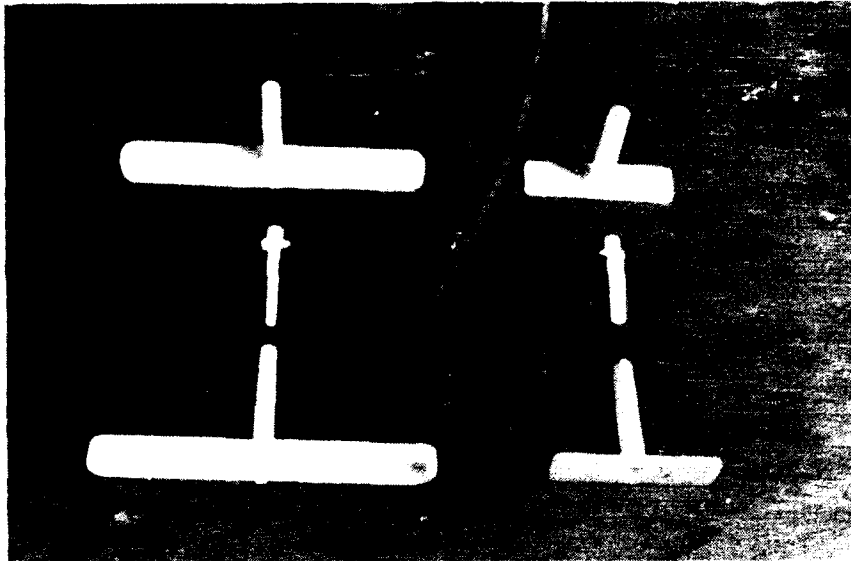
Figure 1. Molded injection ports designed for surface mounted applications
(Type A, left, and Type B, right)

23. In general, all of the failures resulted from leaks developing around the parameter of the injection port and propagating through the interface of the epoxy seal coat and the injection port. This problem was primarily due to the inability of the epoxy to securely bond to the polyethylene. In no instance did the injection ports physically fail. The results indicate that surface-mounted ports will withstand lower injection pressures than ports mechanically mounted in a drilled port hole. The Lily Injecti-port withstood pressures of 200 to 275 psig when inserted within a drilled port hole, but only 150 psig when surface-mounted. Also, the ability of a surface-mounted port to withstand injection pressures seems to be related to the surface area of the port in contact with the concrete; ports with a larger surface area were able to withstand the least amount of pressure. The surface-mounted Lily Injecti-port withstood the greatest test pressure, 150 psig, while having the least contact surface area, 0.8 cm^2 . The Type B (refer to Figure 1) surface-mounted port had the greatest contact surface area and withstood the least amount of pressure.

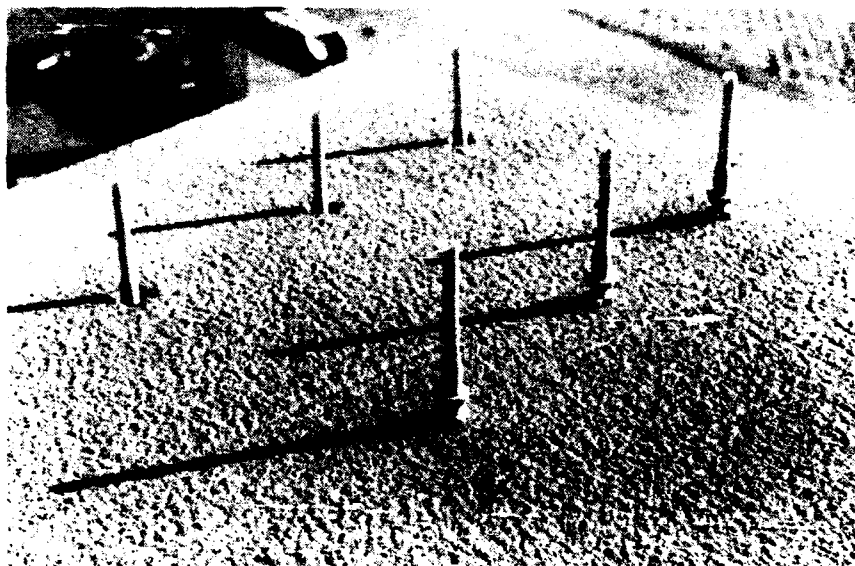
Figure 3. Injecti-port nozzles inserted into a drilled port hole and surface mounted onto the concrete test slab (before application of seal coat)

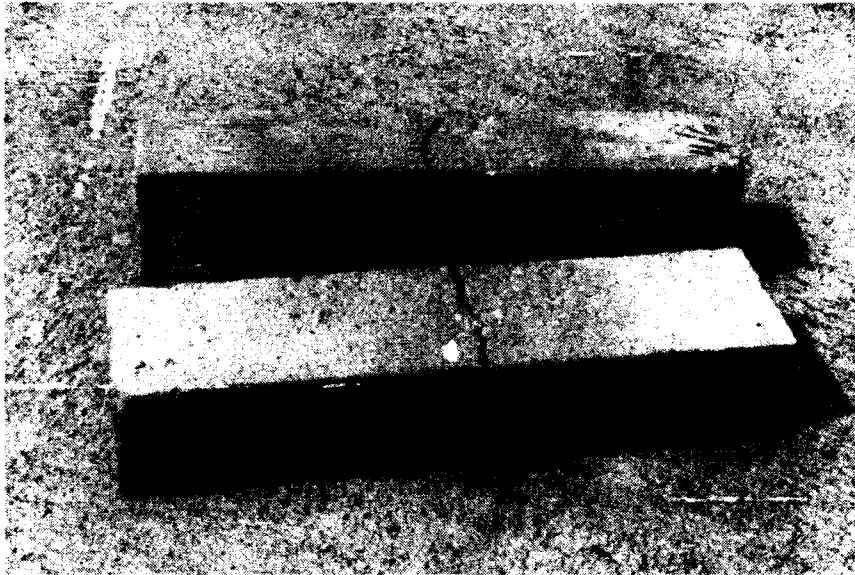
Figure 5. Cracked flexure beam used in the freezing and thawing study

42. A visual examination of the beams throughout the test showed very little physical damage. Slight surface scaling was noted on some of the beams after approximately 125 cycles.

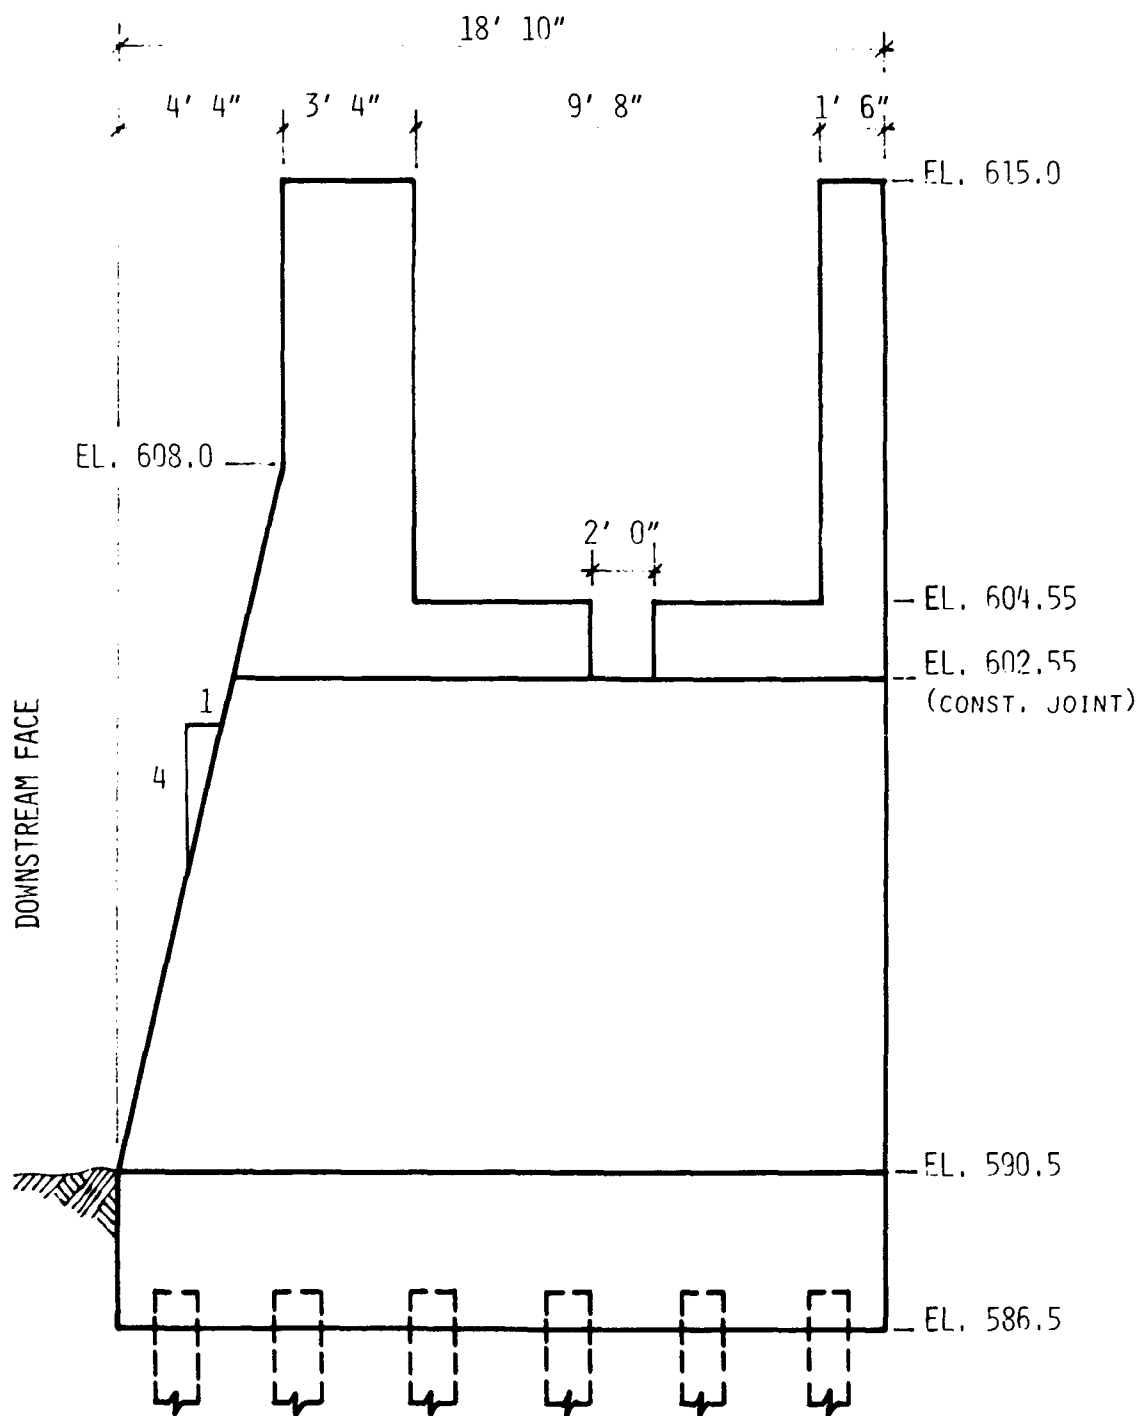
Figure 7. Elevation of (Illinois face) Pier No. 13

46. Periodic inspection of Pier No. 13 indicated extensive deterioration in the lower 12-ft of the pier, i.e., between El. 590.5 and 602.55 (Figure 7). The deterioration was characterized by an extensive crack network running throughout the base of the pier, large sections of drummy concrete in the corners, and excessive amounts of efflorescence on the exterior surfaces (Figures 8-10). The inspection reports are presented in Appendix A.

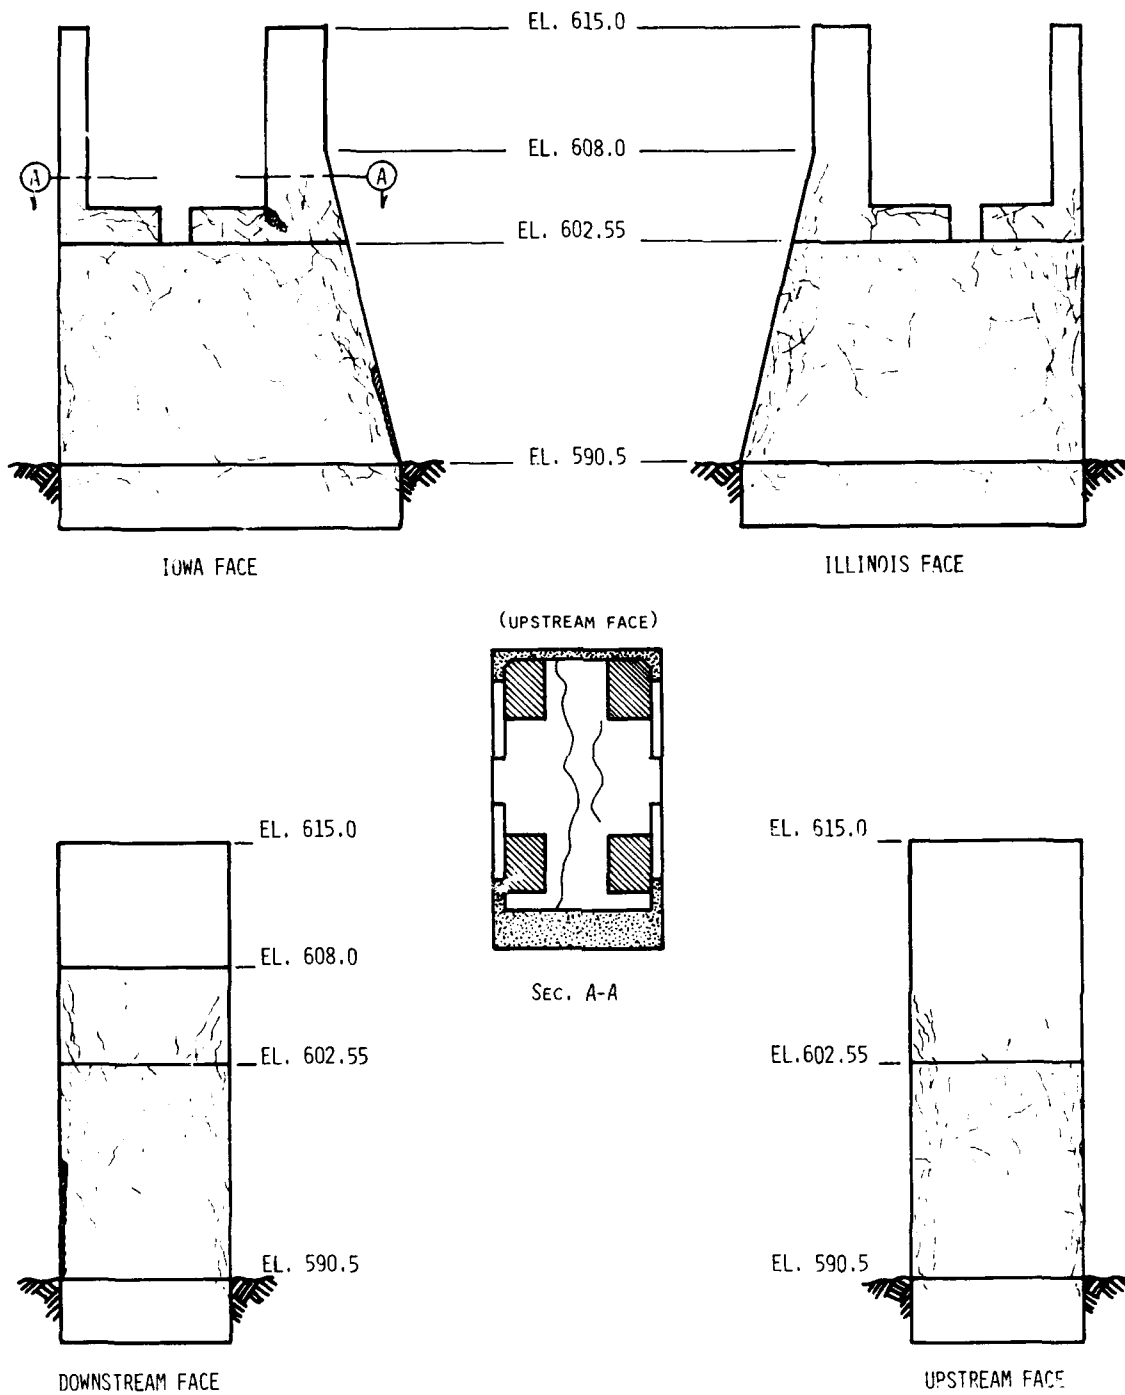
- e. Iowa face - the face was highly cracked around its perimeter, below the level of the construction joint. The interior portion of the face did not appear to be highly cracked; however, it sounded very delaminated. The corner shared with the downstream face, as previously noted, was partially broken away as a result of the cracking and delaminations. The upstream portion of the bearing seat curtain wall was cracked but relatively sound. The downstream half, however, was badly deteriorated and needed to be patched before the cracks could be repaired.

Figure 13. Drawing showing crack patterns

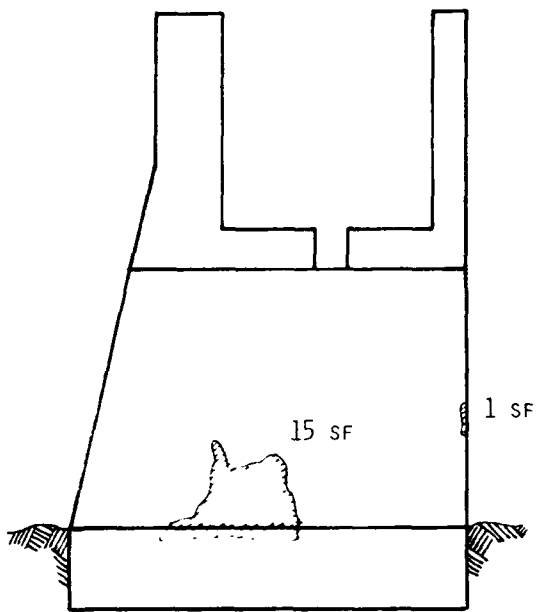
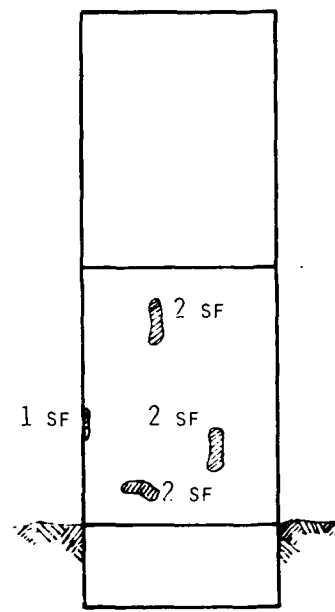
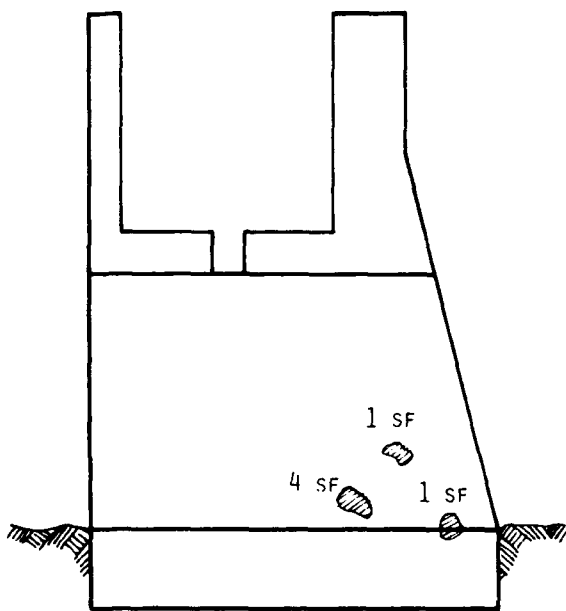
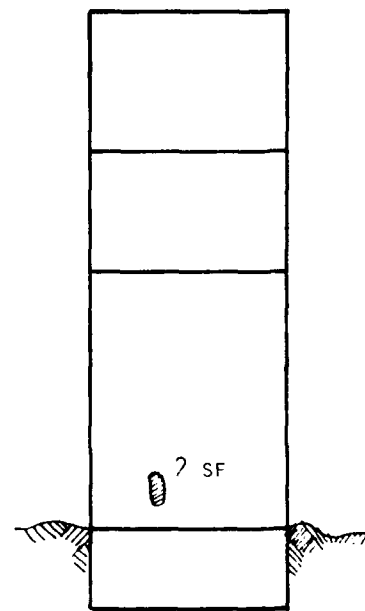
Figure 28. Void areas marked for reinjection

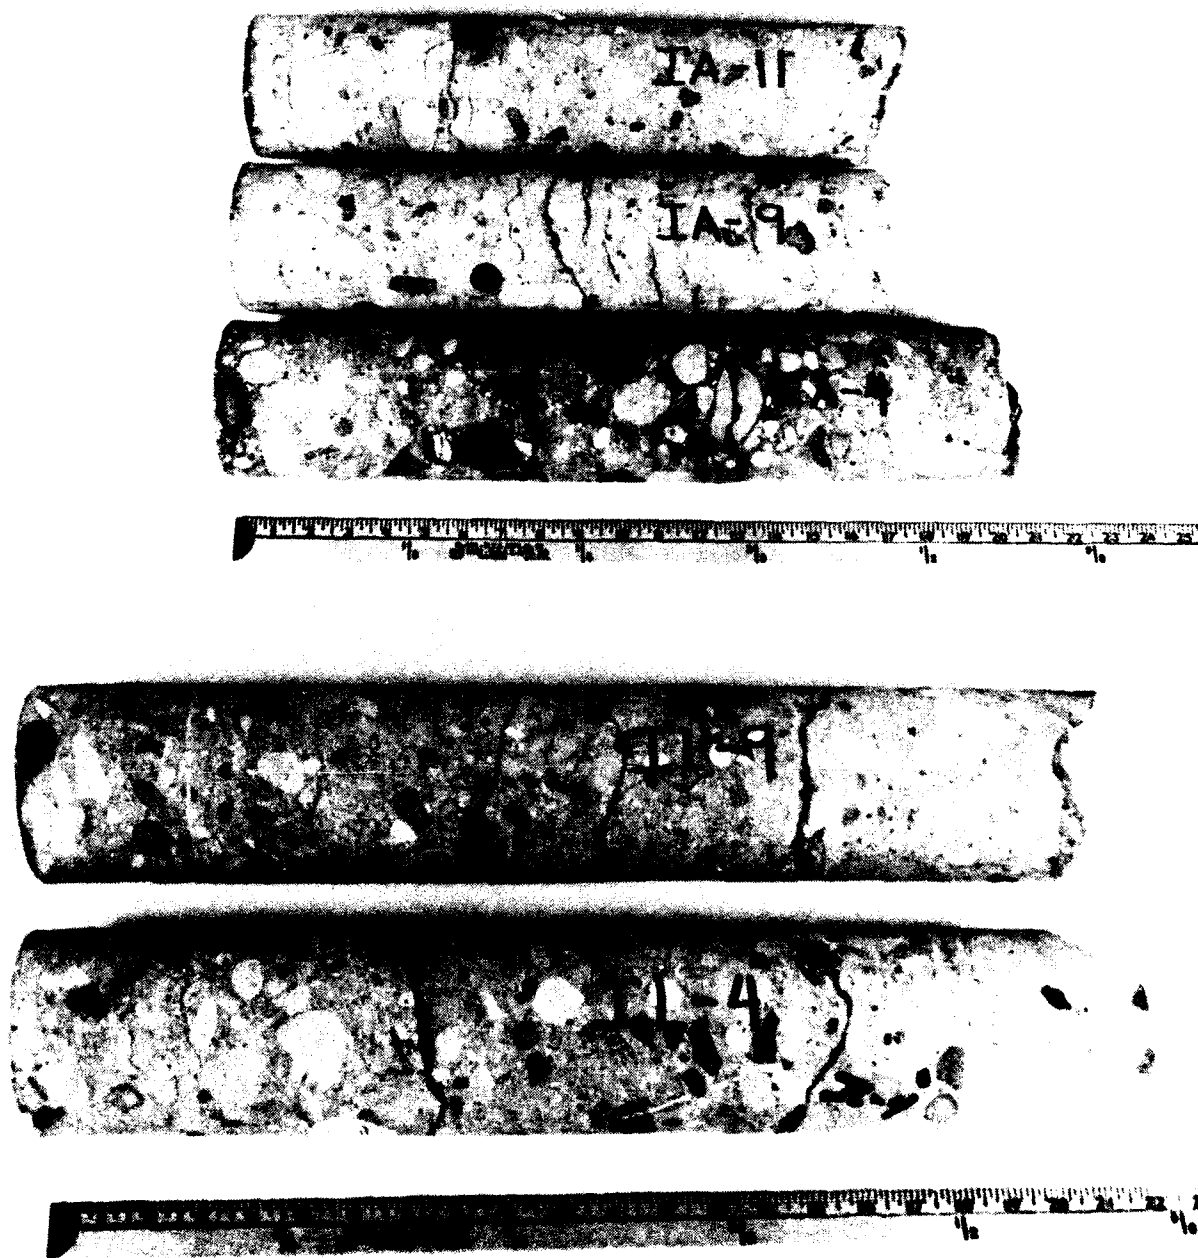
84. The results of the ultrasonic pulse velocity tests and the visual examination of the postinjection cores indicates that the crack network within the top 6 to 10 in. was repaired by the epoxy injection, which appeared to have

Figure 30. Cores removed from Pier No. 13 after epoxy injection repair

created a protective shell, 6 to 10 in. in thickness, around the face of the pier. It should be noted that this thickness directly corresponds to the depth to which the port holes had been drilled. Therefore unless the crack planes within the pier were intersected by the drilled port holes, they were not repaired by injection. Also, there seemed to be significant cracking within the interior of the pier that did not appear in the cores taken before injection. This analysis helps to explain why the postinjection pulse velocity readings taken between the Illinois and Iowa faces of the pier were so much lower than those readings through the corners of the pier. Those readings taken through the corners were taken through the zone which had been repaired, while those readings taken between the Illinois and Iowa faces were influenced by the unrepaired cracks within the interior of the pier.

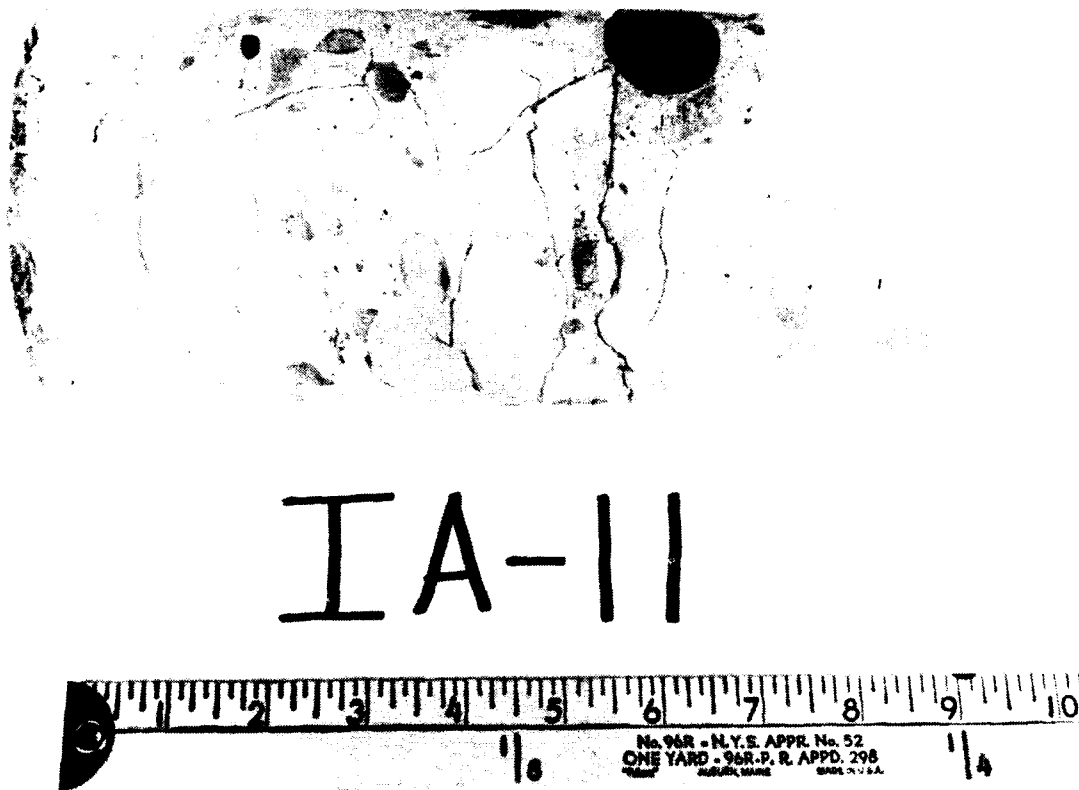
Figure 31. Closeup of core IA-11 showing epoxy-filled crack network

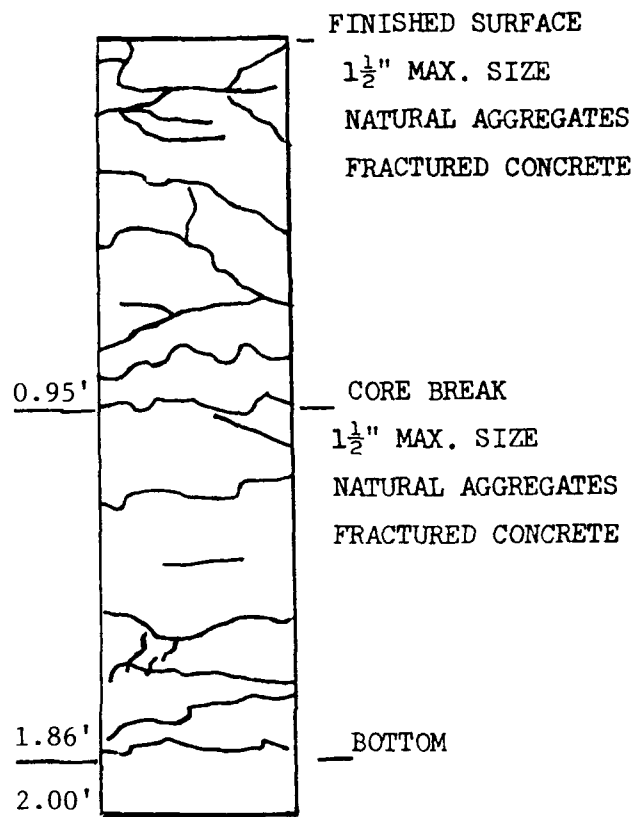
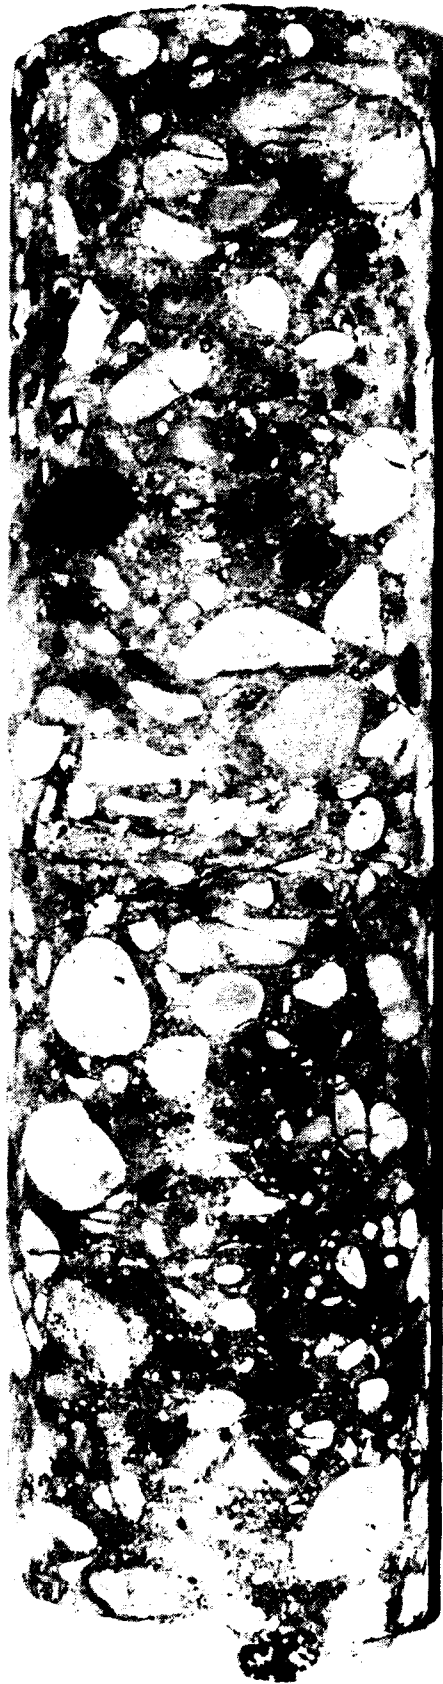
6-inch DIA. CONCRETE CORE
 LOCK AND DAM 13
 PIER 13
 LOG OF VERTICAL CORE
 21 AUGUST 1980

a. Lock No. 13, Pier No. 13 0-1.84 ft. This core is highly fractured with multiple parallel cracks about $\frac{1}{2}$ to 1-inch apart in the first one foot of core running parallel to the face of the core. Then the cracks become somewhat diagonal and about 3 to 4-inches apart. Much evidence of silica gel deposits around white and brown chert particles is noted. Many of the chert and sandstone - siltstone particles are shattered. The crack pattern is characteristic of freeze-thaw action and probably results from poor frost protection of the mortar since it is not air-entrained. Some of the porous cherts and siltstones are of low durability also. Alkali-silica reactivity is evident, but it is believed that the freeze-thaw cracking came first, then the reactivity along the cracks which were open to water. Some cracks are lined with lime deposits and much of the silica gel has become carbonated.
