The First Annual Navy Corrosion Control Workshop

Microbiologically Influenced Corrosion in Copper and Nickel Seawater Piping Systems

Executive Summary

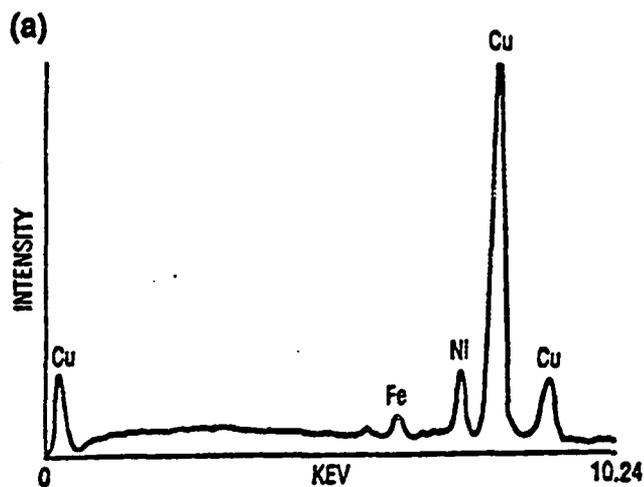
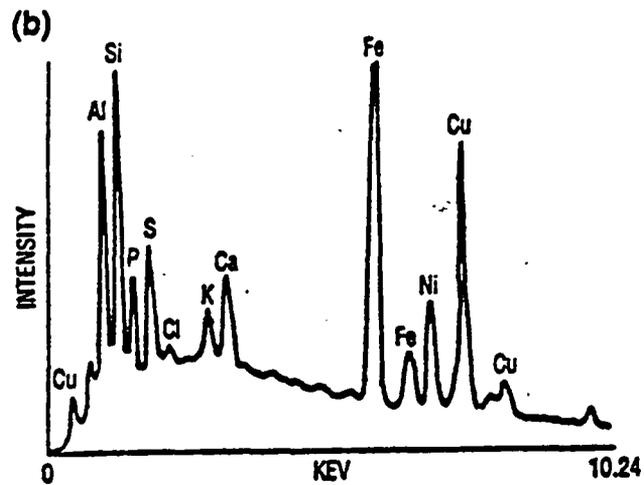
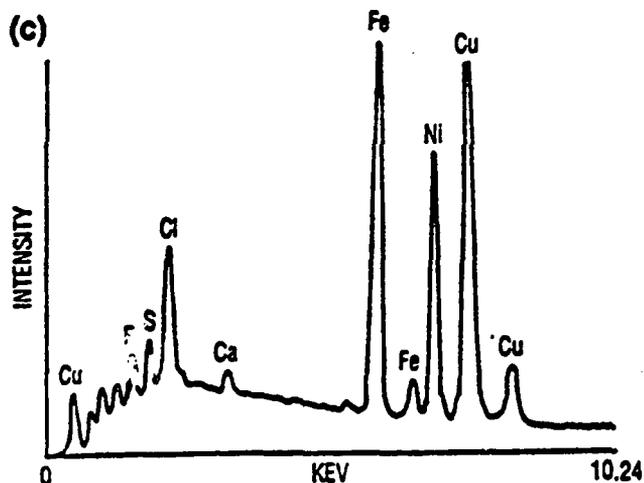
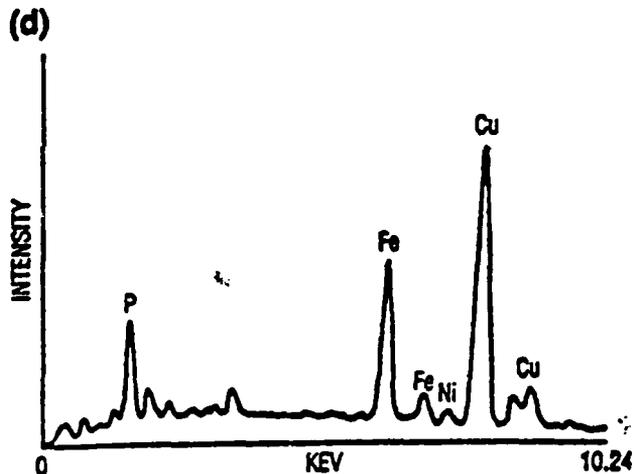
A. EDAX SPECTRUM OF CLEAN COPPER ALLOY BEFORE EXPOSURE

B. EDAX SPECTRUM OF PITTED REGION OF COPPER ALLOY, SHOWING ACCUMULATION OF ALUMINUM, SILICON, PHOSPHORUS, SULFUR, CALCIUM AND ELEVATED AMOUNTS OF IRON AND NICKEL.

C. EDAX SPECTRUM OF PITTED REGION OF COPPER ALLOY, SHOWING THE ACCUMULATION OF CHLORINE AND ELEVATED AMOUNTS OF IRON AND NICKEL.

D. EDAX SPECTRUM OF SPONGY MATERIAL BENEATH BACTERIA, SHOWING AN ACCUMULATION OF PHOSPHORUS, AN ENRICHMENT OF IRON AND A DEPLETION OF NICKEL IN THE BASE OF THE PIT.

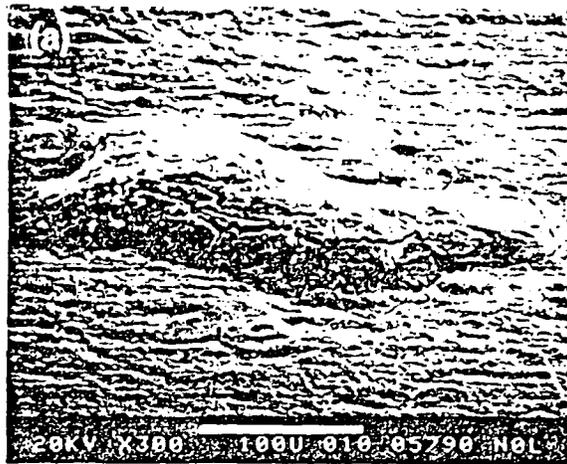
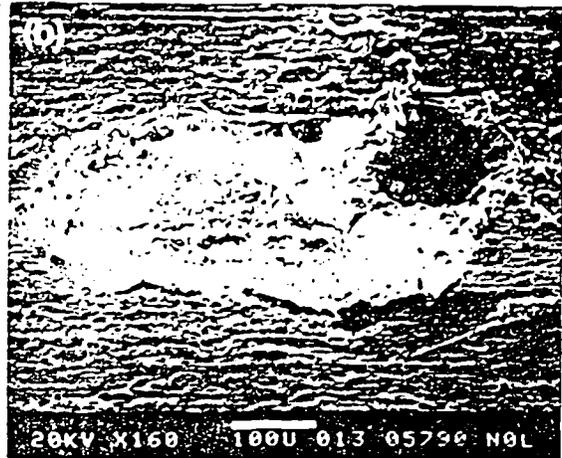
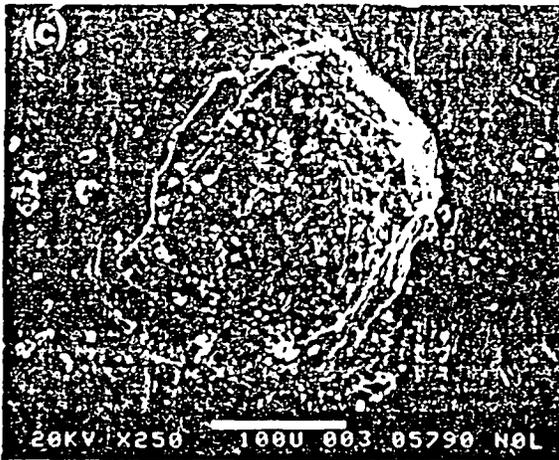
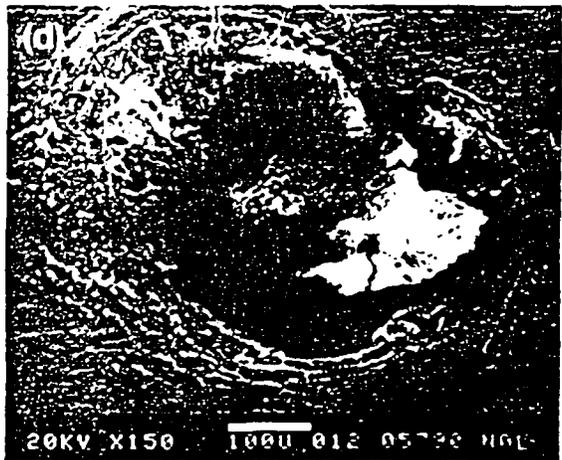
A AND C. BLISTERS ON THE SURFACE OF NICKEL TUBE.

B AND D. PITS ON NICKEL TUBE.

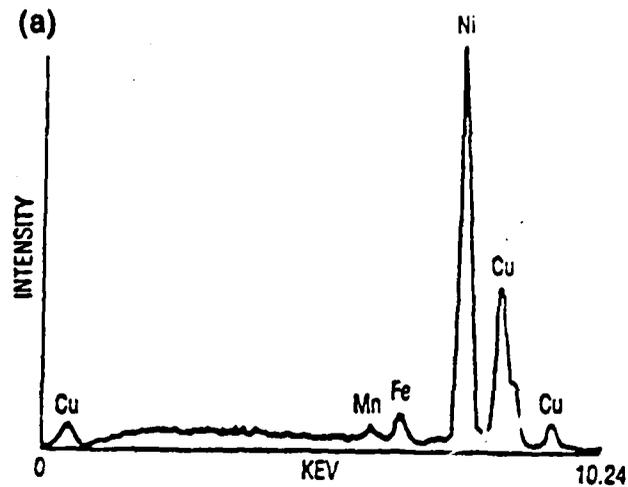
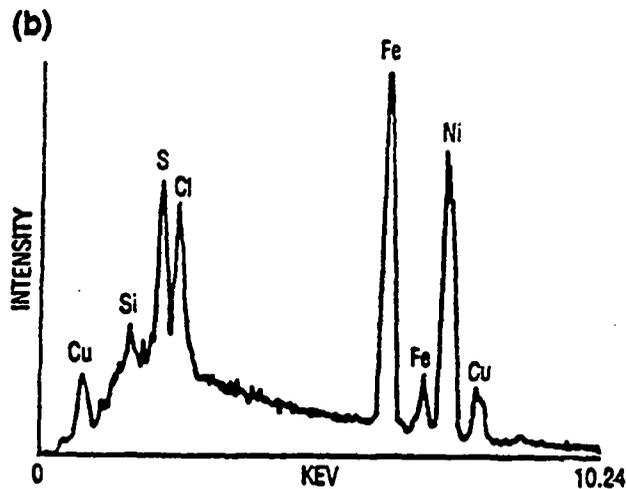
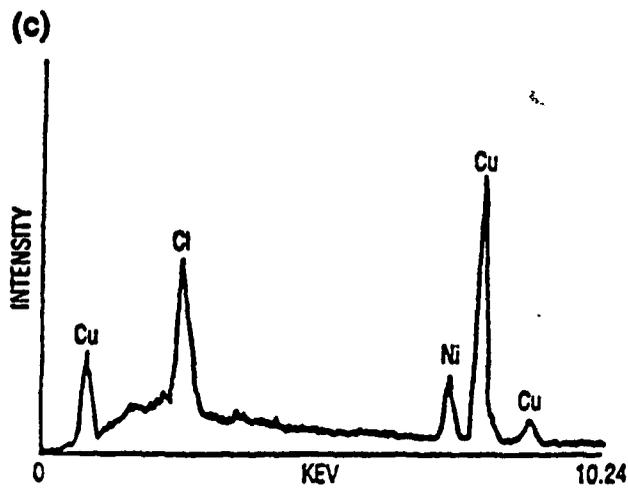
A. EDAX SPECTRUM OF UNEXPOSED NICKEL ALLOY.

B. EDAX SPECTRUM OF NICKEL ALLOY AFTER EXPOSURE TO ESTUARINE WATER FOR 6 MONTHS SHOWING ACCUMULATIONS OF SILICON, SULFUR, AND CHLORINE WITH ELEVATED CONCENTRATIONS OF IRON AND NICKEL.

C. EDAX SPECTRUM OF THE RESIDUAL METAL IN THE BASE OF THE PIT SHOWING NICKEL DEPLETION AND COPPER ENRICHMENT.

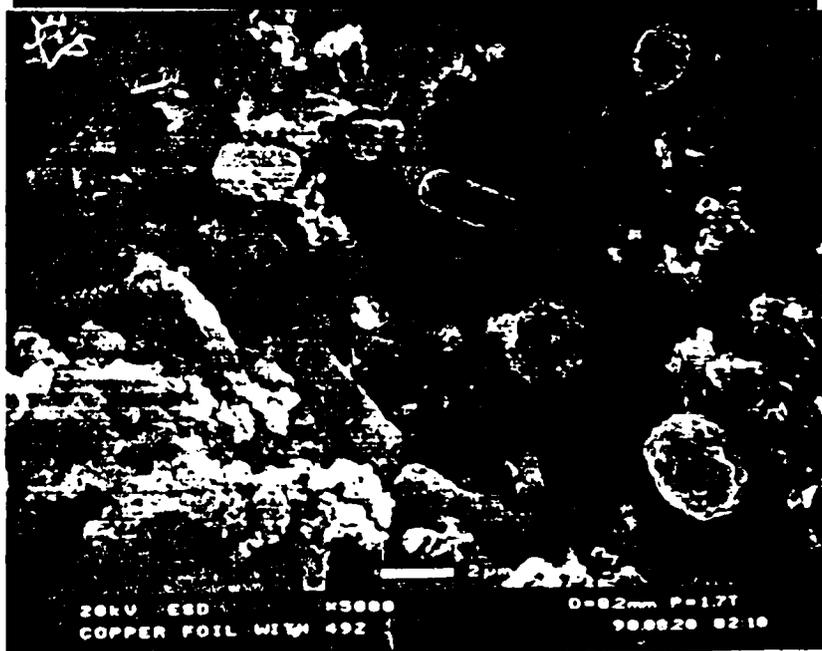
BACTERIA ASSOCIATED WITH CORROSION PRODUCTS.

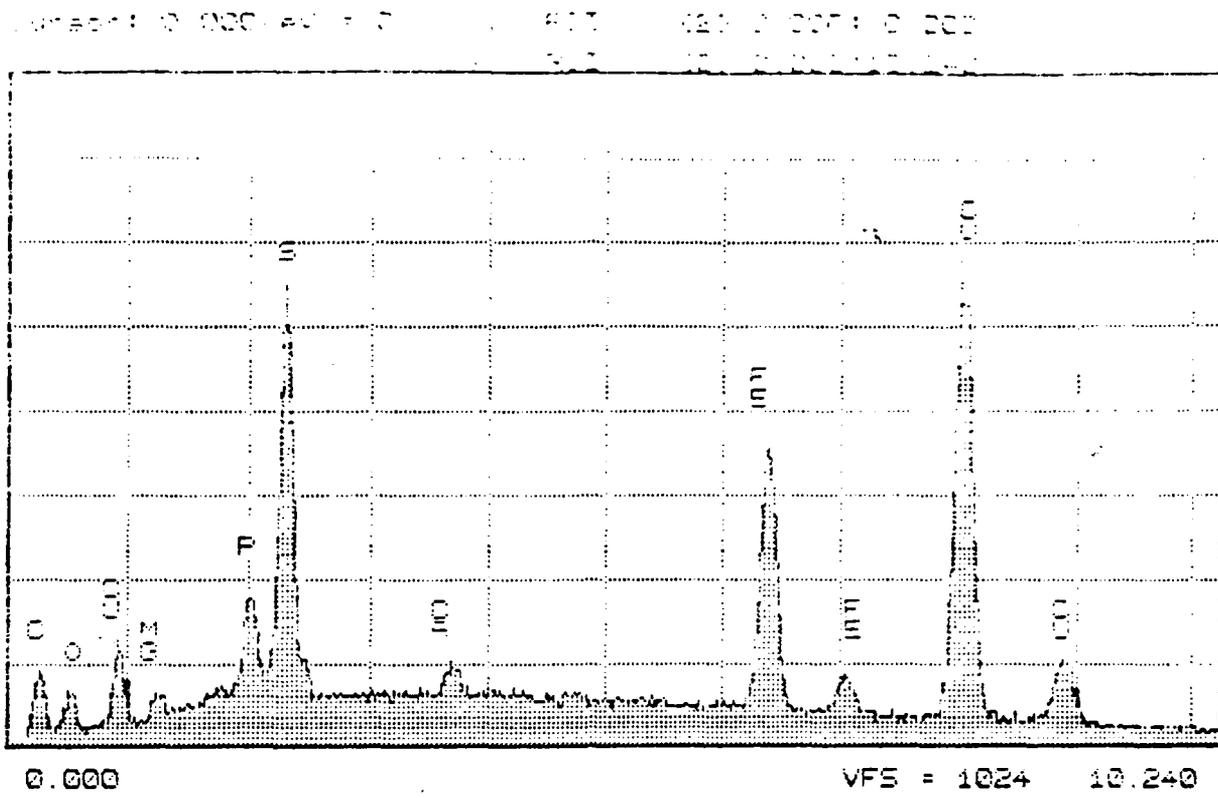
EDAX SPECTRUM OF 99CU COLONIZED BY CULTURE IV.

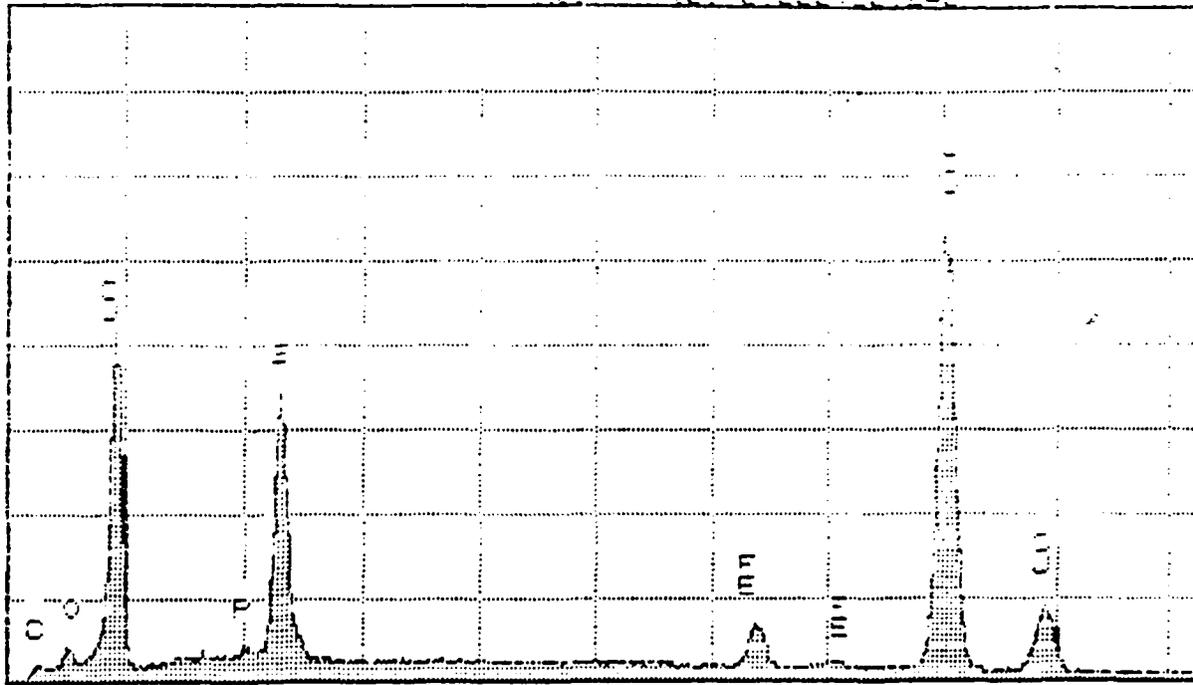
EDAX SPECTRUM OF THE 99CU METAL SURFACE UNDER CULTURE IV.

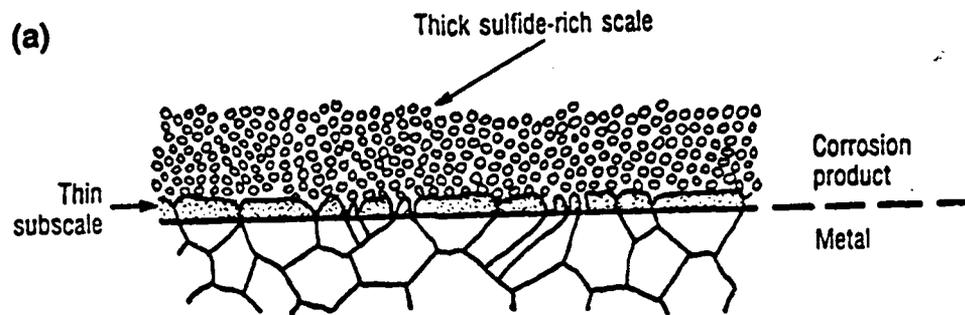
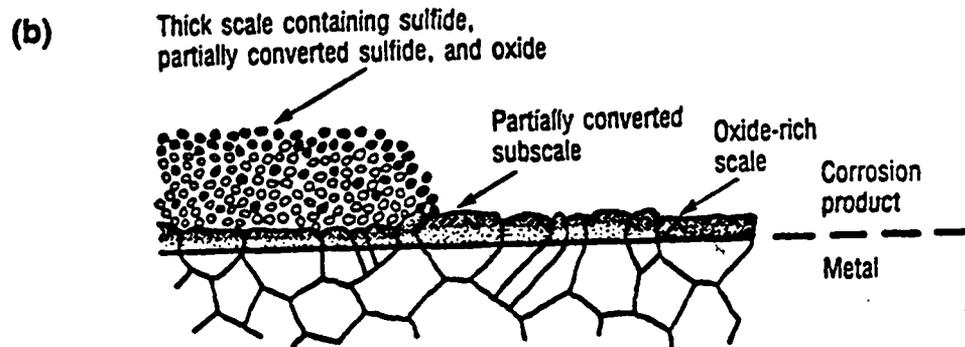
A. SCHEMATIC OF THICK SULFIDE-RICH SCALE FORMING ON COPPER ALLOY (TAKEN FROM SYRETT, 1980).

B. SCHEMATIC SHOWING DISRUPTION OF SULFIDE-RICH FILM ON COPPER ALLOY BY THE INTRODUCTION OF AERATED SEAWATER (TAKEN FROM SYRETT, 1980).
