MTL TR 90-53

FAILURE ANALYSIS OF THE LAU-7/A LAUNCHER RETENTION BAND ASSEMBLY

VICTOR K. CHAMPAGNE, Jr. and GARY WECHSLER
MATERIALS TESTING AND EVALUATION BRANCH

November 1990

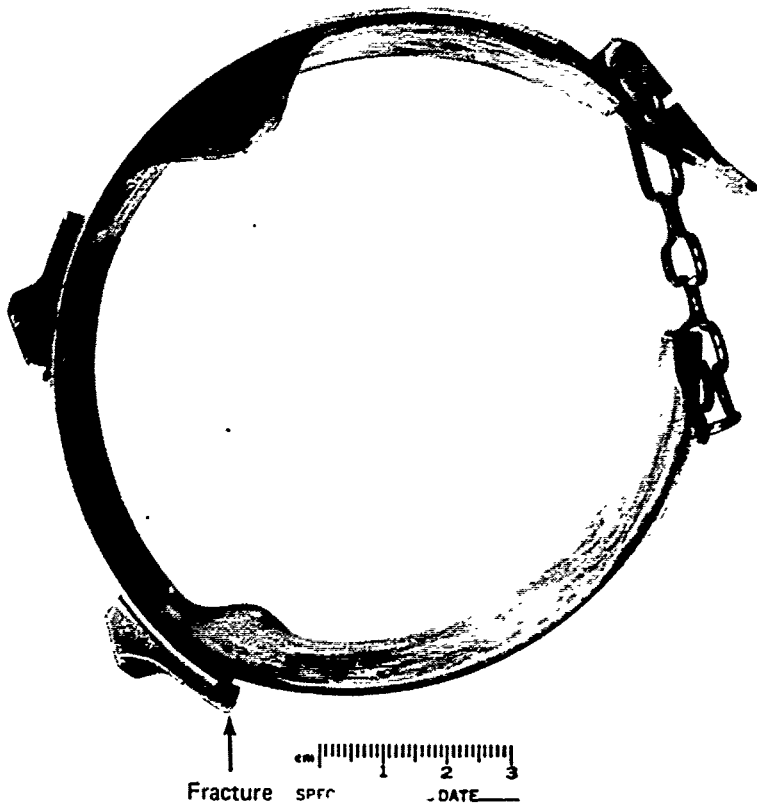
Figure 6 shows the retention band assembly in the as-received condition. The failure occurred at the spot-welded regions where the base, P/N 58A164C528 was joined to the band, P/N 58A164B532 (refer to lower left-hand corner of the macrograph). The inside liner which was bonded to the 301 stainless steel band experienced delamination in several places, including the area across the fracture zone. The significance of this finding was that the interface between the two parts caused by the debonding, could entrap moisture and/or an aggressive species which may initiate crevice corrosion. Another ideal situation for crevice damage was observed between the 17-4 PH stainless steel base and the band. Since spot welds were utilized to connect the parts together, the perimeter of the base was not adequately sealed off from the environment. This design provided an entrance for corrosives and a suitable haven for crevice corrosion to occur between the mating surfaces. Figure 7 reveals the fractured region from a different angle. It can be easily distinguished from this view that the failure occurred across the three spot-welds. The weld nuggets remained intact with the base while the band was completely severed from the welded assembly. The external surface of the band appeared to be free of any significant amounts of general corrosion or pitting, but

Figure 6. Shows the retention band assembly in the as-received condition.

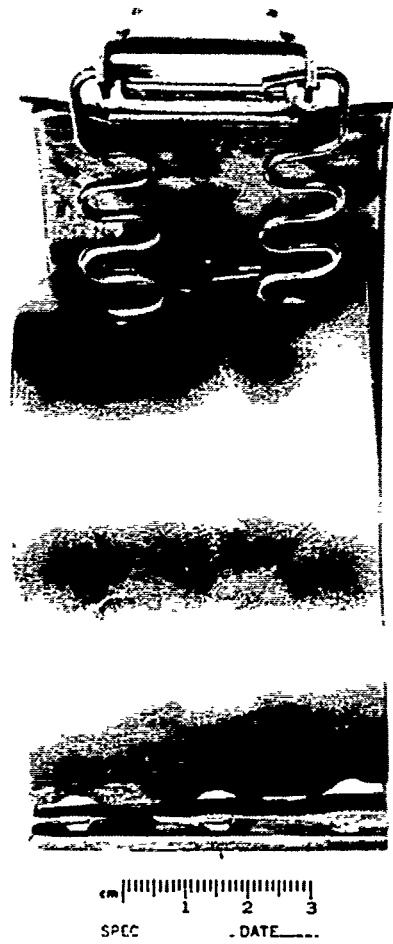
Figure 7. Reveals the fracture which occurred across three spot welds used to attach the retention base to the band.

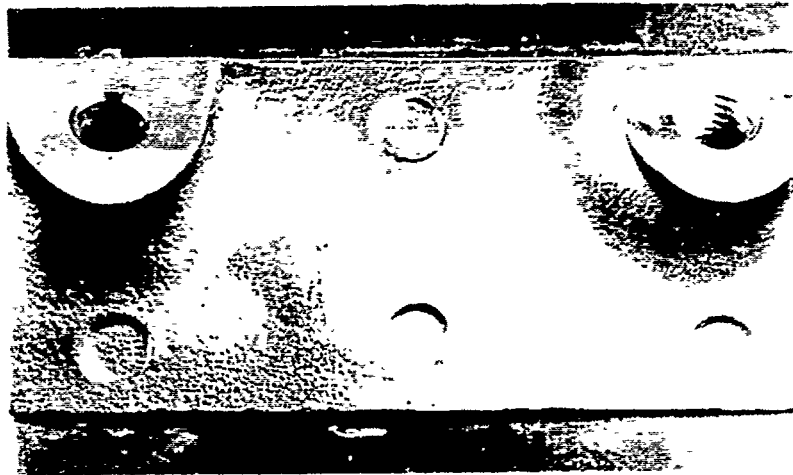
Examination of additional randomly selected retention band assemblies verified that the spot welding procedure was not adequately controlled. Figures 11 through 13 represent the spot welds of three additional components. The welded regions of Figures 11 and 13 are much less pronounced than the deep impressions contained in Figure 12. These cavities can act as stress concentration areas where a fatigue crack could initiate.

Figures 11 through 13. Optical photographs showing spot welded regions of three separate retention bands. Note that the surface depressions occur randomly, indicative of a welding proces. that had not been adequately controlled. Mag. 2.2X

- Uniform electrode force should be applied to prevent blow hole formation.
- Weld surfaces should be properly cleaned to provide uniform resistance. The retention band and base contain passivated oxide layers which need to be removed prior to welding. This chromium oxide layer is a refractory material and has a high melting temperature. In addition, surfaces greases and oils can cause inclusions and porosity, as well as alter the chemical composition within the weld.

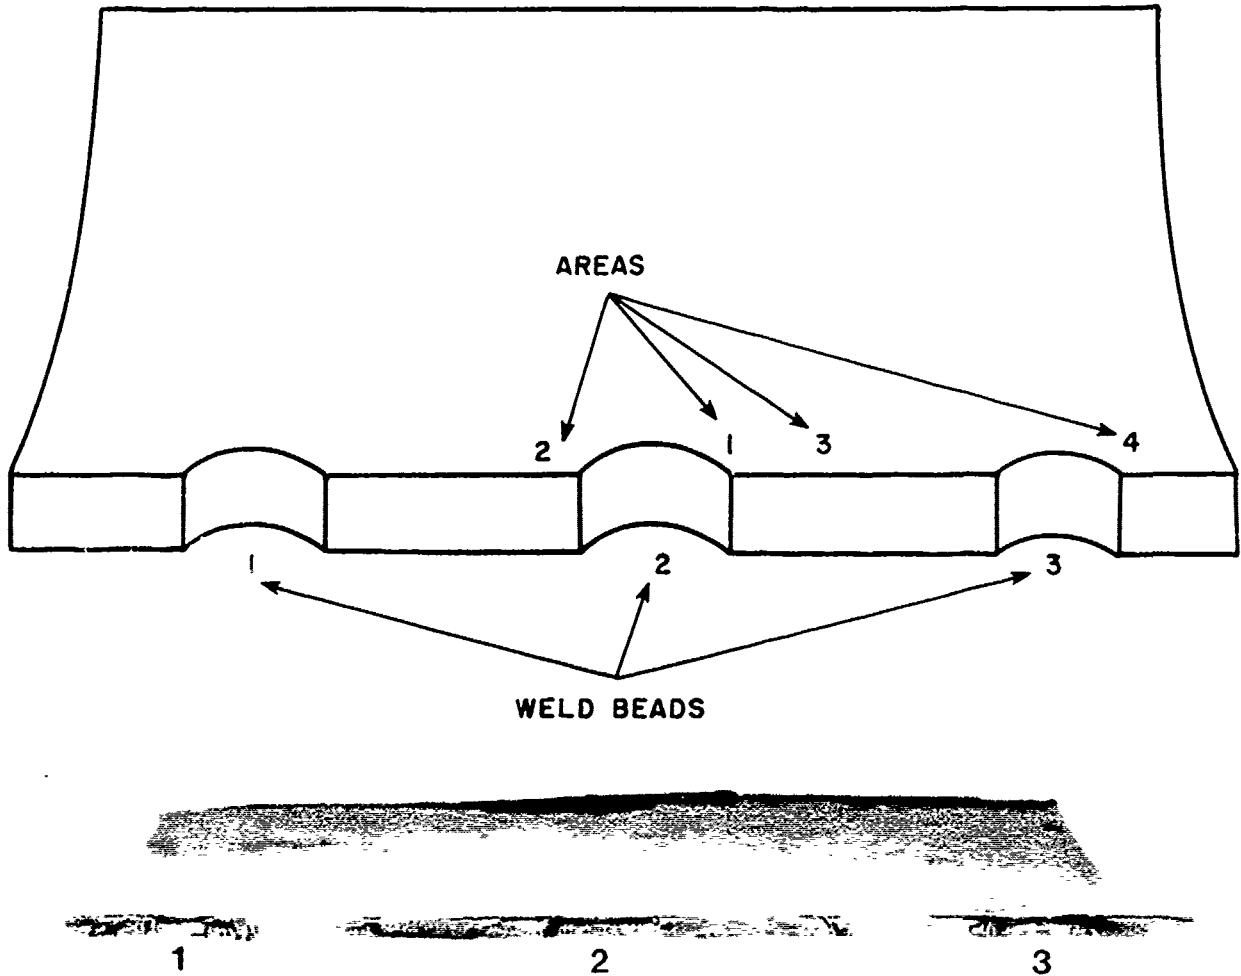
The area of the retention band that contained the fracture was sectioned and removed from the assembly. Figure 14 shows the locations where the three weld beads had ruptured. These areas have been appropriately identified for future reference. Macroscopic examination under low magnification was utilized to determine the crack origin and to correlate fracture surface characteristics with the overall geometrical configuration of the component and the loading conditions. Figure 15 contains the fracture surface to the right of the weld bead no. 1 (refer to Figure 14 for exact location). The most important observation was the existence of beach marks which can be seen emanating from the bottom left-hand corner of the weld bead and resemble the ripples or waves that form, such as when a stone is dropped into a still body of water. Beach marks, often referred to as clamshell marks, may occur from oxidation of the fracture surfaces during periods of crack arrest from intermittent service and are associated with fatigue failures. They could also be the result of changes in loading or frequency.

Figure 14. Shows the location of the failure where the three weld beads had ruptured. Mag. 3X

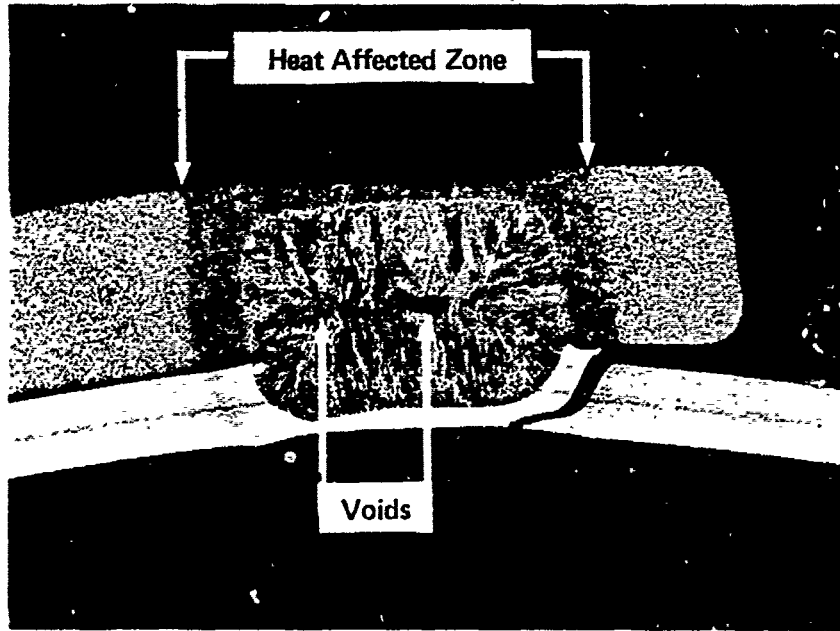
A cross section of the failure site located at weld bead no. 2 was taken and prepared for metallographic examination. The sample was etched utilizing a solution of 97% HCl and 3% HNO₃ with the addition of one half gram of CuCl₂. The resulting microstructure of the spot-welded assembly is revealed in Figure 18. The thin component is the 301 stainless steel band while the bottom part is the 17-4 PH stainless steel base. The failure occurred across the HAZ of the band at the corner of the depression made by the spot-welding electrode. Deeper cavities can be seen beneath the weld nugget and can act as stress raisers in the material. The HAZ is easily recognized at the areas which have etched darker and are characterized as the two vertical bands on either side of the weld bead. The weld nugget itself exhibits a typical dendritic structure representative of an as-cast material. Two voids can be observed near the center of the weld bead and may have been caused by entrapped gas or shrinkage.

Figure 18. Reveals the microstructure of the failed spot-welded assembly. Note the failure occurred within the HAZ. Mag. 10X

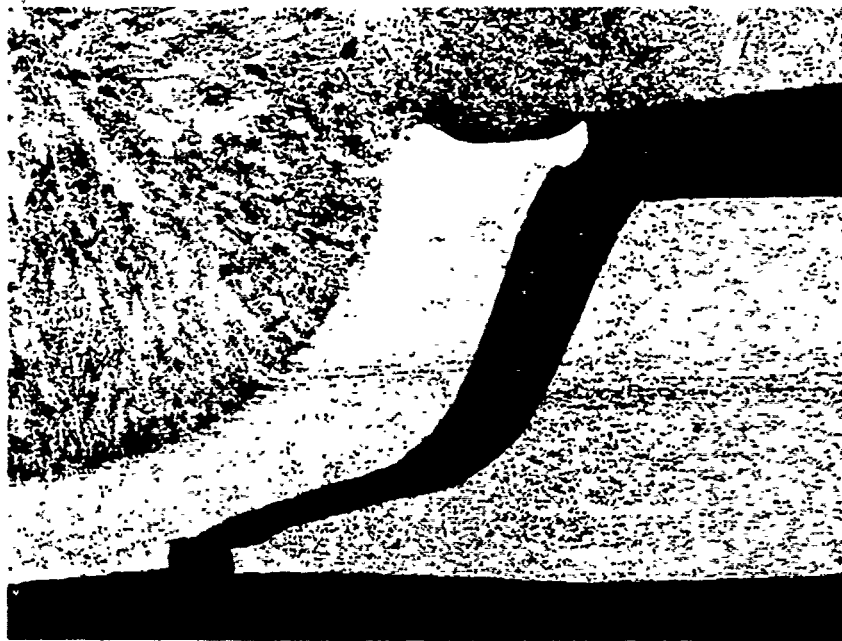
Figure 19 shows the failure site at higher magnification. The slender bands that run horizontally across the 301 stainless steel have preferentially etched darker because of prior cold working which occurred during primary material processing. The center grains have been compressed from external rolling forces forming flow lines. Figure 20 contains the microstructure outside of the HAZ of the 301 stainless steel band, while Figure 21 reveals the structure within the HAZ. The flow lines are much more discernable at these magnifications. Recrystallization has taken place within the HAZ which is signified by a smaller equiaxed grain size.

Figure 19. Higher magnification of the failure region showing flow lines at the center of the band. Mag. 50X

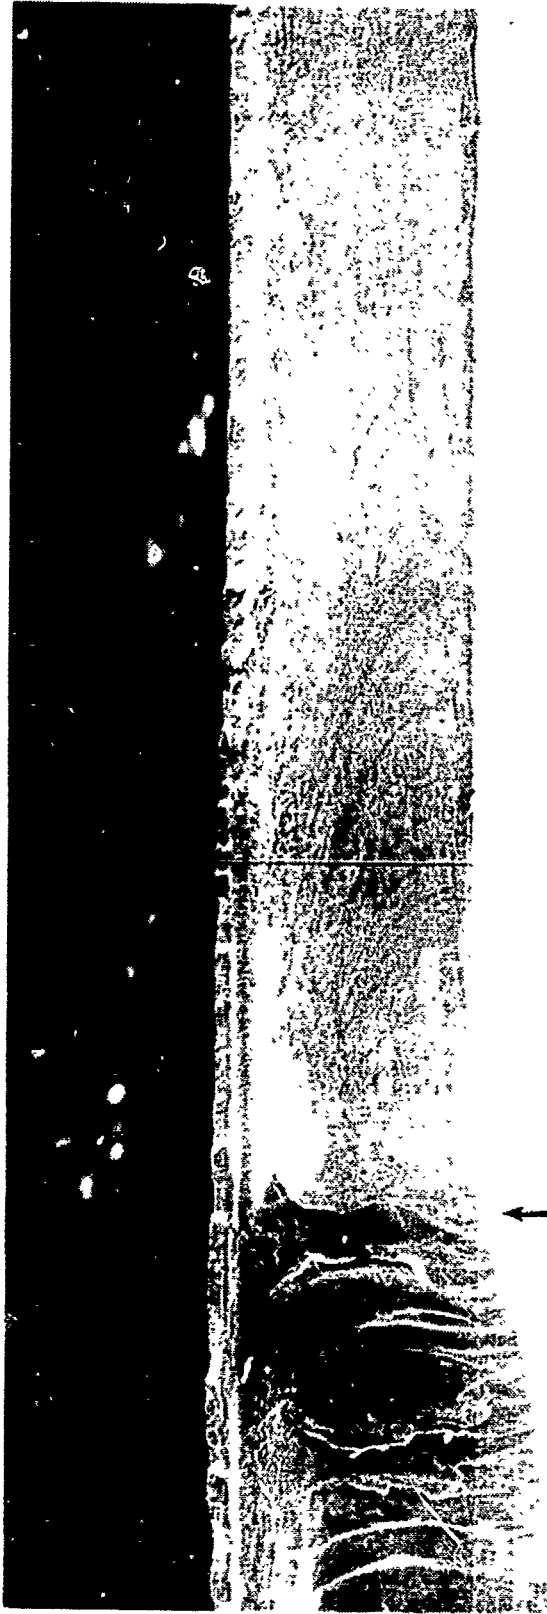
The fracture faces of the retention band were examined at a higher magnification utilizing the scanning electron microscope (SEM) in order to identify the failure mode in each of the three weld bead areas. Figure 24 shows the fracture surface within area 1 of weld bead no. 2 (identified previously on Figure 14). Well-defined beach marks are clearly distinguishable on the fractograph. The arrow points to the possible origin of the fatigue crack which is the common point where the beach marks converge. The surface near the crack nucleation site was relatively smooth and flat faced. Closer examination of the crack initiation site did not reveal any evidence of an inclusion or a surface defect, such as a corrosion pit.

Figure 24. SEM photograph showing the fracture surface within area 1 (identified previously on Figure 14). Mag. 50X

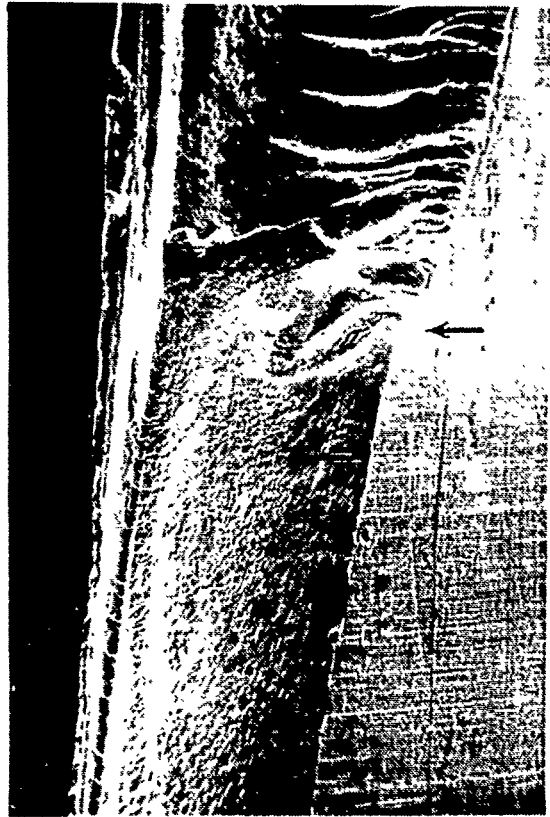
Figure 25 represents area 2 located near the same weld bead approximately 180° away from area 1. The beach marks observed in this region extend outward in an opposing direction to those contained in Figure 24. Another notable feature which was observed to the right of the crack origin (designated by the arrow) was parallel steps extending vertically across the thickness of the weld bead. These same markings were also found to the left of the crack initiation site contained in Figure 24 and are shown at higher magnification in Figure 26. These macroscopic patterns were the result of an advancing crack front which expanded across different planes.

Figure 25. SEM fractograph of area 2 located near weld bead no. 2 showing beach marks. Mag. 50X

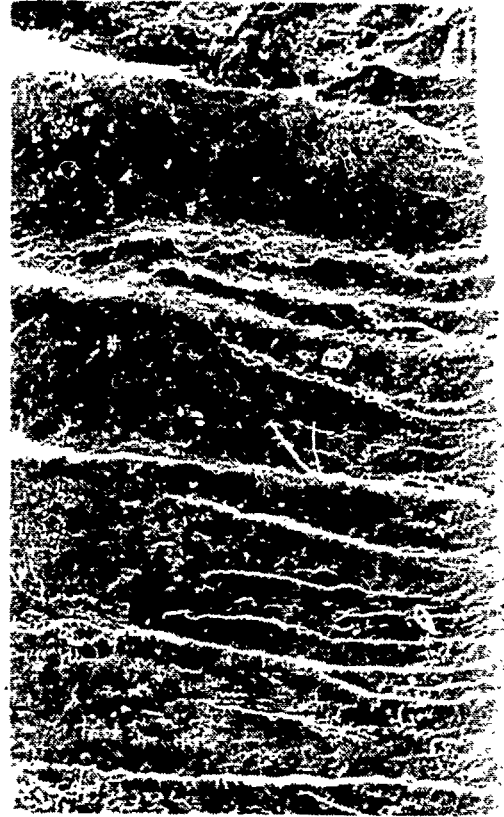
Figure 26. SEM micrograph revealing fracture patterns left behind by the advancing crack front. Mag. 100X

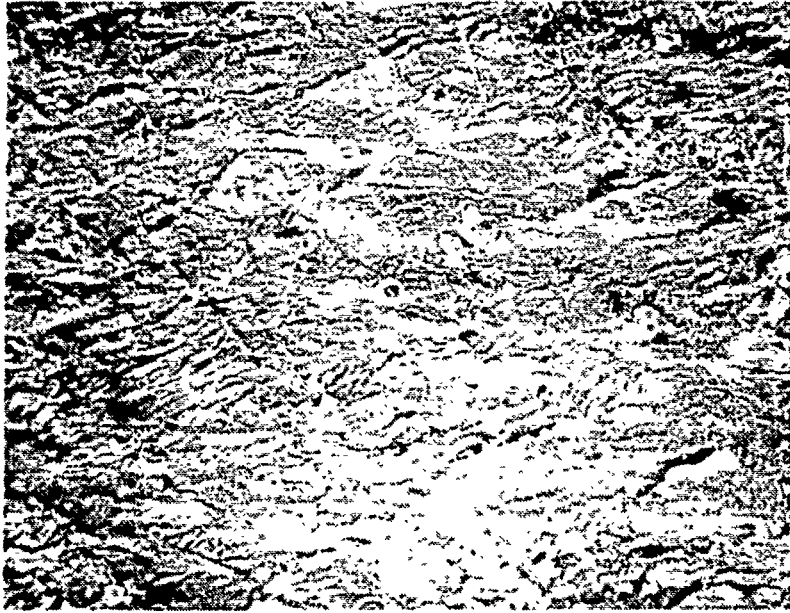
Figure 27 verifies that the fracture mechanism near the crack origin was transgranular in nature, where crack growth proceeded along crystallographic planes. Further examination of

Figure 27. Confirms that the fracture mode was transgranular near the crack origin. Mag. 1KX

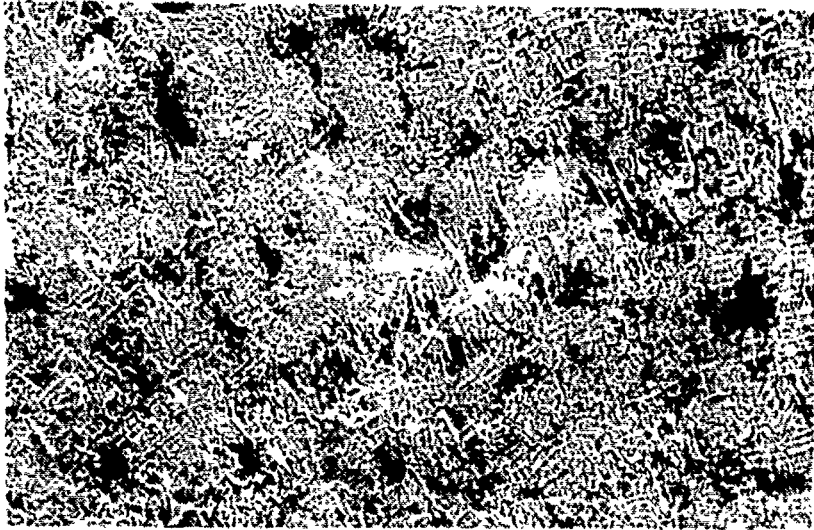
Figure 29. SEM fractograph verifying the existence of fatigue striations. Mag. 500X

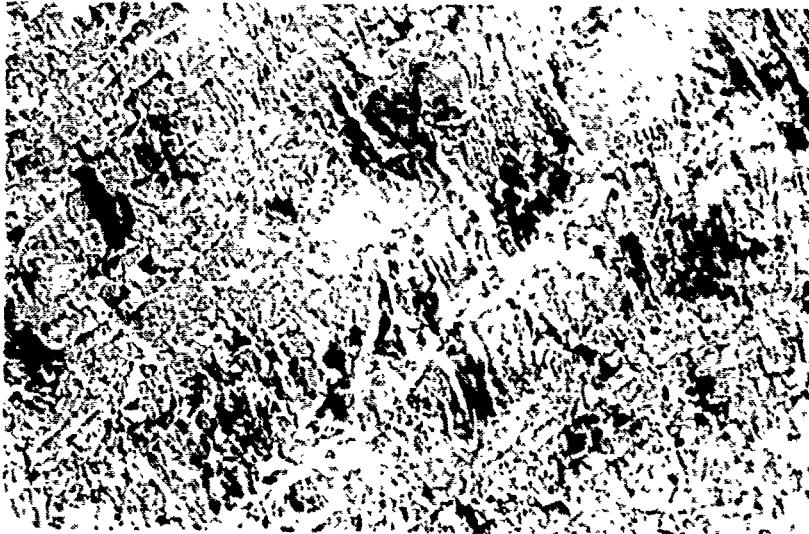
Figure 30. Higher magnification of striations contained in Figure 24. Mag. 1KX

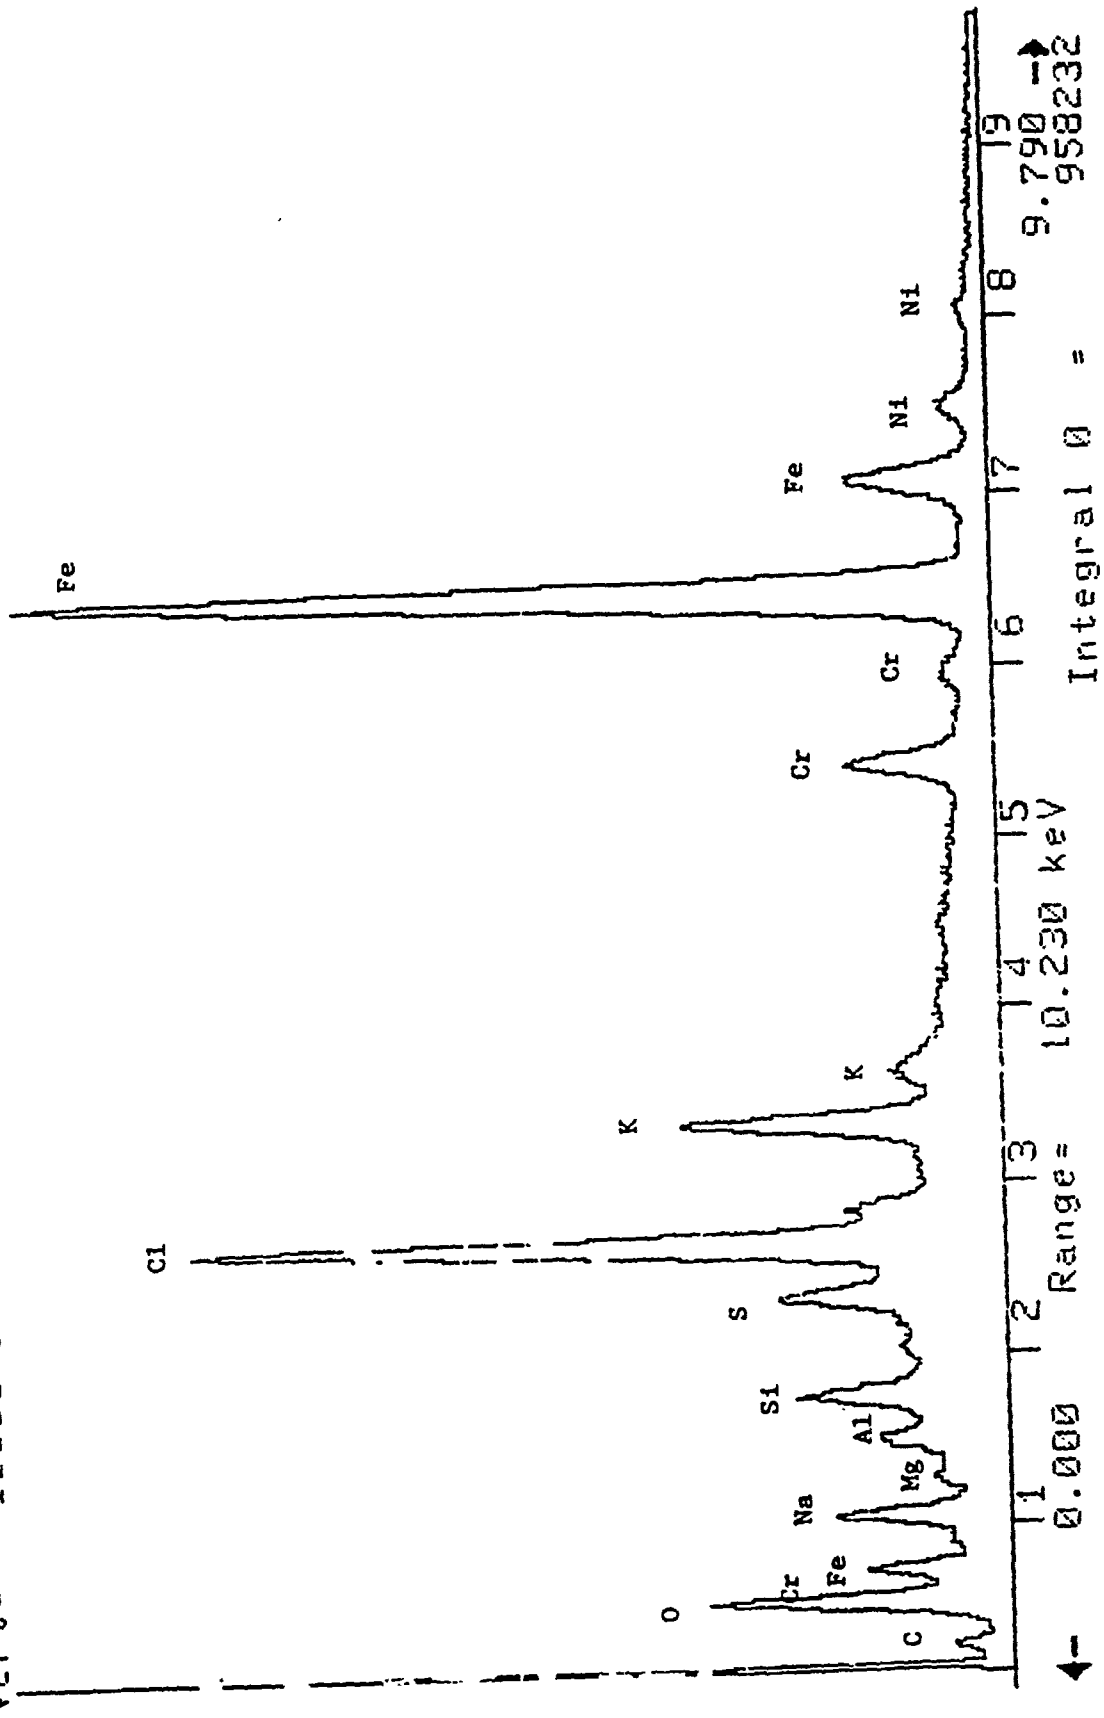
Figure 32. EDS spectra of dark corrosion spots within the fatigue region.

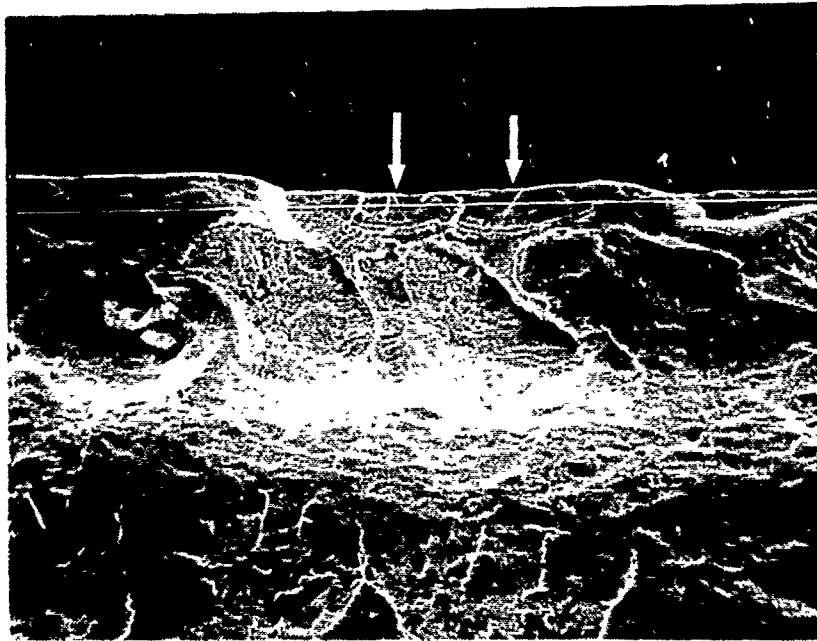
When examining the surface edge of area 3, positioned between weld beads no. 2 and no. 3, multiple cracks were observed side by side originating from the surface as shown in Figure 33. Multiple crack sites are associated with corrosion fatigue but there was no evidence of corrosion pitting and the crack origin was clearly visible. Often the crack initiation site of a corrosion fatigue fracture is indistinct because the compression portion of each stress cycle has forced corroded mating surfaces together forming behind an irreconcilable fracture surface. Figures 34 and 35 are SEM fractographs showing secondary cracks which were observed within the HAZ of all the weld beads. Corrosion fatigue failures may display cracks or fissures perpendicular to the primary fatigue crack. These secondary fractures were confined only to the HAZ of the weld beads. Metallographic specimens sectioned from areas adjacent to and beyond the HAZ and further fractographic examination within similar regions did not reveal further signs of cracking. This evidence suggests that the stresses induced into the component during spot welding caused these fractures which may have initiated at carbides.

Figure 33. SEM fractograph of area 3 where multiple crack sites were found. Mag. 500X

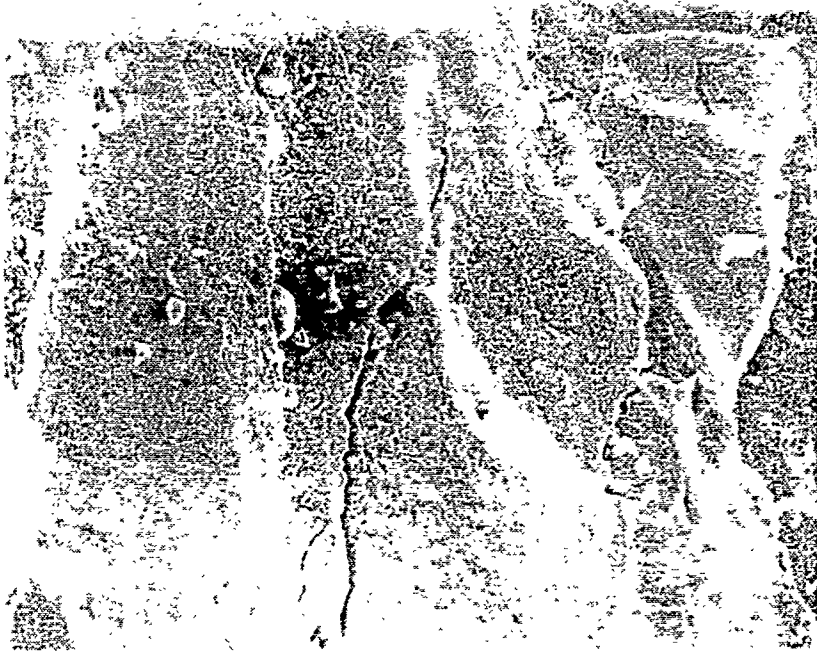
Figure 34. SEM micrograph showing secondary crack
within the weld beads. Mag. 400X

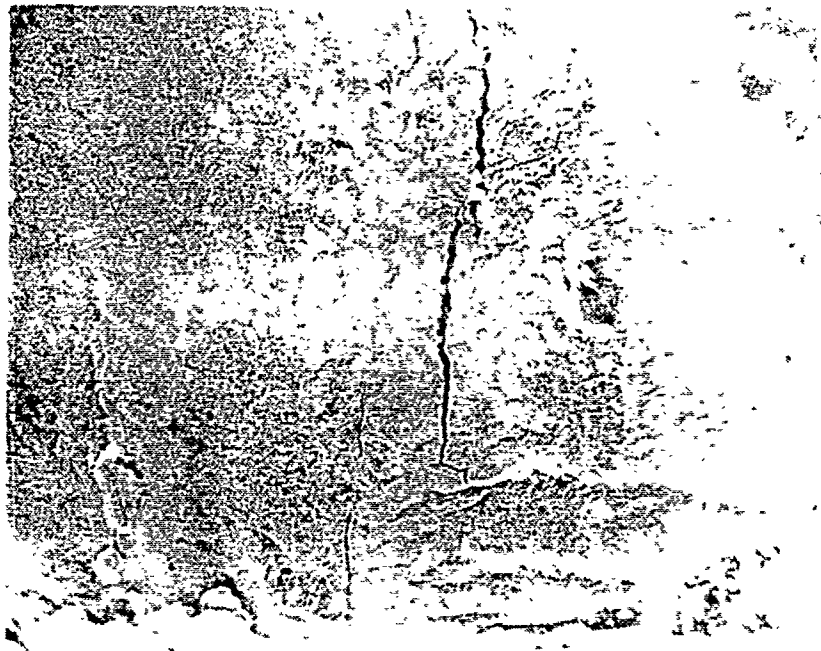
Figure 35. SEM micrograph showing secondary crack
within the weld bead. Mag. 500X

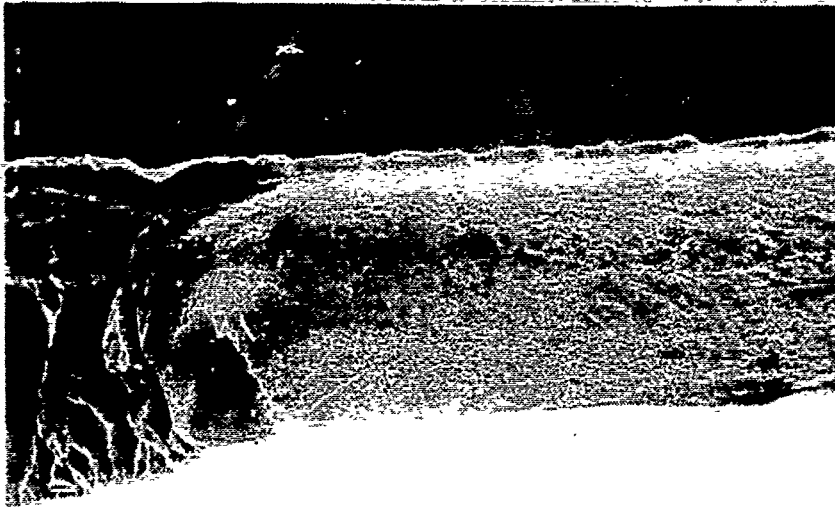
The failure mechanism and surface morphology of the remaining weld beads were consistent with those of weld bead no. 2 with the exception of the appearance of the beach marks and the size of the final fast fracture zone. Figure 36 shows the beach marks found in area 4 of weld bead no. 3 which were significantly fainter and less pronounced. In addition, the fast fracture zone of weld beads no. 1 and no. 3 were larger. The surface topography within the fast fracture regions were expected to display evidence of dimples which are indicative of

Figure 36. SEM fractograph of the faint beach marks observed in area 4 of weld bead no. 3. Mag. 50X
