AD-A231 443 SSC-337
(PART 2)

SHIP FRACTURE MECHANISMS

**A NON-EXPERT'S GUIDE FOR
INSPECTING AND DETERMINING THE CAUSES OF
SIGNIFICANT SHIP FRACTURES**

SHIP STRUCTURE COMMITTEE
1990

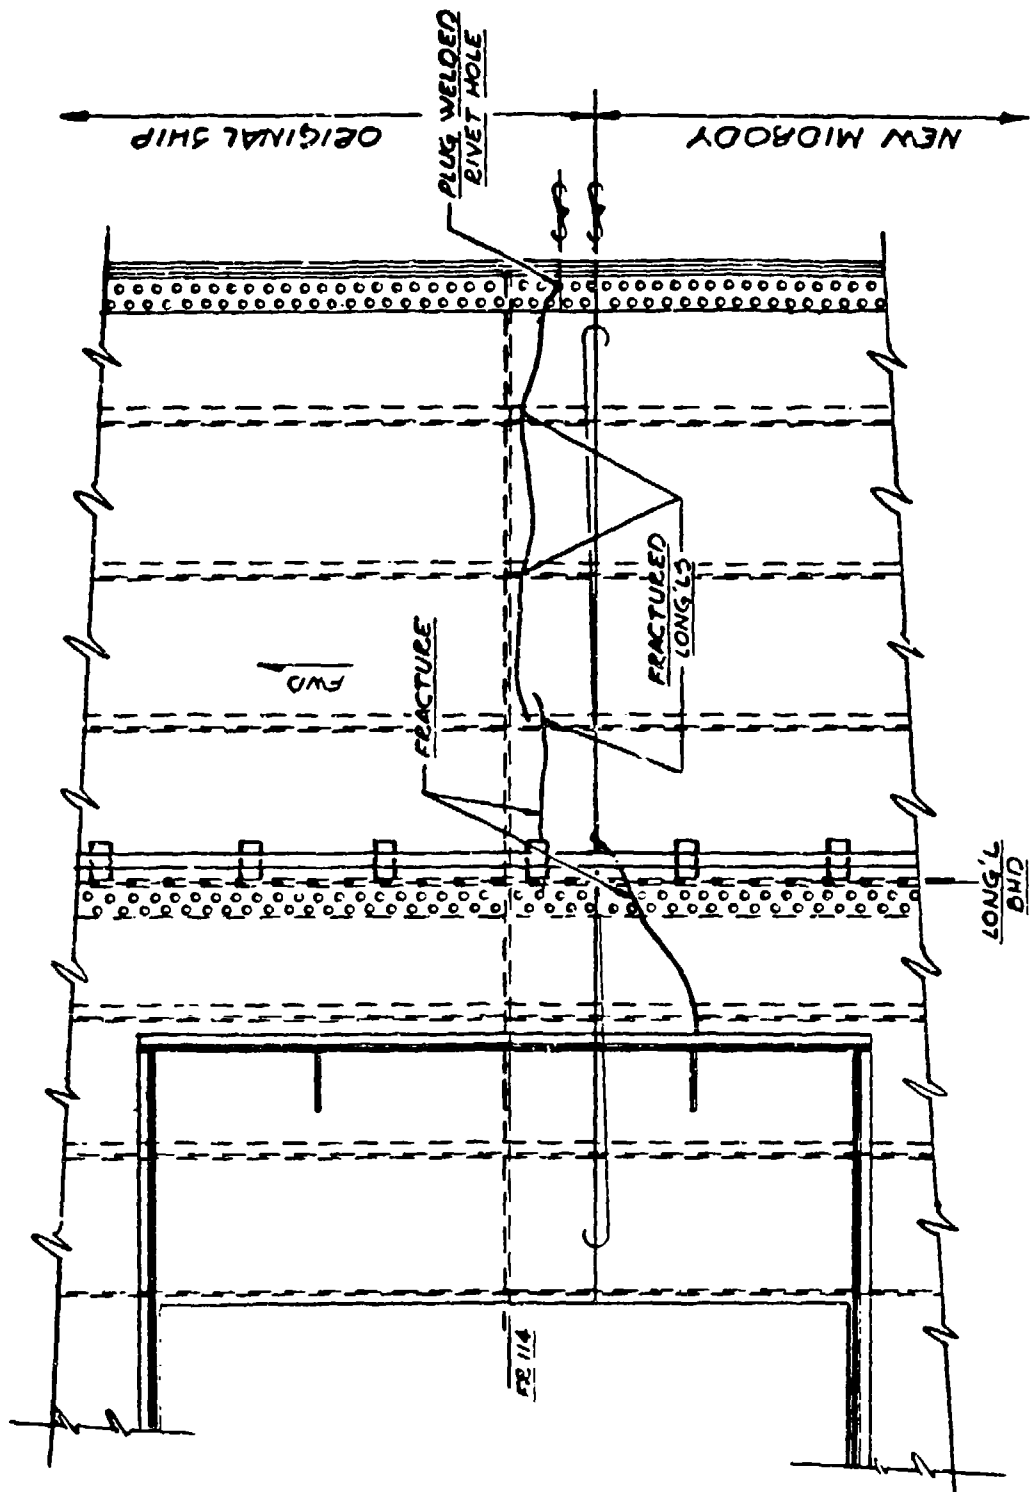
Figure 4-3. Fracture Path on the Spar Deck of the Great Lakes Bulk Carrier

SKETCH A
PLAN OF SPAR DECK @ FR 114

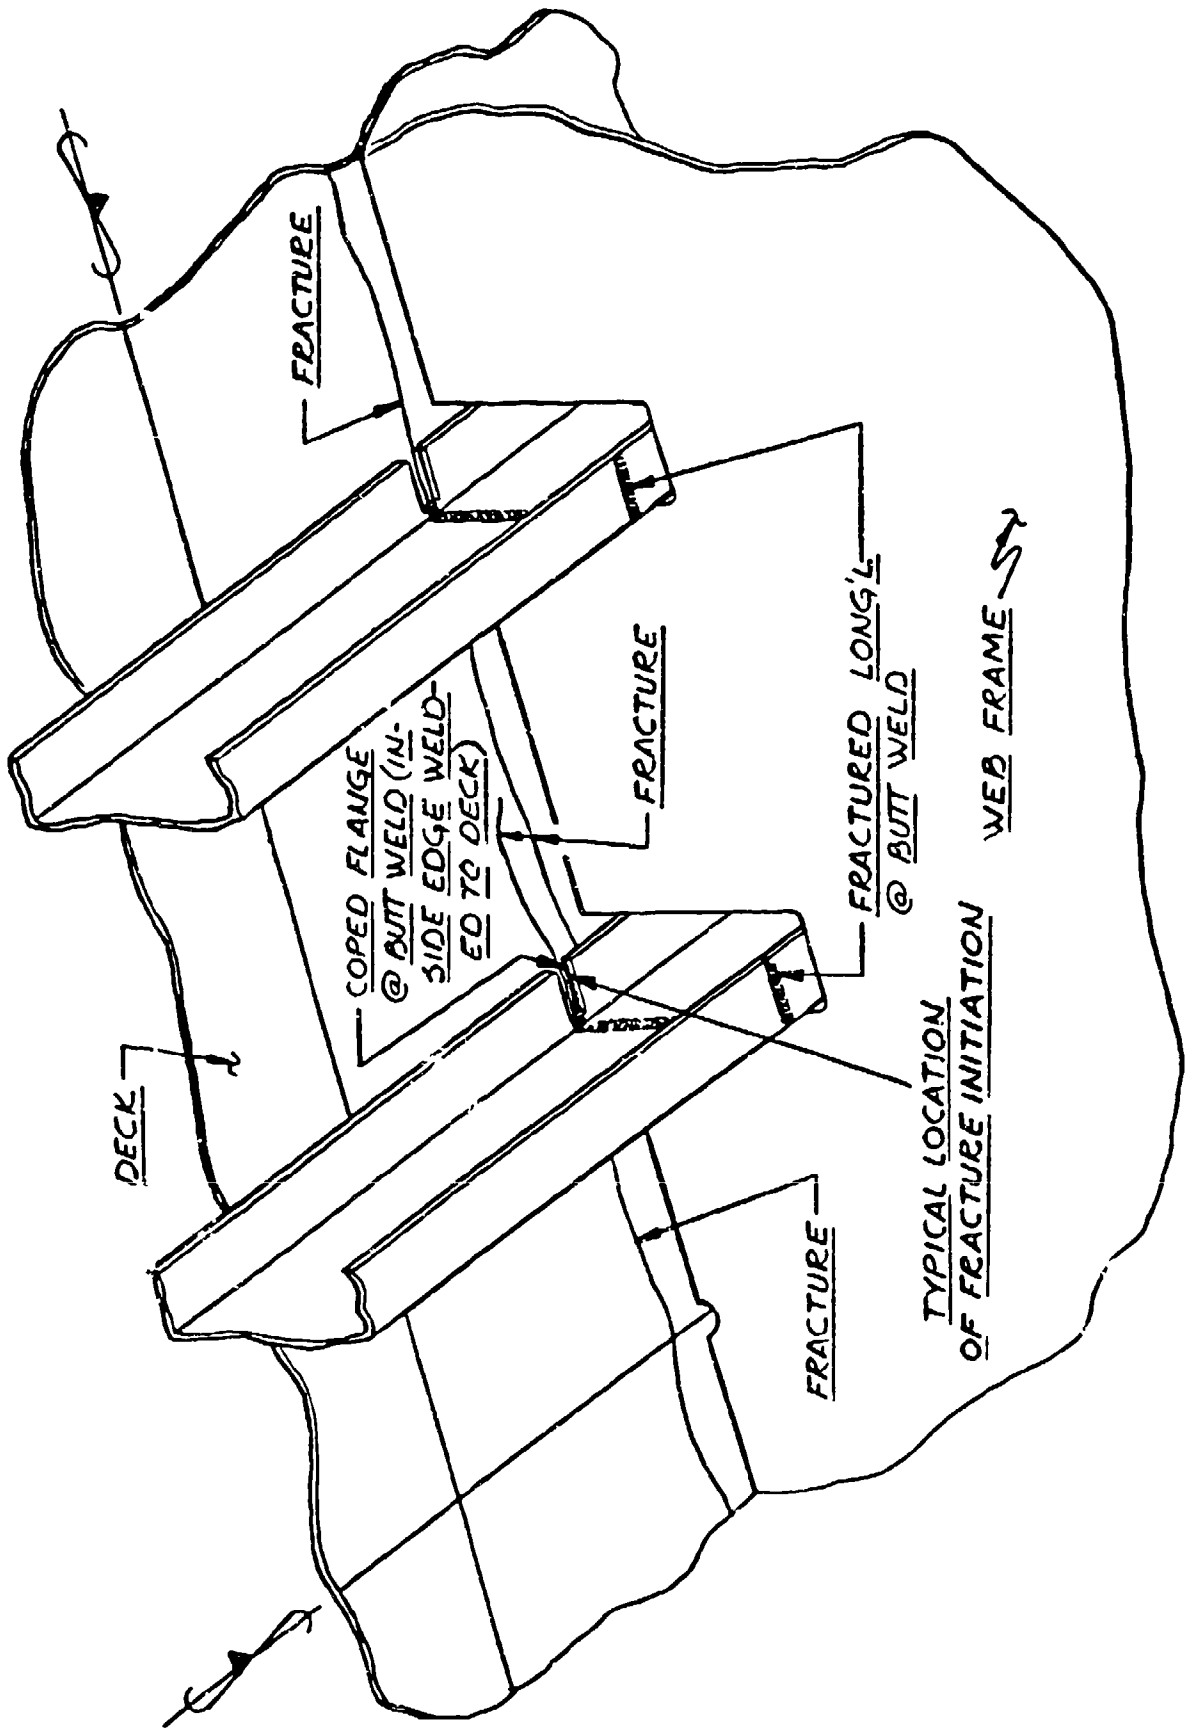
Figure 4-5. Construction Details Associated with the Initiation of the Fracture on the Great Lakes Bulk Carrier

The significant fractures all originated at longitudinals where the flange was cut for butt welding. The initiating defects at the origin were small. However, the ship operated for over 30 years with those poor fabrication details, suggesting relatively high forces in the ship structure from adverse weather at the time of fracture. This is also suggested by the multiple origin points. Because the fracture originated at poor fabrication details (notches), it is surprising that the ship survived in service for many years without fracturing.

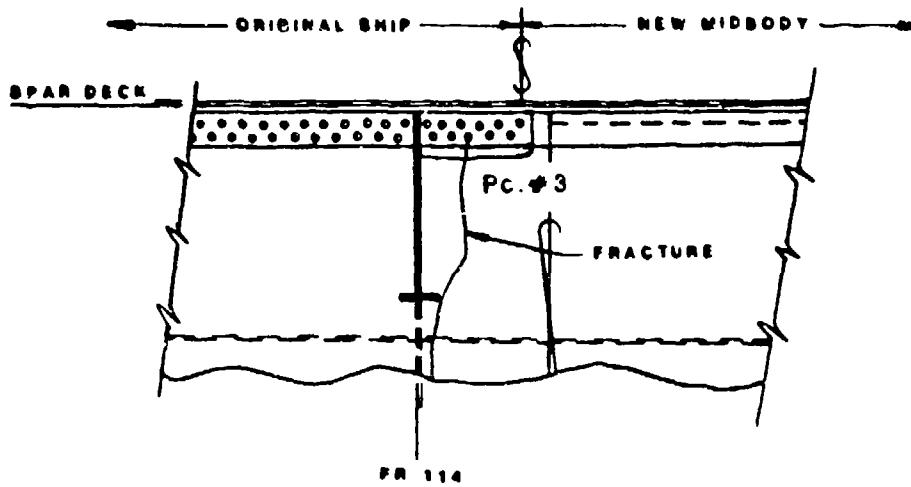
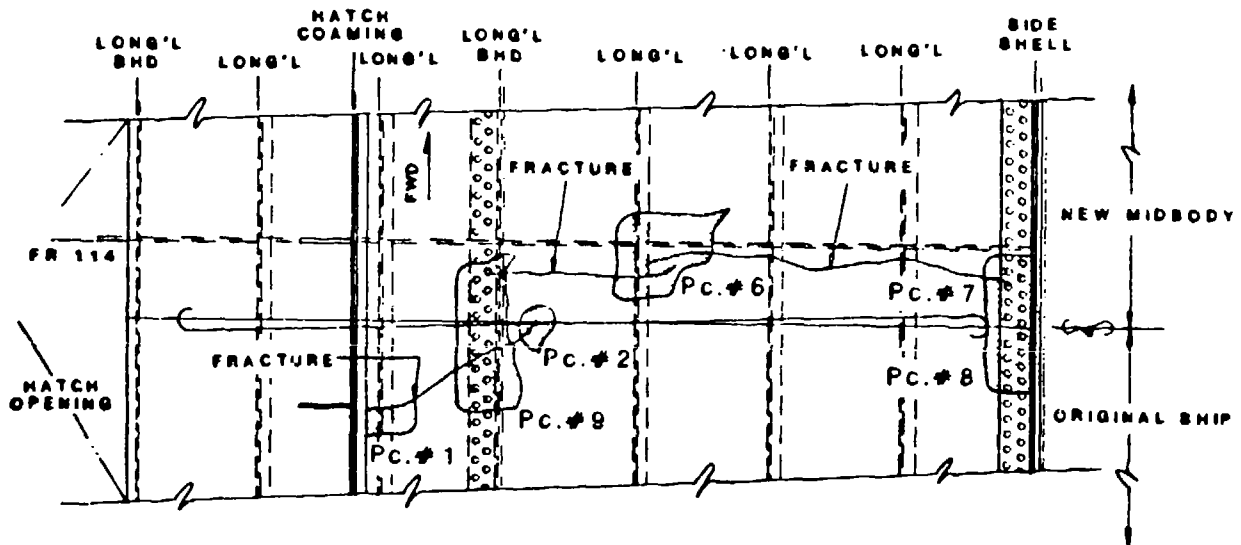
Figure 4-6. Location of Plating Samples from the Great Lakes Bulk Carrier.

The origins of the various fractures were located by inspecting the edge of the fracture samples and establishing the orientation of chevron patterns. All the samples taken had clearly developed chevron marks. Examples of these markings on the surface of piece No. 1, which were typical, are seen in Figure 4-7. Sample No. 1 was cut from the spar deck plating located at the edge of the hatch coaming and extending outboard along part of the fracture surface as shown in Figure 4-6. Clear chevron markers point to the initiation site located in the transverse weld joining the coped out longitudinal flanges to the deck plate as shown in Figure 4-5. The fracture ran in two directions: under the hatch coaming and outboard across the deck through sample No. 9 and on into sample No. 2 where it terminated. As far as sample No. 9 is concerned, the fracture simply extended through this plate and did not directly result in propagation of fractures into the longitudinal bulkhead.

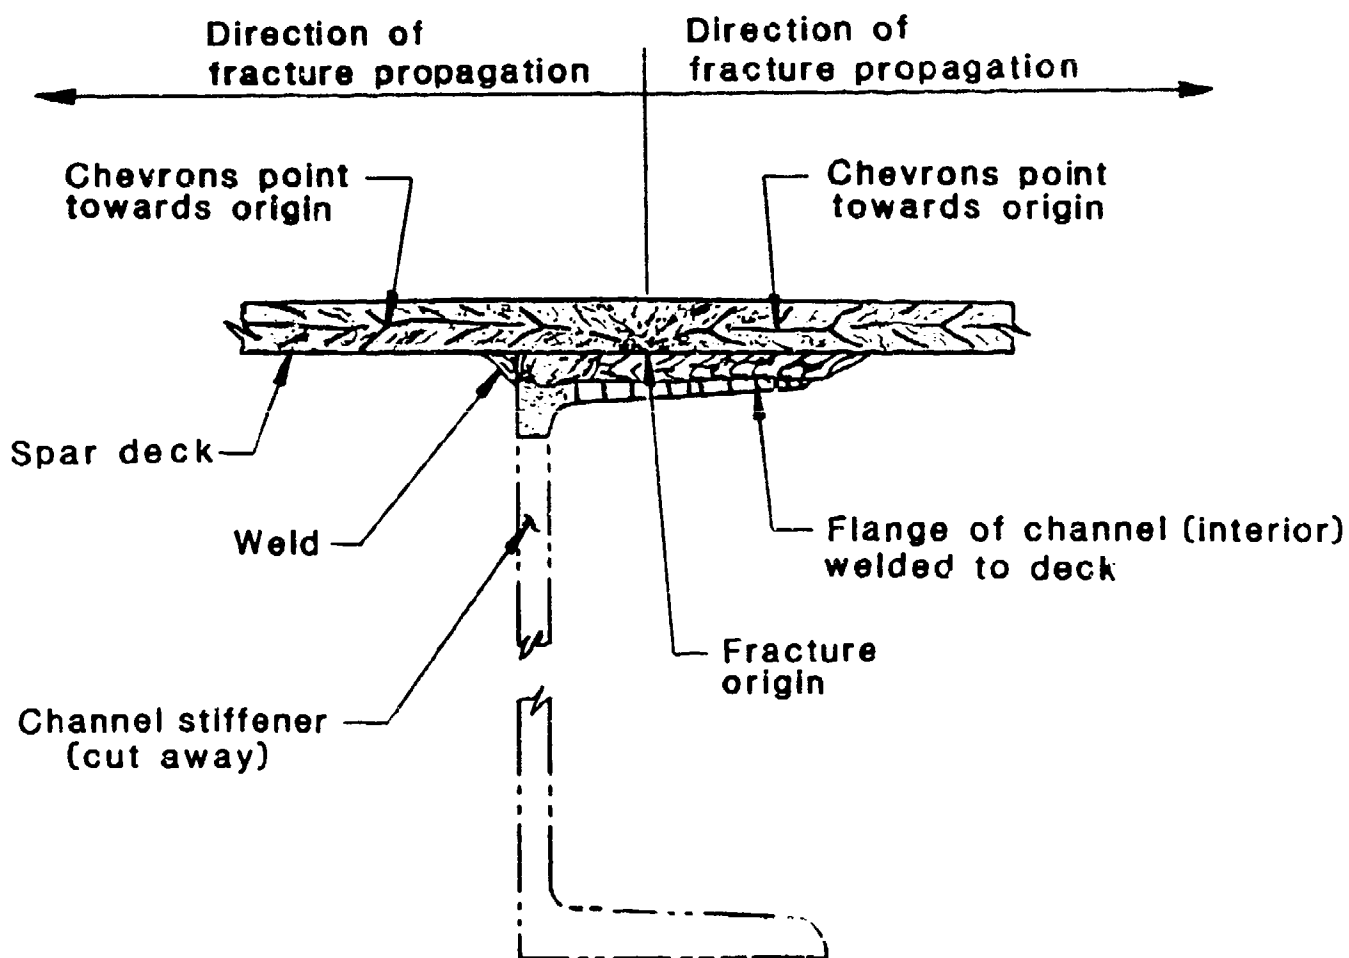
Figure 4-8. Location of the Fracture Origin in Sample No. 6.

Sample No. 6 contains two separate fractures. Cutting the sample to reveal the fracture surfaces showed that the aft-most fracture extended inboard and outboard. From Figure 4-8 it can be seen that the chevrons point toward the

weld of the flange cutout. The chevrons in the forward-most fracture in Sample 6 point outboard indicating that the fracture propagated inboard. The chevrons in the corresponding fracture in sample No. 7 point outboard indicating this fracture propagated inboard. Therefore, this fracture had to initiate somewhere between Samples Numbers 6 and 7, and shown in Figure 4-9 and probably at one of the two longitudinal flange cutouts.

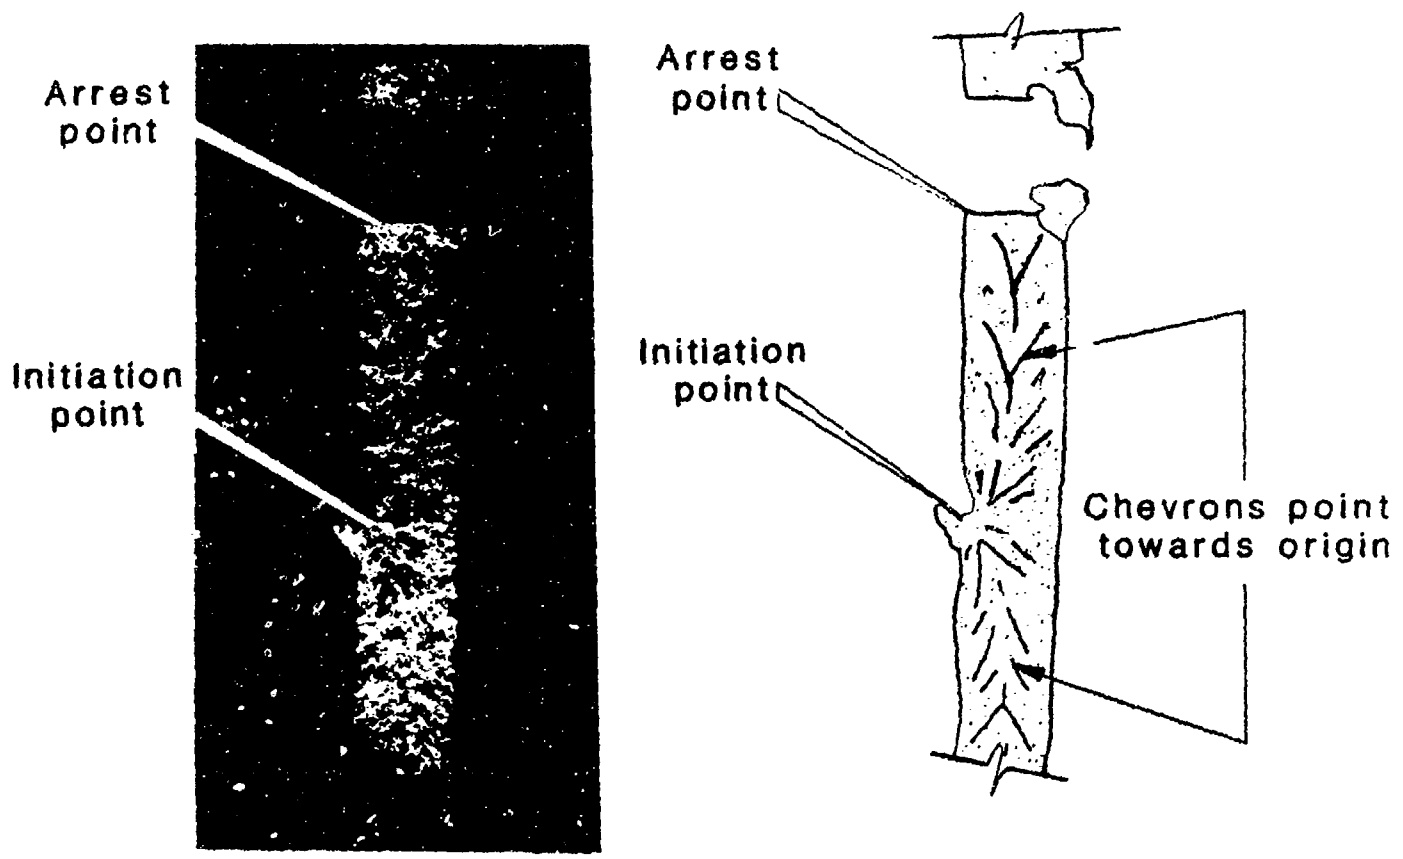
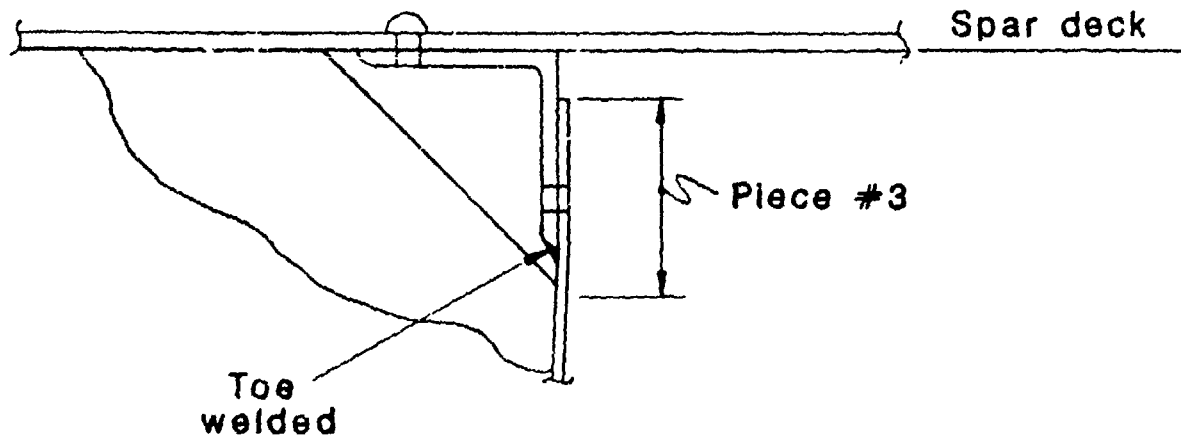
Figure 4-10. Piece No. 3 (Top of Longitudinal Bulkhead) Initiation Site Showing Crack Entering Piece No. 3 through Weld of Angle to Piece No. 3. Crack Goes to Rivet Hole on Right and Down the Bulkhead
