ADDENDUM TO THE INSTALLATION
RESTORATION PROGRAM PHASE I RECORDS SEARCH

FOR AIR FORCE RESERVE AND
AIR NATIONAL GUARD FACILITIES AT GENERAL
BILLY MITCHELL FIELD, MILWAUKEE, WISCONSIN

November 1986

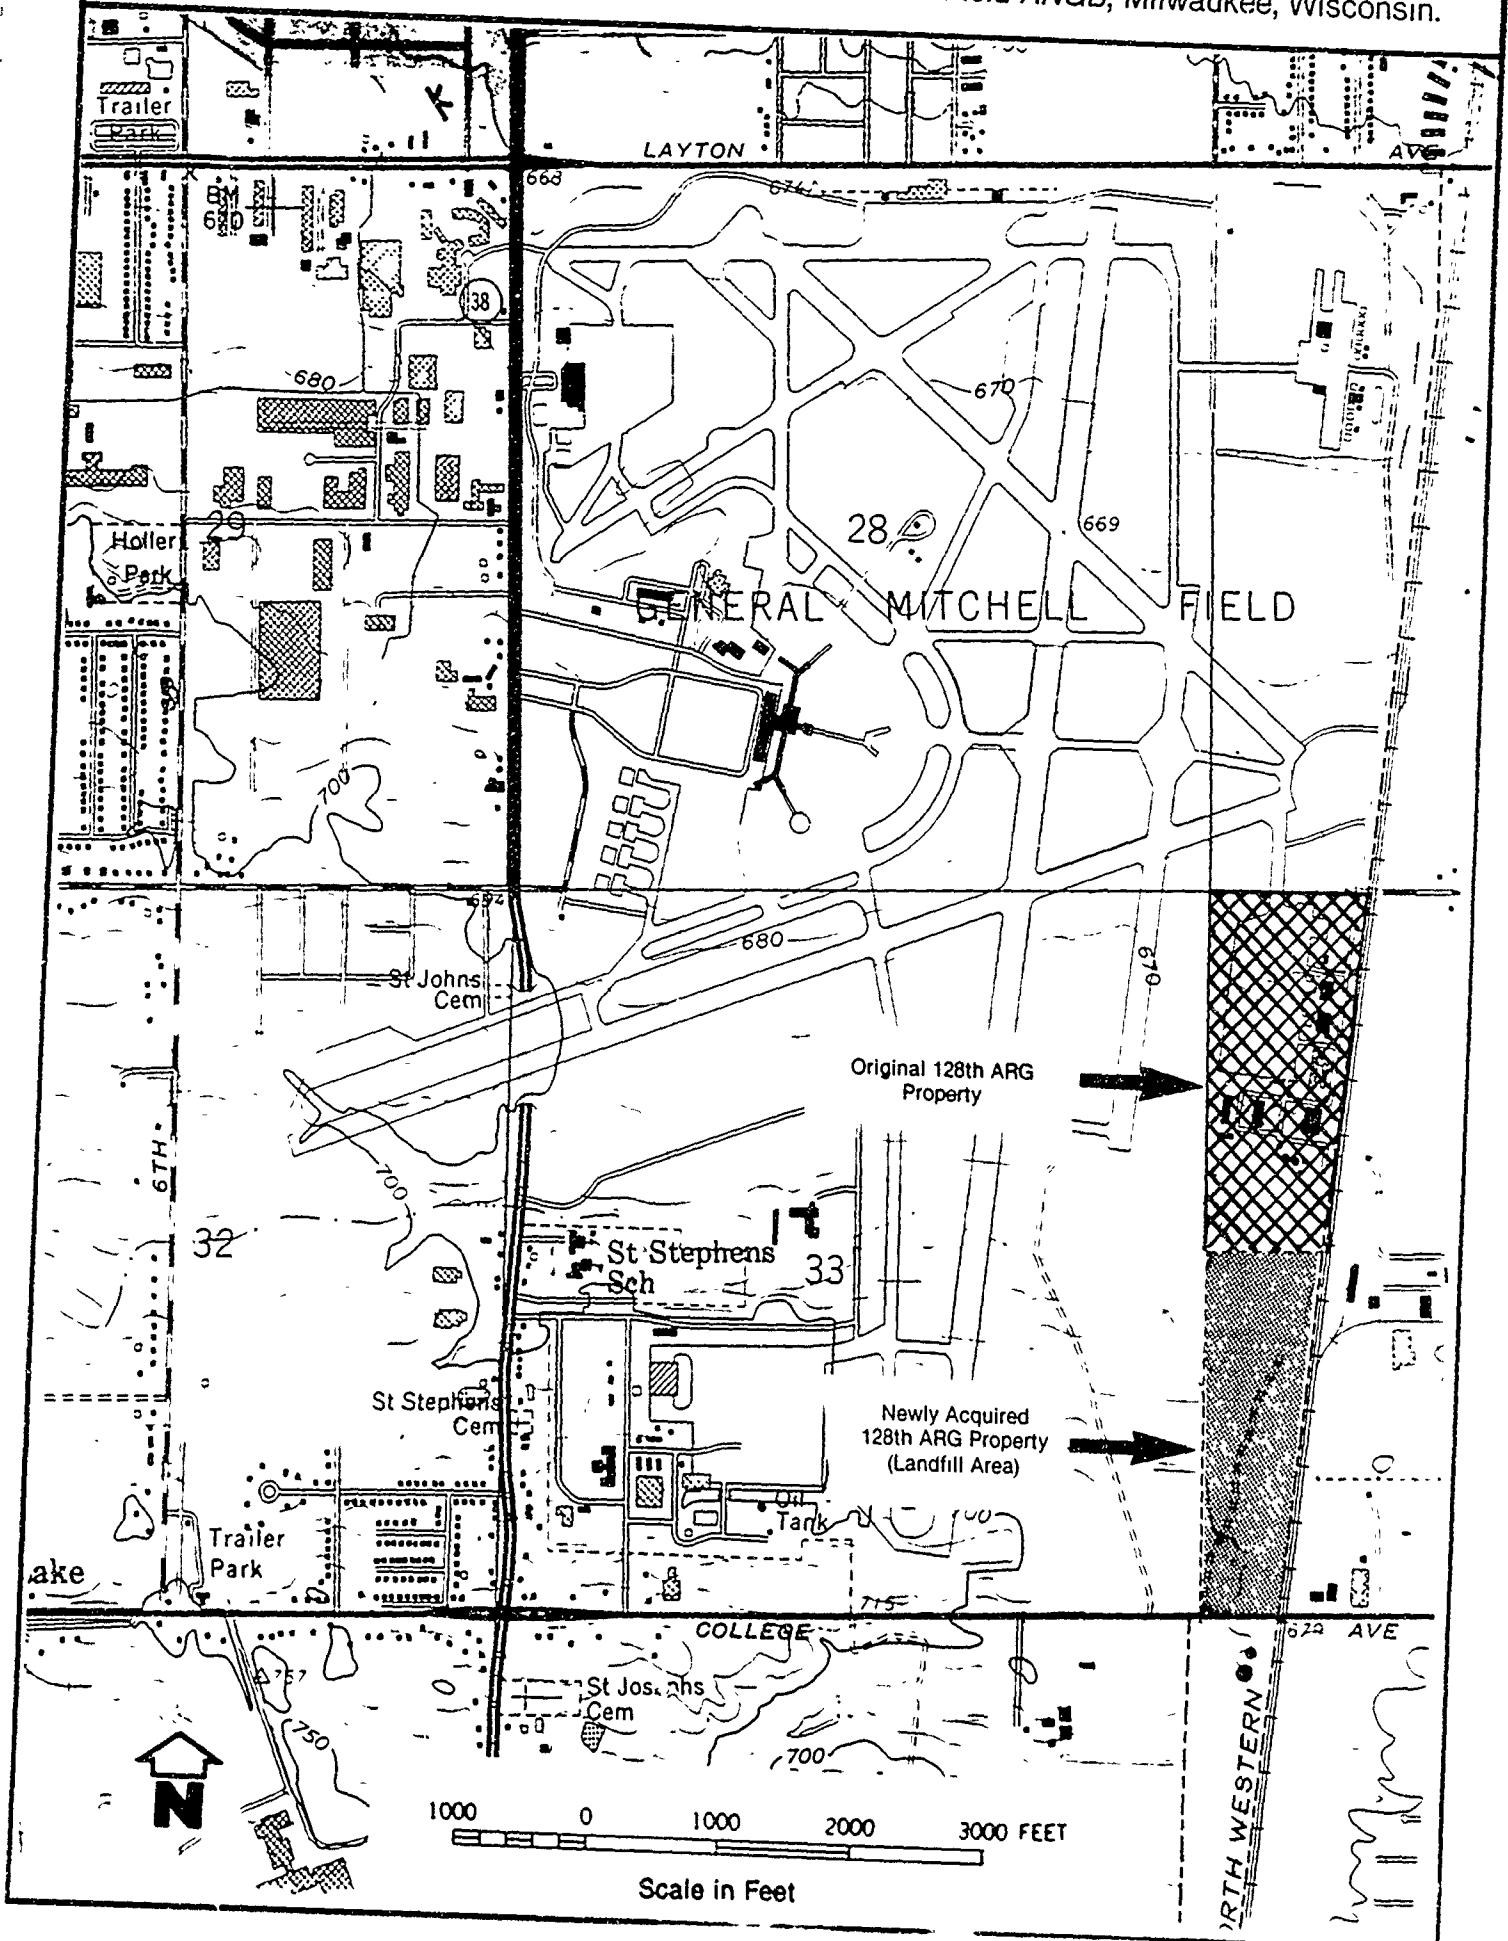
Figure 4.

In 1986, 128th ARG acquired a landfill previously owned by the City of Milwaukee. There is no evidence that the landfill was used as a sanitary landfill, or for disposal of hazardous wastes. As is indicated in Figure 4, the landfill is located between what was previously the southern border of the base, and College Avenue. Inquiries were made to the City of Milwaukee Health Department's Sanitation Section concerning the nature and history of the landfill. City records on the subject were sparse. City officials estimate that the landfill was in use prior to the 1940's until 1985. Types of materials disposed of in the landfill are reported to consist of cans, bottles, and scrap metals. In recent years, the site was used for road construction rubble and gravel disposal. The site was also used for

The 128th ARG has excavated several test pits at the landfill with backhoes. The excavations are to a depth of four feet. Materials unearthed are consistent at each of the excavations, consisting of bottles, rusted cans, plastic containers, gravel, concrete, and scrap metal. Earth in other areas of the landfill has been moved and graded in order to provide a entranceway to the 128th ARG. Materials revealed during the grading process were identical to those found in the test pits. Upon touring the landfill, HMTC saw no evidence of hazardous waste disposal from materials exposed on the surface. As there is no evidence that hazardous wastes have ever been disposed of at the landfill, HARM Scoring is not considered necessary, and no further action is required.
