FAILURE ANALYSIS OF FUEL INJECTION PUMPS FROM GENERATOR SETS FUELED WITH JET A-1

INTERIM REPORT
BFLRF No. 268

Belvoir Fuels and Lubricants Research Facility (SwRI)
Southwest Research Institute
San Antonio, Texas

January 1991

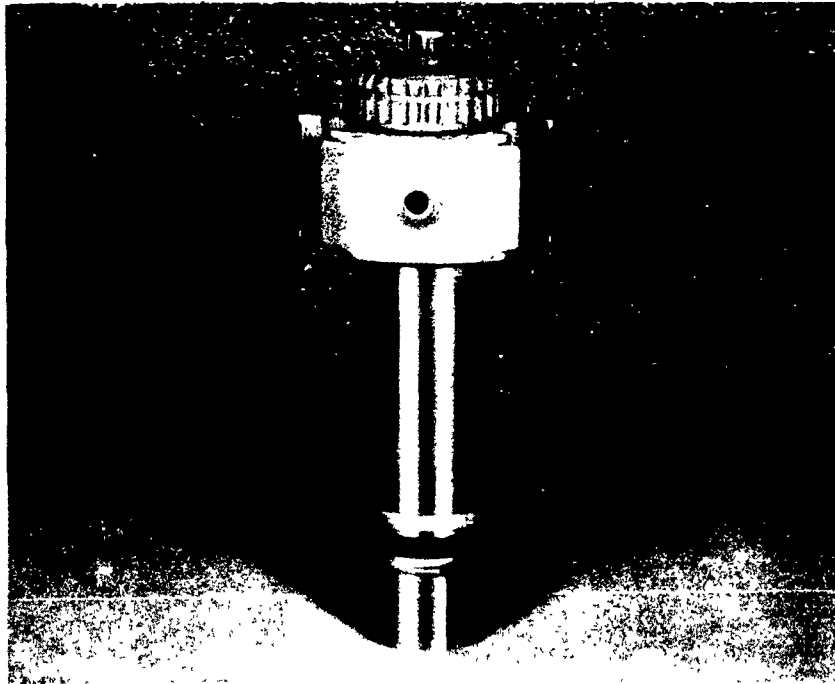
In running the engine with diesel fuel, seizure at this position normally indicates that excessive side thrust is occurring at the transfer pump, due either to mechanical or hydraulic loading. Such loading is normally caused by one of the following:

Figure 3. Rotor from Pump No. 5545723
[Note: Abraded ring caused by seizure (close to transfer pump at the bottom of the picture).]

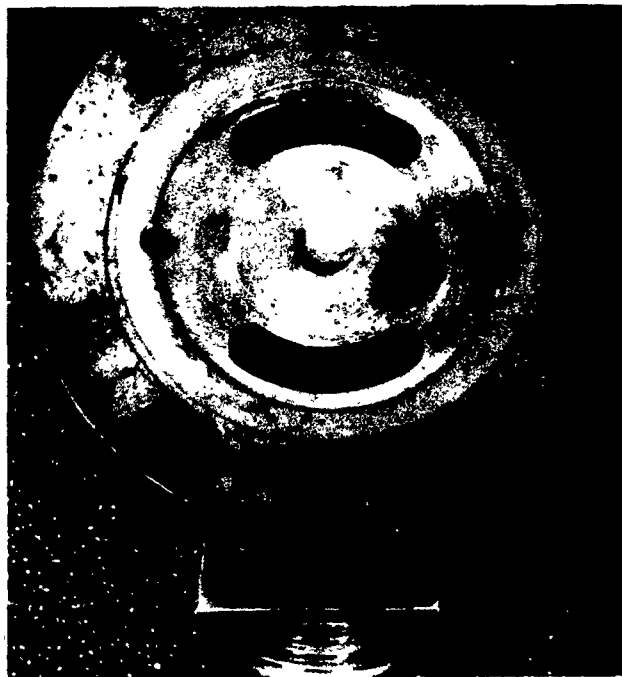
Figure 5. Debris on internal parts of Pump No. 6192152

On disassembly, particles and fine debris were found throughout the pump, as shown in Fig. 5, which depicts the cam screw plug and end plate. X-ray analysis (EDAX) of representative particles collected from around the advance piston mechanism confirms that the particles are predominantly ferrous in nature.
