N-1826

March 1991

Technical Note

DEVELOPMENT OF A SEAWATER HYDRAULIC ROCK DRILL

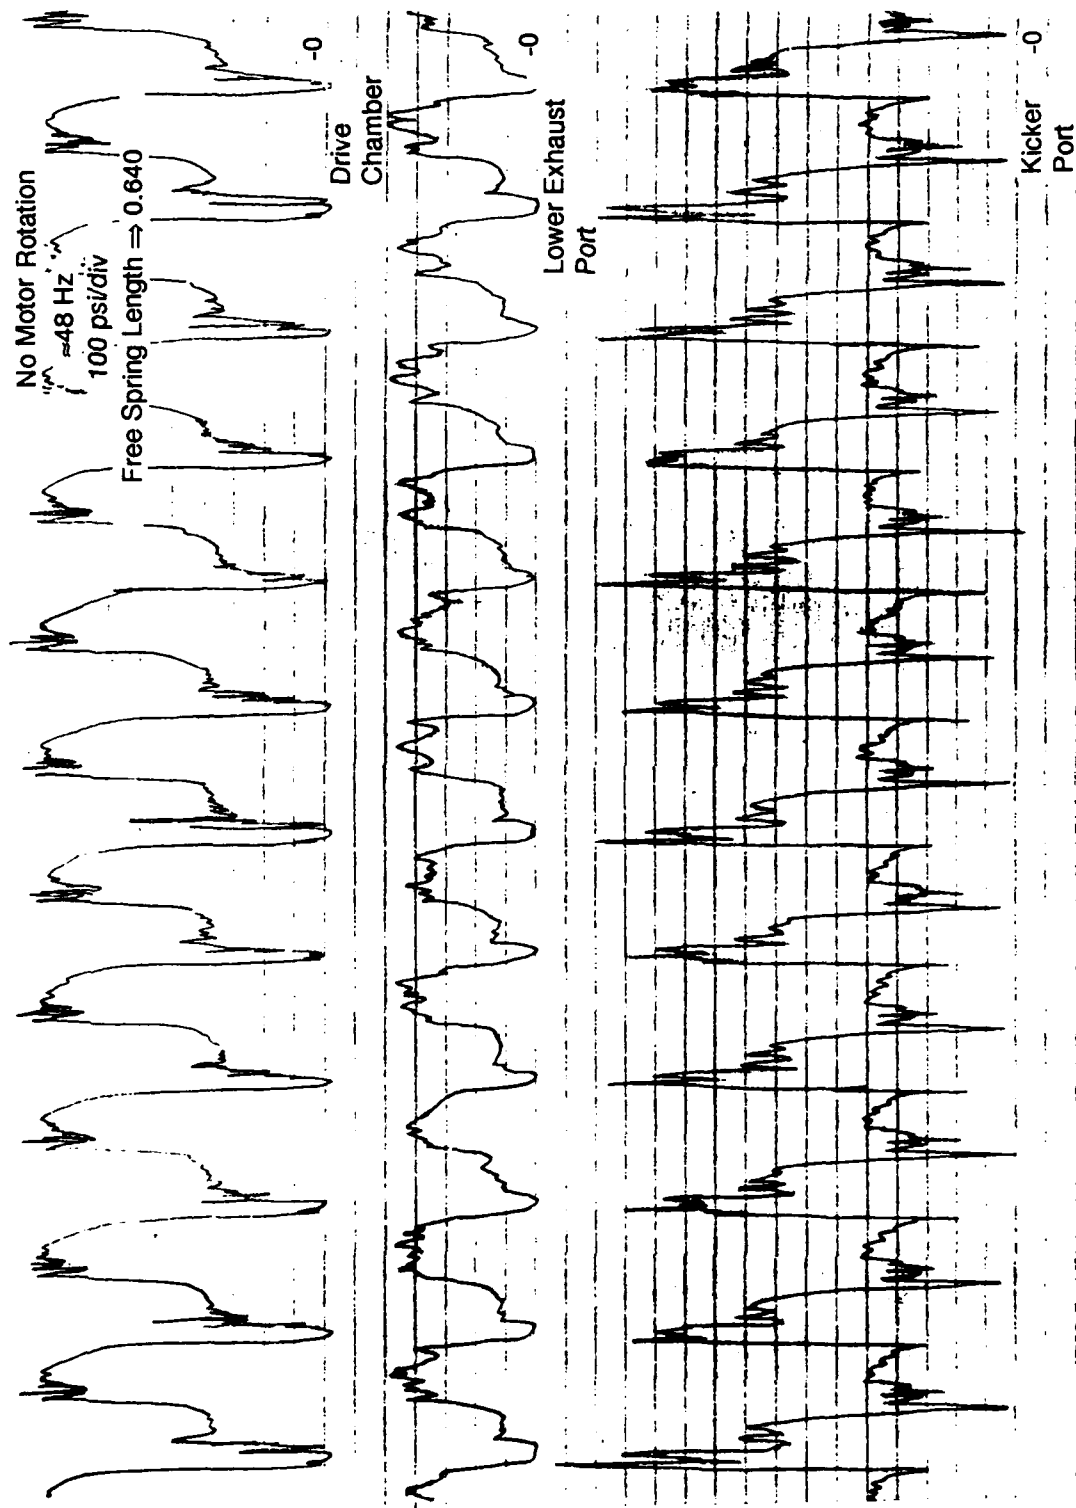
Figure 9. Increased drive chamber pressure.
