MONITORING COMPLETED COASTAL PROJECTS PROGRAM

MISCELLANEOUS PAPER CERC-91-10

**MONITORING OF COMPLETED BREAKWATERS
AT CATTARAUGUS CREEK HARBOR, NEW YORK**

September 1991

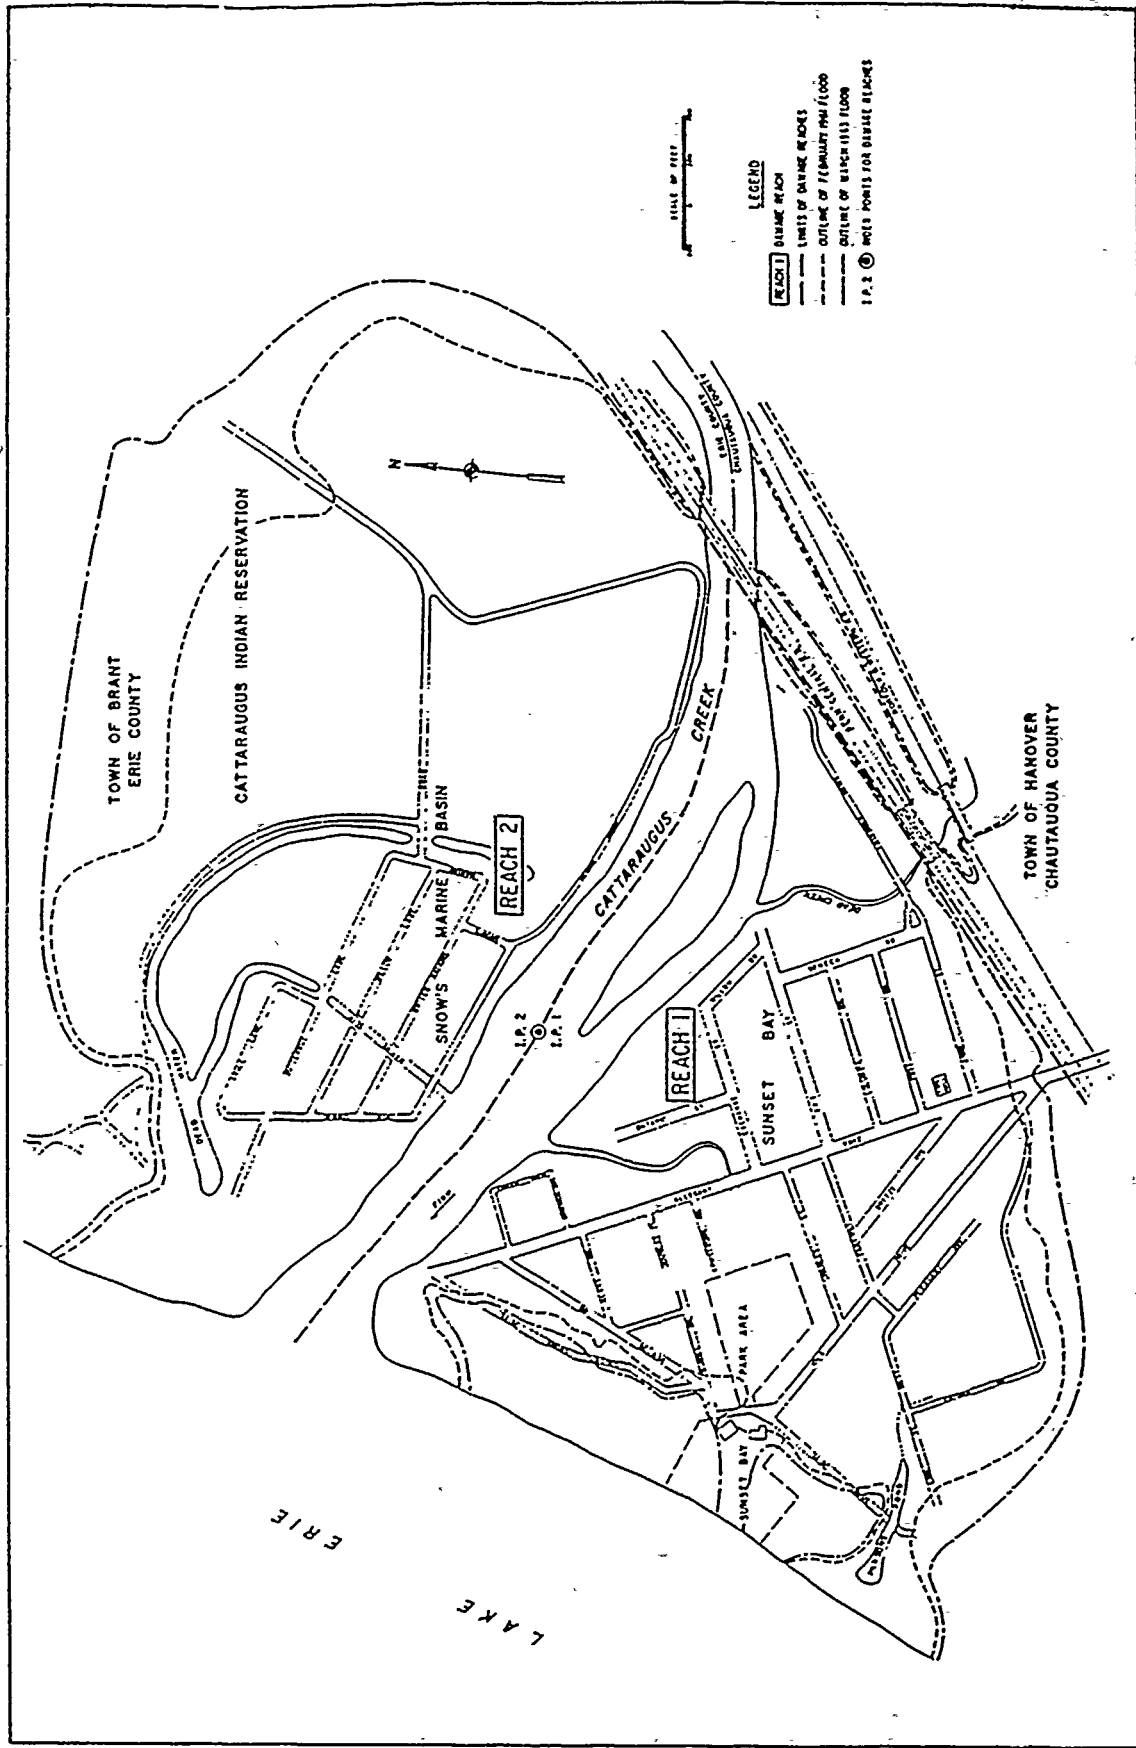
Figure 94. Flooded outlines for the 1961 and 1963 ice jam

71. The occurrence of two major ice jams within 4 years after project completion resulted in questioning whether the project design was deficient (USAED, Buffalo 1987). It was determined that prior to project construction, ice would jam at a minimum of two locations near the mouth. Initially it would occur upstream of the mouth at the New York Central Railroad Bridge. As the water behind the jam rose, the pressure would finally break the jam, and the flow would progress downstream to the mouth (USAED, Buffalo 1963). At the mouth, a second jam formed when the ice arrested at the sandbar. The sandbar normally extended 1 to 2 ft above the lake surface and was covered by

windrowed lake ice in the winter. As the channel filled, water overflowed the banks just below the railroad bridge. On the right bank, the water and ice traveled overbank to an old abandoned channel of Cattaraugus Creek. The velocity and strength of the water opened this abandoned channel to the lake and provided an outlet for part of the floodwater. On the left bank, the floodwater and ice passed over the low banks downstream of the railroad embankment and passed through Sunset Bay to the lake. The flood found two avenues at the lake, one through the area known as Parson's Pond and the other at a relatively low section of the beachfront near Iola Drive. Figure 94 presents flooded outlines for the 1961 and 1963 ice-jam floods.

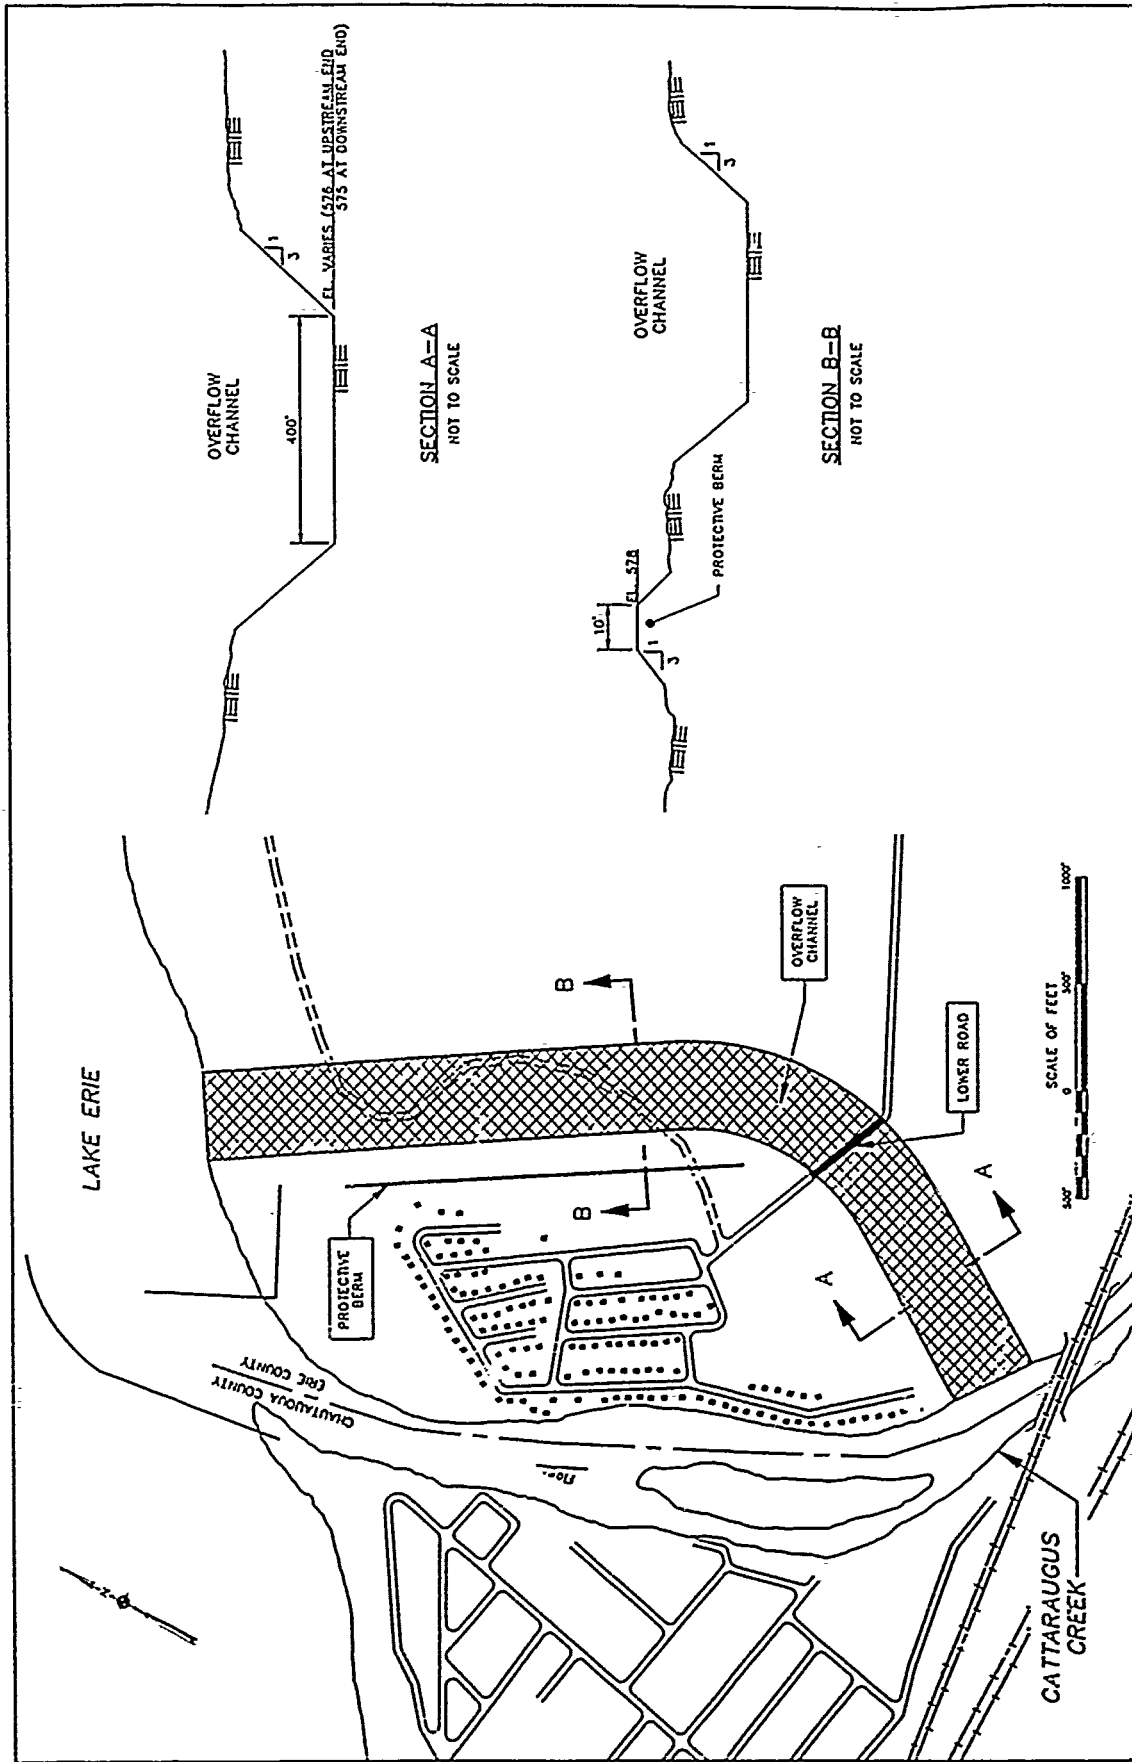
Figure 97. Sketch of cross section for berm height reduction

75. To alleviate the increased flood damages estimated at \$87,800 on an annual basis (USAED, Buffalo 1987), a rectification project consisting of lowering the north breakwater berm from +12.0 to +5.5 ft LWD was proposed. A 400-ft length of the berm was proposed to be lowered with construction scheduled for the summer of 1987, provided that a right-of-entry be obtained from the Seneca Nation of Indians. It was not obtained, and there is little potential for implementation in the foreseeable future. Figure 97 presents the proposed modified berm cross section.

76. The reduction in the berm crest height was estimated to reduce average annual damages by 50 percent but would not prevent ice-jam formation. Possible solutions were identified during the Cattaraugus Creek Study (USAED, Buffalo 1987) and evaluated in a two-stage iterative process. Nine preliminary alternatives in addition to the "no-action" option were initially formulated and assessed. These alternatives fell into two broad categories: local protection plans in areas where a high concentration of flood damages exists (Sunset Bay and Arcade) and dam reservoir plans at Springville. For the plans at Springville, hydroelectric power generating facilities and recreation facilities were also considered to maximize the economic efficiency of the basic flood-control plans.

107. Experience at Cattaraugus Creek supports the lowering of the berm on the north side of the creek entrance, as has been recommended (USAED, Buffalo 1987), if permission can be obtained from the Seneca Nation.

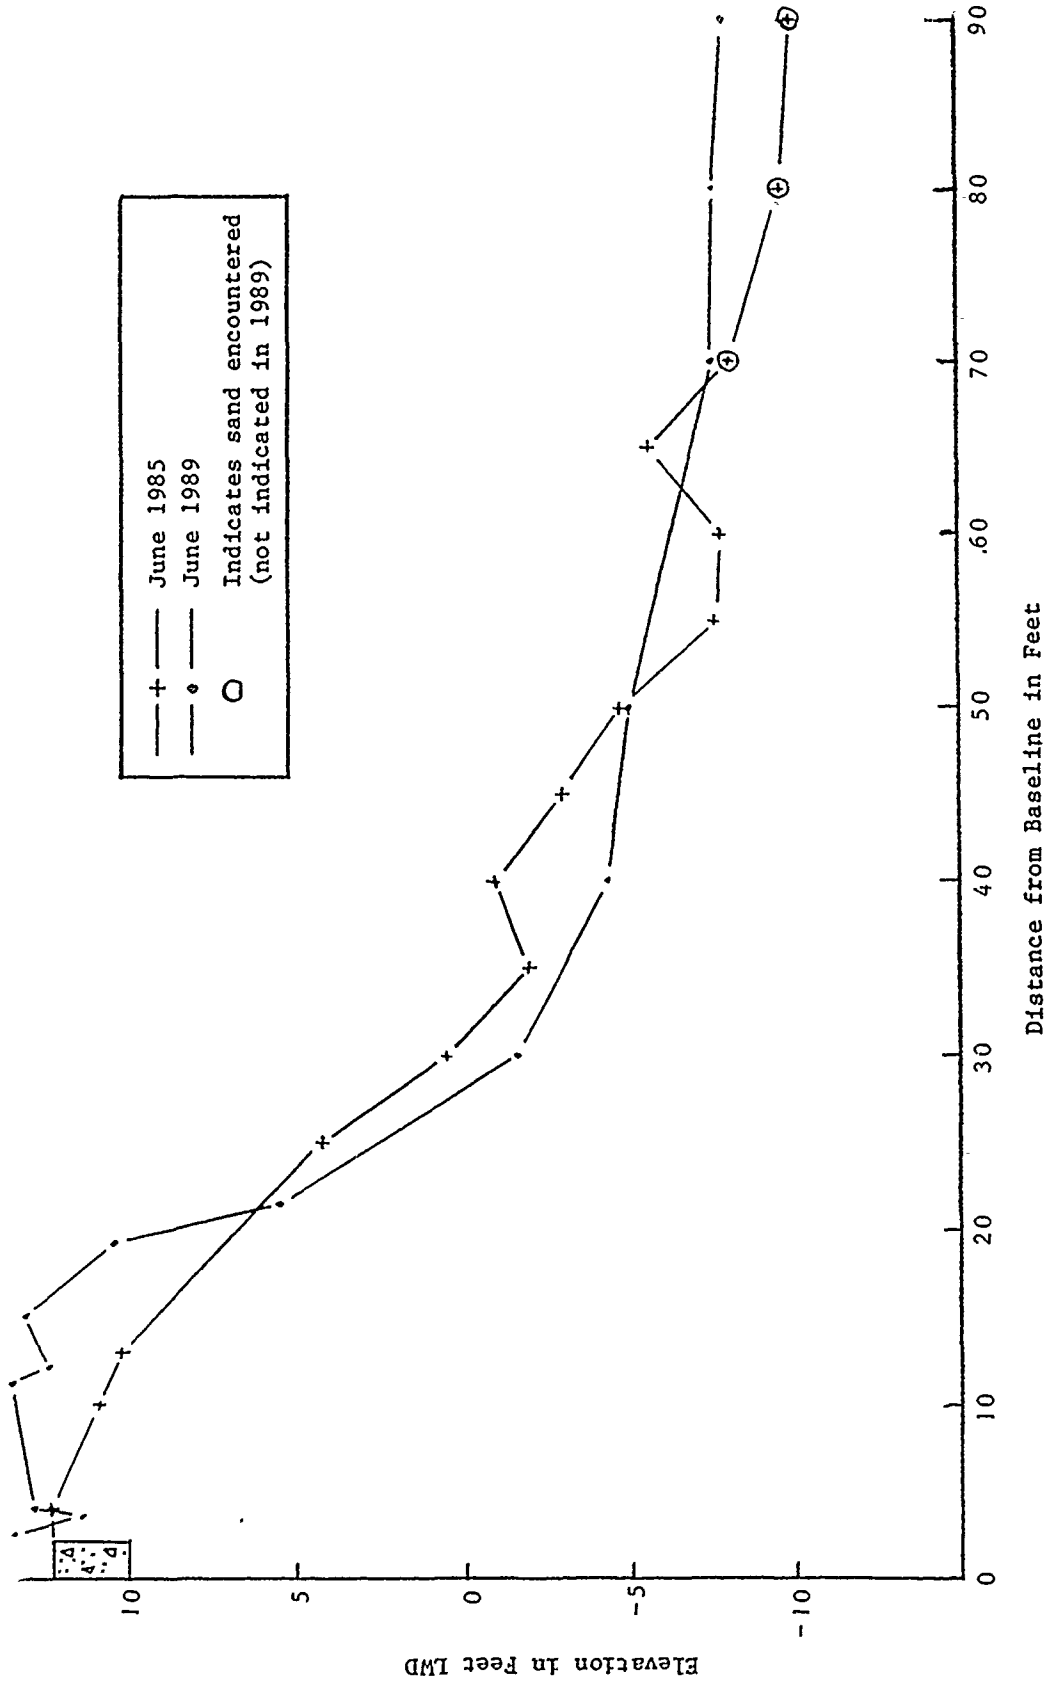
Figure 100. Offshore bathymetry changes in the vicinity of the south breakwater head, 1985-1989

79. As indicated previously, it was observed that a 4-ft scour hole had developed off the head section of the south breakwater some time during the period August 1984 to June 1985. During maintenance soundings of the entrance channel in June 1989, additional soundings in the vicinity of the June 1985 scour hole were obtained. These data revealed that the scour hole had generally filled in except for a very small portion approximately 650 ft from the structure head. Minor offshore steepening had occurred, and a shoal had developed at the mouth of the entrance channel. Figure 100 presents the offshore bathymetric changes in the vicinity of the south breakwater head.
