TECHNICAL REPORT ARCCB-TR-91034

**MATERIALS ANALYSIS OF A
FATIGUE TESTING MANDREL**

**M. BRODSKY
J. SENICK
G. YOUNG**

NOVEMBER 1991

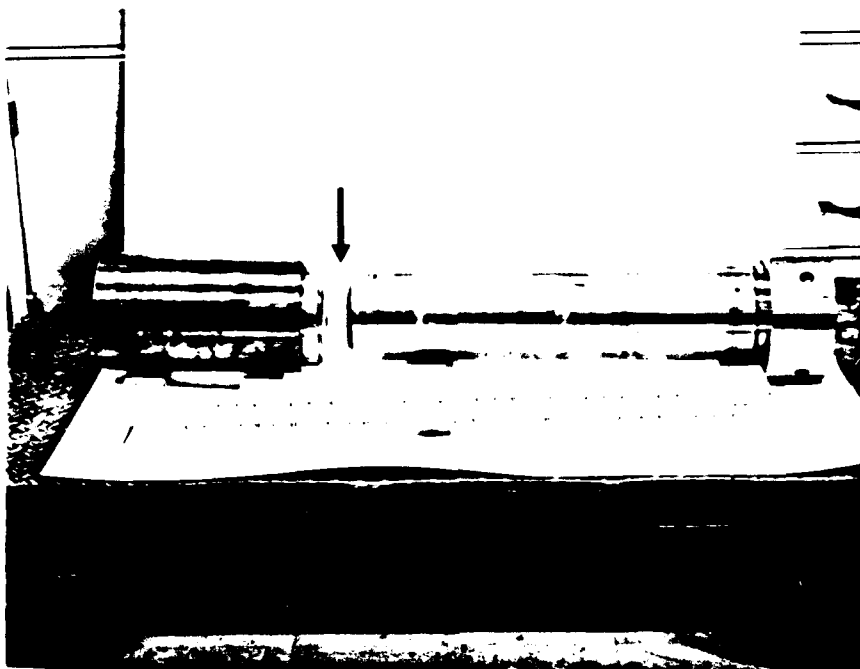
Magnetic particle examination was performed on both mating fracture surfaces of the subject mandrel, as well as the entire machined surface, as shown in Figure 1, to determine the presence of macroscopic crack indications. No indications were found along the outside finish-machined surface. Large indications, however, were discovered along the outer perimeter of the fracture surface, adjacent to the finish-machined circumferential surfaces, as shown in Figure 2a.

Figure 1. Failed fatigue testing mandrel,
as-received (scale in inches).

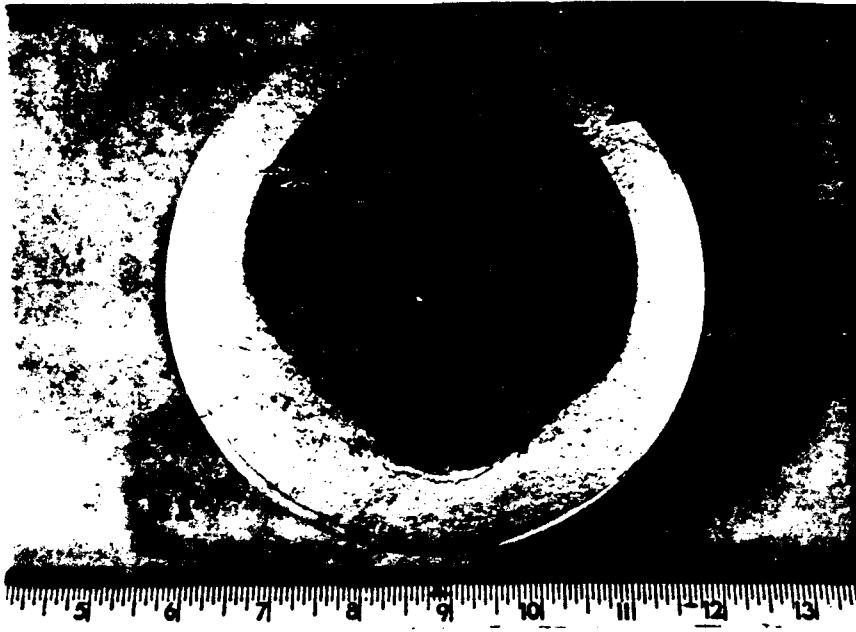
Upon general inspection by both visual and stereoscopic means, several prominent surface features were observed. First, as shown in Figure 2a, the overall fracture surface appeared to be divided into three roughly concentric rings: a relatively smooth outer ring of 3/8 inch maximum width (R1) bounded by the finish-machined surface and a circumferential indication, then a slightly coarser, shiny ring of 3/4 inch maximum width (R2), and finally the inner circle (R3) of 3 3/4 inches maximum diameter, noticeably darker in color and covered with ridges. Located between R2 and R3 were two crescent-shaped indications

In order to determine the depth of the circumferential indication exhibited in Figure 2a, it was necessary to divide one of the mating fracture surfaces of the mandrel in half. Figures 4a and 4b show the longitudinal plane of the fracture surface that clearly identifies the circumferential indication as a crack. These figures also show the depth and severity of this crack. In addition, the crack was measured and determined to extend a maximum of approximately 1 3/8 inches into the mandrel at a 45-degree angle to the transverse plane. Note in Figure 4a that the crack extends from both sides of the fracture surface, and that the various depths of this crack are virtually equal to the depth of the striated region of the primary crack leading to failure. A similar secondary crack exists at the same location in the mating half of the mandrel, which also extends at 45-degree angles from the fracture surface and 90-degree angles from the previously mentioned secondary crack.

Figure 2a. Photograph of fracture surface showing concentric rings, as-received.

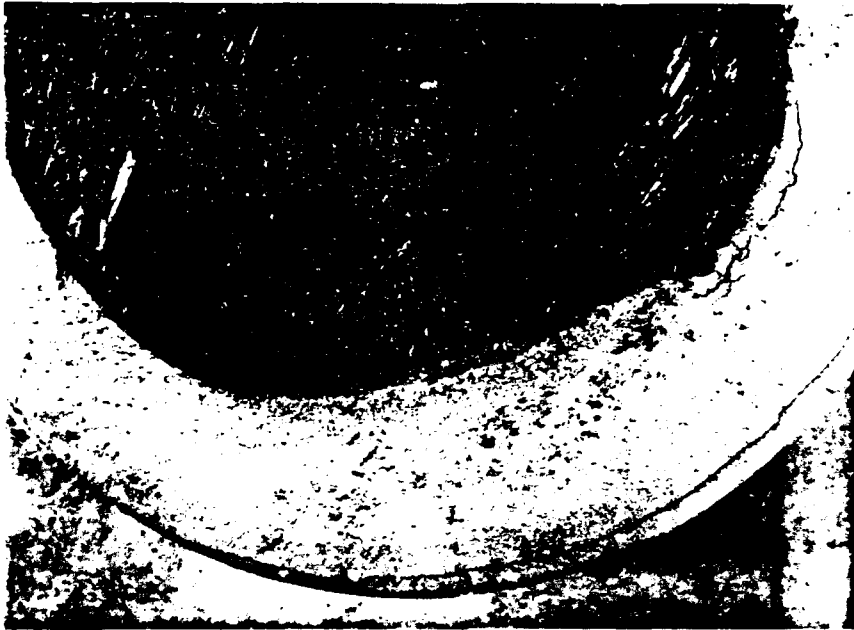
Figure 2c. Photograph of fracture surface exhibiting bridges, wood chips, and crescent and crack indications, as-received.

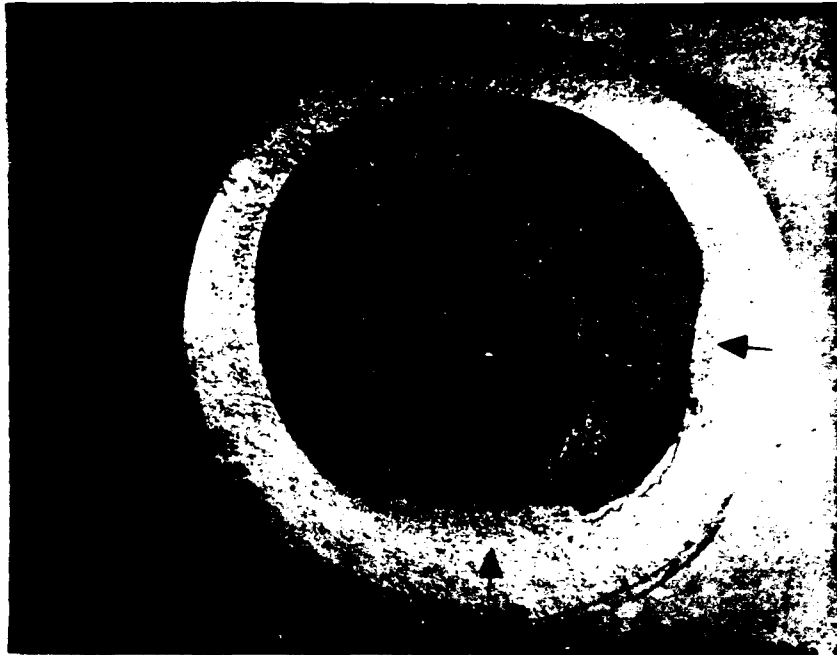
approximately 1/2 inch by 2 inches and 3/8 inch by 1 1/4 inches, as shown in Figure 3a. Both of these were traced by the directions of the ridges found on the surface of the inner circle, as illustrated in Figure 3b. Also shown in this figure are two additional niche-shaped indications of approximately 1/4 inch by 1/4 inch and 3/8 inch by 1/4 inch maximum, which were discovered in R1 along the finish-machined surface. As seen in this figure, the indications were located behind the large crescent. All of these observations are characteristic features commonly associated with the progressive nature of fatigue failures.

Figure 3a. Fracture surface of fatigue testing mandrel, post-cleaned condition.

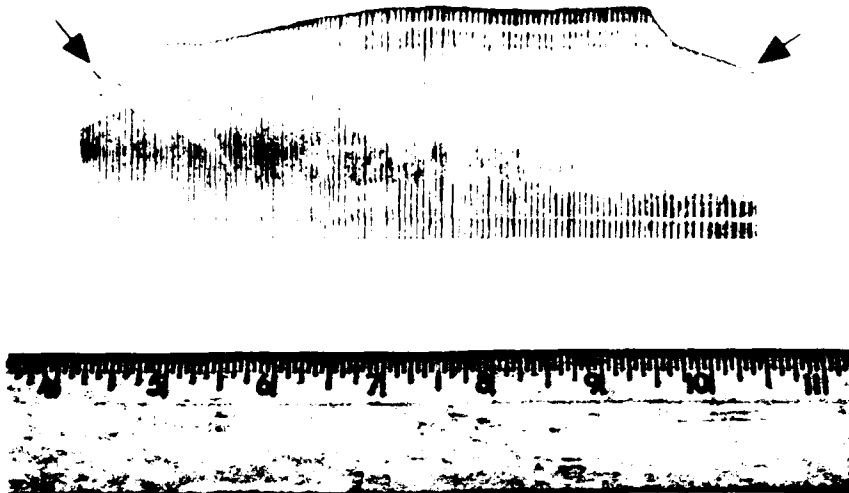
Figure 4a. Longitudinal view of fracture surface showing depth of secondary crack.

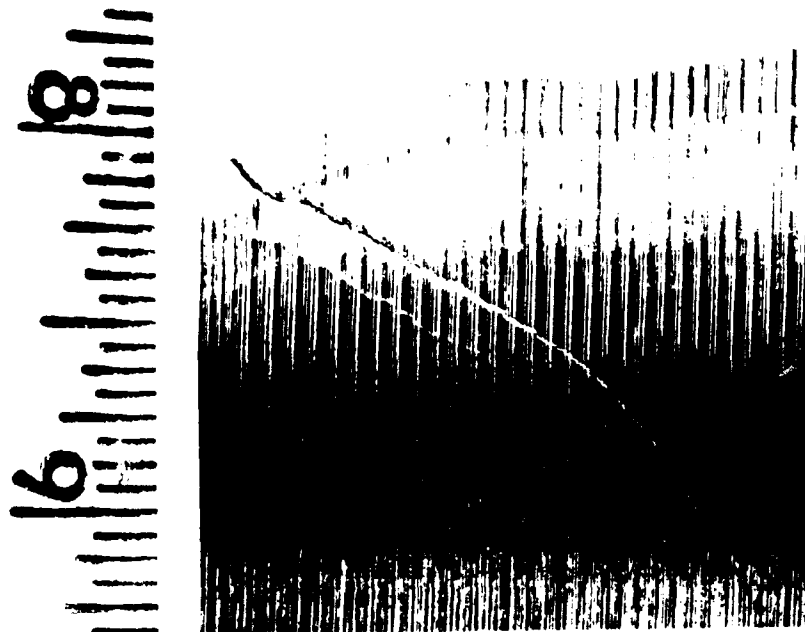
Figure 4b. High magnification view of secondary crack found in mandrel.

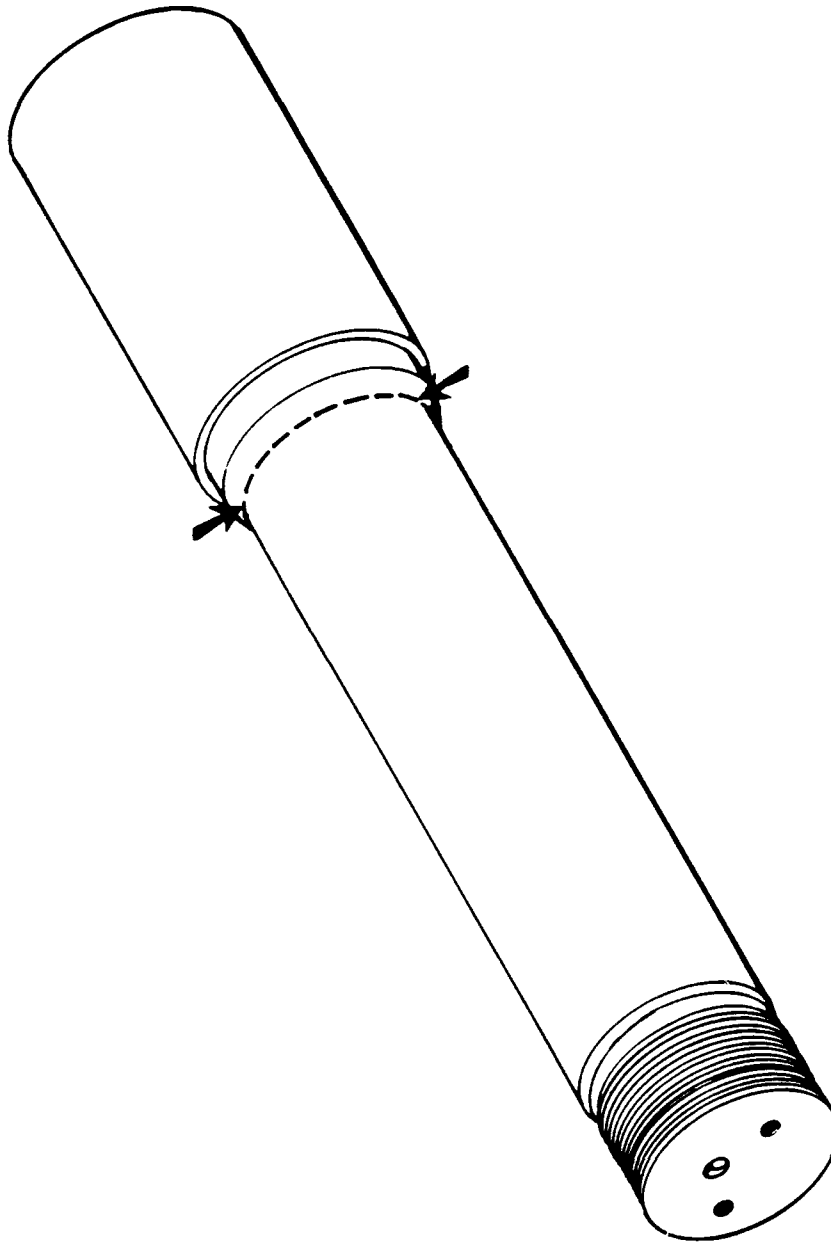
The mandrel fractured at the sharpest radius point as shown in Figure 5. When a post-failure inspection was performed on this area, the radius was measured and the average was determined to be 0.030 inch. This measurement,

although within specifications of $0.03R + 0.01$, was at the low end of the requirement, making this radius the sharpest acceptable within the above limits.

Figure 5. Schematic of fatigue testing mandrel showing location of failure.

To avoid similar problems in the future involving fatigue testing mandrels with deficient mechanical properties, it is imperative that a post-heat treatment hardness check be instituted. This will minimize the possibility of improperly processed material entering service. It is also suggested that more accurate receipt and material processing records be documented. Furthermore, we suggest periodic magnetic particle in-service inspections in the following order: post-fabrication, after the mandrel has been in service for 3,000 cycles, and subsequently every 1,000 cycles. The mandrel should be retired at the instant cracking is exhibited during inspection.

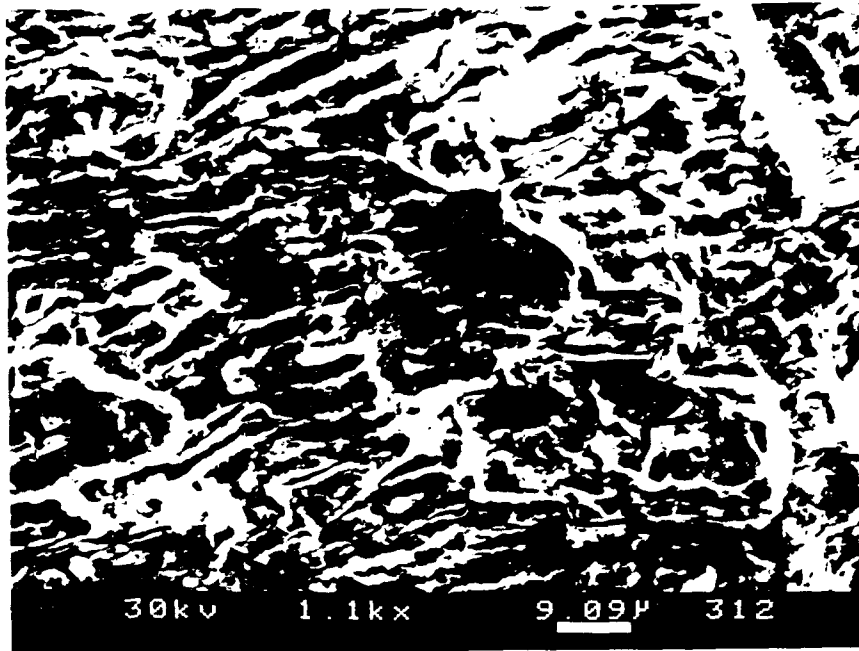
Scanning electron microscopy (SEM) was used to characterize the fracture surface of the mandrel. The most prevalent feature discovered throughout the outer two rings, R1 and R2, was the presence of fatigue striations, depicted in

Figure 7a. SEM fractograph showing fatigue striations discovered on fracture surface. Backscatter emission (150X).

Figure 7b. Fatigue striations found on fracture surface. Backscatter emission (470X).

Figure 7c. High magnification fractodograph of fatigue striations. Secondary emission (1100X).

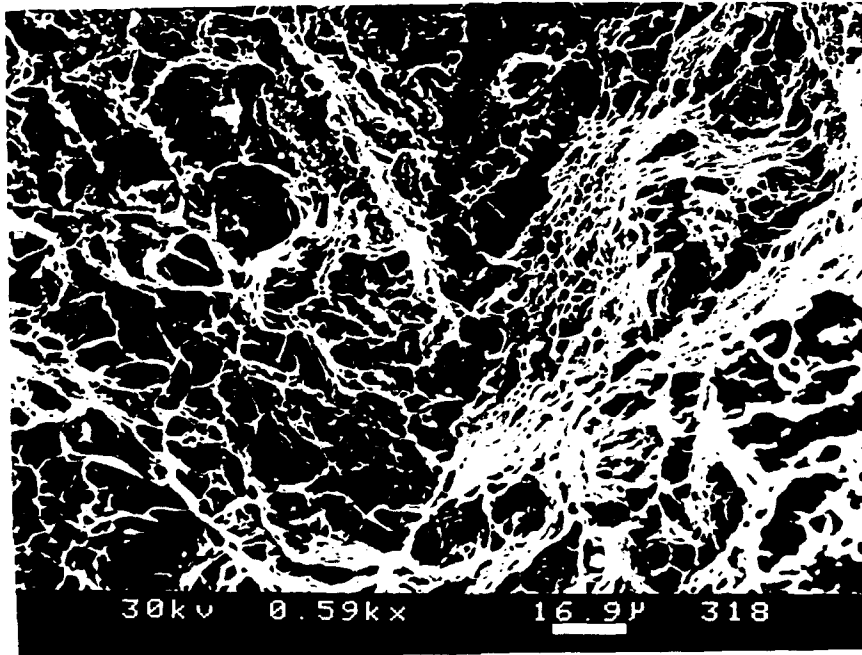
Figures 7a through 7c. In contrast, the center region of the fracture surface displayed rather ductile characteristics, as shown in Figure 7d.

Figure 7d. Ductile rupture discovered in center region of fracture surface. Secondary emission (590X).

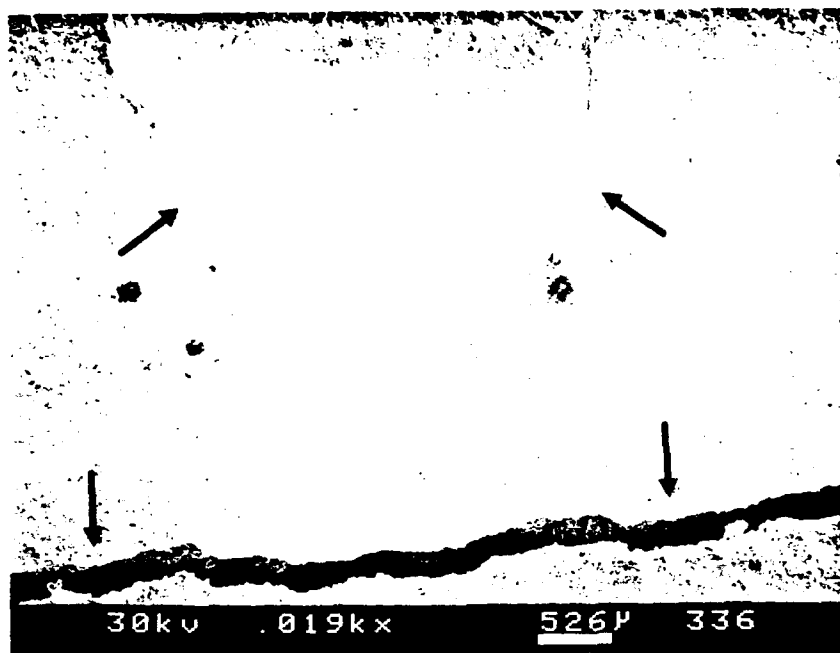
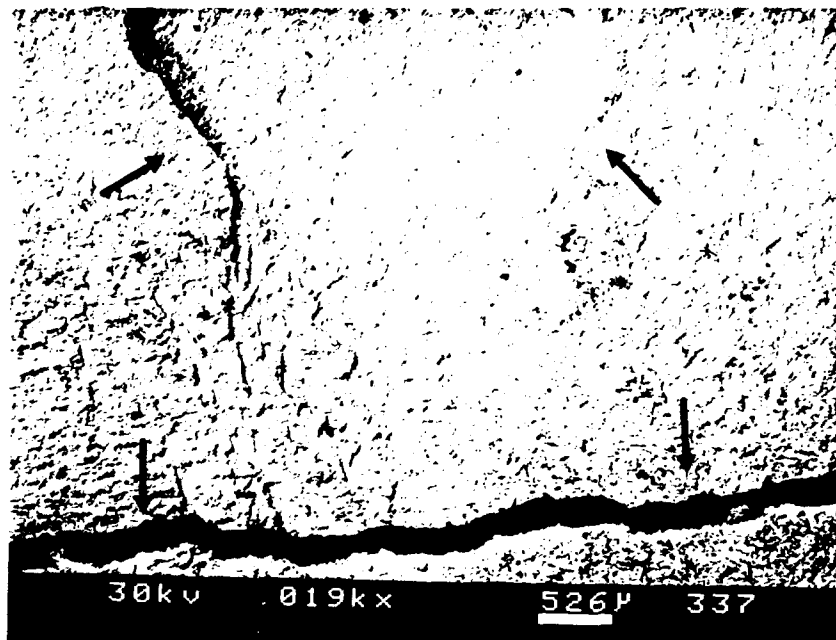
Figures 8a and 8b illustrate one of the niche-shaped indications and the circumferential crack. This indication may have been an initiation site for the primary (fatigue) crack. Since fatigue was present in substantial amounts, this crack likely propagated to critical size by this mechanism. As stated earlier, two secondary cracks were found propagating at 45-degree angles to both the fatigue crack and the transverse plane. One crack was opened for examination. Figures 9a and 9b depict the fracture surface and the intergranular nature of this crack.

Figure 8a. Fractograph showing secondary crack and large indication. Secondary emission (19X).

Figure 8b. Large indication and secondary crack discovered on fracture surface. Backscatter emission (19X).

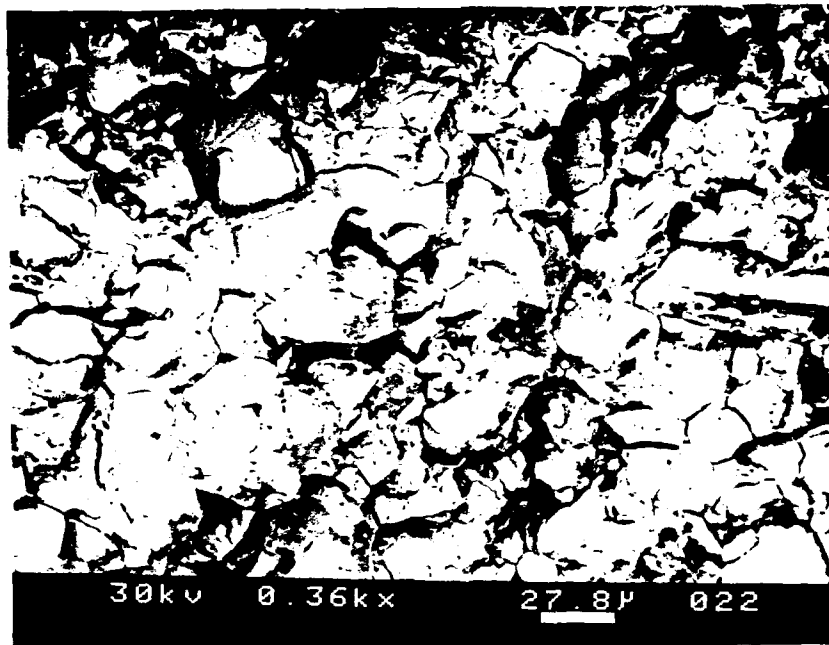
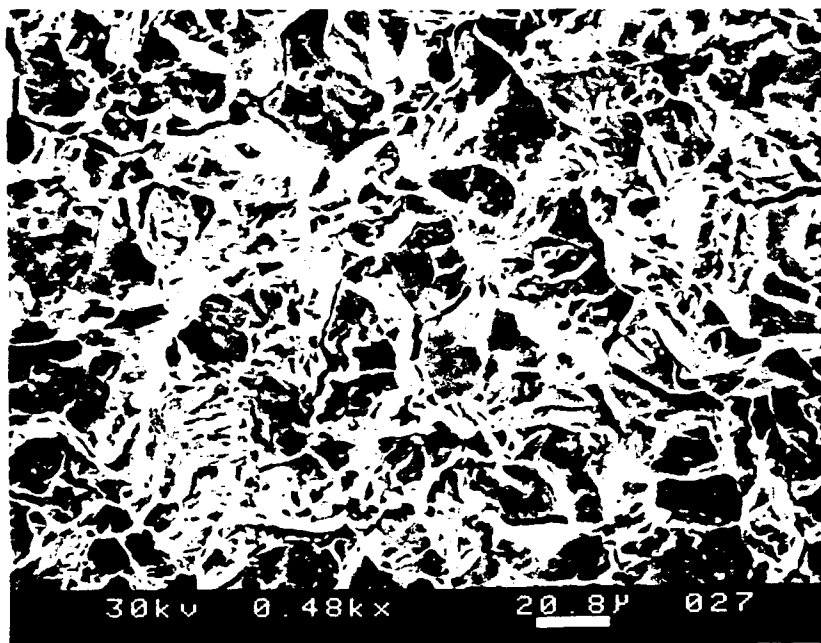
Figure 9a. Fractograph of secondary crack showing intergranular cracking. Backscatter emission (360X).

Figure 9b. Fractograph of secondary crack showing intergranular cracking. Secondary emission (480X).

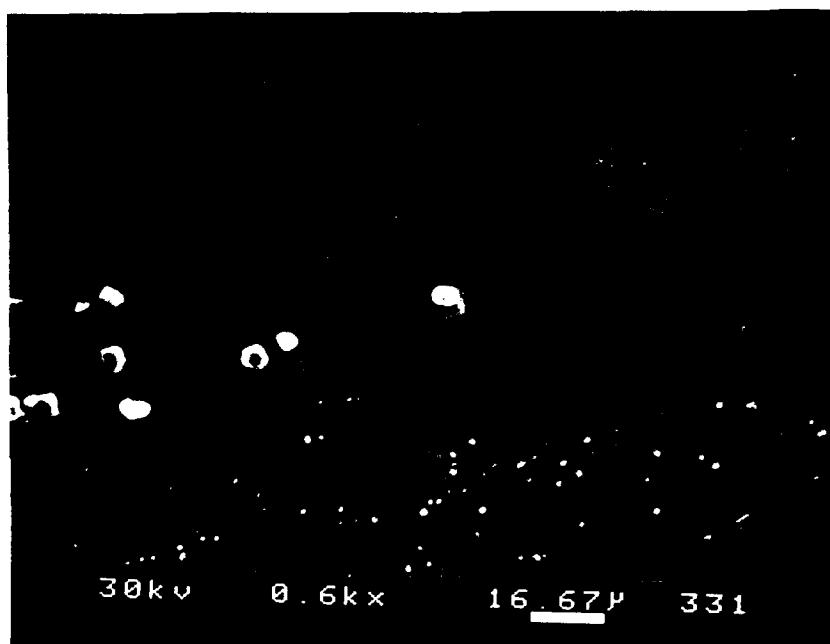
Energy dispersive spectroscopy (EDS) was conducted on the metallographic samples, and the two particle types that were analyzed are displayed in Figure 10. The results in Figure 11 show that the bright, globular-shaped particles are titanium-rich, common to maraging steels, while the elongated particles are additionally rich in molybdenum as illustrated in Figure 12.

Figure 10. SEM micrograph showing globular and elongated particles. Backscatter emission (600X).

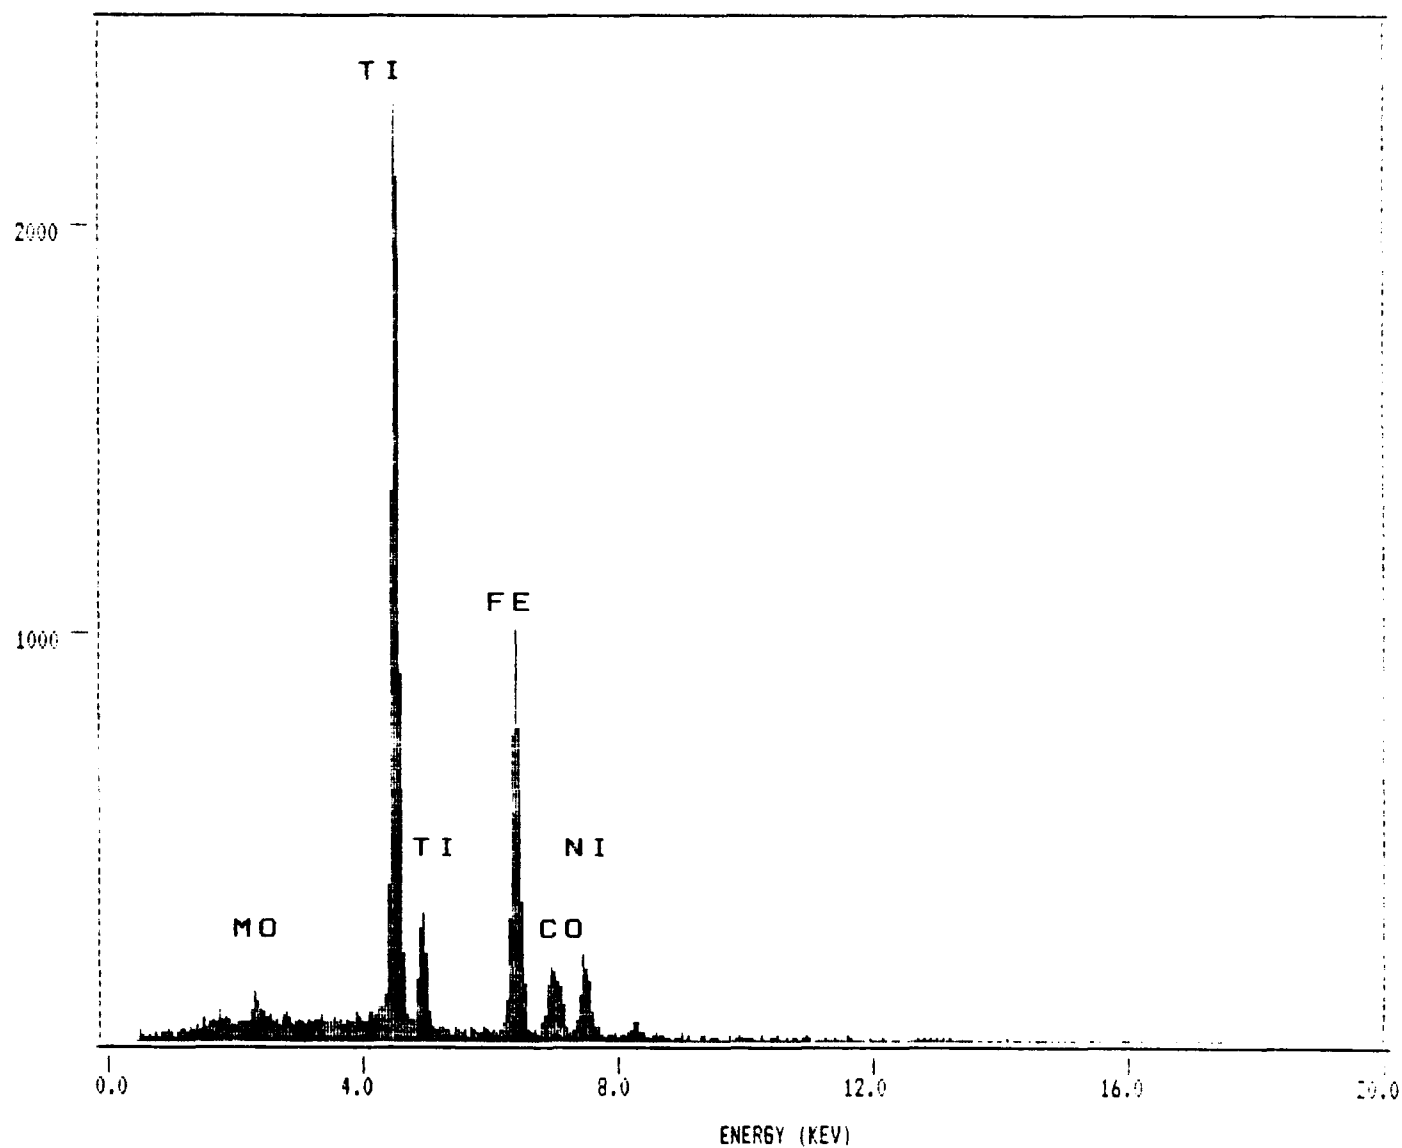
Figure 11. EDS analysis of globular particle.

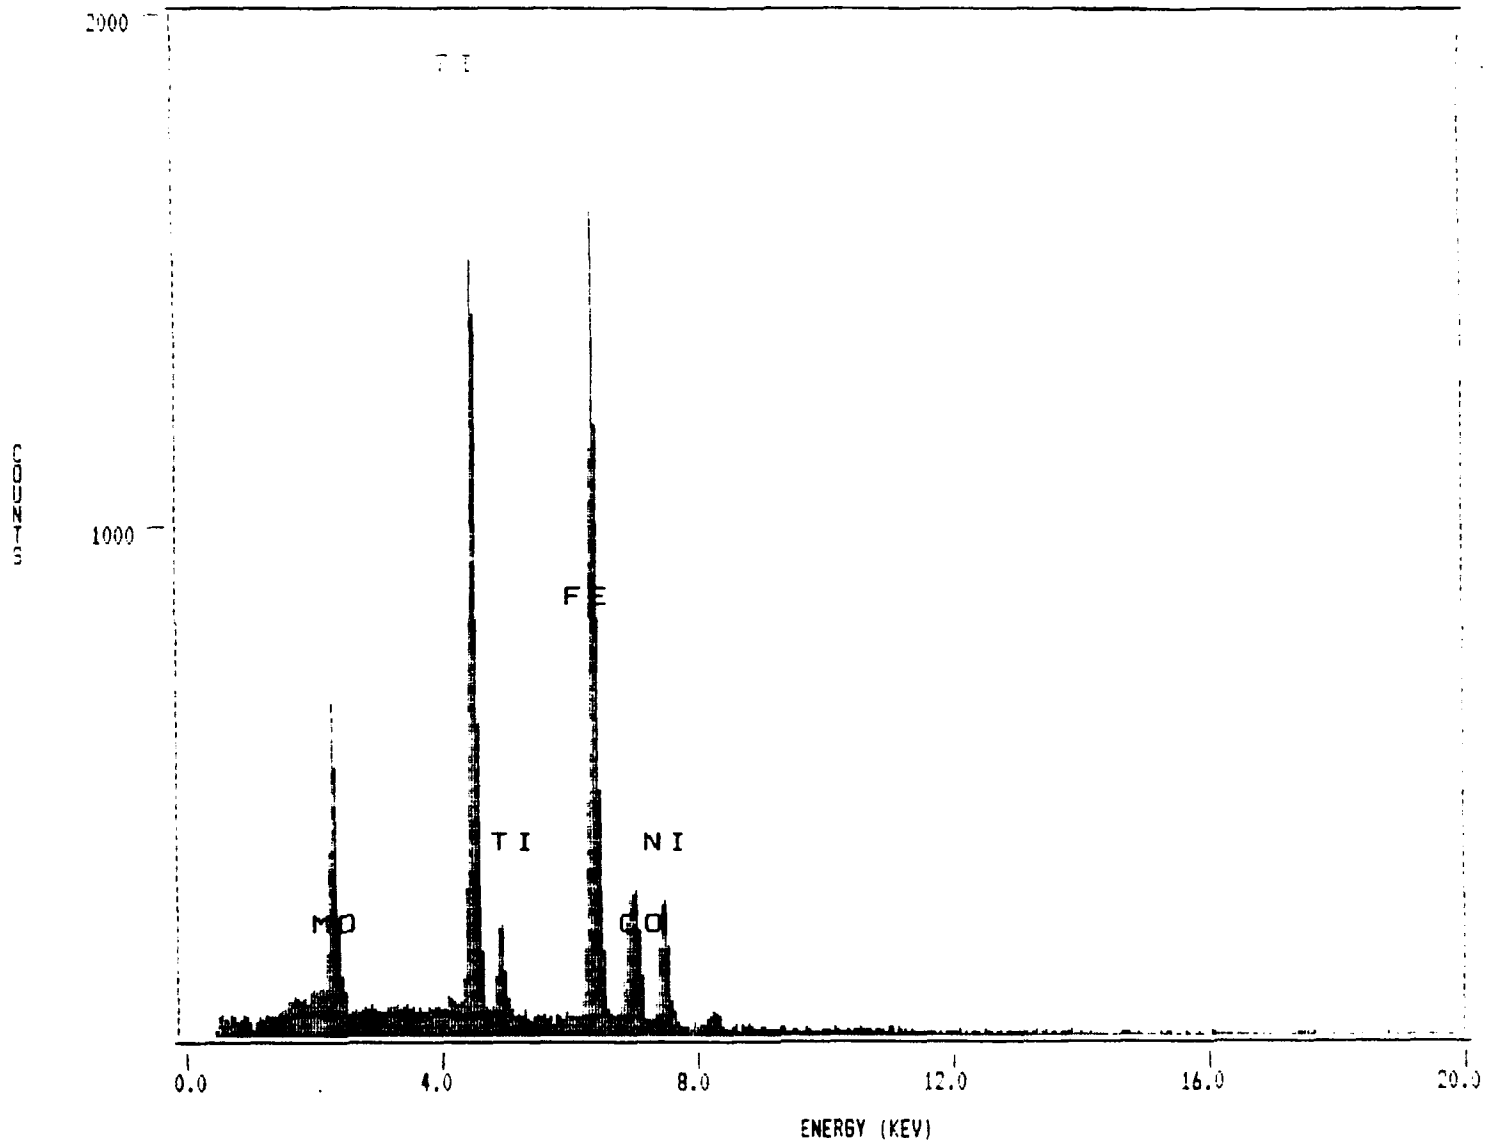
Figure 12. EDS analysis of elongated particle.

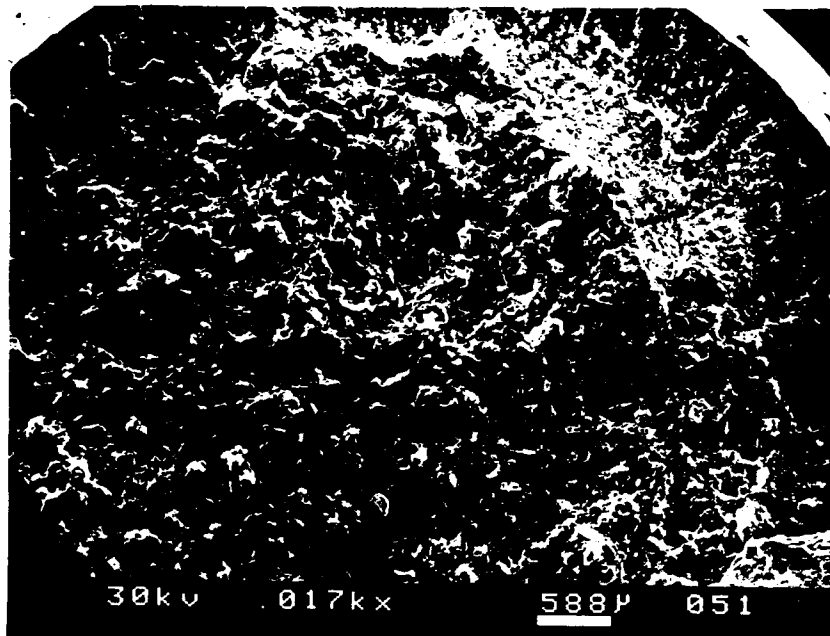
Figures 13a, 13b, 14a, and 14b reflect the SEM investigation of tensile and Charpy test bars, respectively. At low magnification, the tensile test bar appeared to have a coarse, granular-type appearance in the fracture region. Upon closer investigation, the fracture mode was identified as microvoid coalescence, characteristic of a ductile material, as was the Charpy fractograph shown in Figure 14a. Figure 14b depicts a magnified region of a Charpy bar that contained several titanium particles. These particles were found sparsely distributed throughout the ductile fracture surface.

Figure 13a. SEM fractograph showing the shear lip and fracture region of longitudinal tensile test bar. Secondary emission (17X).

Figure 13b. SEM fractograph depicting ductile appearance of longitudinal tensile test bar. Secondary emission (49X).
